2020
Jordan River Parkway
Inventory

The purpose of this document is to record the results of an inventory project conducted by the Jordan River Commission in the summer of 2020. This inventory explored the differences in trailside amenities and design aspects through extensive fieldwork and data collection. Fieldwork and data collection was completed by Commission staff, two University of Utah interns, and assistance from Wasatch Adaptive.

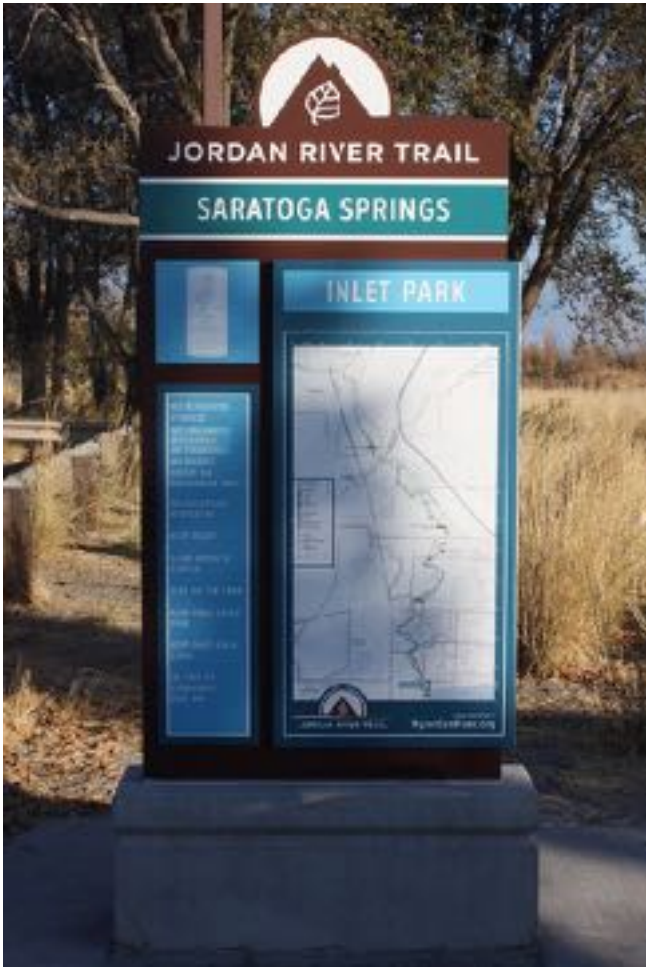
Inlet Park Trailhead

Site Notes: Large park with fishing areas, a playground, pavilion, and open space.

Several sections of broken pavement, bridge has a raised ledge that may caused tripping, and there is fair amount of litter along the trail in the park.

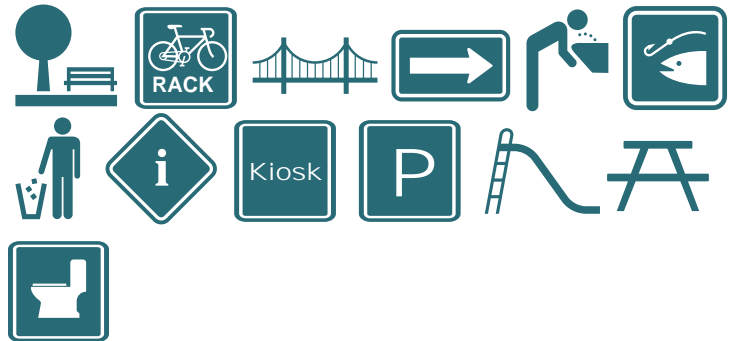
Features

Condition: Needs Improvement

Condition: Good

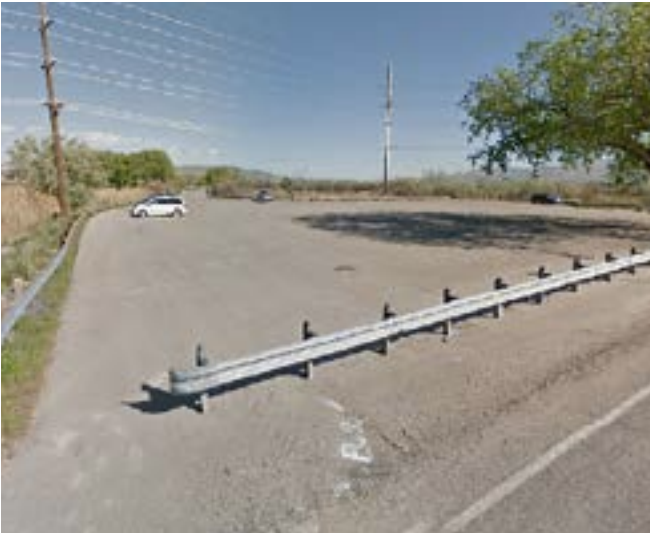
Trail: Inlet Park to RC Airplane Park

Short section of trail (with crosswalk) connecting the two trailheads.

Condition: Good

Width: 10'

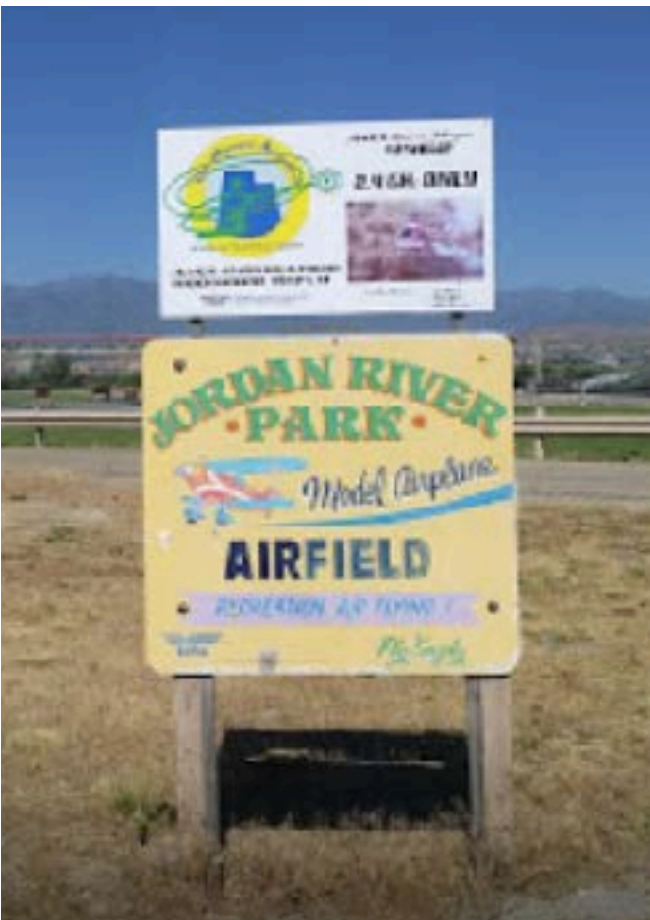
Saratoga Springs Radio Controlled Airplane Park

Site Notes: Remote control airplane park with Port-O-Potties, picnic tables, open grass area, and fishing.

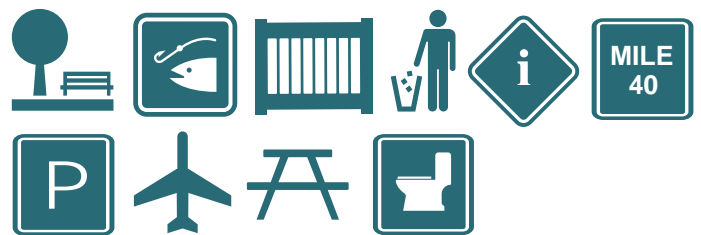
Features

Condition: Fair

Some areas with broken pavement.

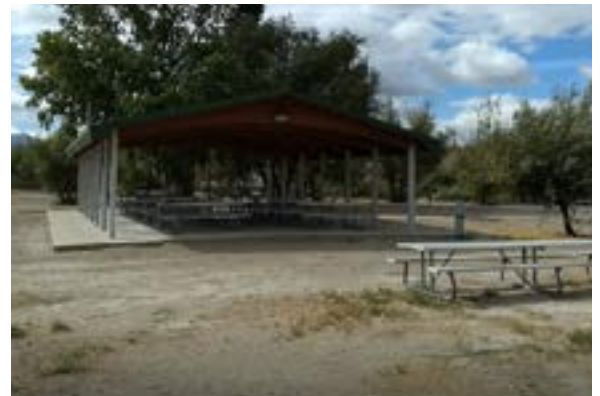
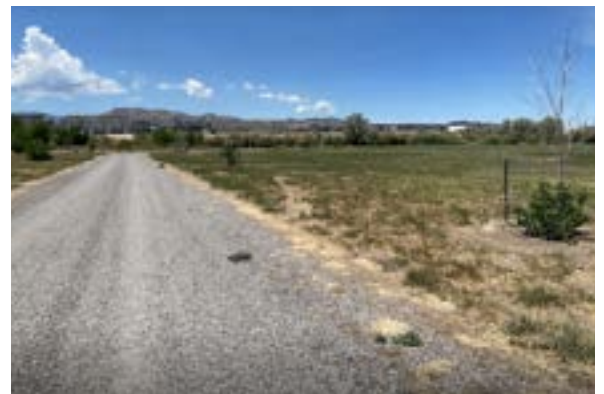
Concerns

Lots of puncturevine and problems with weeds.

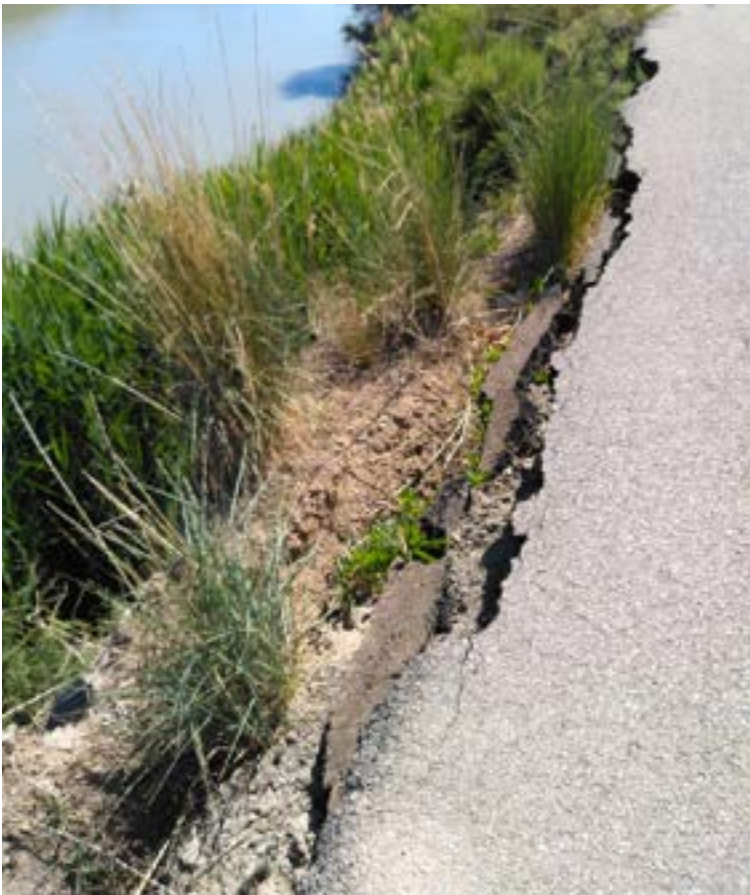
Concerns

Crumbling areas of trail with a steep drop off around coordinates 40°25'14.0"N 111°53'51.4"W. One unmarked crosswalk. Graffiti on the bridge.

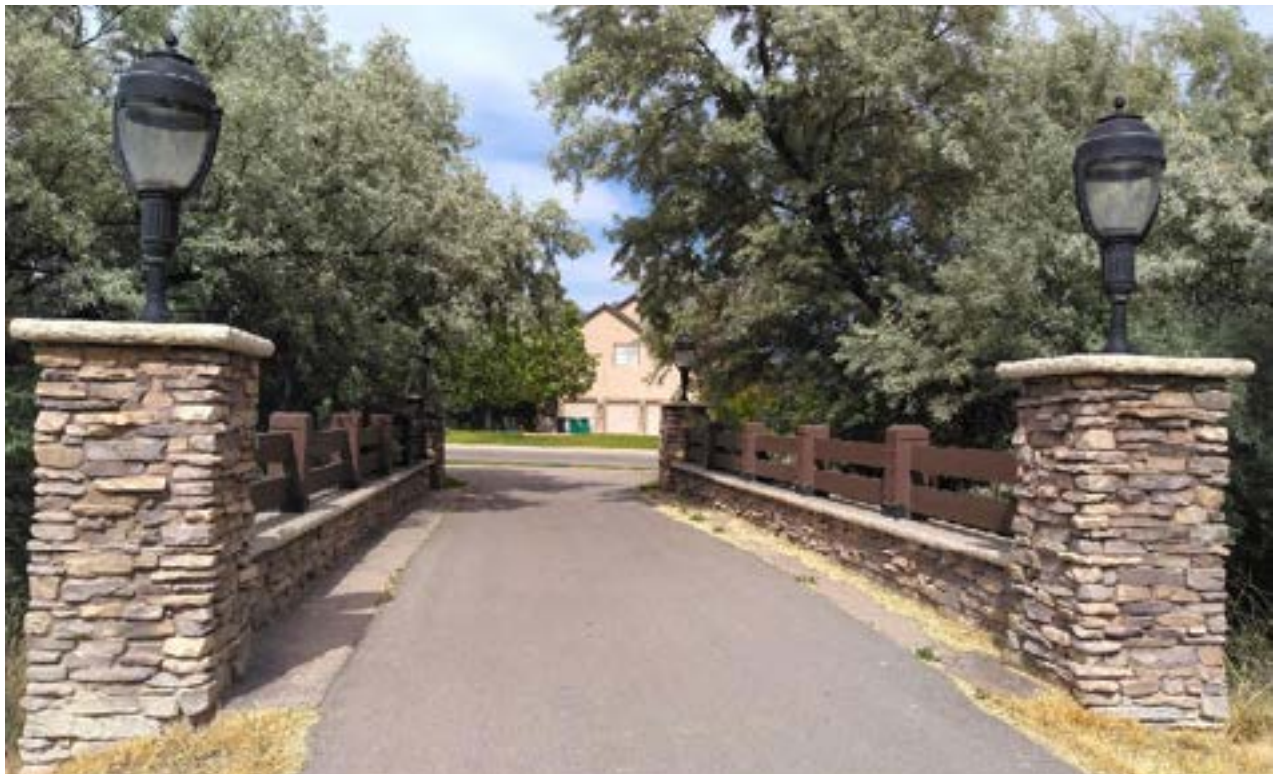
Concerns

Some narrow bridges, crosswalk buttons may be too high for those in wheelchairs. Sharp curbs on bridges.

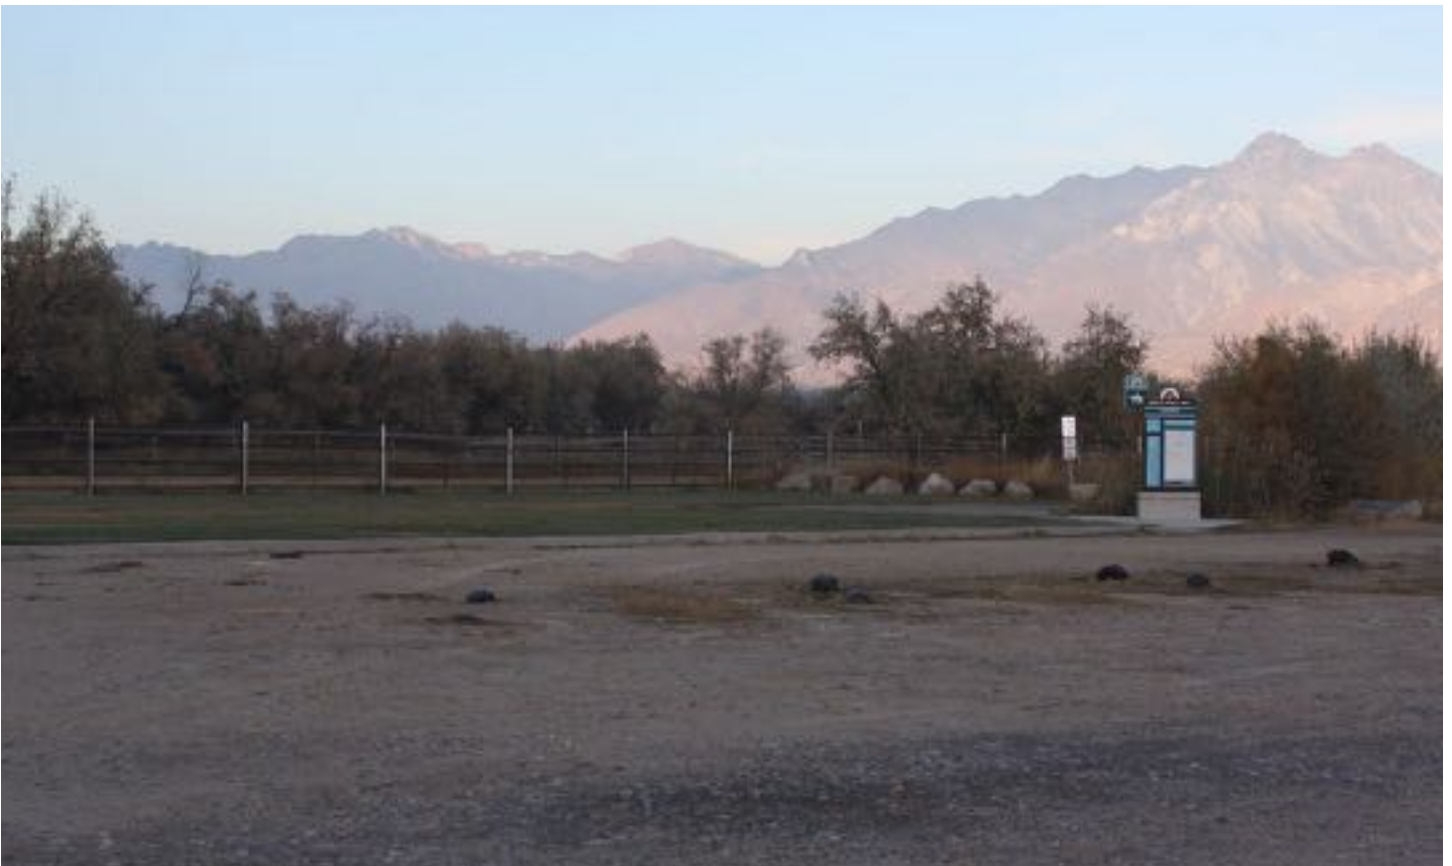
Concerns

The parking lot is unpaved and full of weeds. No marked accessible parking.

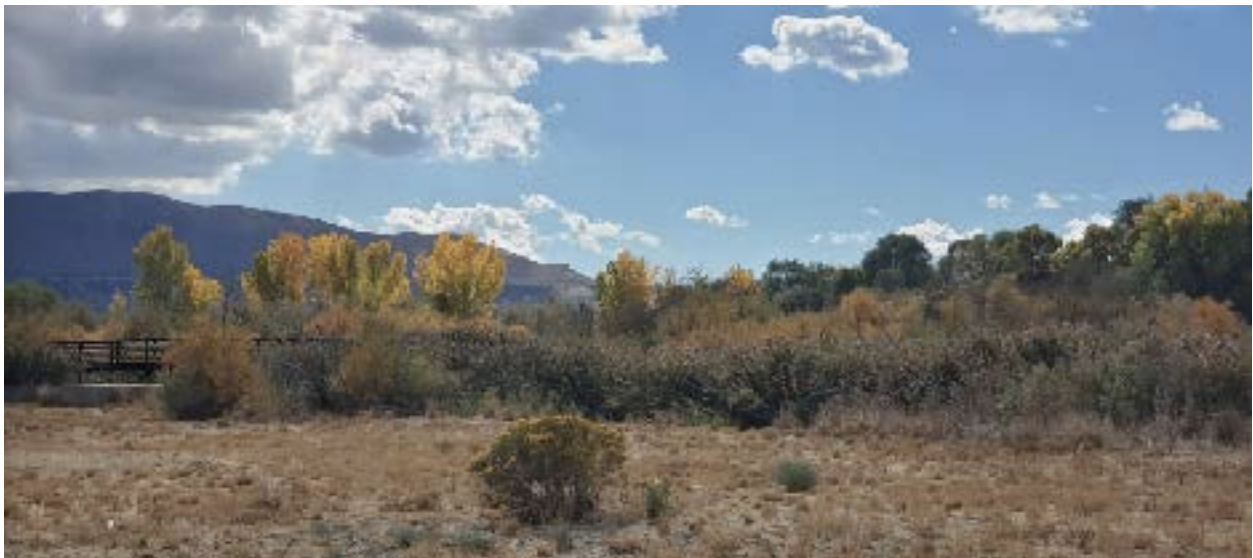
Concerns

Confusing signage makes connector trail seem like main trail.

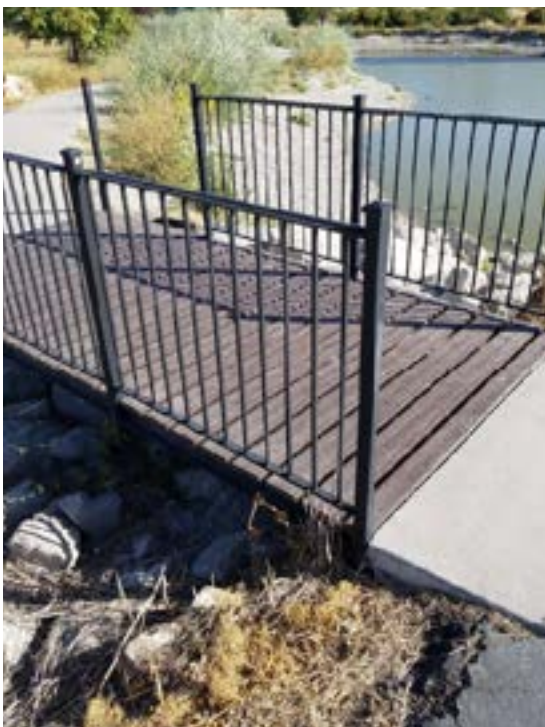
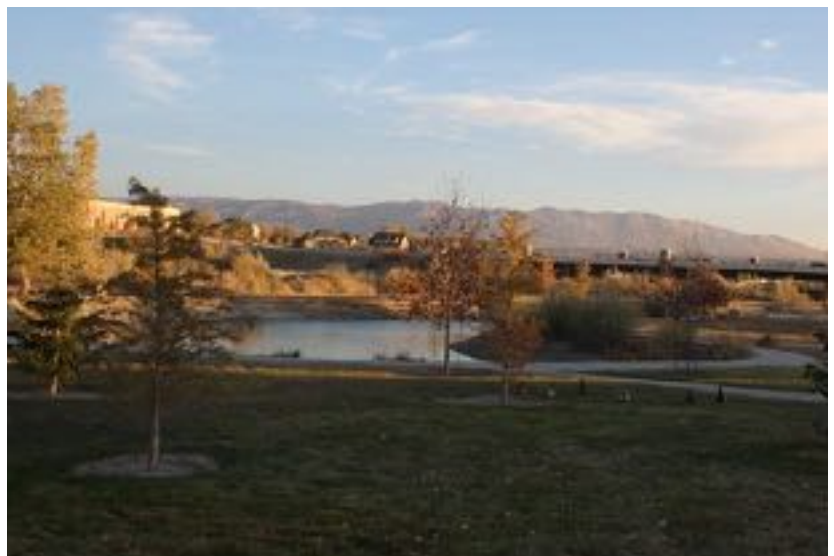
Concerns

Some narrow sidewalks and a small bridge with a sharp turn for bikes.

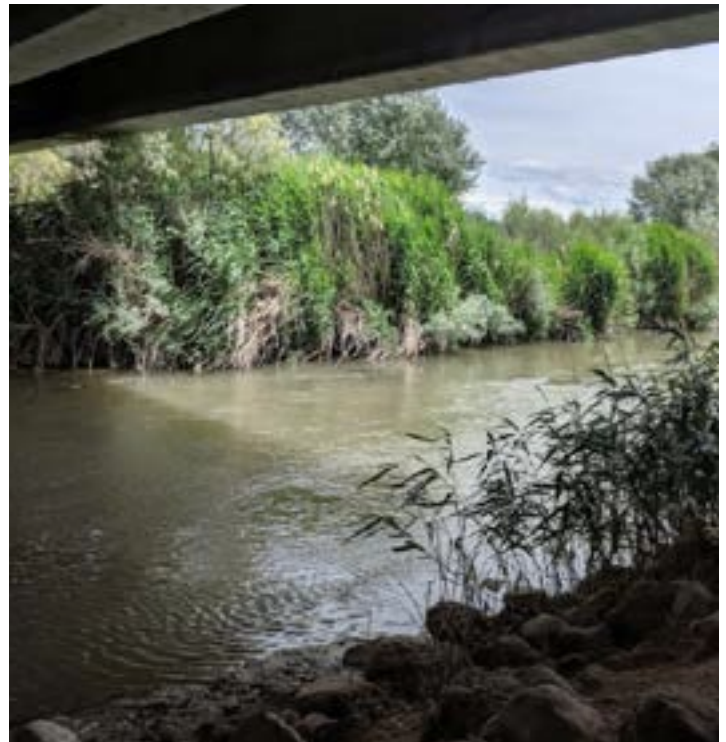
The underpass at South Jordan Parkway has a blind turn and a 6 degree incline that could be difficult for some.

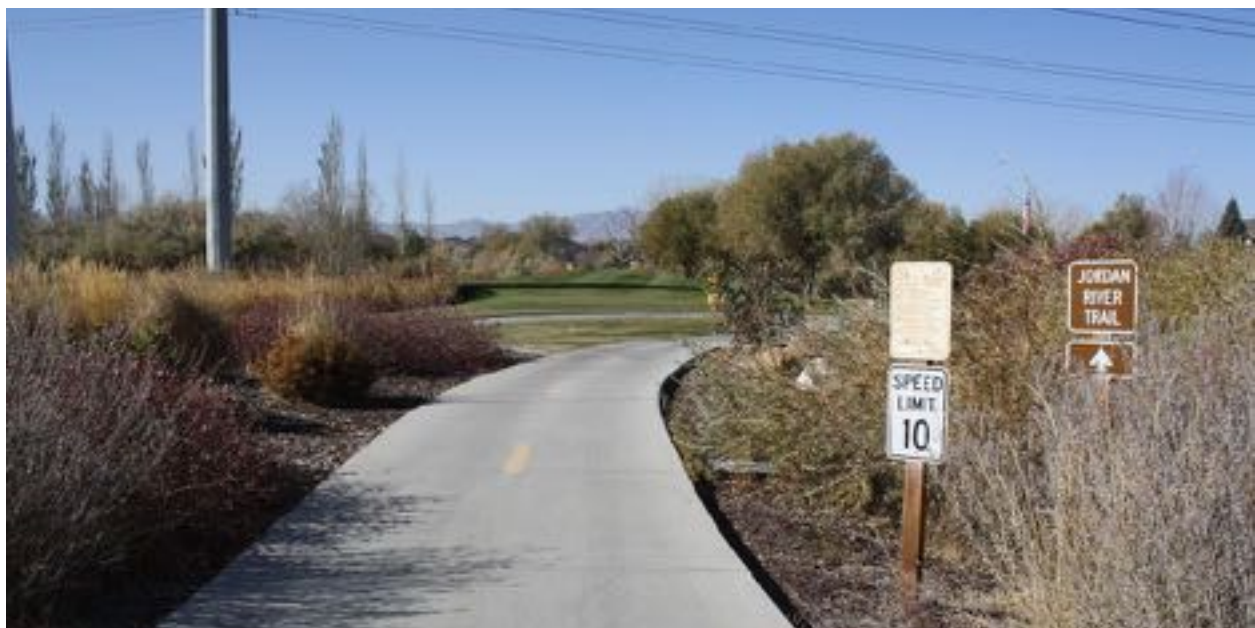
Can be confusing to navigate just before the tunnel at the driving range. The bridge connecting the 7800 S Trailhead to Gardner Village and Trax is south of the 7800 S trailhead. Because of this, the 7800 S Trailhead can easily be bypassed. Navigation can be confusing, and improved directional signage would be beneficial.

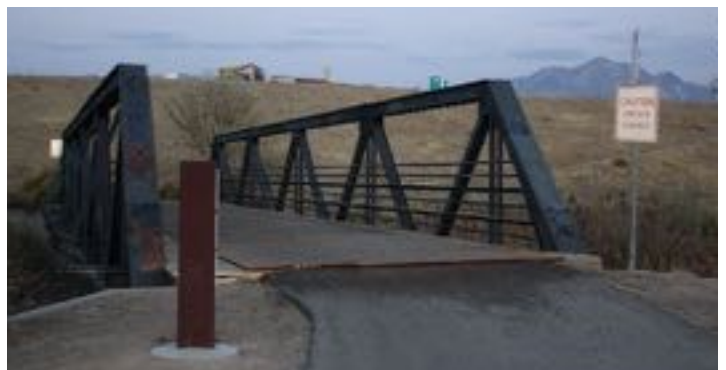
The bridge just south of the 7800 S Trailhead connecting to the west side of the river is covered in plywood and in severe need of repair. The underpass at 7800 S is also covered in plywood, prone to flooding, and in severe need of repair (see page 59 for picture).

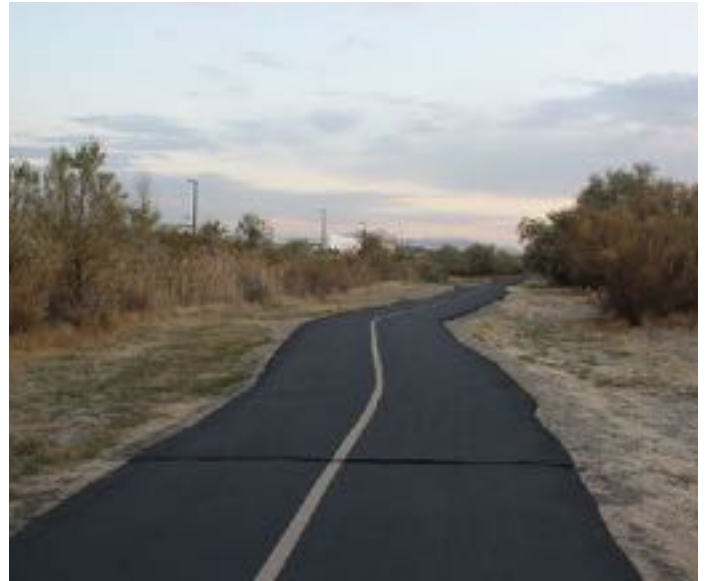
The bridge connecting the main stem of the trail is in very bad condition, however, there is an optional gravel path. Directional signage is confusing and can make it seem like the neighborhood connector trail heading west is the main trail.

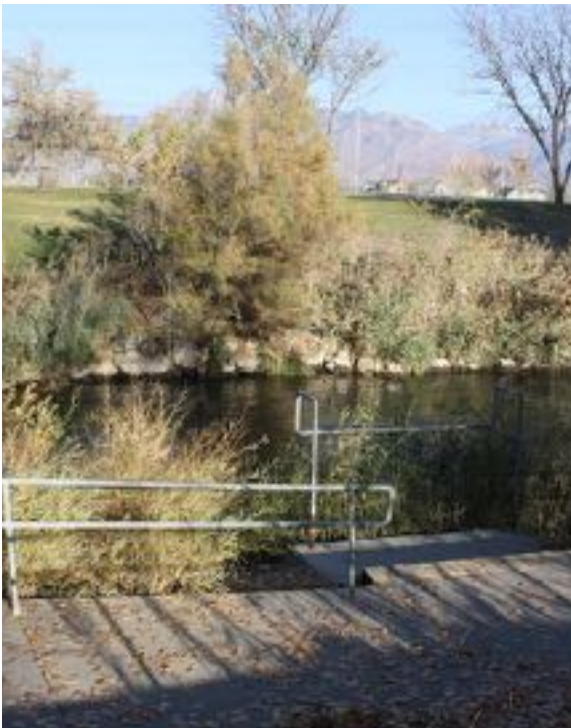
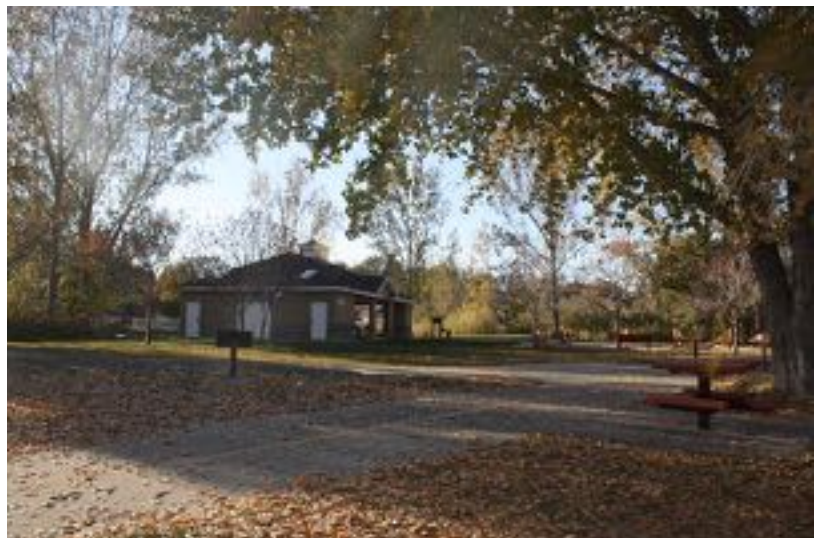
Directional signs could be lower for wheelchair visibility. Boat ramp is not wheelchair accessible. Restrooms could be made more accessible with a bathroom door assist button. No recycling cans available.

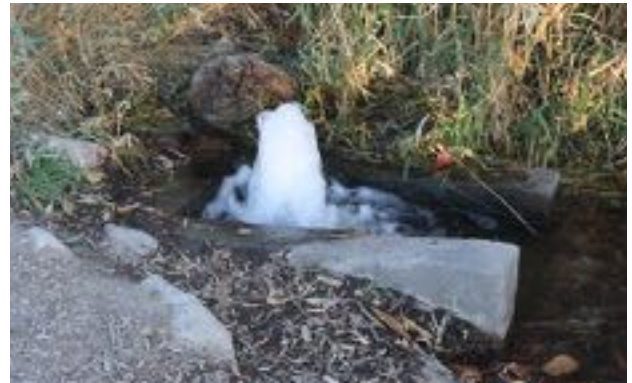
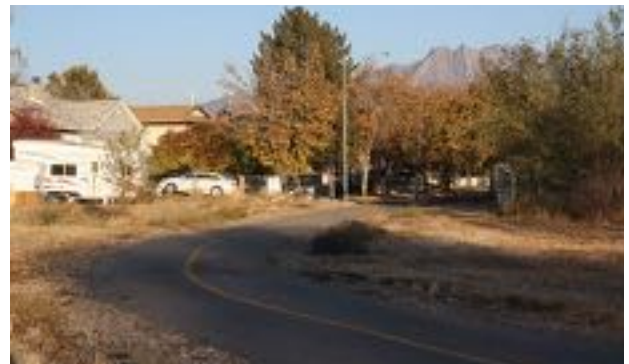
Crosswalk button at 5800 S is too high for small wheelchairs. On the edge of the river, there seems to be a broken pipe gushing water.

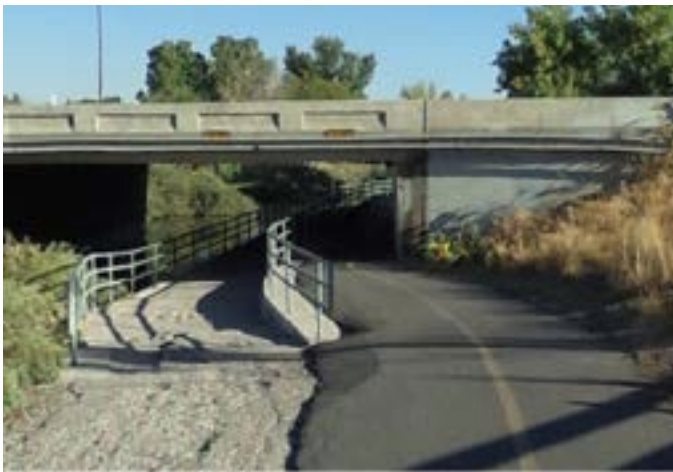
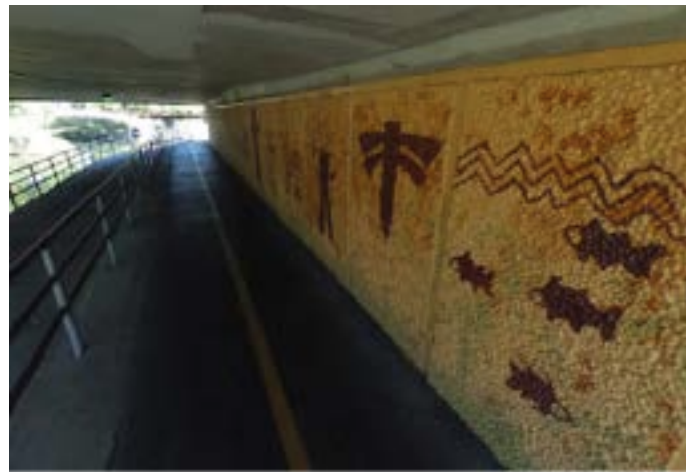
North end of underpass is very narrow at 7' wide. Needs warning sign cautioning, "slow down." Could also use reflective line painting, brighter lighting, and a larger directional mirror.

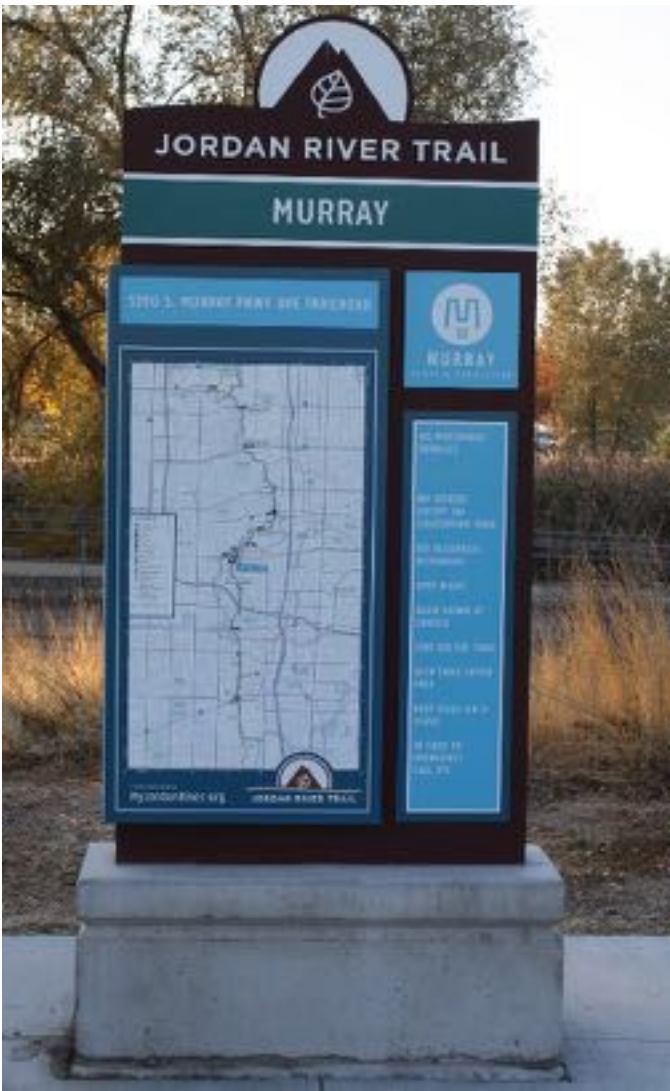
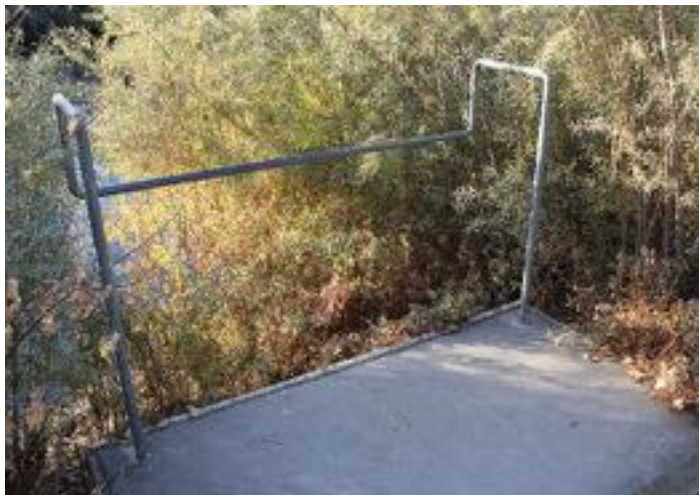
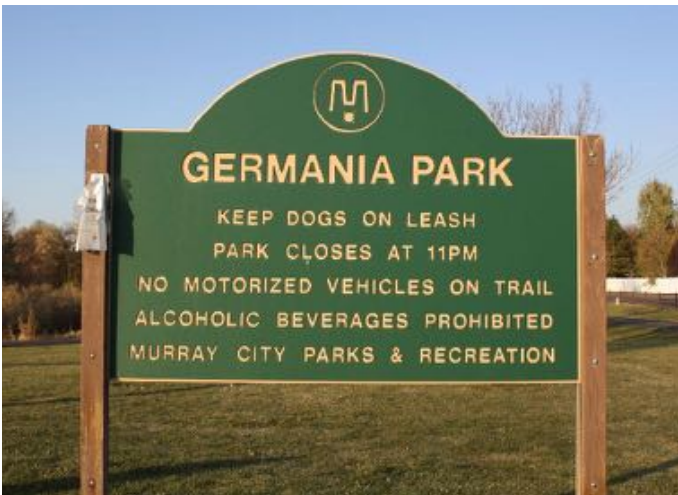
Boat portage appears to be inaccessible.

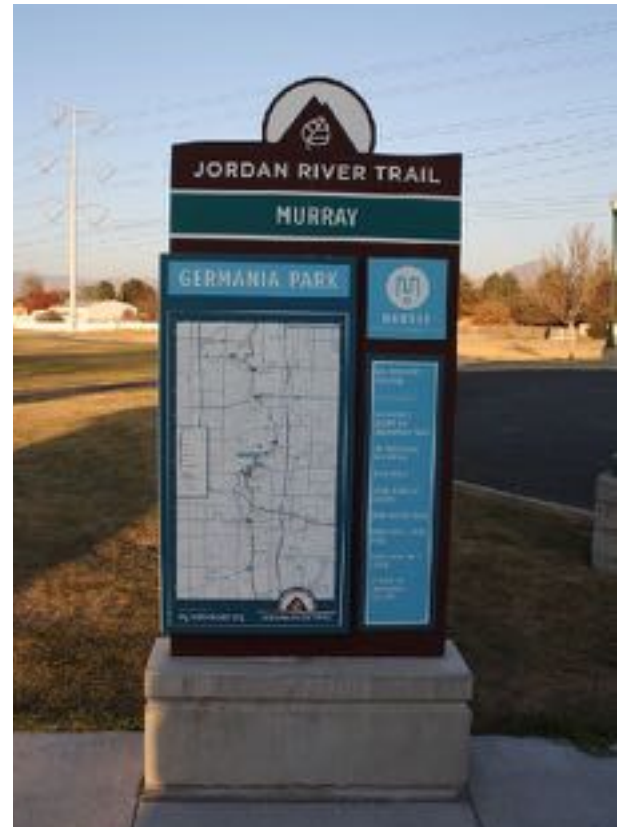
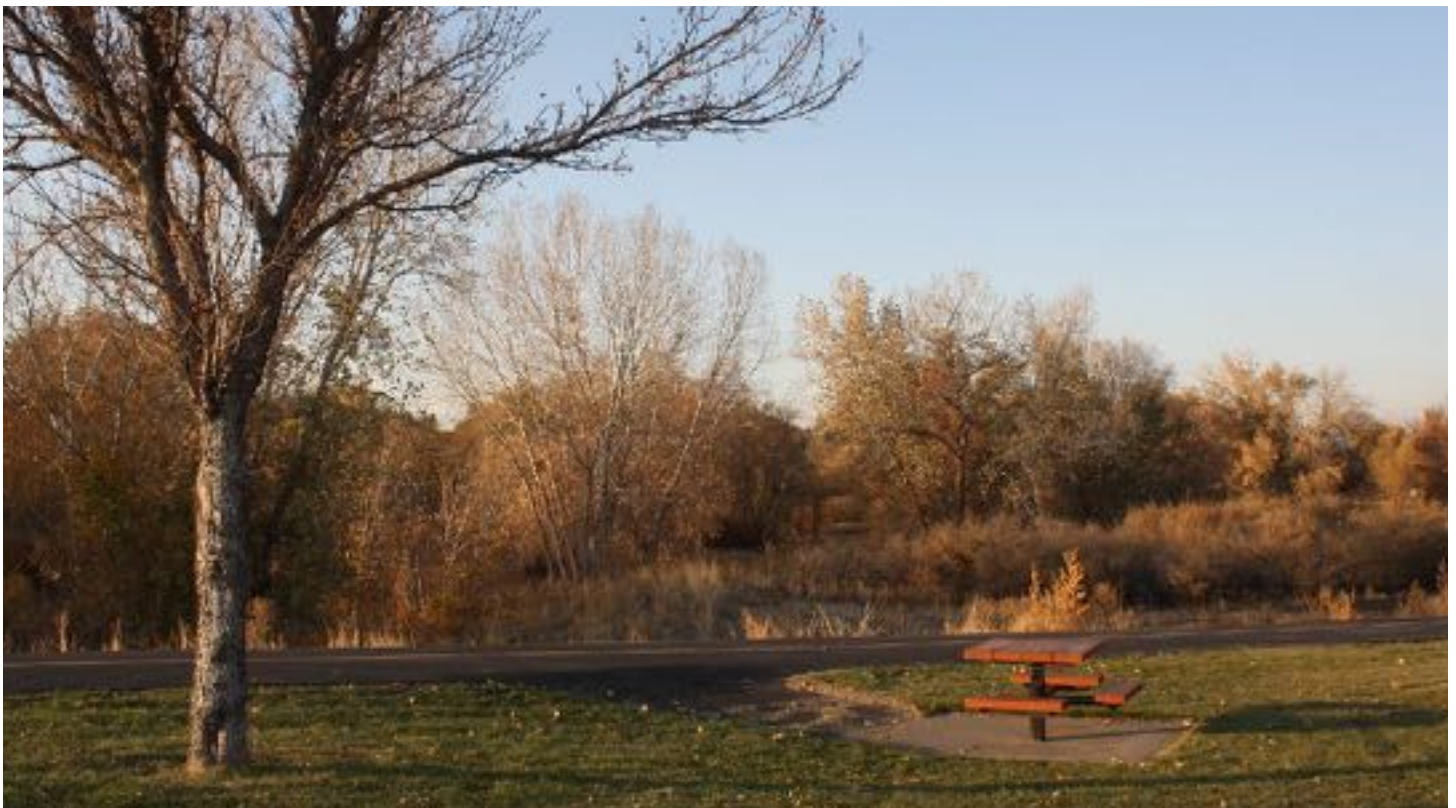
No cutout adaptive wheelchair picnic tables. No recycling receptacles.

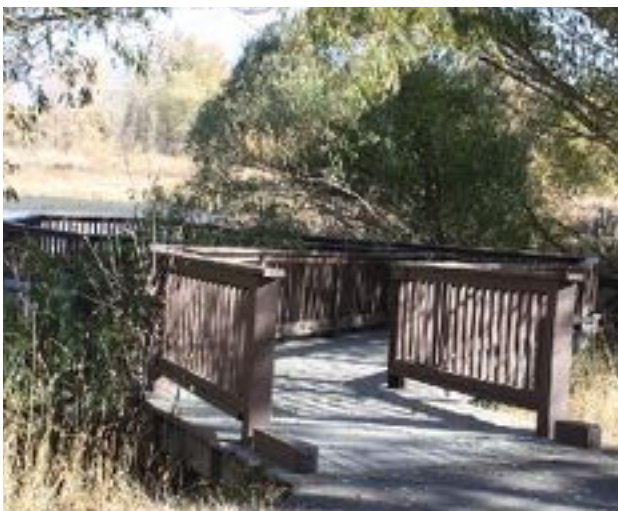
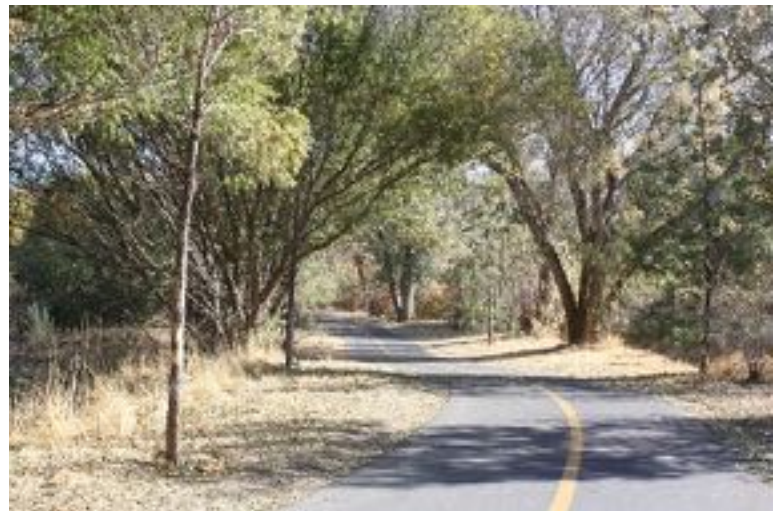
Raised pavement may pose a tripping hazard.

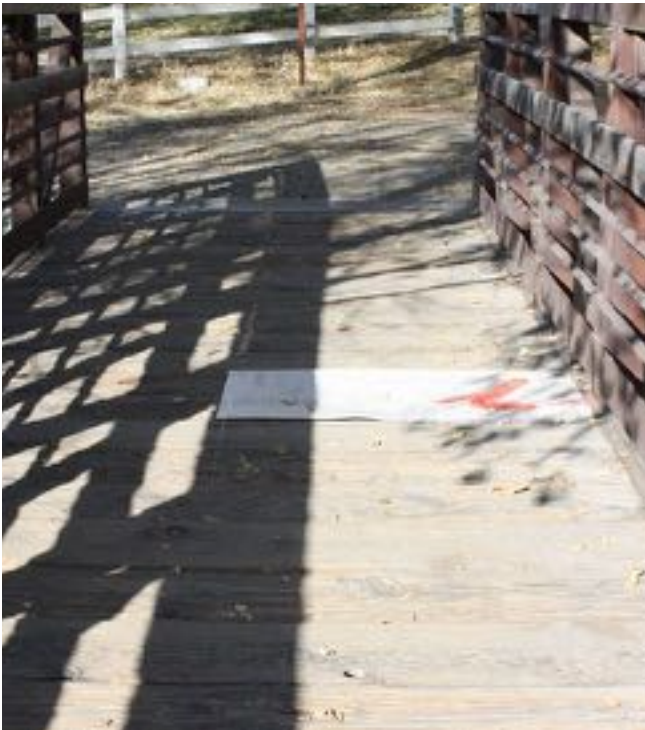
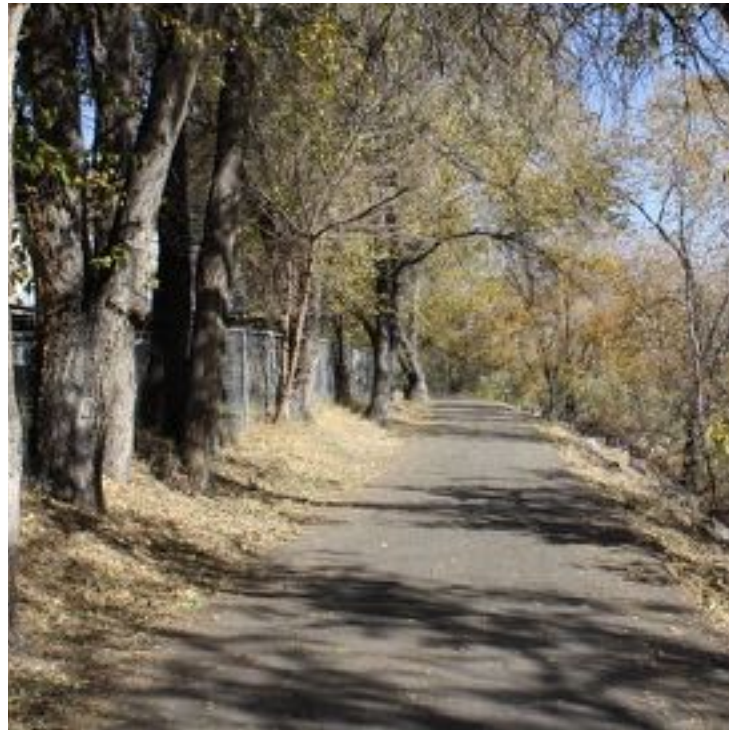
Some wide gaps on bridge between planks. Some planks also feel wobbly. There is a metal sheet nailed down.

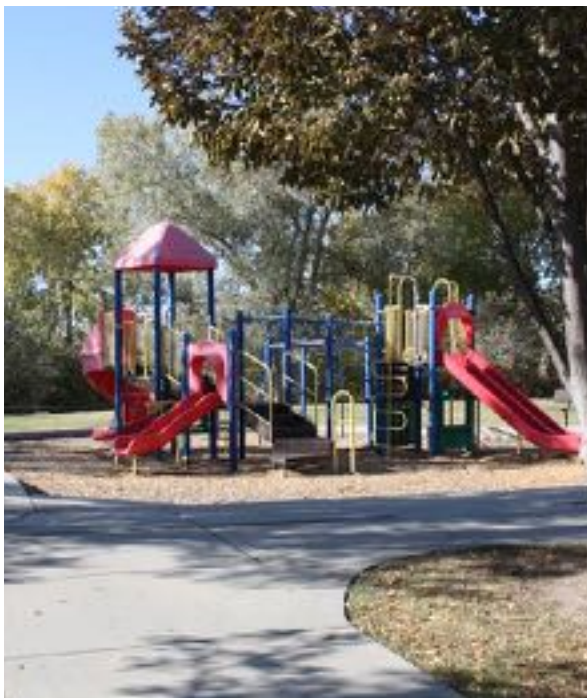
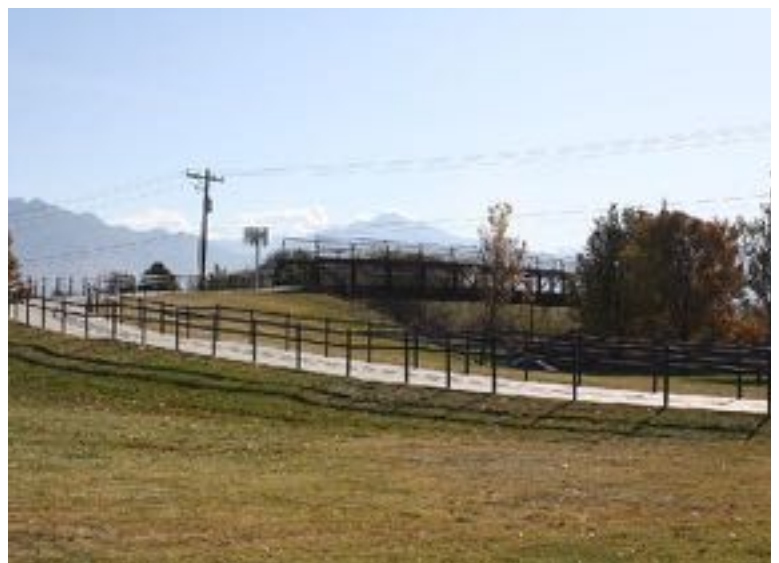
7" drop off from concrete to playground.

Playground has accessible ramp but playground is not accessible due to wood chips. No recycle cans. No wheelchair accessible picnic tables. Lots of weeds.

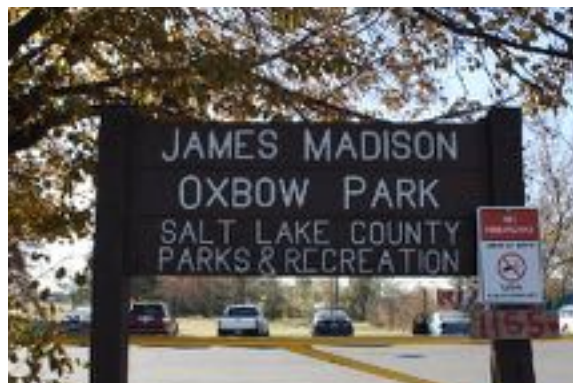
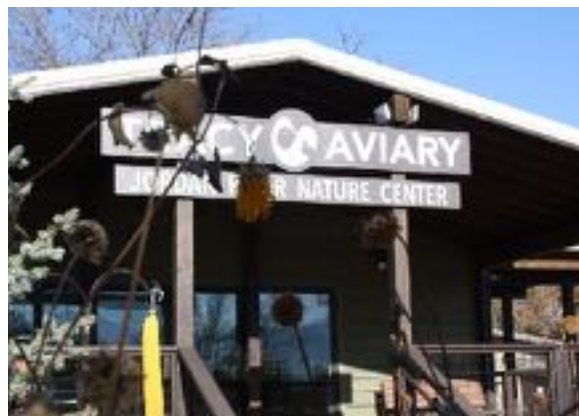
The official boat launch is inaccessible.

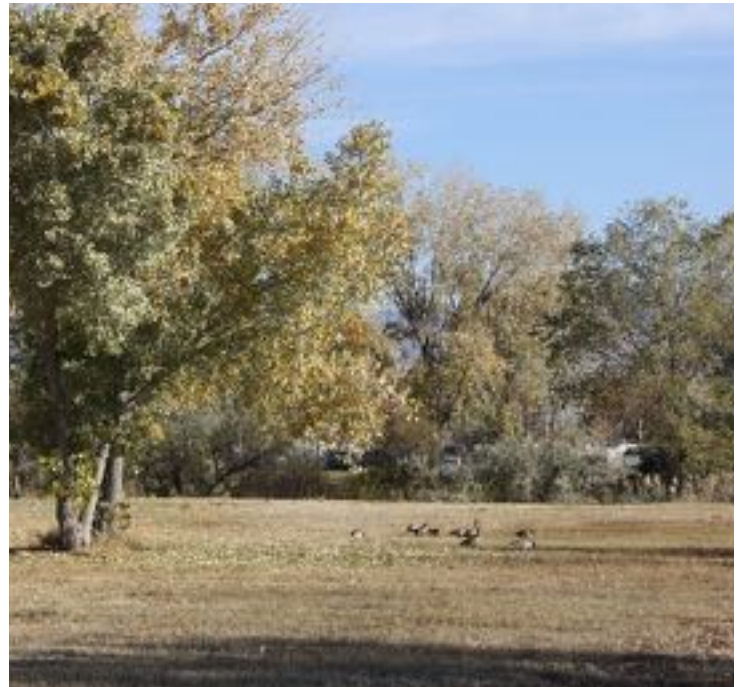
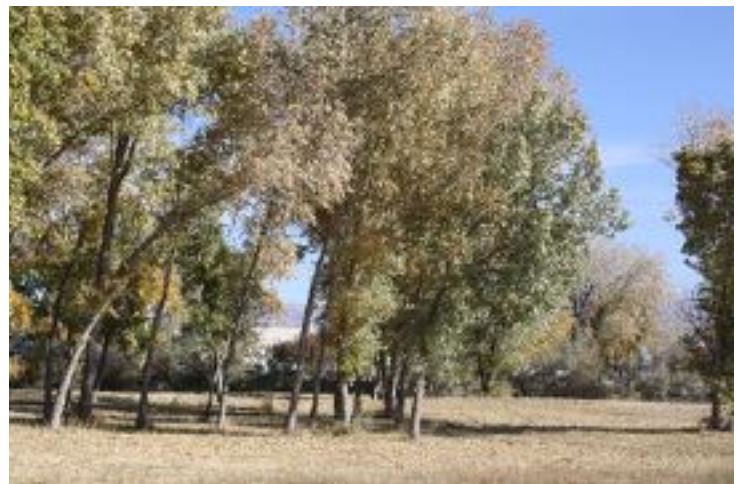
The underpass at 3300 S is narrow and there's a sharp incline on the north side of it. The pavement by the surplus canal in poor condition. There was a moderate amount of litter and lots of puncturevine growing in this area. The first bridge is narrow.

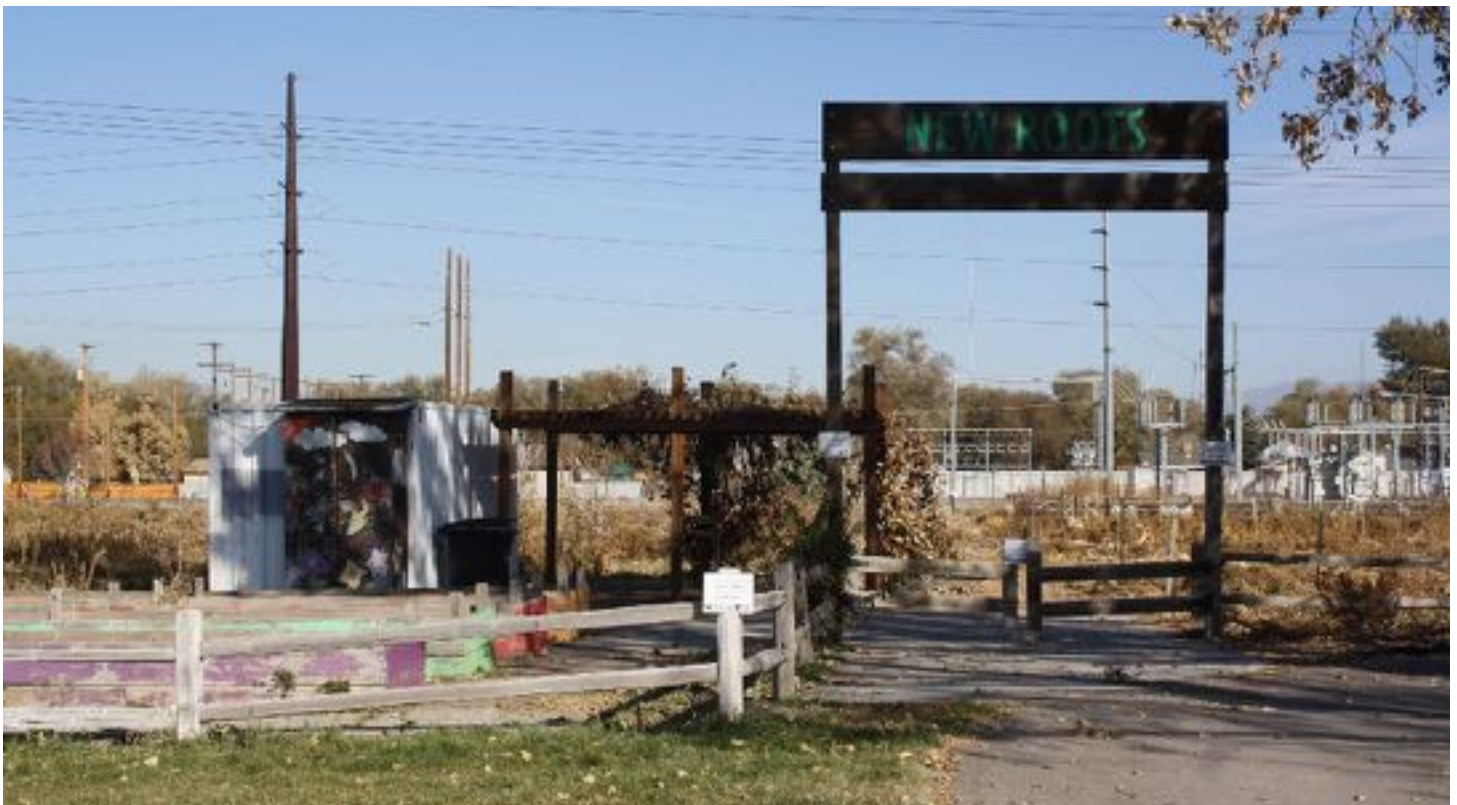
Trail: Lester Street Connector

Notes: Good by playing fields, worse by the farm—tree roots have raised and cracked the pavement.

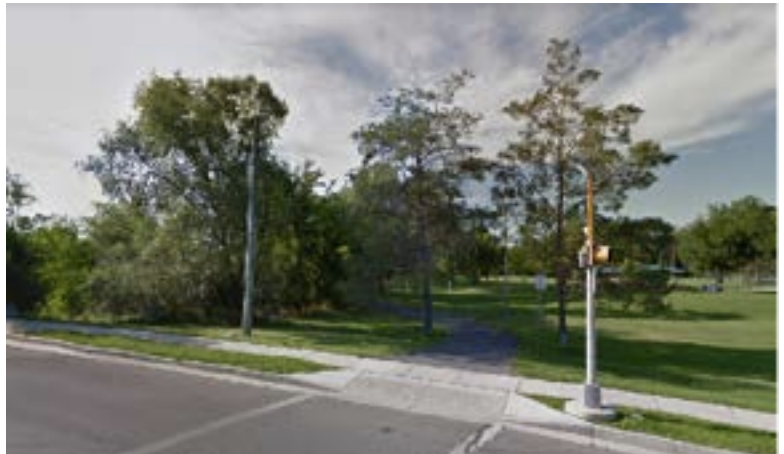
Jordan Park

Site Notes: off-leash dog park, skate park, horseshoe court, 2 pavilions, 2 volleyball courts, bike polo court, 3 playgrounds. Home of the International Peace Gardens. There is one bridge at the southwest end of the park that connects to the trail on the west side of the river.

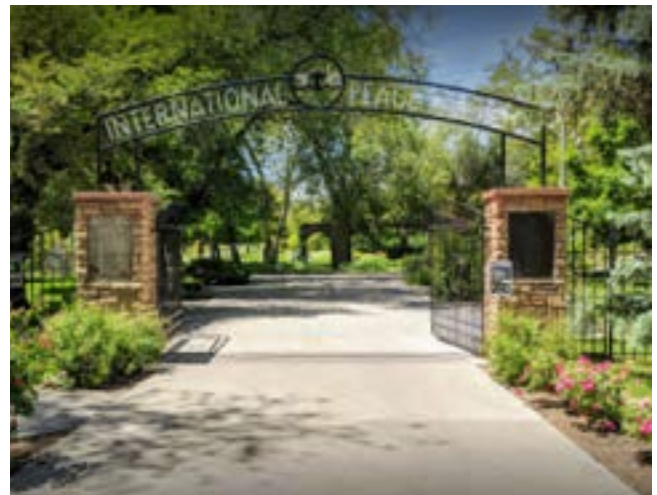
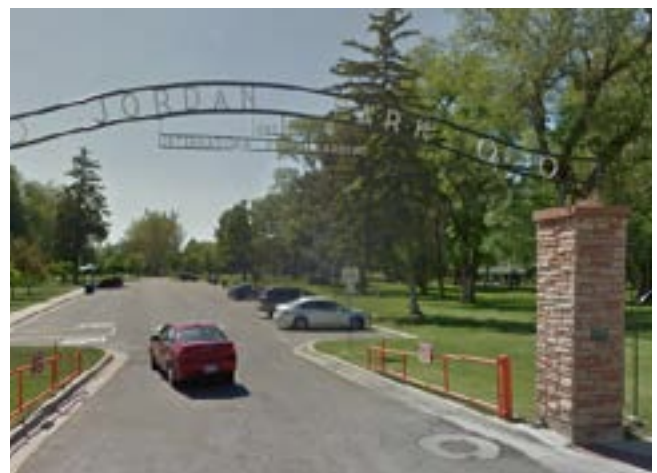
Trail: Jordan Park to Genesee

Trail Notes: The Fife Wetland Preserve is sandwiched between Jordan Park and 9th South River Park. The restored wetland features benches, local art, educational signage, and opportunities for wildlife viewing. This section of trail is bisected by the 9 Line Trail. There are two bridges on this section. One connects from the north side of Jordan Park to the Fife Wetlands. The other connects from 9th South River Park to the northwest side of the Fife Wetlands.

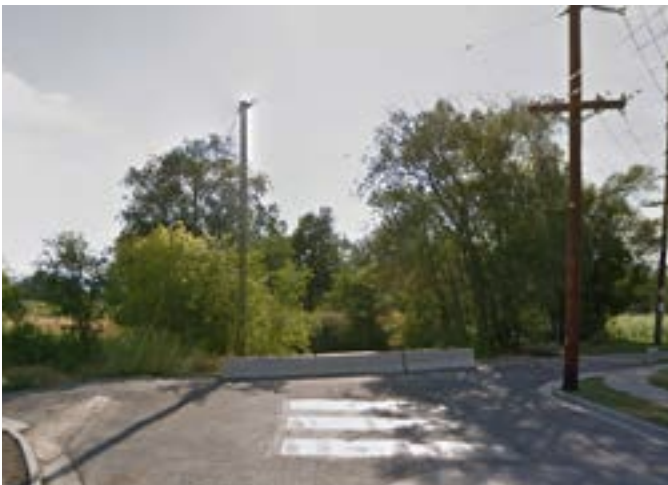
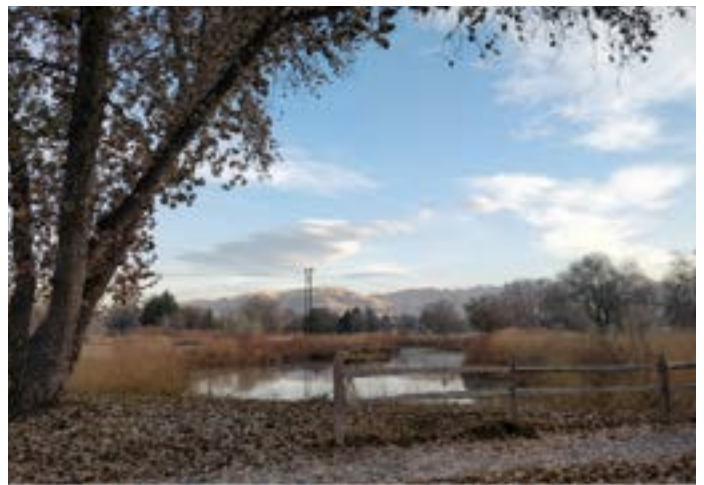
Genesee Trailhead (9th South River Park)

Site Notes: Park with restrooms, picnic tables, benches and walking path.

Several broken benches.

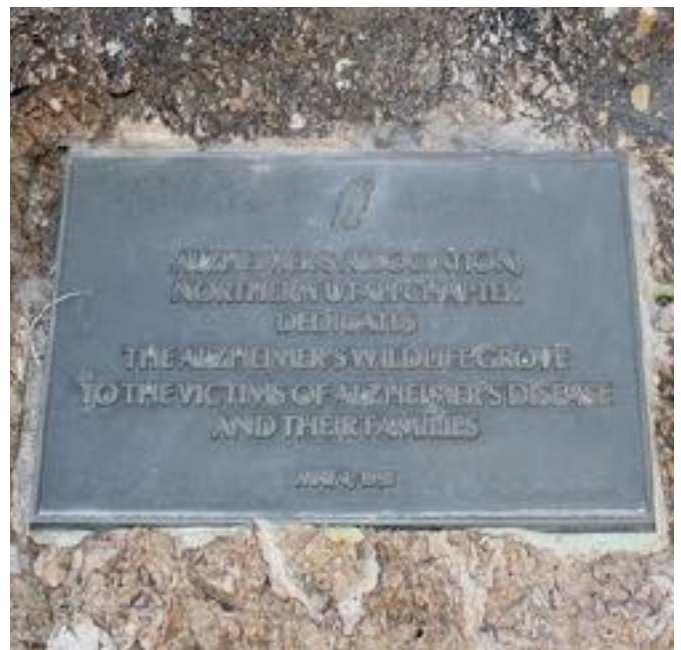
Trail: Alzheimers Park to Gatsby Trailhead

Trail Notes: One underpass, and one large bridge. This section of trail passes by Fisher Mansion, the industrial area of Salt Lake City, and through several railroad crossings. There are several upcoming improvements to the area including a boat portage, and restoring the Fisher Mansion Carriage House.

Blind corners on either end of the underpass by I-80. Underpass is also narrow and dark.
