2020
Jordan River Parkway
Inventory

The purpose of this document is to record the results of an inventory project conducted by the Jordan River Commission in the summer of 2020. This inventory explored the differences in trailside amenities and design aspects through extensive fieldwork and data collection. Fieldwork and data collection was completed by Commission staff, two University of Utah interns, and assistance from Wasatch Adaptive.

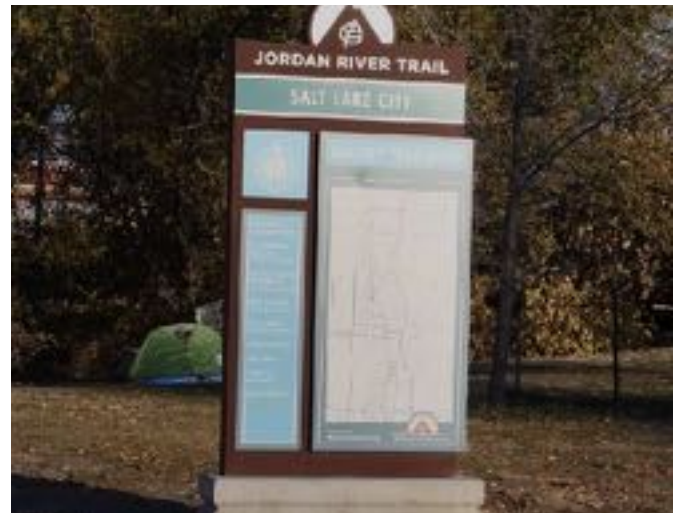
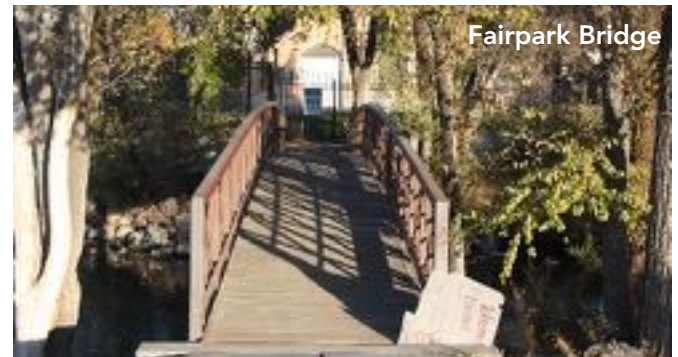
Fairpark Bridge

Narrow bridges, crosswalk button may be too high to be accessible to those in wheelchairs. Sharp turns to bridges. Navigation between Utah State Fairpark and Constitution park can also be confusing and may benefit from additional signage. Lots of litter and vandalism in this section.

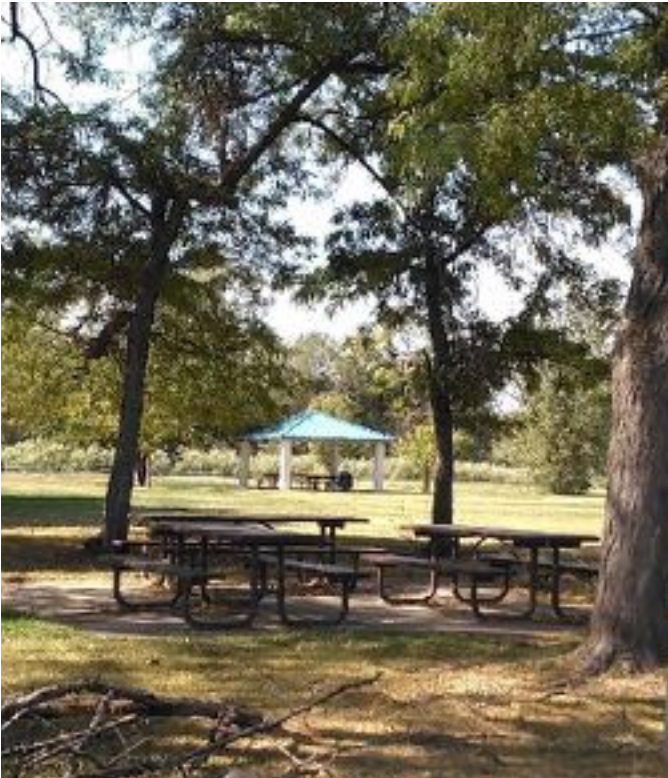
Constitution Park Trailhead

Site Notes: Location of Northwest Recreation Center. Site includes benches, picnic tables, boat portage. Bike rack, restrooms and drinking fountain at the recreation center.

Notes: Very narrow. Graffiti on bridge.

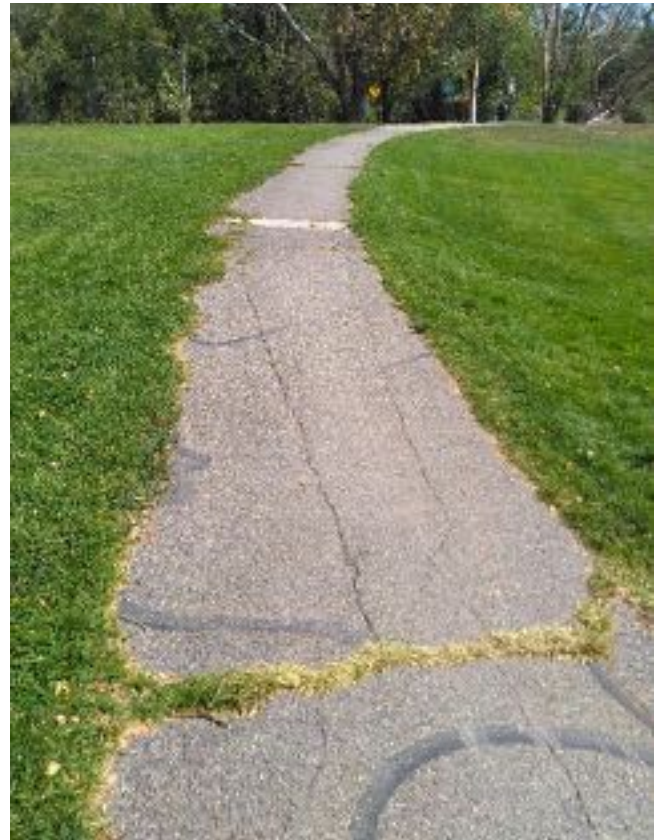
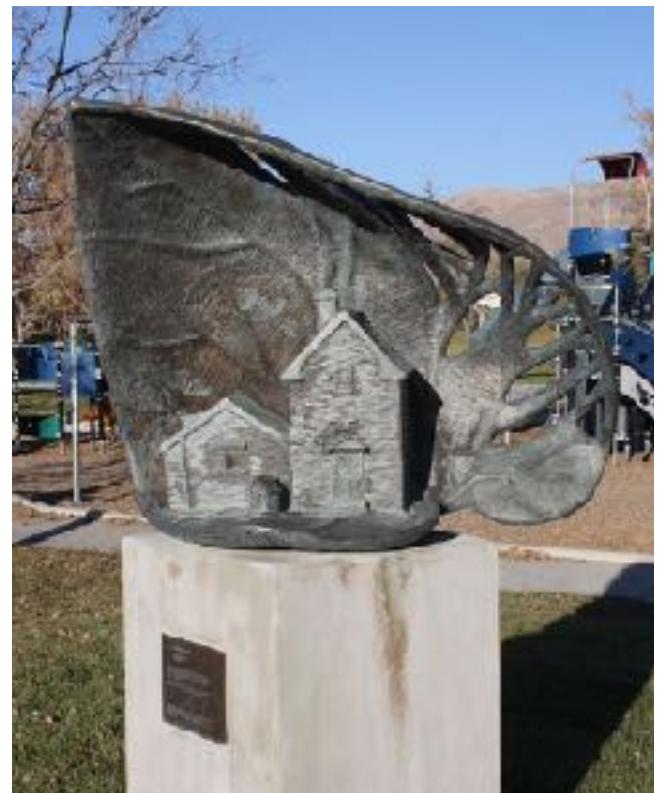
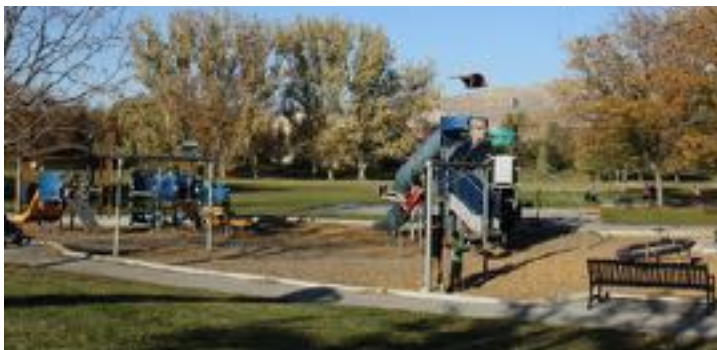
Broken sidewalks, lots of litter and graffiti.

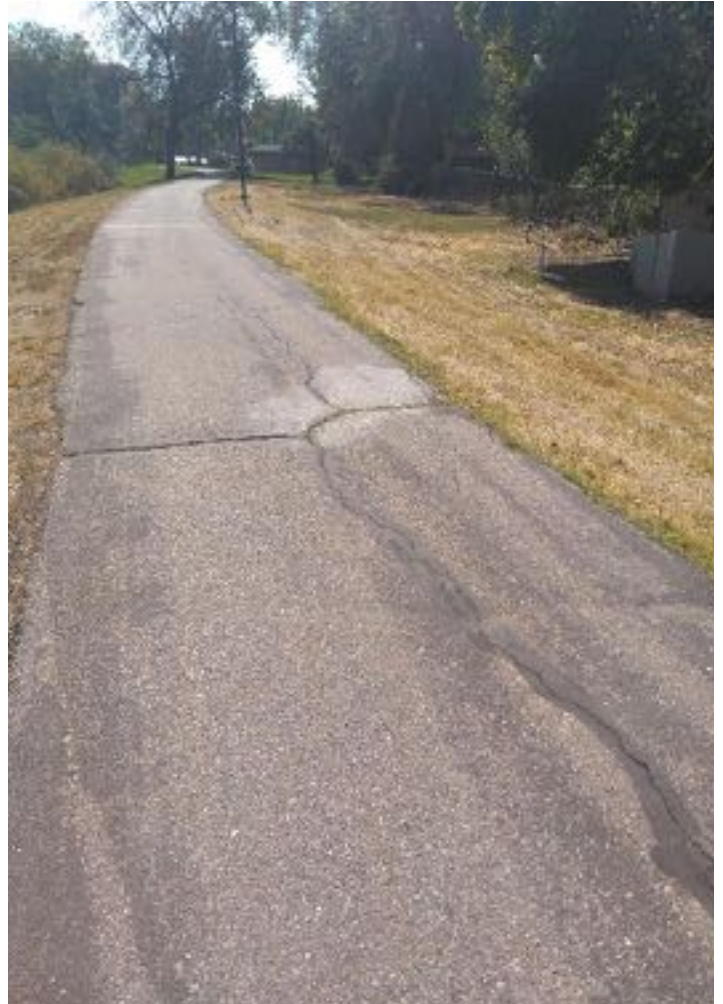
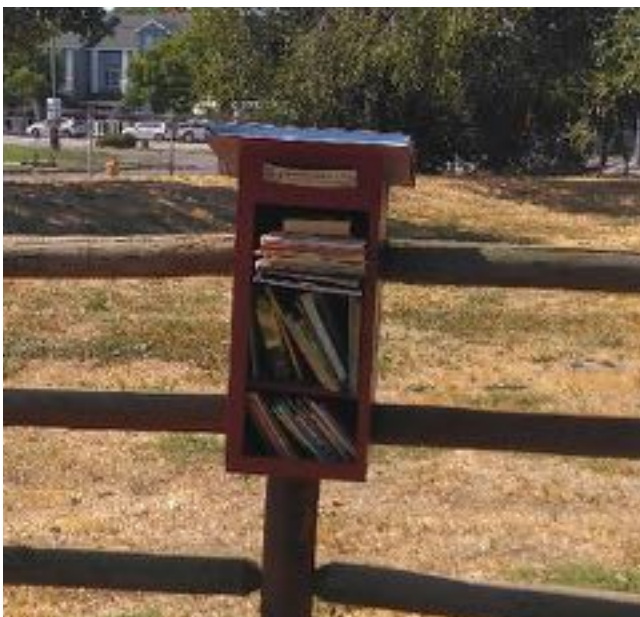
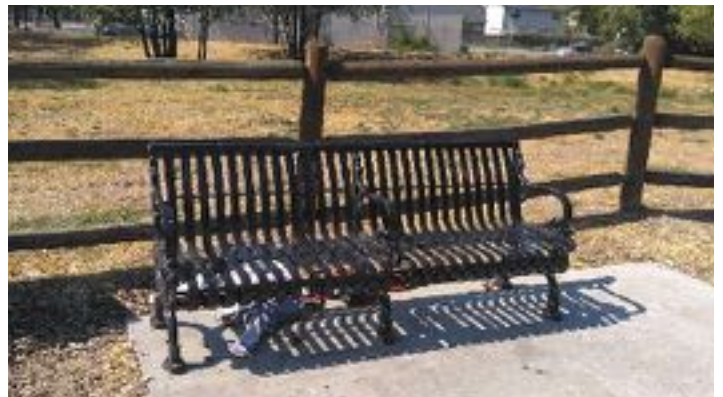
There are many homeless camps and lots of litter along the way.

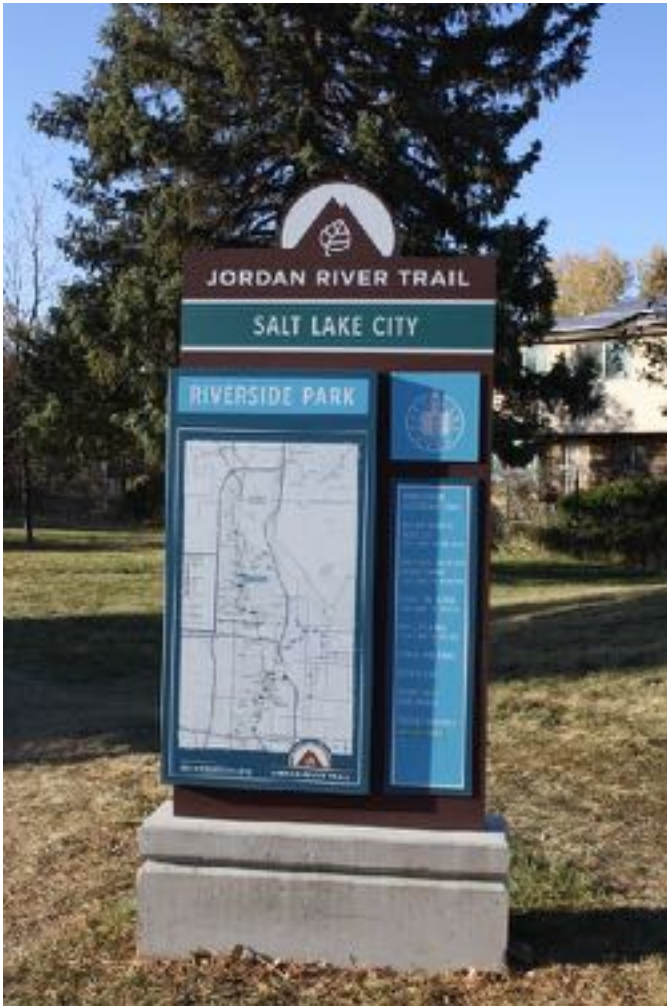
Riverside Park Trailhead

Site Notes: This park is home to two playgrounds, two sets of restrooms, three drinking fountains, two soccer fields, two softball fields, two baseball fields, one basketball half court, four tennis courts, and one volleyball court. There are also two pavilions for rent.

Some litter and graffiti.

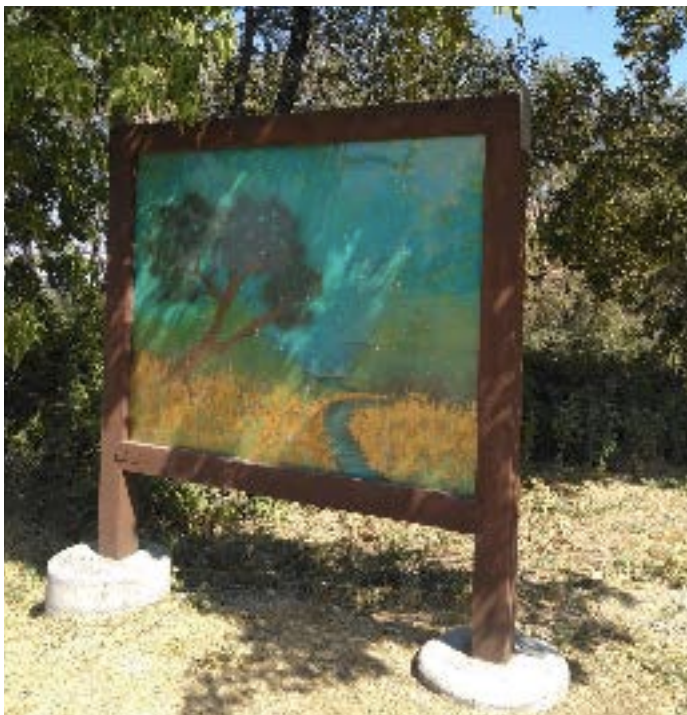
Trail Notes: This section of trail is roughly 2 miles long. Part of this section of trail (from Riverside Park to the Day-Riverside Library) is currently under construction. An alternate route can be taken from Riverside Park across the bridge west to Riverside Dr., then up to 1000 N. In addition to the bridge by Riverside Dr., there is a second bridge at the Rose Park Golf Course. This section also features local art, equestrian access, two Free Little Libraries, and benches. There are lamp posts along the trail before the golf course.

Sharp left turn onto bridge by Rose Park Golf Course. Some litter and graffiti.

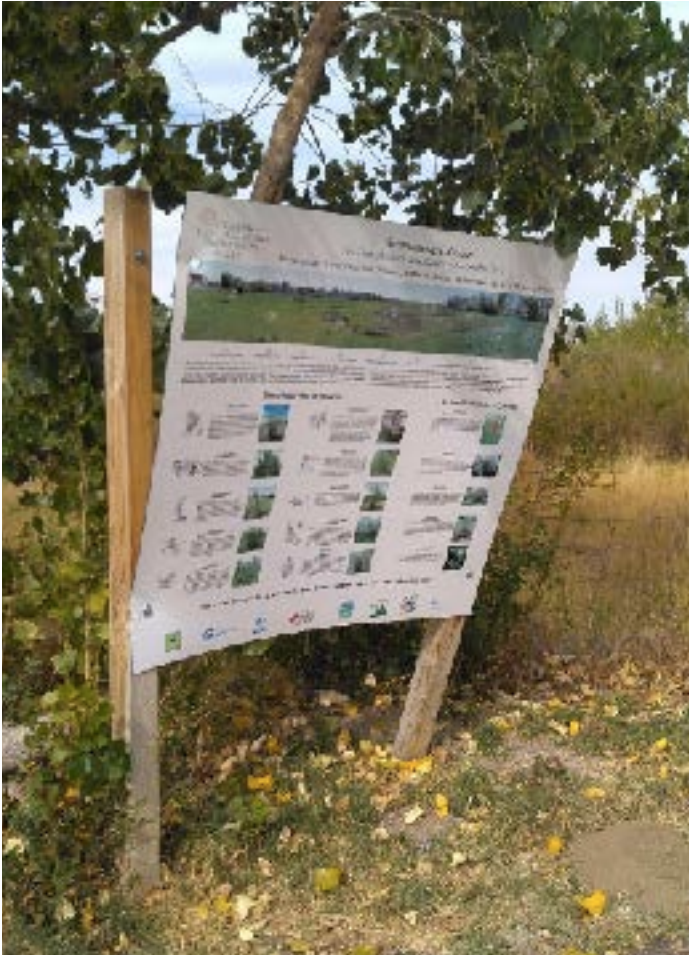
Trailside Trailhead

Site Notes: Small trailhead just north of Northwest Middle School. Includes benches, educational signage, and equestrian trail access.

One educational sign by the Center of Documentary Expression and Art is falling apart.

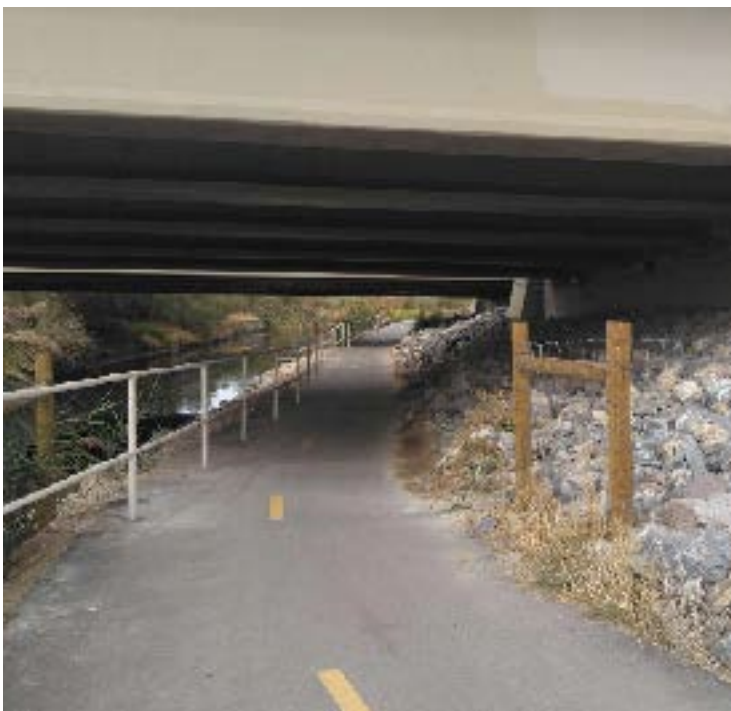
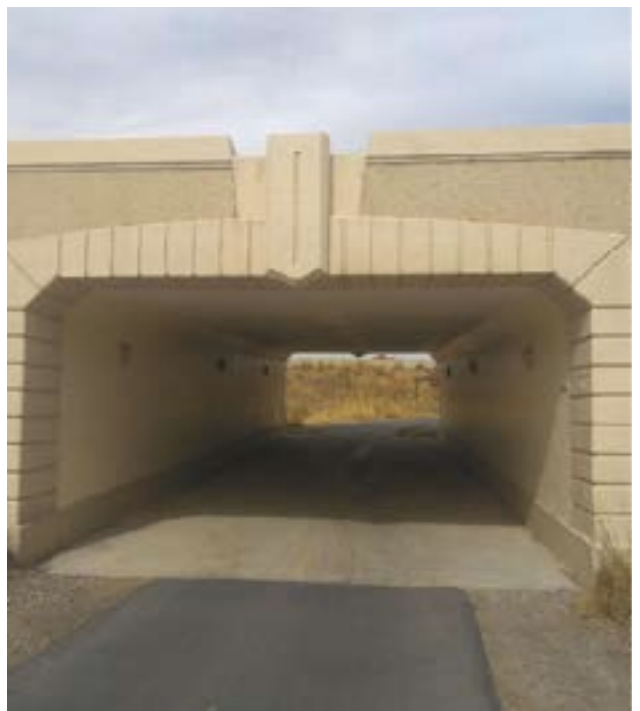
Porter's Landing Trailhead

Sharp left turn off of bridge heading north.

Signage becomes confusing once the Jordan River Trail and Legacy Nature Trail meet.
