## Eel River Recovery Project 2013 Citizen Assisted Water Temperature and Flow Monitoring

Prepared for: **Eel River Recovery Project**  
By: Patrick Higgins, ERRP Volunteer Coordinator

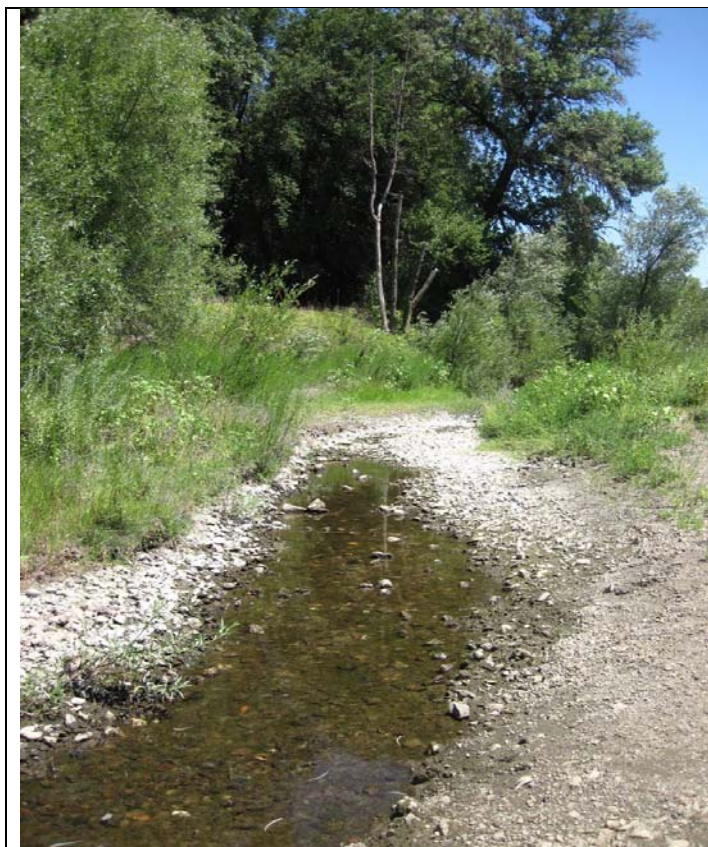
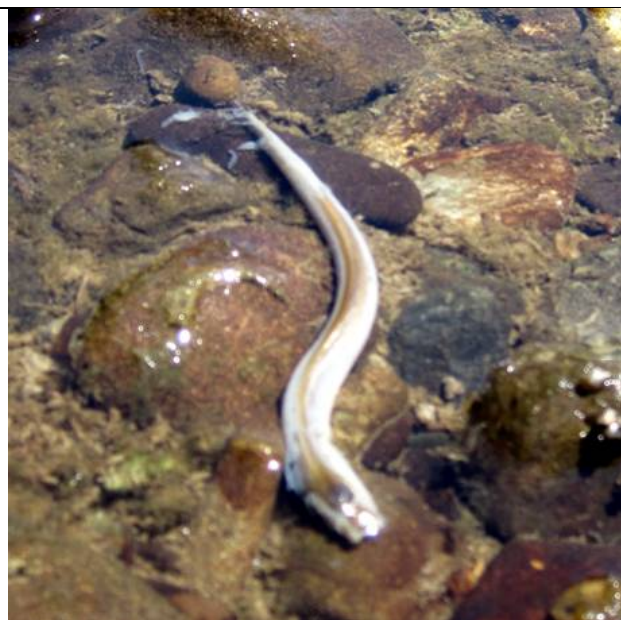
**Figure 5. At left is Ten Mile Creek drying up on 7/27/13 at the Black Oak Ranch and above is a dead lamprey ammocetes larva that had been living in the cool sediment of the stream bed before desiccation.**

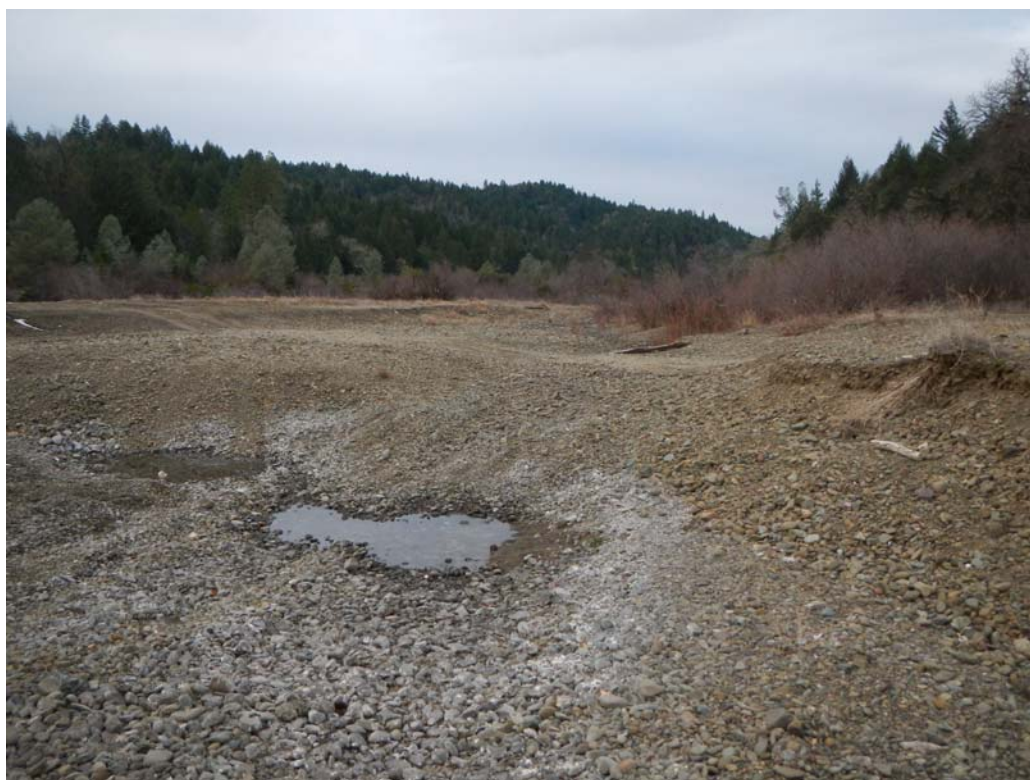
**Figure 6. Tomki Creek bed looking upstream at its convergence with Rocktree Creek on 12/18/13.**

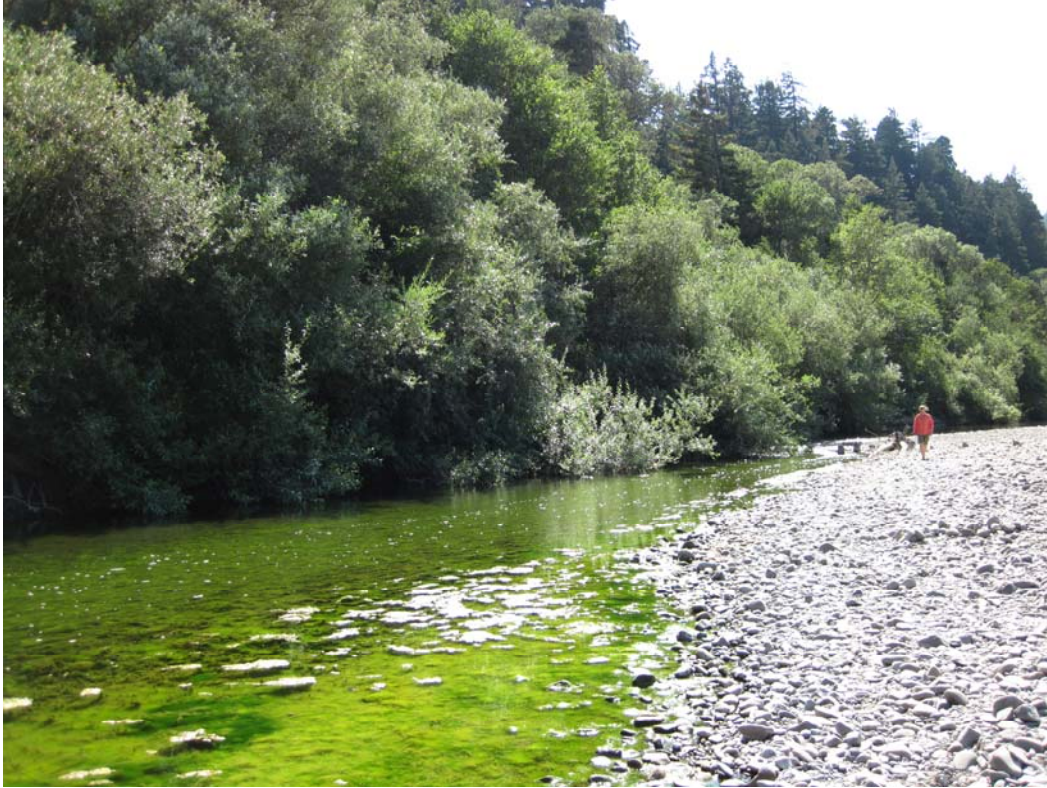
**Figure 8. Looking up the South Fork Eel River at Dyerville with profuse algae growth in the margins. ERRP volunteer Sunshine Johnston is at right in the distance. August 7, 2013.**

Water Quality Observations, Recreation, and Toxic Algae Development: ERRP published reports on water quality and algae blooms, including photo-documentation (Figure 8), to alert the public about deteriorating conditions (Higgins 2013b, 2013c, 2013d) so they would avoid recreating in areas with visible algal mats or scums. On July 23, the Humboldt County Department of Health and Human Services (2013) issued a public health advisory for potential exposure to toxic blue-green algae, including the South Fork Eel River and Van Duzen River. The public health warning is part of a State wide strategy to help cope with this emerging problem (SWRCB, CDPH & OEHA 2010). No pet mortalities or human health effects were reported for the Eel River in 2013.

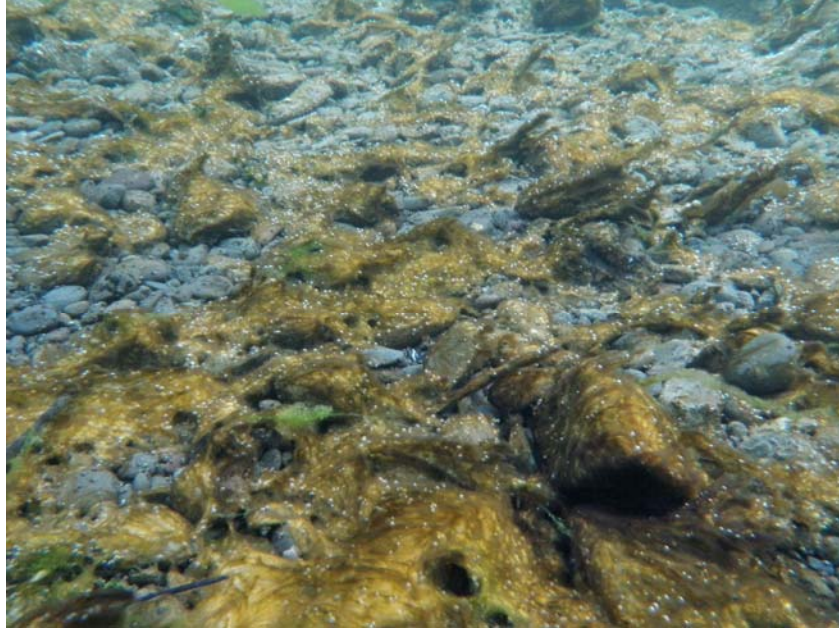
**Figure 11. Phormidium mats on the stream bottom near Phillippsville. Note the orange and brown coloration. From Bouma-Gregson (2014).**

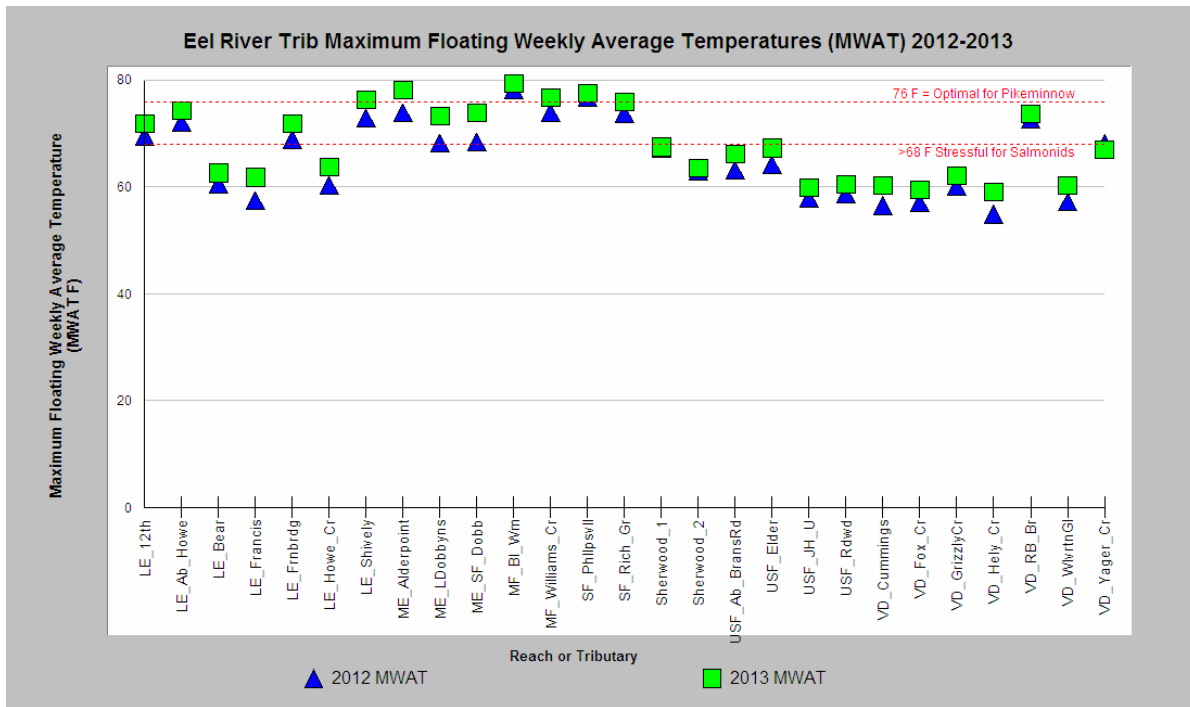
**Figure 14. Maximum floating weekly average water temperatures at locations where ERRP collected data in 2012 and 2013. LE = Lower Eel, ME = Middle Eel (Dos Rios to Dyerville), SF = South Fork, USF – Upper South Fork (above Ten Mile Creek), and VD = Van Duzen sub-basin. Temperature references are from McCullough (1999) and Bell (1991).**

Comparison of 2012 and 2013 Temperatures: A summary of MWAT comparisons at ERRP monitored sites measured in both 2012 and 2013 is displayed as Figure 14 and complete tabular results for 2013 are in Attachment 1. Data shows a pattern of increase at almost all locations between 2012 and 2013. However, Sherwood Creek (Outlet/Middle Eel) water temperatures were almost identical in both years, likely because probe locations are near groundwater sources. Also, warm mainstem locations, such as the South Fork Eel at Phillippsville, Middle Fork Eel below Williams Creek, Van Duzen at Rainbow Bridge, and lower Yager Creek above the Van Duzen all had nearly identical temperatures between the two years. As noted above, very low flows and lack of rain events during summer in 2012 may explain similar mainstem MWATs.

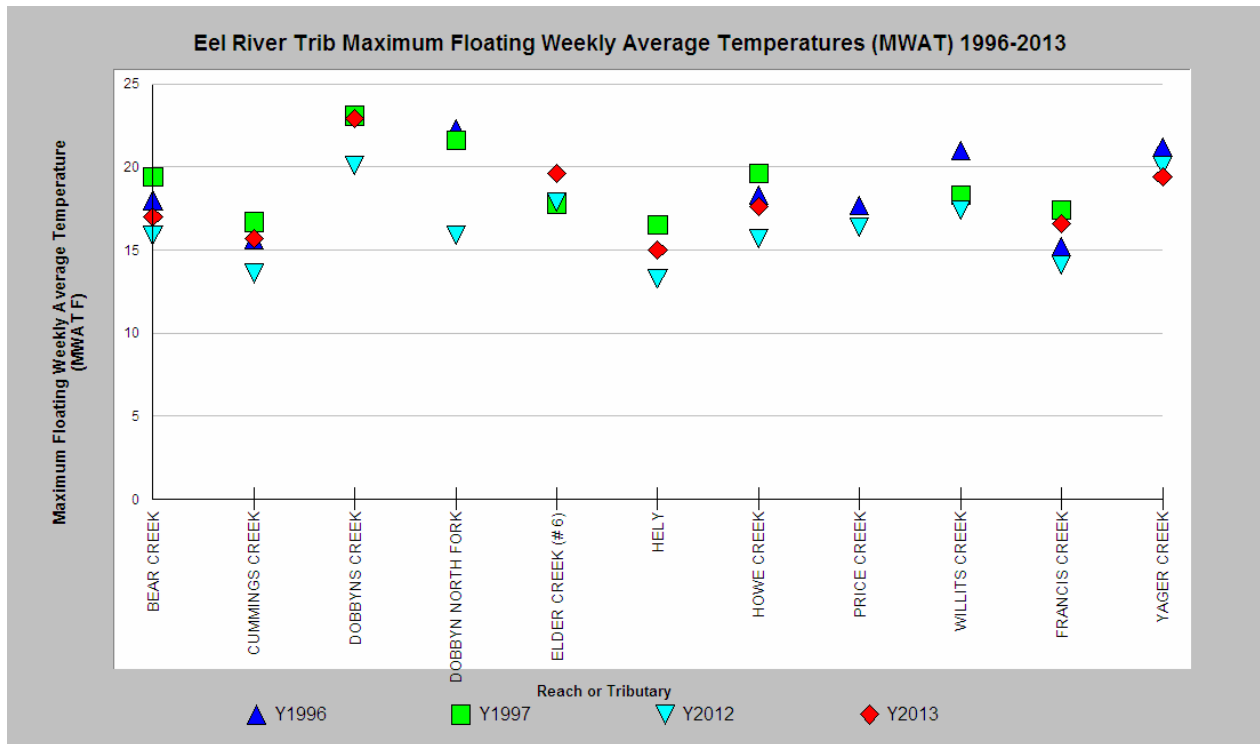
Figure 16. MWAT comparison of recent ERRP data (2012-2013) and Humboldt RCD data (1996-1997) show temperature recovery trends in 2013 at several locations versus those collected earlier despite the drought.

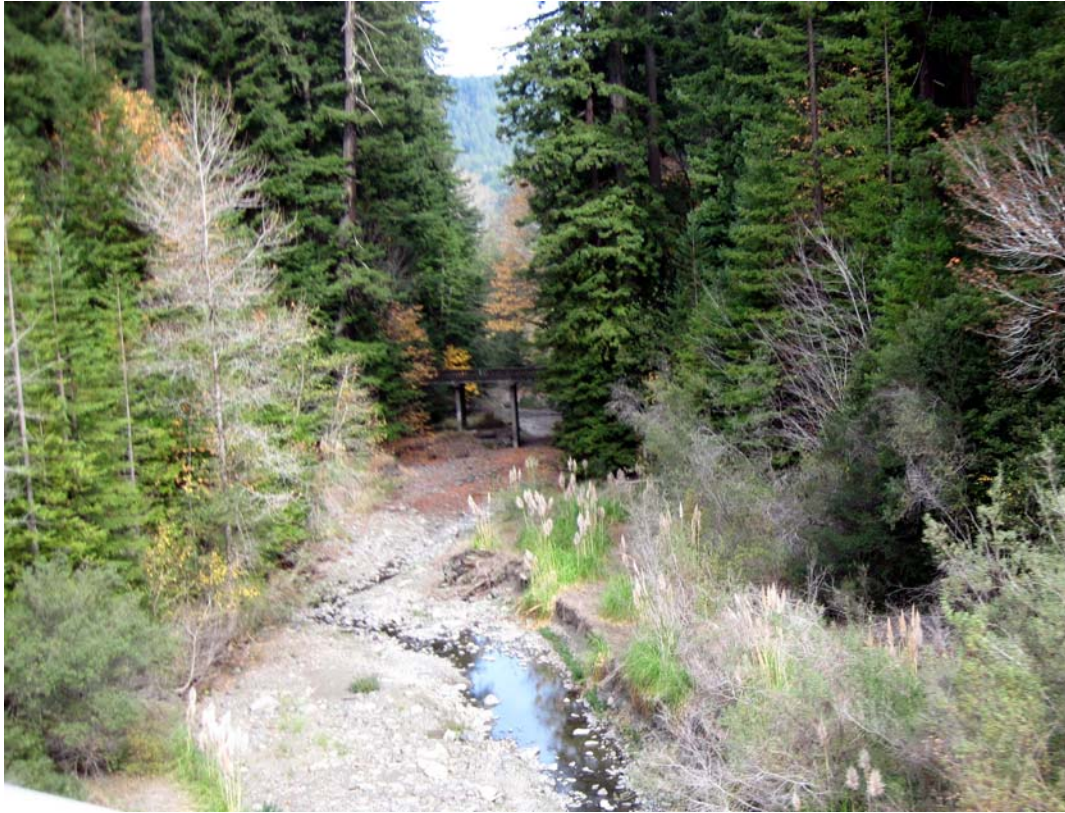
**Figure 17. The bed of Jordan Creek is shown here looking downstream from the Highway 101 Bridge with the stream barely flowing on the surface despite rain in the preceding days. November 27, 2013.**

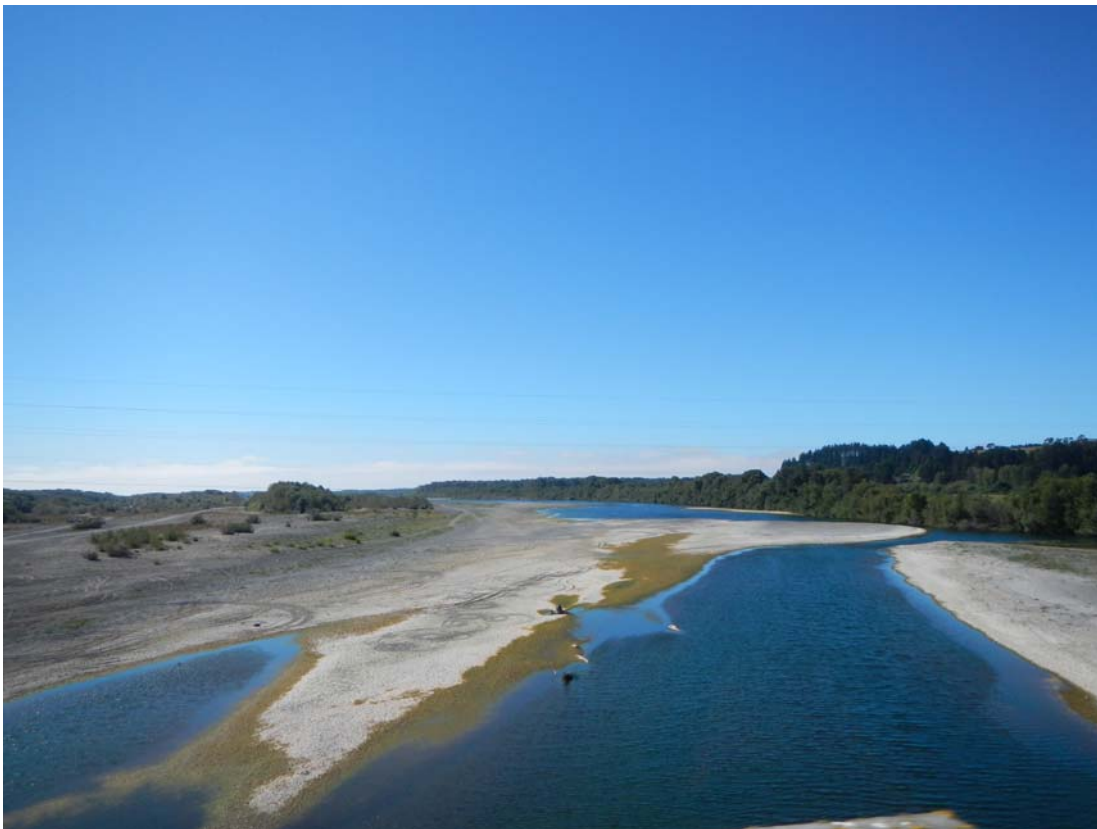
**Figure 22. Lower Eel River below Fernbridge on September 19, 2013 showing shallow, stagnant conditions with insufficient flows and depth for Chinook salmon passage.**

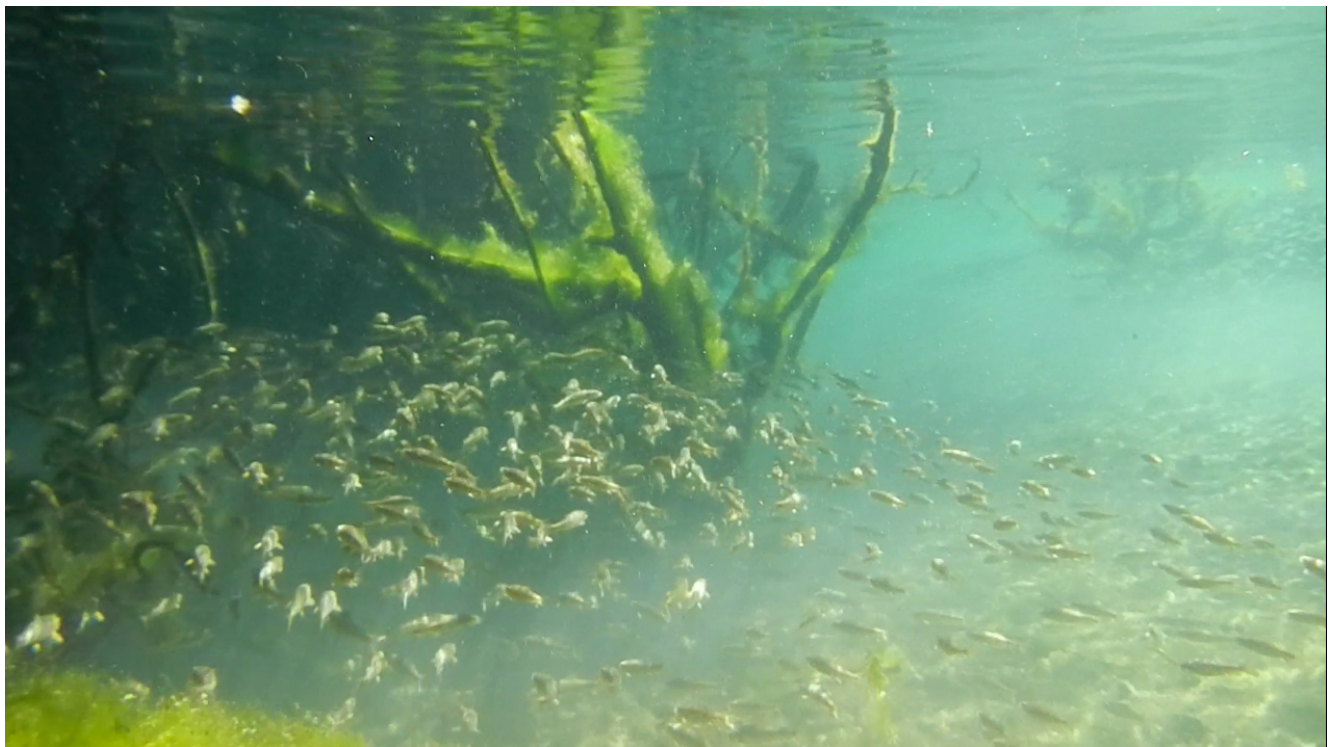
**Figure 24. Juvenile suckers in a pool near Southern Trinity High School that was showing signs of stratification on the main Van Duzen River above Dinsmore. 9/18/13.**

*Native Warmwater Fishes:* On the Black Butte River, a major Middle Fork Eel tributary, water temperatures had already attained lethal levels for juvenile steelhead on July 2. However, a large number of juvenile Sacramento sucker juveniles were present there in mid-September 2013 when temperature probes were retrieved (Figure 23). This species has been depleted by pikeminnow predation and low, warm flows in 2013 appeared to be producing a successful year class. Thousands of sucker juveniles were also spotted in late September during an ERRP upper Van Duzen River reconnaissance dive at Southern Trinity High School above Dinsmore, another indication that this species is drought adapted (Figure 24).

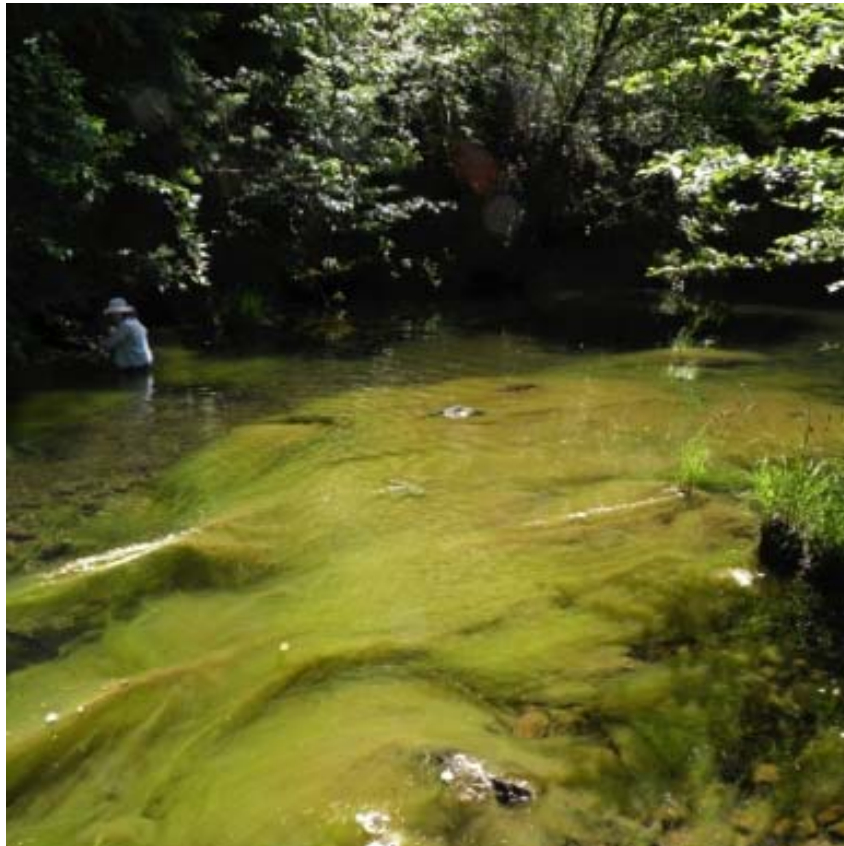
**Figure 23. South Fork Eel River at UC Angelo Reserve with a major *Cladophora* bed in early June 2014. Photo courtesy of Keith Bouma-Gregson.**
