Hopkins Solar Farm, Ty Croes, Carmarthenshire. Coal Mining Risk Assessment

**A REPORT FOR SPRING
DECEMBER 2019**

P19158_R1

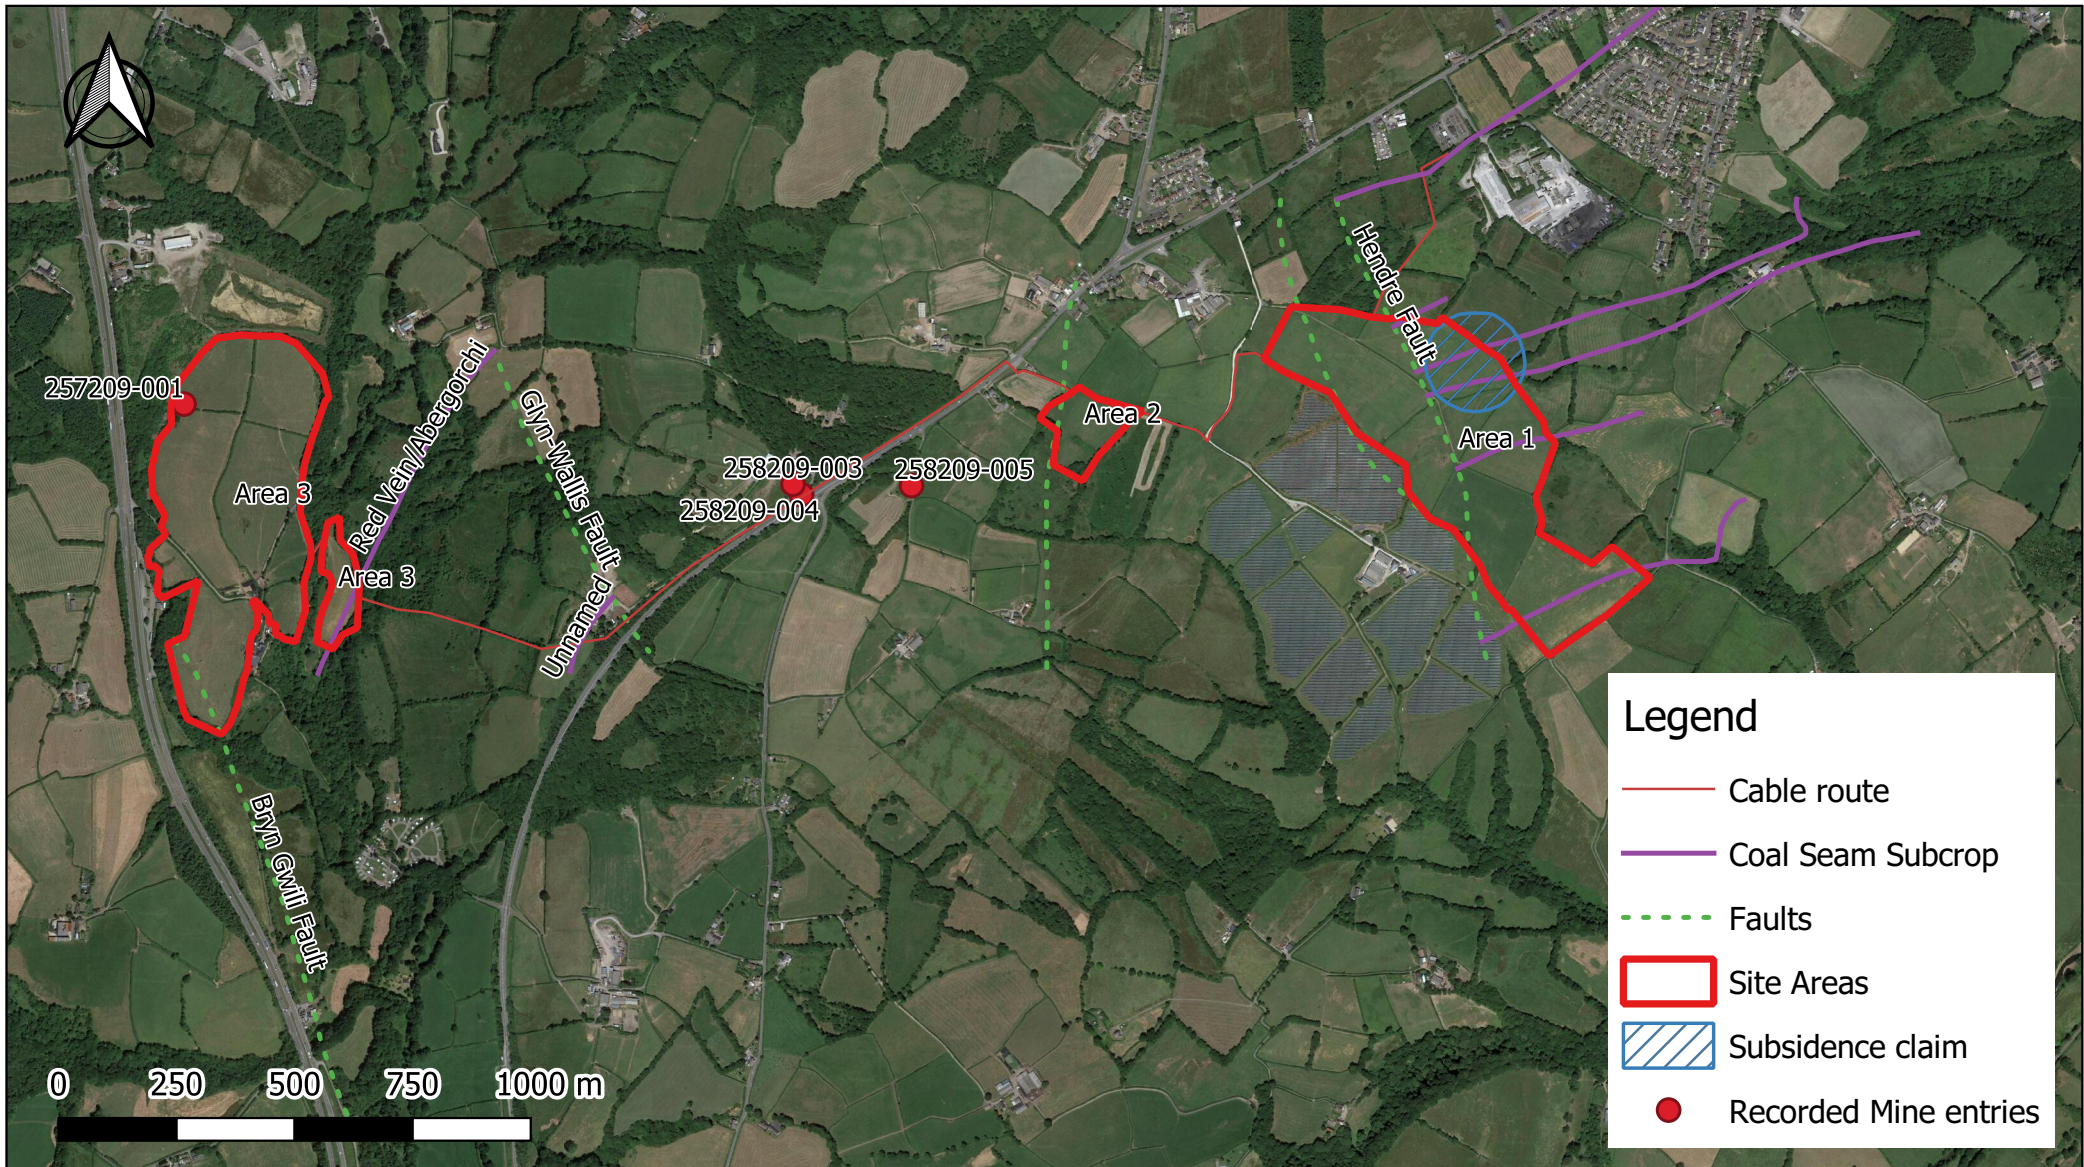
Figure Title	Client	Date	Drawn
	Hopkins Solar Farm Site Layout and Coal Mining Features	Renplan	17/12/2019	JRB
		Drawing Number	Scale	Checked
	19158_R1_02	1:16000	GRO	
Project Number	Original	1		
19158	A4	Hopkins Solar Farm, Ty Croes

Three recorded mine entries are noted to be present at or in the vicinity of the site. One is located in the northwest of Area 3, the remaining two are situated close to the cable route along the A843.

A recorded mine entry (257209-001) is noted to be present in the northwest of Area 3. This mine entry is noted on the 1879 OS mapping and should be treated as a credible feature, and hence a potential hazard to the development. The coal seam worked by this shaft remains unclear and any associated workings are presumed to be at shallow depth and unrecorded. The 1:10 560 geological mapping for this particular area has not identified the presence of coal seams in the vicinity of the shaft, however this does not necessarily mean that the coal seams are absent. The proposed development comprises the placement of a number of solar arrays and the installation of associated cabling. This will result in a negligible change of loading in the area, consequently shallow workings associated with the mine shaft are not considered to be a risk to the development and mitigation measures are not required. However the shaft itself is considered to be a potential risk to the development.

Two recorded mine entries (258209-003 and 258209-004) are noted to be present in the immediate vicinity of the cable route north of the junction of the A483 and the B4297. Mine entry 258209-004 is located within the carriageway of the A483 whilst mine entry 258209-003 is located immediately north of the A483, close to the access road to Cefn Gwili.
