New York City Oyster Monitoring Report 2022

This is the fifth edition of the New York City Oyster Monitoring Report. The report was produced by Billion Oyster Project and summarizes the 2022 monitoring results of 12 oyster study sites (**Figure 1**, **Table 1**) in New York Harbor. Data were collected by academic partners, community scientists, students, teachers, etc., using protocols developed by Dr. Michael McCann from The Nature Conservancy. For more information about past oyster restoration projects, please refer to our annual reports, which are available on our website.

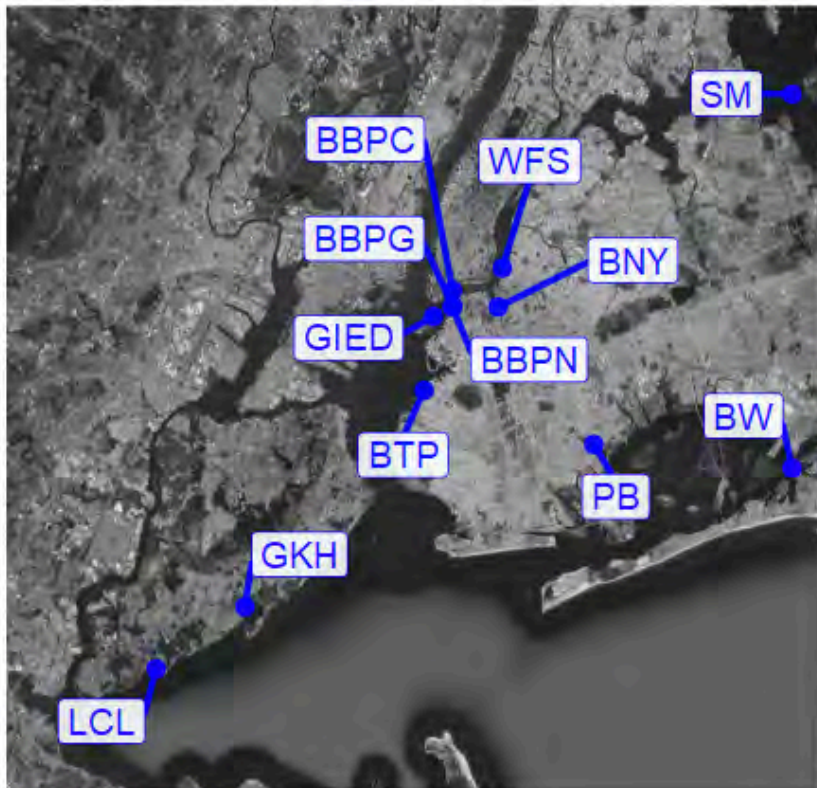
Figure 1. 2022 oyster restoration sites in New York Harbor described in this report. Refer to Table 1 for acronym definitions.

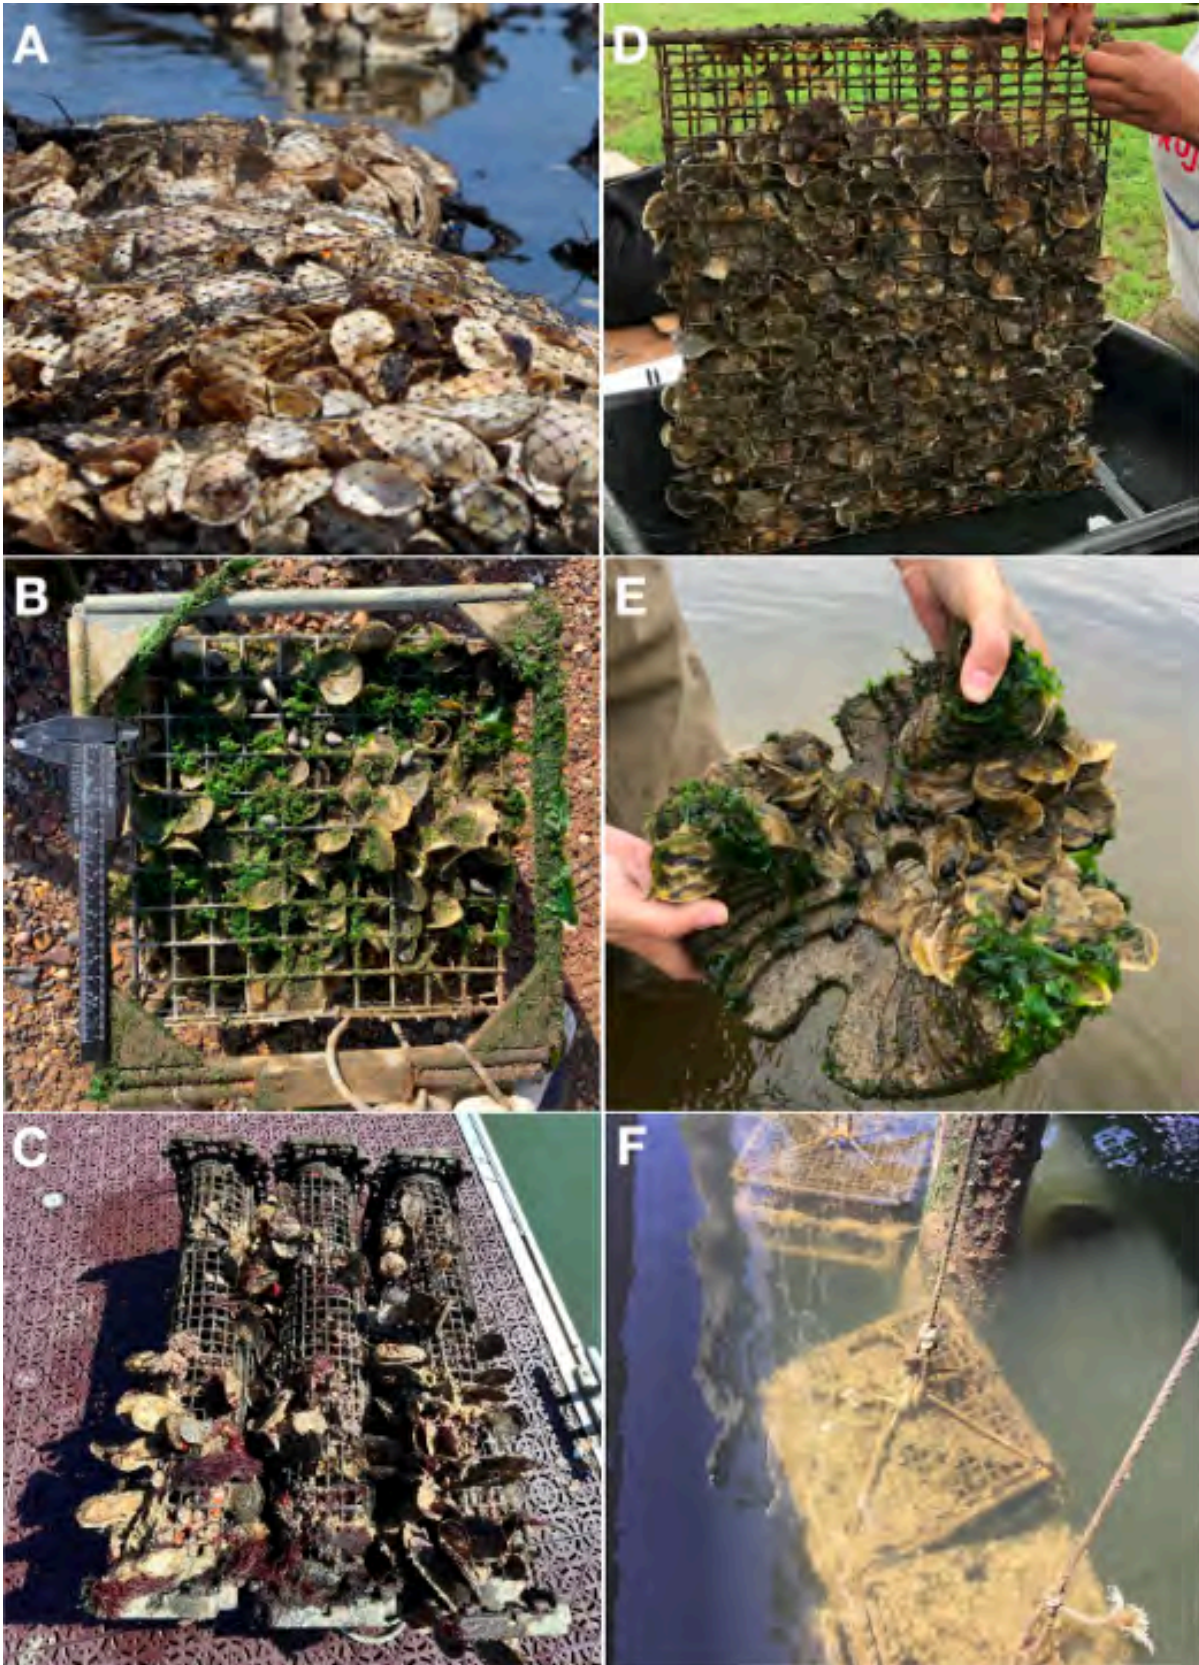
Figure 2 A-F. Examples of structures previously used to install oysters: (A) bags, (B) mini-gabions, (C) OysterGros®, (D) community reef files, (E) EConcrete® discs, and (F) Super Trays. (Photos courtesy of Finola Fung-Khee, Dr. Elizabeth Burmester, Robina Taliaferrow, and Dr. Michael McCann).

- **Bagged shell (Figure 2A):** individual plastic mesh bags that hold approximately 600 spat-on-shell and 0.3 cubic yards of material. Individual bags are placed within a 10' x 6.6' plot and secured with PVC pipes that are inserted on the outer edge of the plot.

- **Gabions (Figure 2B):** welded steel structures filled with spat-on-shell. Once installed, they act as surrogate reef structures in the absence of natural oyster reefs while the juvenile oysters grow, and create a multidimensional habitat for endobenthic, epibenthic, and hyperbenthic species. BOP has used three sizes of gabions (cube: 1' x 1', rectangle: 2' x 1', large: 4' x 2' x 2').

- **SEAPA Cages (Figure 2C):** 20L baskets typically used in aquaculture to grow oysters, these structures are filled with spat-on-shell and suspended off-bottom in stacks of 2-3 to form nurseries.

- **Community Reef Cabinets (Figure 2D):** welded rebar frames that contain mesh files filled with oysters. Cabinet reefs facilitate hands-on programming by students and community members. These cabinets have a complex opening mechanism designed to deter poaching. BOP uses two sizes of cabinets, a 4' x 2' x 2' welded rebar frame with 14 mesh files, and a 10' x 2' x 2' with 28 mesh files.

- **EConcrete® disks (Figure 2E):** 26 cm x 11 cm cast concrete units made of innovative concrete admixture and aggregate to encourage biofouling. Each disk weighs approximately 10-12 pounds.

- **SuperTrays (Figure 2F):** UV-resistant aquaculture plastic trays measuring 2' x 2'. Super Trays are stackable and may be bridled together using $\frac{3}{8}$ inch polypropylene line to facilitate setting in the remote setting facility or suspension from floating docks or piers.

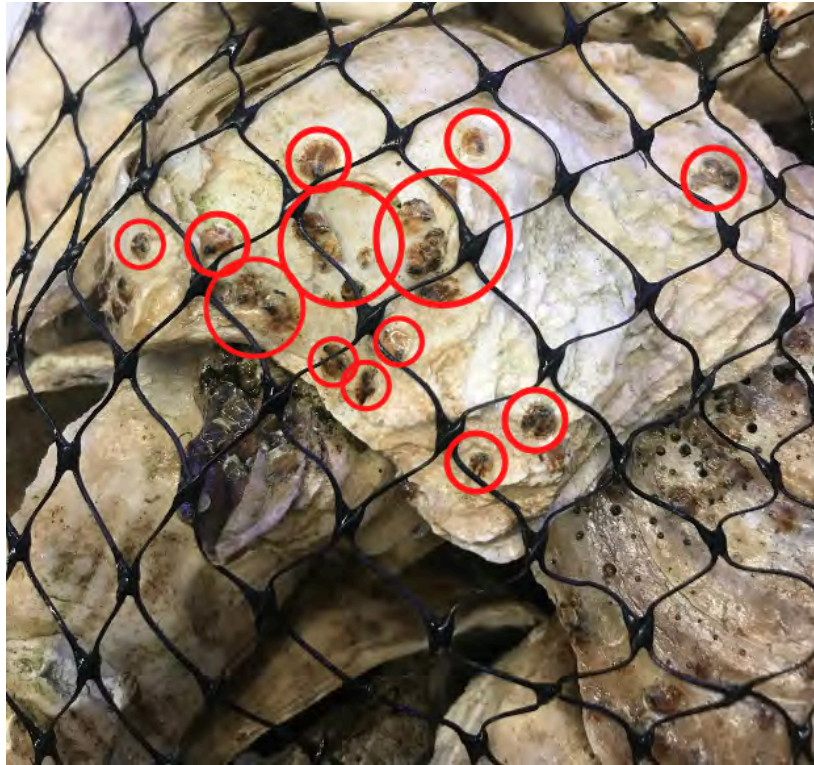
Figure 3. This spat-on-shell was set at the hatchery on Governors Island. (Photo courtesy of Rebecca Resner)

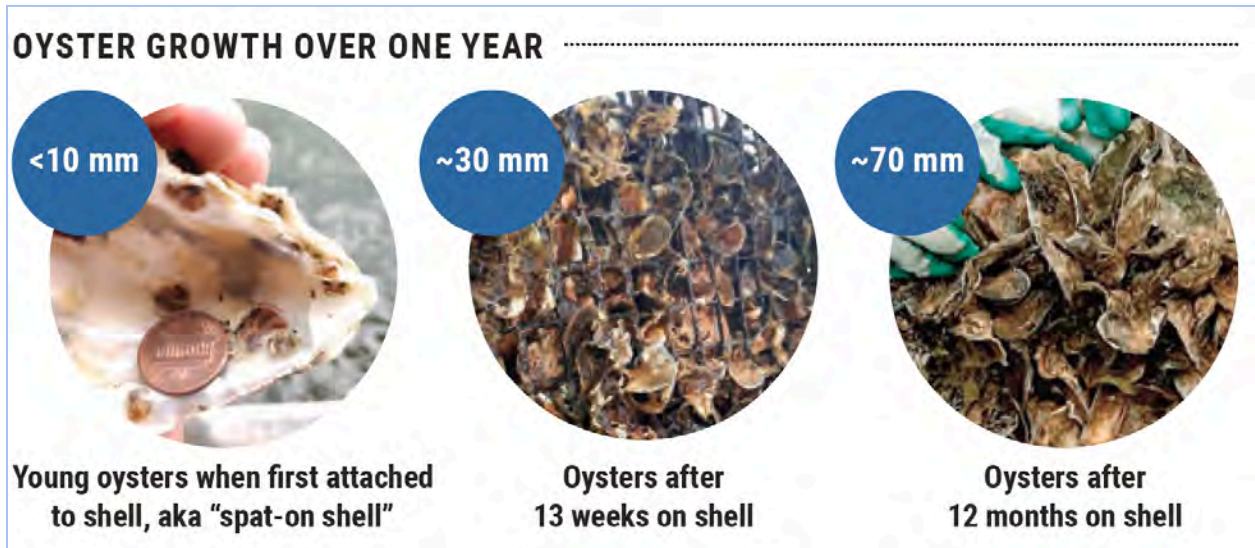
Figure 4. These photos show oyster growth in the first year of restoration at sites with fast growth. (Photos courtesy of Billion Oyster Project Staff)

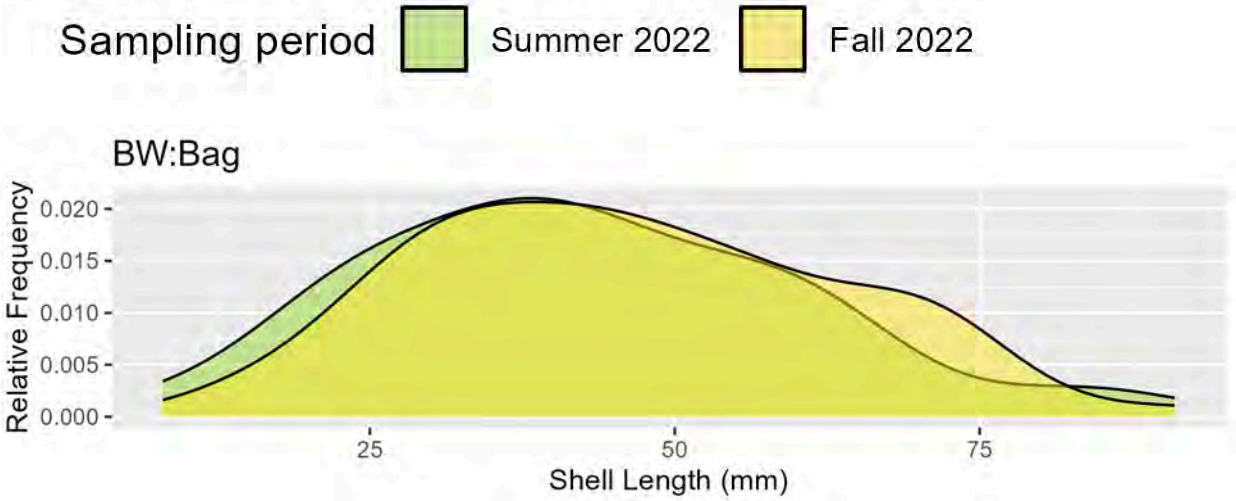
Figure 8. Size frequency distribution graph shows increasing shell length over two monitoring seasons for a single cohort at Bayswater Point State Park (BW).

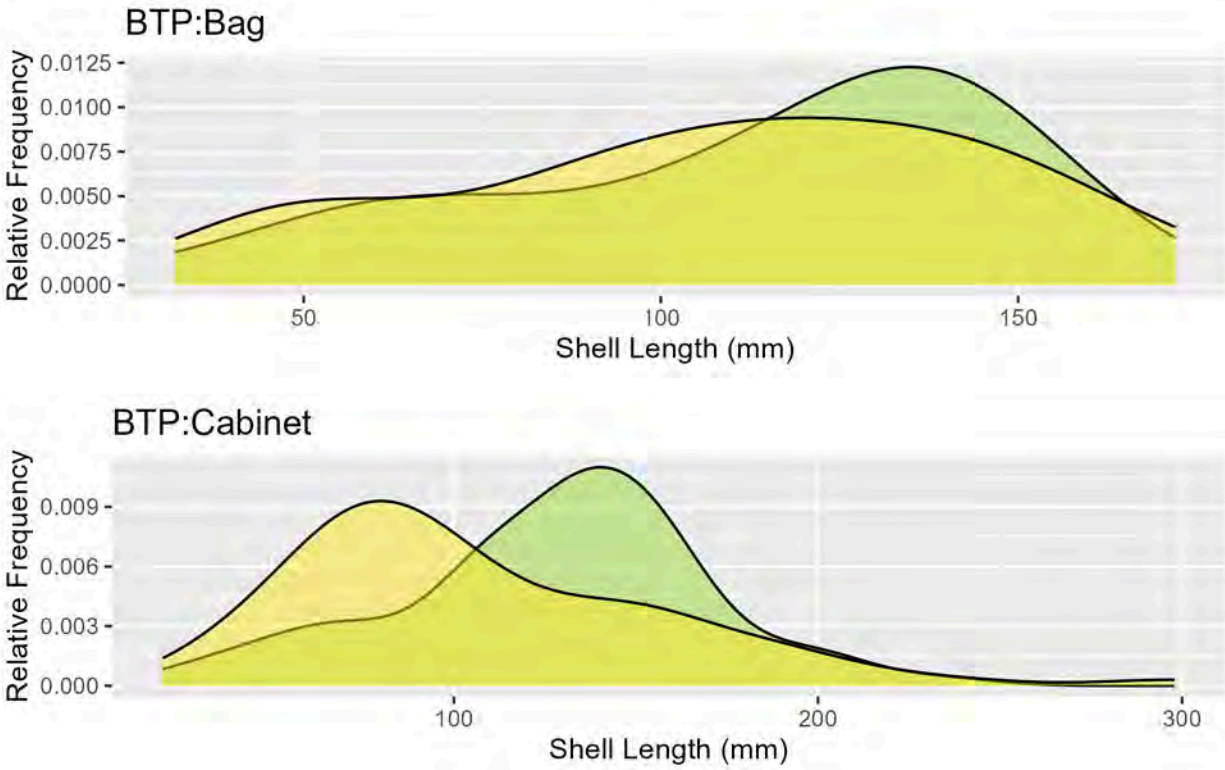
Figure 11. Size frequency distribution graph shows signs of wild recruitment in the bagged shell reef and cabinets over two monitoring seasons for oysters at Bush Terminal Park (BTP).

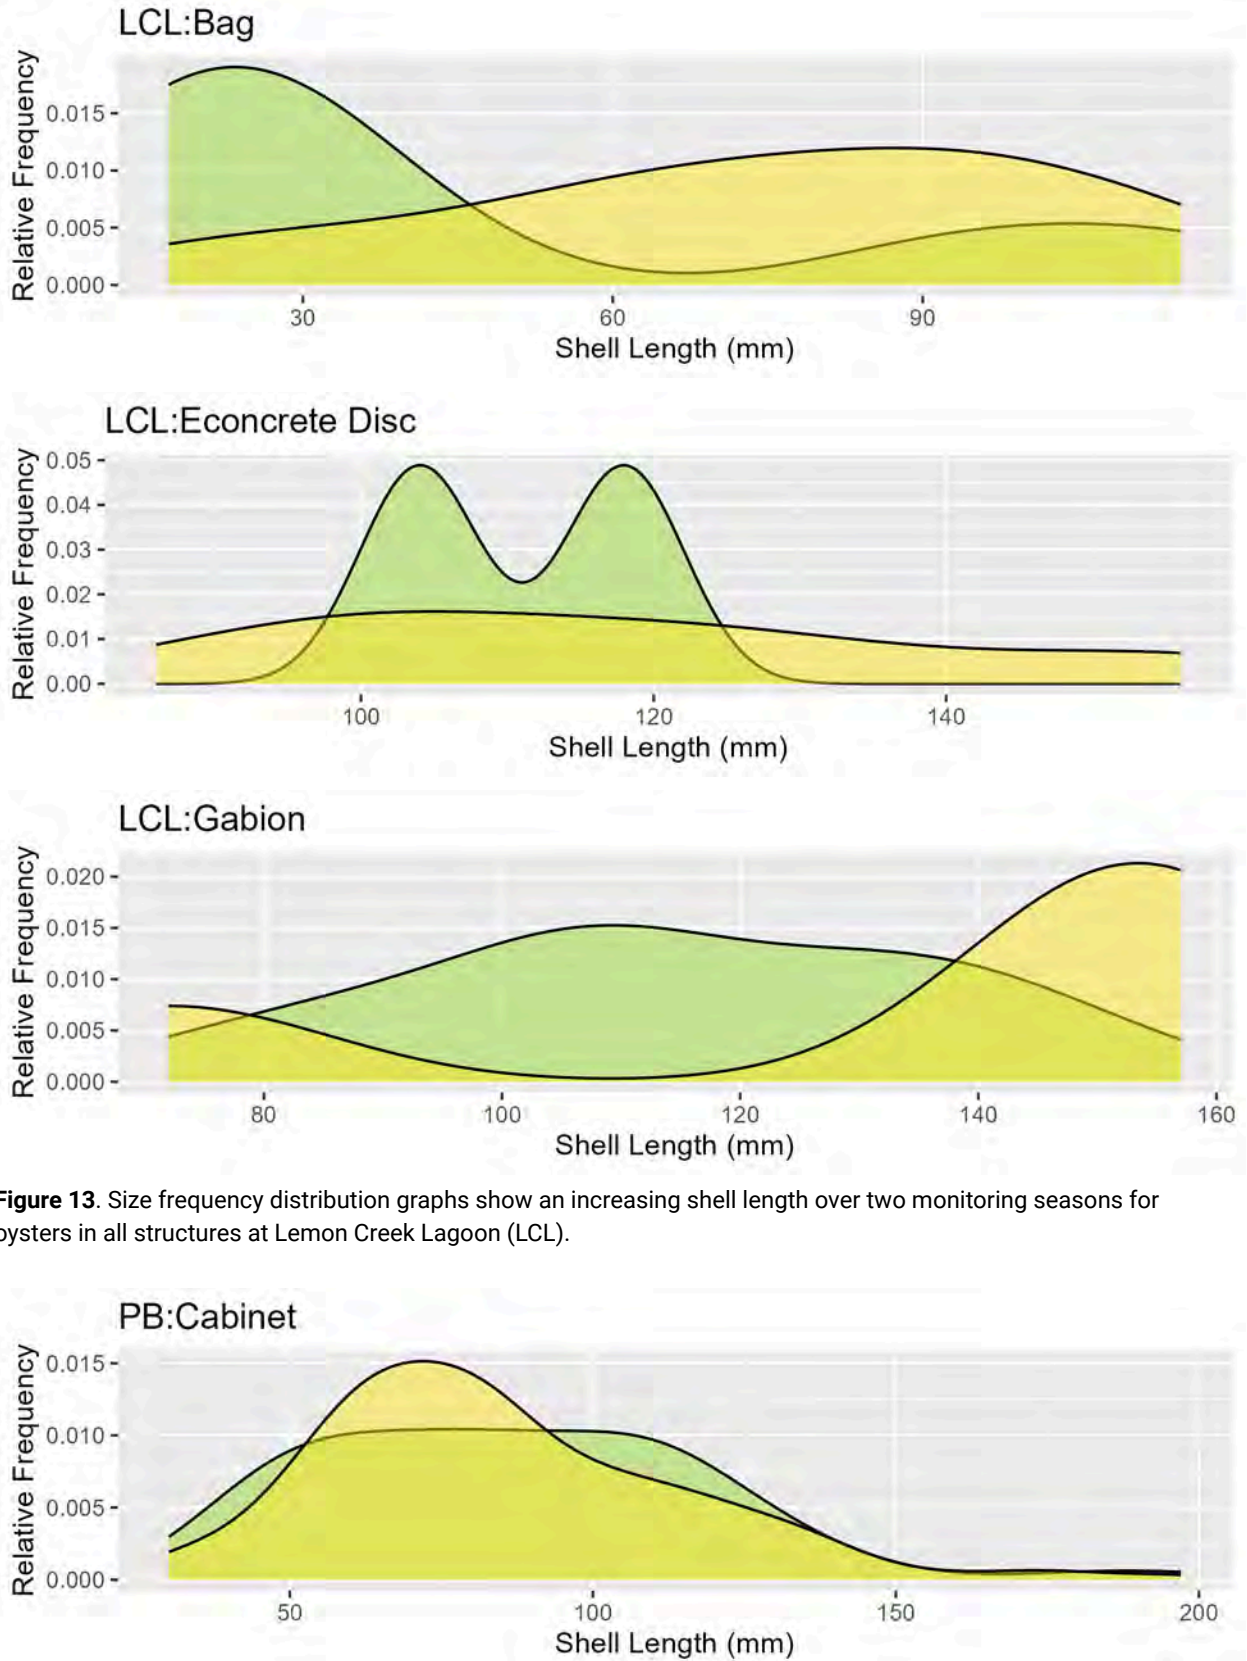
Figure 13. Size frequency distribution graphs show an increasing shell length over two monitoring seasons for oysters in all structures at Lemon Creek Lagoon (LCL).

Figure 14. Size frequency distribution graph shows a stabilizing shell length over two monitoring seasons for a single cohort at Paerdegat Basin (PB).

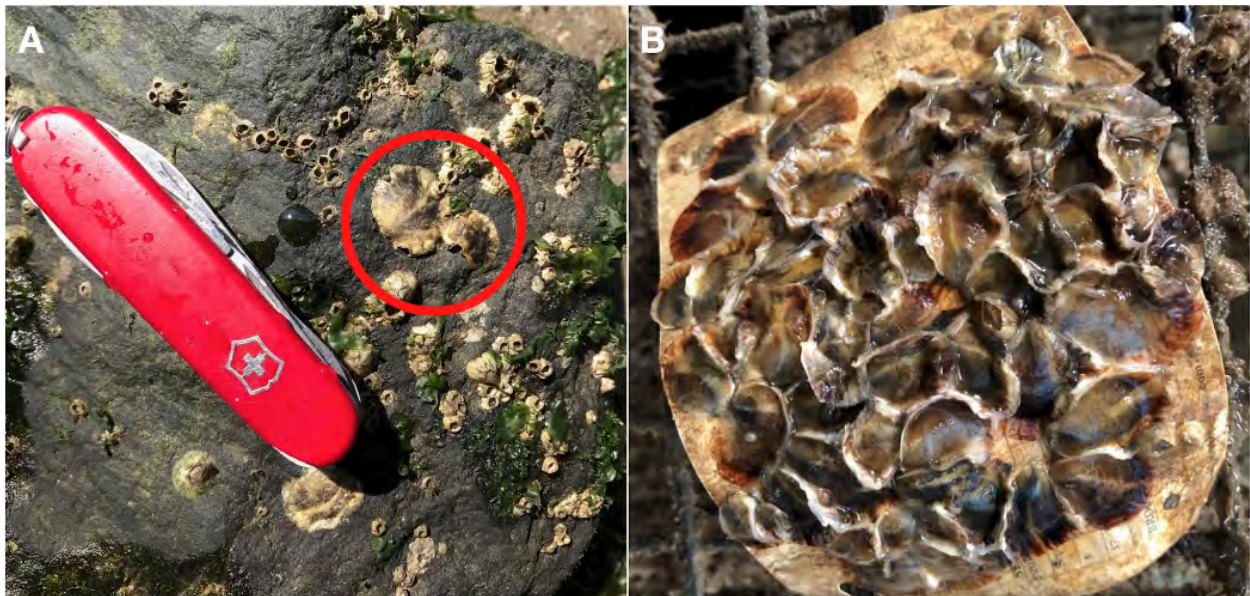
Figure 16. (A) Wild oyster recruits circled in red, along with barnacles and anemones, on intertidal rocks adjacent to the Coney Island Community Reef in summer 2018 (Swiss Army multitool for size comparison), and (B) wild oyster recruits seen at West Harlem Piers Park at 125th Street in Manhattan.

The presence of juvenile oysters, or “recruits,” is a positive indicator of progress toward a self-sustaining oyster population (**Figure 16**). While it is difficult to determine without genetic testing if the young recruits at a site are the offspring of the restored oysters or wild oysters, their presence indicates that site conditions are suitable for larval transport and survival. For example, the juvenile oysters observed on intertidal rocks at Coney Island Creek are not the offspring of the restored oyster population at that site, as they were less than one year old and therefore not yet reproductively mature. The recruits’ presence, however, indicates that a naturally occurring source population is nearby and that site conditions are supportive of larvae development and spat settlement.

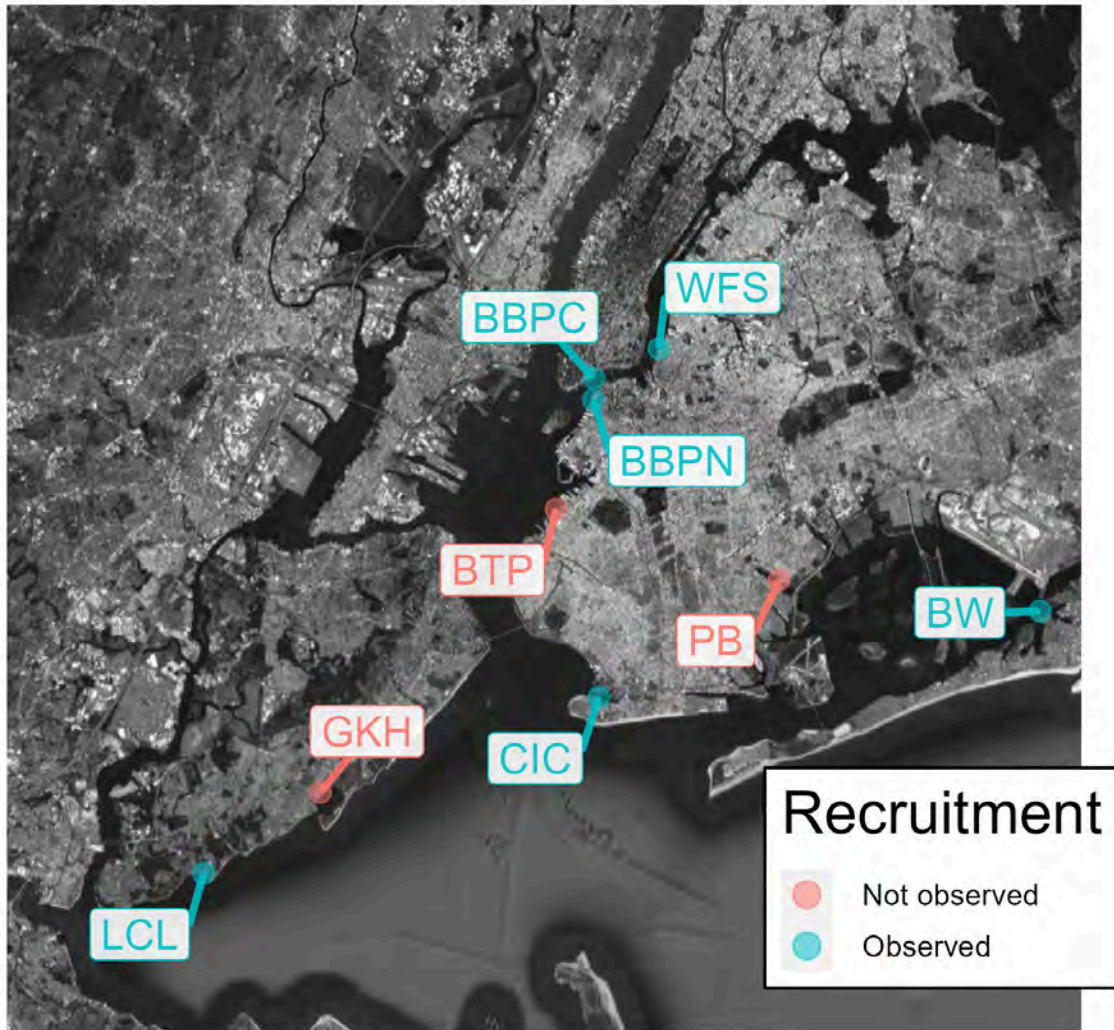
Figure 17. Map of restoration sites where wild recruitment (shell length <15 mm) was observed. Sites in red did not show recruitment, while sites noted in blue observed wild oyster recruitment.

Figure 17 displays wild recruitment (oyster shell height less than 15 mm) observed at selected BOP restoration sites across the harbor. Data sources vary and include informal surveys of the substrate adjacent to restored reefs or nurseries, such as intertidal rip-rap or bulkheads, as well as “unseeded” restoration structures like EConcrete® discs or bagged shell not set with larvae in the hatchery. Among the sites listed in **Figure 17**, no recruitment was observed at Bush Terminal Park, Paerdegat Basin, or Great Kills Harbor.

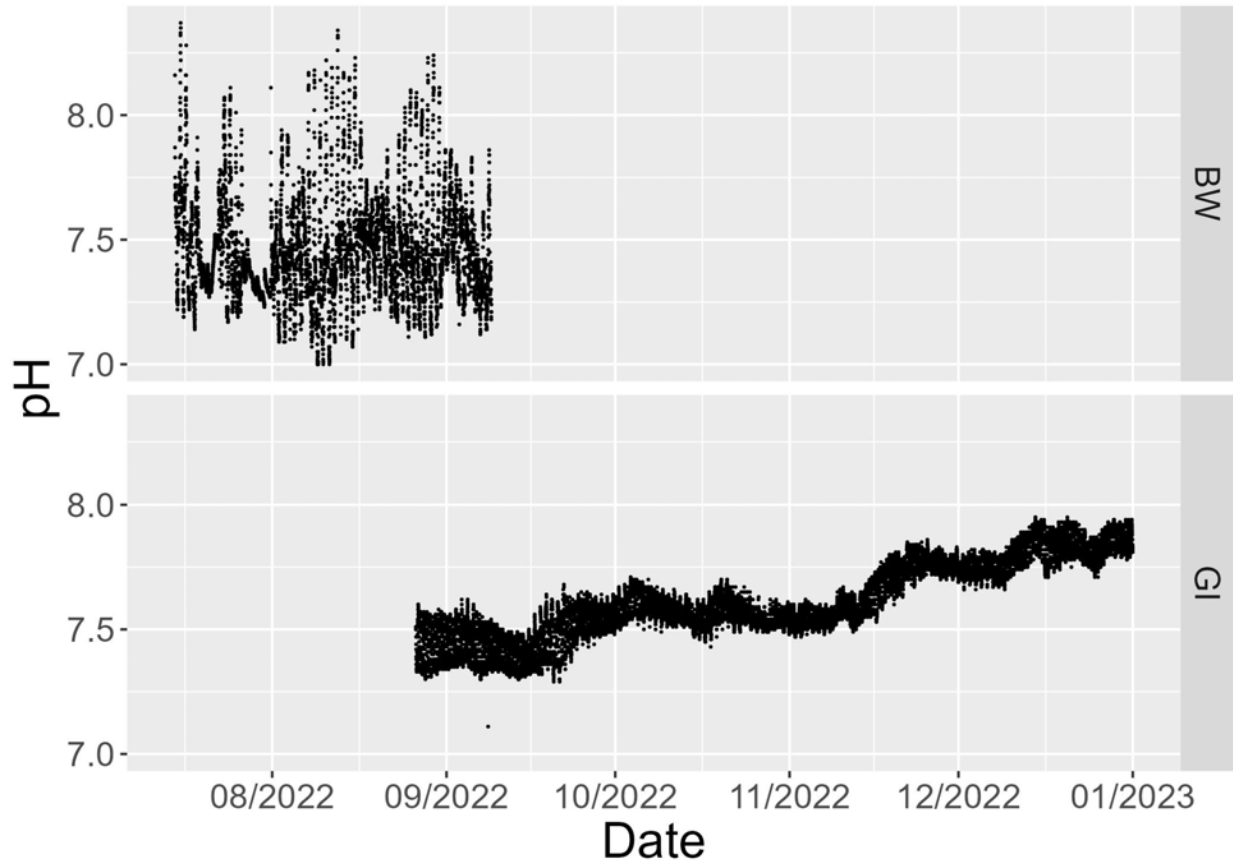
Figure 21. pH data for Bayswater Point State Park (BW), and Governors Island Ecodock (GI).

After long-term storage, the pH loggers needed some technical maintenance and calibration before they were deployed in late summer at BW and fall at GKH. Both sites had pH values that approached the lower threshold for suitability of 7.5 in the summer and early fall (**Figure 21**). If these low pH values persist during other times of the year, they may pose a threat to oysters at these sites (Brown & Hartwick 1988).

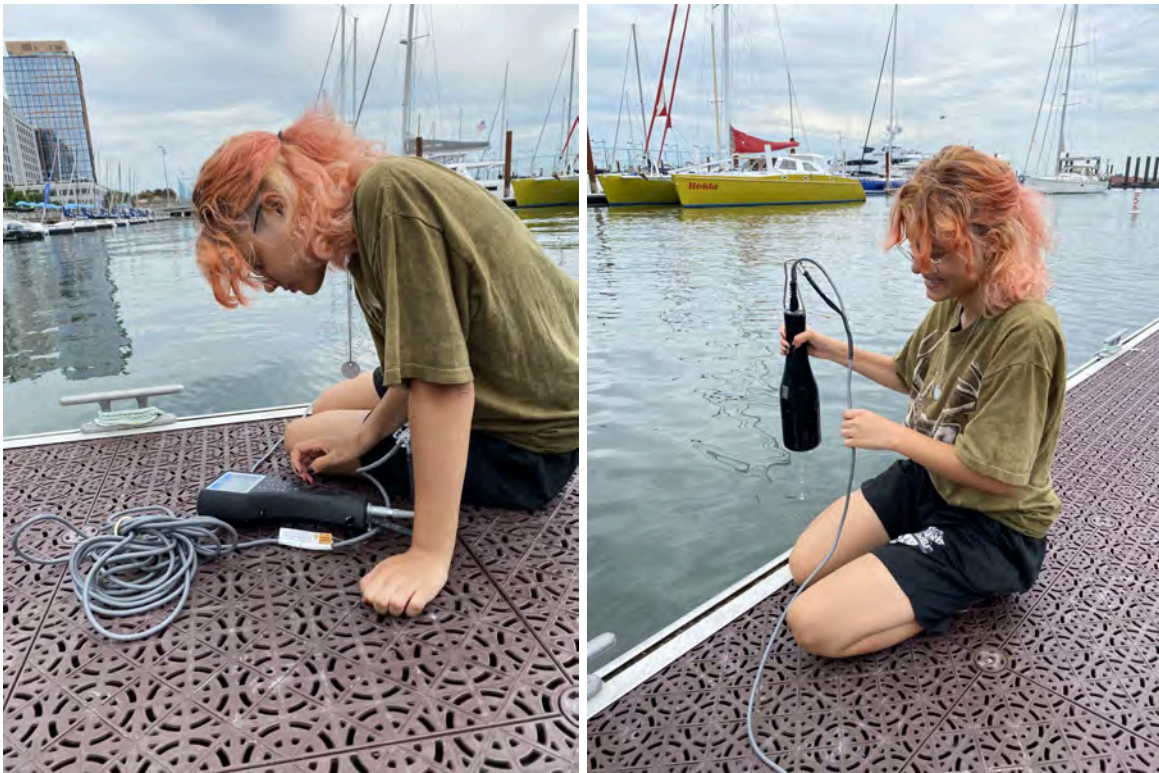
Figure 22. Billion Oyster Project summer intern deploying the Horiba probe at Brooklyn Bridge Park One15 Marina (right) and recording point water quality measurements using the Horiba hand-held device (left). (Photos courtesy of Jennifer Zhu)
