Corbels at DIG: a Resilience Year 2 Project

An Insight Report

By Dr. Chris Tuckley
and
Adam Raw Mackenzie

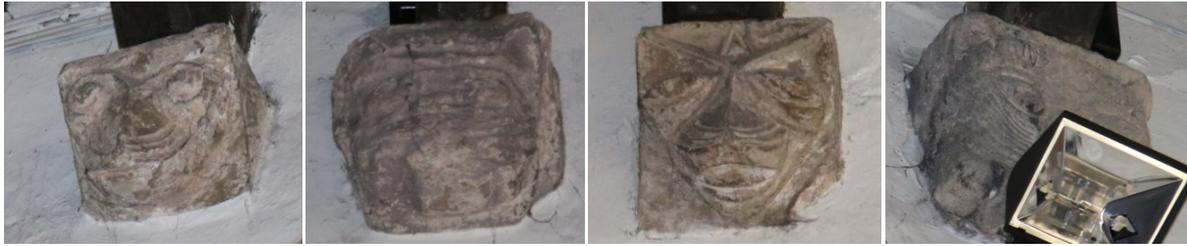
Figure 1: the corbels at St Denys

Nearby churches which also retain decorative 12th-century fabric include St Margaret (now the Centre for Early Music), Walmgate (whose 12th-century south doorway comes from the vanished church of St Nicholas); and St Lawrence, Lawrence Street (the east doorway in the 12th-century tower). St Denys, Walmgate, has a reset 12th-century doorway and four reset corbels of the same period. As at St Saviour's, these corbels are now inside the building, positioned high up on the south side of the south nave arcade (see figure 1). It has been suggested that a corbel acquired by the Yorkshire Museum in 1913 from excavations in Piccadilly may have belonged to the same group. None of these corbels is strikingly similar to any of the examples from St Saviour's in subject or treatment; this is true for the other half-dozen or so isolated examples of extant 12th-century corbels in York.

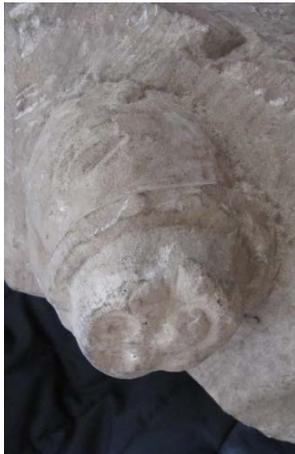
Figure 2: a 12th-century 'muzzled bear' corbel found by YAT in excavations at Clementhorpe, York, in 1977.

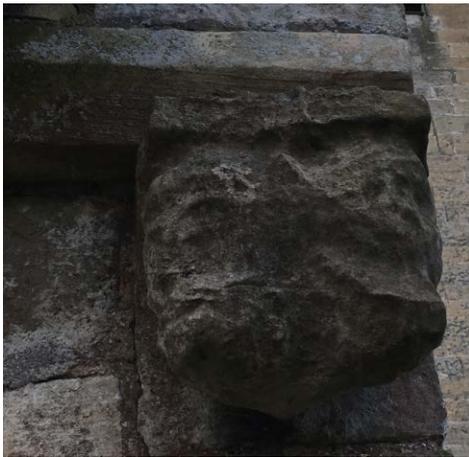
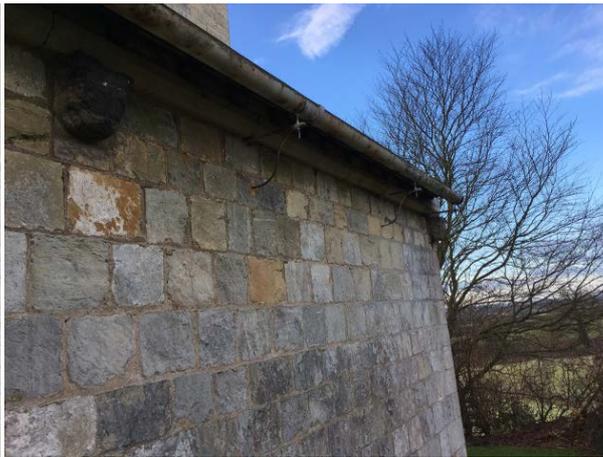
Figure 3a: detail of the paired-head corbel at the west end of the north wall at St John the Baptist, Healaugh, and (3b) its position within the corbel table.

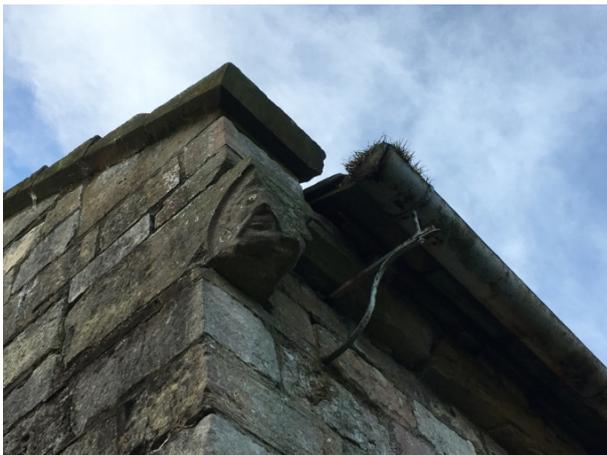
Figure 4: paired-head corbel at the east end of the north wall at St John the Baptist, Healaugh.

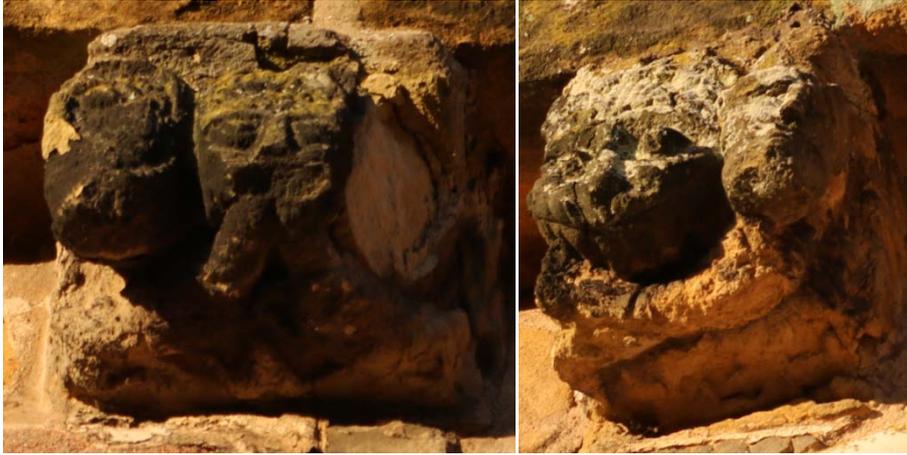
Figure 5: triple (5a) and paired (5b) heads at St Mary, Alne. Human heads appear here in combination with monstrous heads. The triple-head corbel has suffered damage since it was photographed for the Romanesque Yorkshire publication, when the monstrous head was flanked on each side by a human head: only one of these now survives.

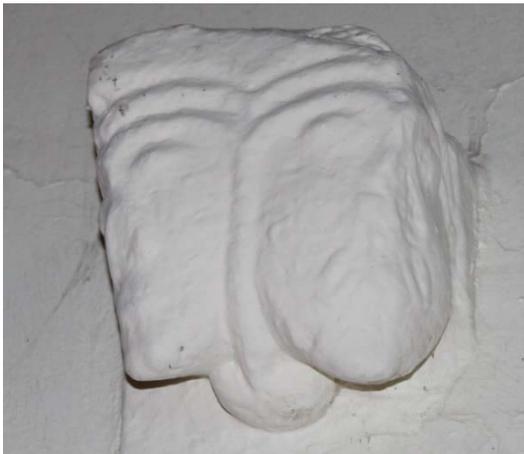
Figure 6: reset paired-head corbel above the south doorway inside St Peter, Harswell.

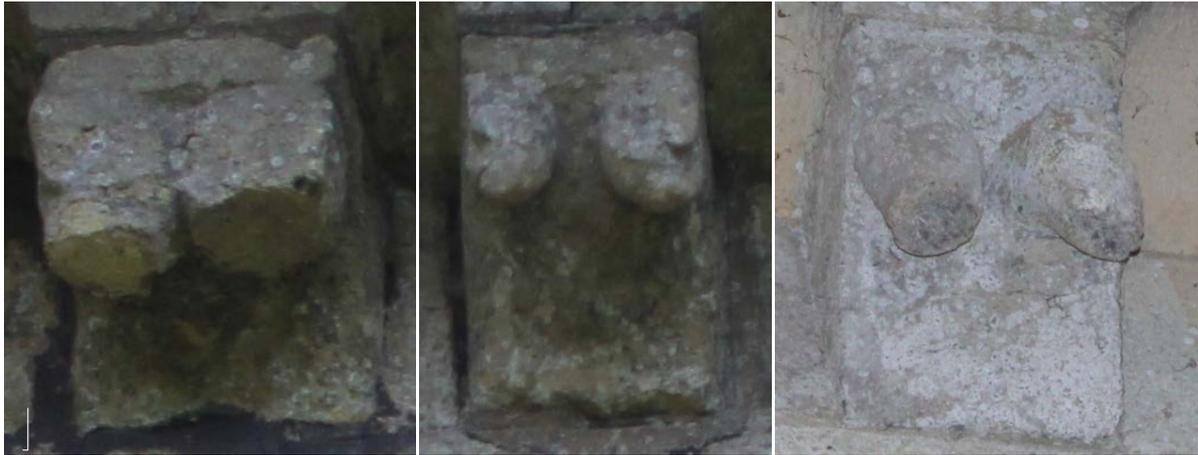
Figure 7: paired human- and animal-head corbels on the north wall at St Mary, Kirkburn.

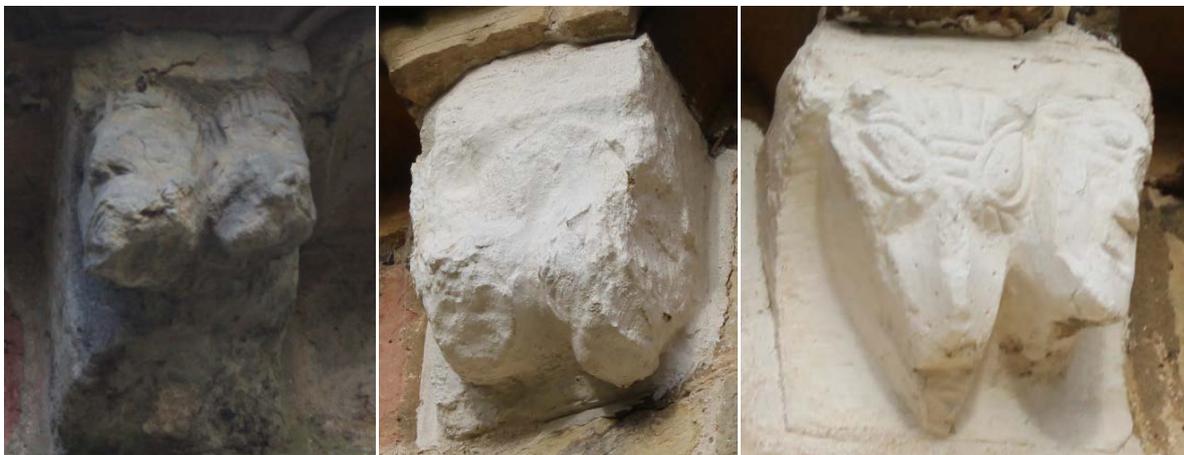
Figure 8: paired-head corbels at St Martin, Fangfoss, on the north (8a) and south walls (8b and c).

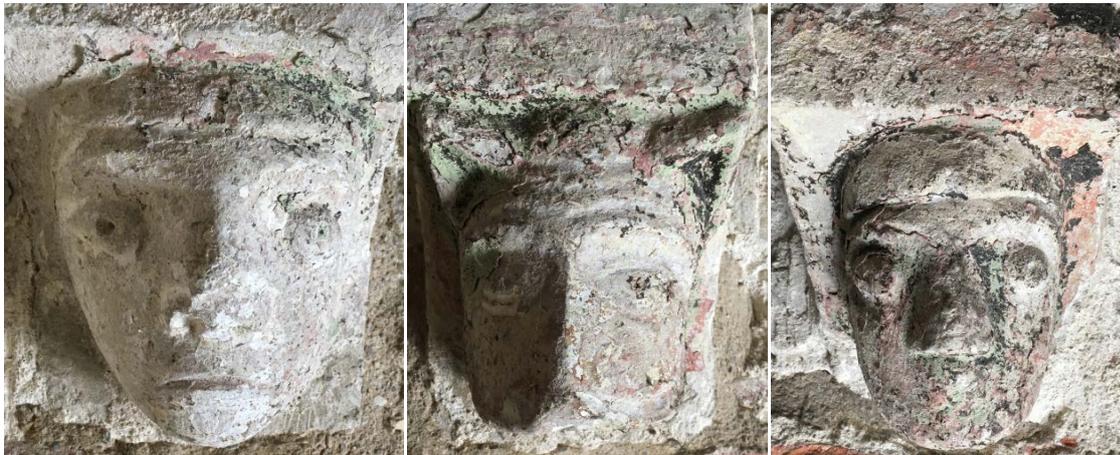
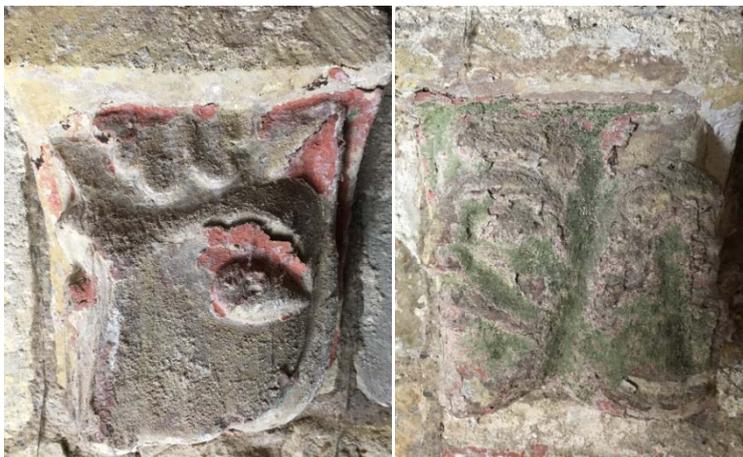
Figure 9: Corbels S1 – 5 and N1 – 5.

S1: Unbearded human face. Drilled pupils. Plain band across brow.

S2: Beast head.

S3: Unbearded human face. Drilled pupils. Small mouth / no mouth. Plain band across brow.

S4: Beast head (skewed to right, proper). Drilled pupils.

S5: Two human heads. One (nearest west wall) inverted.

Each of the corbels was assigned an identifying number, with S1 – S5 running from east to west along the south wall of the tower, and N1 – N5 running from east to west along the north wall.

On close inspection it was seen that the paintwork adhering to the corbels is in generally poor condition and liable to flake off in large pieces at the lightest touch. The degree of variety in the

colour spectrum is limited: only two (possibly three) colours were observed: a rust-coloured red and a mint green, darkening to a near-black in places. In places, the red was seen to constitute a layer below a green / dark green layer, which may suggest an undercoat (or overpainting of an earlier colour scheme). Paintwork in the same colours was observed elsewhere in the tower, apparently on plaster that adheres in patches on the walls. Small flakes of paint were taken for analysis, although the type of analysis to be used has yet to be determined: PLM (polarising light microscopy) has been suggested as a useful first step to identify the pigment particles present.

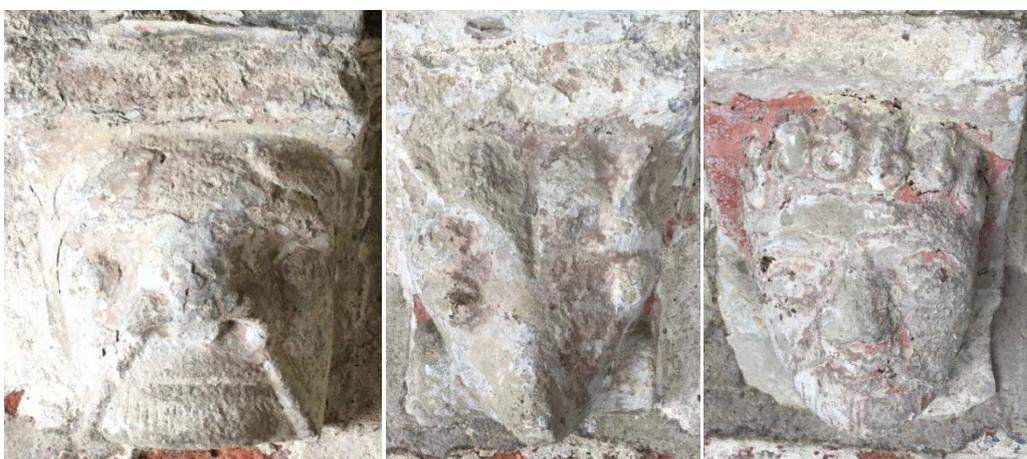
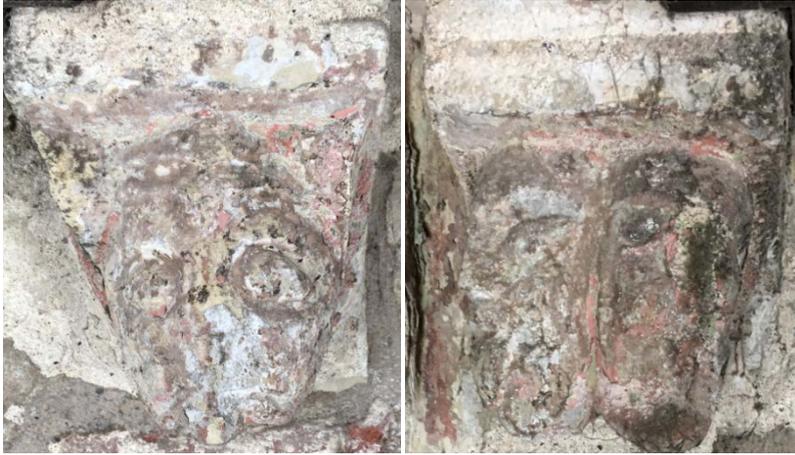
N1: Bearded and moustached human face with squared-off chin (tool marks on underside) and wide nose / flaring nostrils. Drilled pupils. Plain band across brow.

N2: Cat-like beast head biting down on gag. Drilled pupils.

N3: Bearded human face. Carved hair details: curls forming a fringe. 1 drilled pupil (right, proper).

N4: Beast head. Drilled pupils. Treatment of ears different in this than in S2/4 and N2 (where they are small, pointed and forward-facing). N4 has ears that are long and flattened against the head.

N5: Two human heads. Drilled pupils (where visible).

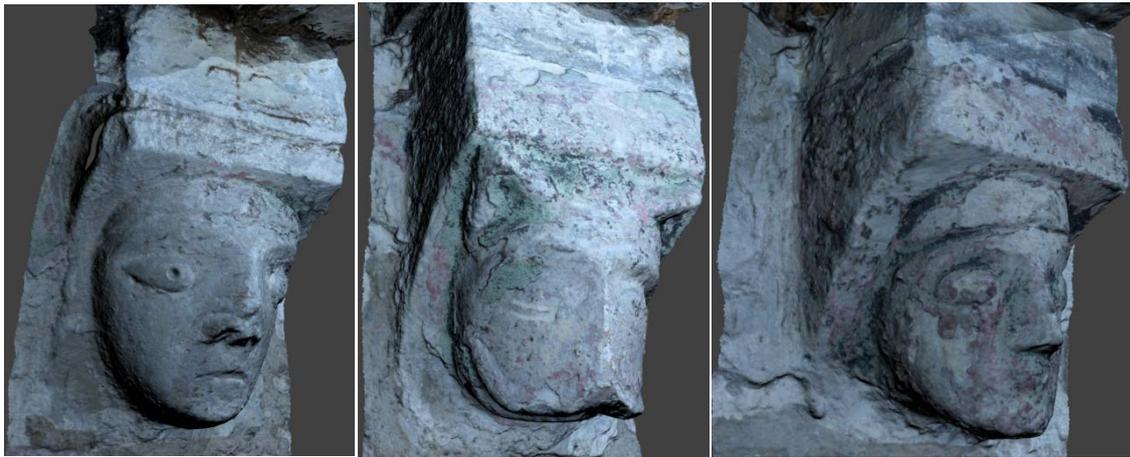
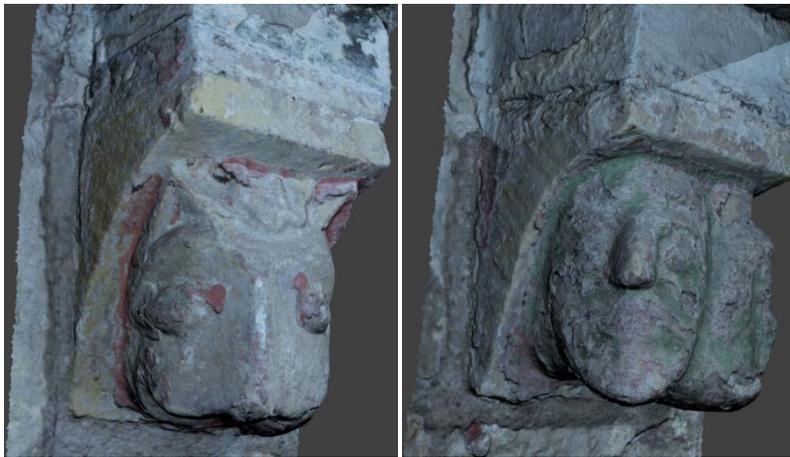
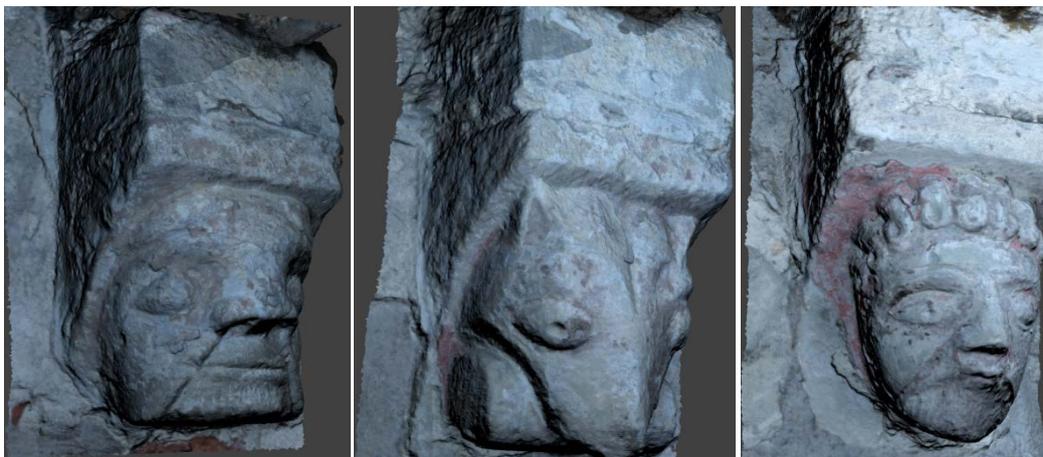
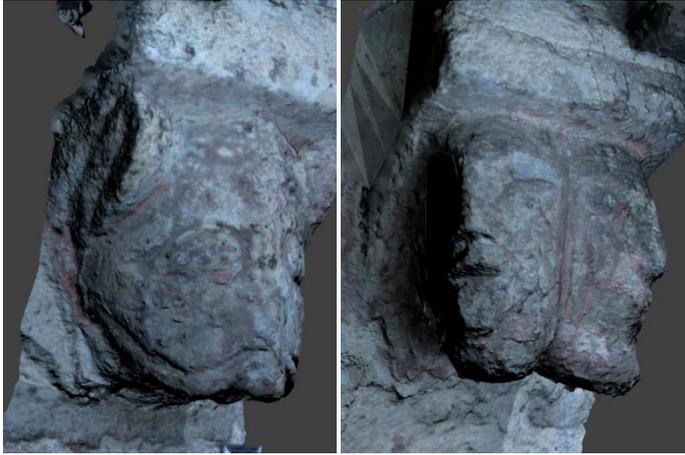
Figure 12: 3D digital models of all ten corbels.

A first pass was made at the 3D models using Agisoft Photoscan Standard. First, the software was used to align the images and create a sparse cloud of points in 3D space (see figure 10). Depending on the quality and number of images captured, the number of points varied from between around 30,000 to 60,000. A dense cloud of points could then be calculated, taking the total number of coordinates to between 6 to 12 million. A 3D mesh was then constructed from these points (see figure 11) and a texture created. The finished model was exported as an .OBJ file that could then be imported into other programs for editing.

A second pass was attempted using Agisoft Photoscan Professional. Similar steps were followed to the workflow above, with a number of additional steps that improved the quality of the sparse cloud by removing points whose locations were uncertain beyond a given threshold. The calibration cards were also used to scale the model, although this only worked for eight of the ten corbels. On one corbel the cards were left out by mistake and on another there were not enough good quality images of the scale cards for the software to automatically calculate the scale in other images.

In future, better-quality lighting and colour calibration could be used to increase the quality of the image, which in turn would improve the 3D model and the final image texture. More powerful lighting would allow a higher shutter speed to be used, lower ISO, and higher depth-of-field to be used, meaning sharper images could be captured initially. The natural light entering the tower through the large west window could perhaps have been blocked out using a large sheet. This would

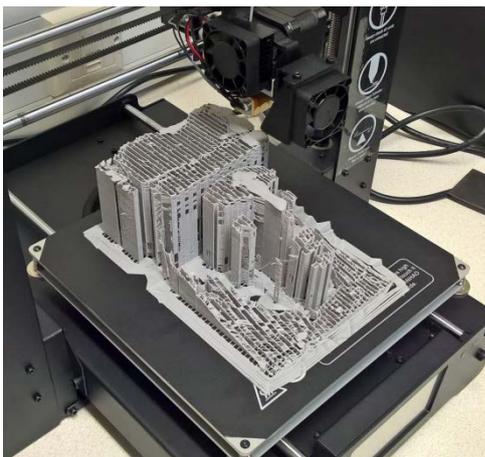
Figure 13: the results of the first attempt to print.

A 3D model was printed using a Wanhao i3 Plus 3D printer and Cura slicing software. The model was printed at half scale, creating an object around 10cm x 15cm x 7cm. The first pass failed, printing only the model support and a small number of surface features. Upon inspecting the printing code, the IT department discovered that the instructions sent to the printer had been incorrect. After troubleshooting the 3D model, it was discovered that the fault had been caused by the model being an open mesh, as opposed to an enclosed, solid 3D model. Once the mesh's border was extruded and enclosed, creating a solid object, the 3D print ran successfully, taking approximately 30 hours to print with a 0.1mm layer height and a 50mm/s.

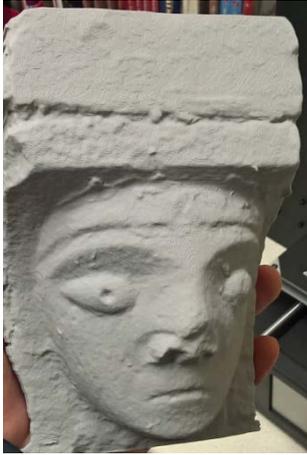
Figure 14: the second, successful attempt, which produced a model of corbel S1.

The 3D print could be improved by reducing the layer height used and by upping the face count on the original 3D mesh. The output is about as good as can be expected with the hardware available.
