TR250 & TR6 Brakes Overhauling Front Brakes

This section describes how I overhauled the front brakes for my '70 TR6. As mentioned earlier, the car is completely disassembled and I was able to take the front suspension assemblies to the workshop to do the work. Everything done here could have been done with the suspension assemblies still on the car.

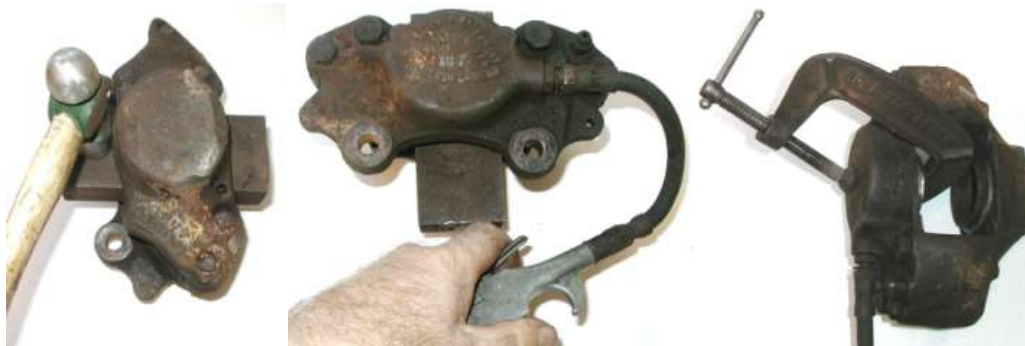
Removing the Pistons: These calipers had been out of use for about 12 years and the pistons were stuck. I first removed the boots around the ends of the pistons (tore them off in pieces) and sprayed PB Blaster around the outside of the piston. After a short time to let the Blaster work, I shoved a steel block between the pistons and used a hammer on each side to drive the pistons into the calipers (left photo). This broke the pistons loose. I then injected compressed air into the caliper using the same adaptor as used on the master cylinder (center photo). One of the pistons moved out. I then used hammer and block to push it back in. I repeated this several times until it moved fairly easily. I then pushed it in and held it (the loose piston) with a clamp (right photo) and applied air again. This caused the other piston to come all the way out. I then tapped the groove in the loose piston a little on each side to work it out. (If you folks look very closely you'll see that these three photos are of the left caliper -- I had already disassembled the right caliper and forgot to take pictures during the process).

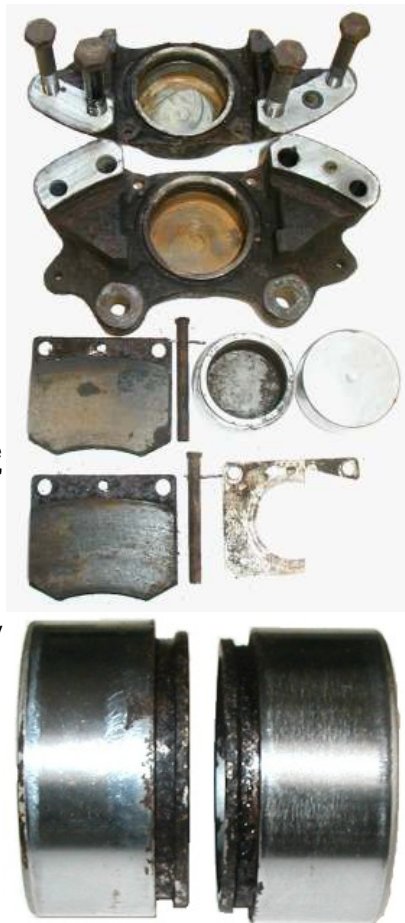
A disassembled caliper with pistons, pads, pins, etc is shown on the right. The funny shaped thing in the lower right corner is an anti-squeal shim. This caliper (we're back to the right one here) has been split in half to show the inside. I'm going to powder coat these calipers and I was concerned that little seal in-between the two halves would be damaged by the 350 degree temperature I use for curing. After researching the fluids (see note on fluids) I'm not so sure that the powder coating temperature will damage the seal since the brake calipers can get to temperatures around 300 degrees F or higher. I'd probably be OK if I kept the powder coating temperature down to around 300 degrees, which will work if I bake them a little longer.

Pistons: The pistons from one of the calipers are shown on right. According to the Moss catalogue the original pistons were made of mild steel with an industrial hard chrome plating. They are really fine looking with a neat finish --- except for the part that extends beyond the seal that rusts, in spite of the boot. The pistons here are heavily corroded in the area under the boots and must be replaced.

Another concern is that the little seal is over 30 years old and probably near it's useful life so it should probably be replaced. The seal is ~ .068" thick for a .062" deep recess with 1/2" OD and 11/32" ID. Moss lists the replacement as part number 583-820 in their TR2,3 & 4A catalog.

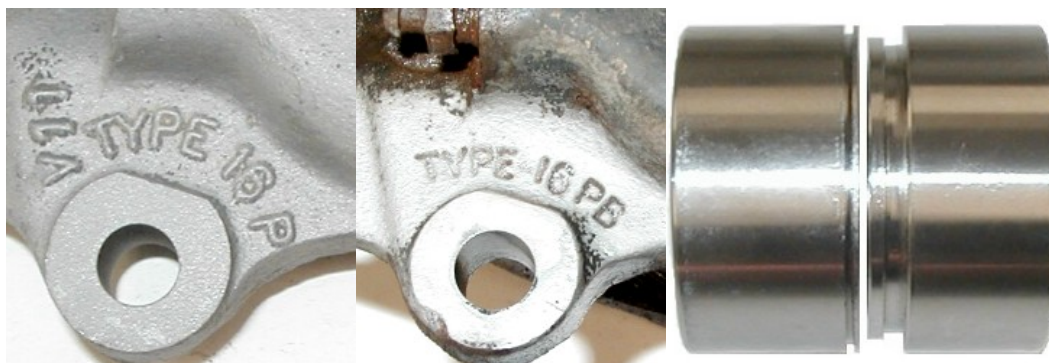
Caliper Variations: There were two changes in calipers during the TR250-TR6 manufacture. The first change at commission number CC29930 (early 69?) was to the front of the piston to accommodate different style boot (the later boot had a spring clip to retain it to the caliper). The photo at the lower right shows the difference in the pistons. These are new stainless steel pistons; the later style is on the far right. The type number on the casting was changed from TYPE 16P to TYPE 16BP when the piston style was changed. There was no change to the caliper castings at this time other than the number. The two style pistons are exactly the same size 2.125" (2 1/8") diameter and 1.140" depth. The 16P caliper is from my '70 TR6 commission number CC53270. The factory equipment for that commission number was the Type 16PB. My guess is that rebuilt calipers were installed at some time and with the early castings and late pistons.

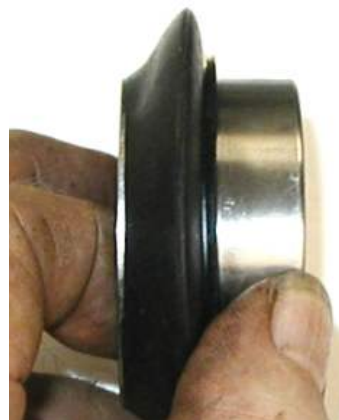
Piston Boots: The early pistons have the narrow groove as shown above. The edge of the boot fits into the groove. The other side of the boot rides on the side of the piston. The boot is shaped such that it naturally spreads toward the front edge of the cylinder to complete a sort of seal. The photo on right shows such a boot installed on an early piston.

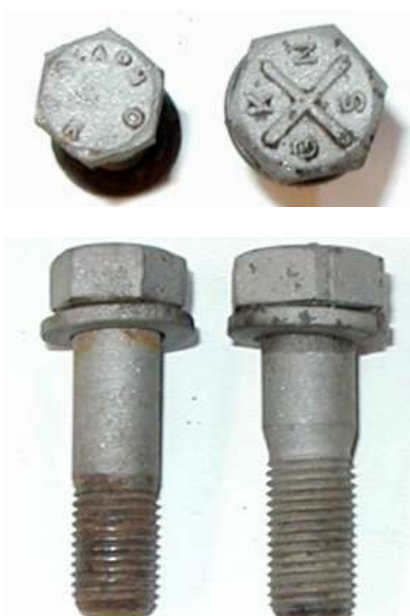
Metric Calipers: The next change, at commission number CC81079 (end of '72) was to convert the calipers to metric. The caliper type was not changed at this time, it stayed 16 BP. I pulled the caliper off the suspension from a '73TR6 I junked a while back. That car was purchased in the early '80s and I'm pretty sure the brakes are original as there were no indications that the car had had any prior maintenance. This caliper has TYPE 16BP cast into the side, as would be expected. The bolts that attach the calipers are clearly different as shown in photos the right. The bolt for the early standard thread type caliper is on the left and the one for the metric caliper is on the right. The actual threads on the end of both bolts are the same to match the caliper mounting plate that wasn't changed. The head of the metric version is 3/4 inch ~ 19 mm. The body of the bolt for the metric caliper is larger diameter matching the larger diameter holes in the calipers. You won't find one of those bolts at the neighborhood hardware store.

The metric caliper had smaller holes (3/16" vs. 1/4") for the pad retaining pins. The holes for the input pipe and bleed nipple are threaded 10 mm with a 1mm pitch (0.394" - 25.4 TPI) rather than 3/8-24 threads. Interestingly, the threads are close enough that I could use the air insertion hose with the 3/8-24 threads to get a piston out. The pistons in these metric calipers are identical to those used on my '70 pictured above.

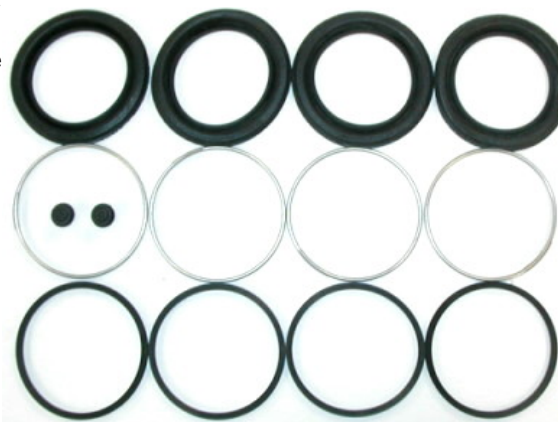
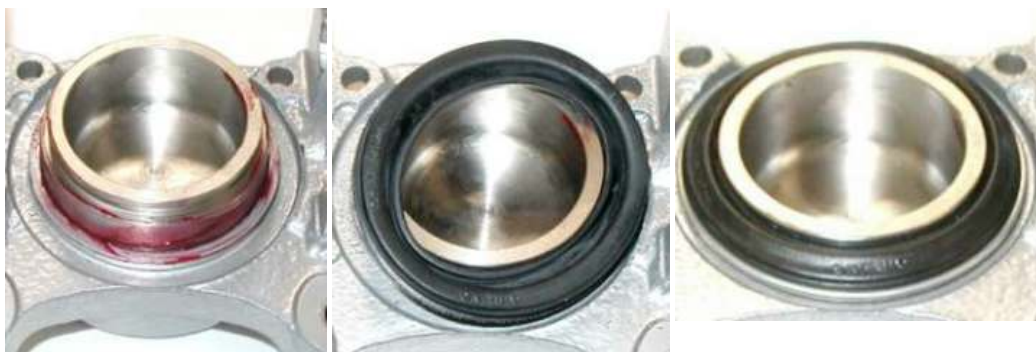
Rebuild Kit: The components in the rebuild kit for late style pistons are shown on the right. The kit for the early style pistons contain the different style boot shown previously and no wire clips.

I coated the inside of the cylinders with brake fluid and then rubber grease. I then inserted the seal, coated the piston with rubber grease and pressed it into the cylinder. Once the piston was in place I stretched the dust cover over the piston (center photo), pushed the piston in as far as it would go and then stretched the dust cover over the cylinder and secured with the spring clip as shown in right photo.

I then inserted a new seal (Moss part # 583-820) in the passage between the two halves of the caliper and bolted the two halves together. I found the little seals listed in the moss TR2, 3 & 4A catalogue. On the same page as the seal was the following caliper tip: **Girling "split" calipers should not be separated for any reason. They were not designed for separation and reassembly and proper torque specifications are not known, other than the inner and out bolts are torqued differently.** The inside bolts are 7/16" diameter and the outside bolts are 3/8" diameter. I torqued the outside 3/8" bolts to 40 ft-lbs and the inside 7/16" bolts to 70 ft-lbs. I then coated the bleed nipple threads with rubber grease, screwed it into position and covered the end with a new cap from the rebuild kit.

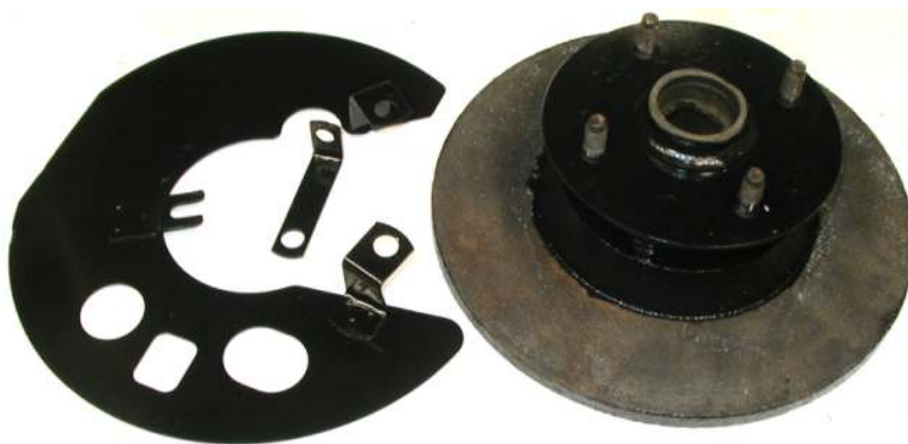
The rotors I decided to use for his project originally came off a '76 and were later used on a '73. They have a thickness of 0.50 inches indicating they have never be resurfaced. The rotor surfaces were heavily pitted from corrosion. I degreased and basted the hubs along with the the brake dust shield and the hose bracket. These components are shown in next photo below. If you look closely you can see the pits in the rotor surface. This was before I had them resurfaced.

Recall that the rotors were 0.50 inches thick before resurfacing. After resurfacing they measured ??? (I'll fill this in when I actually get them resurfaced)

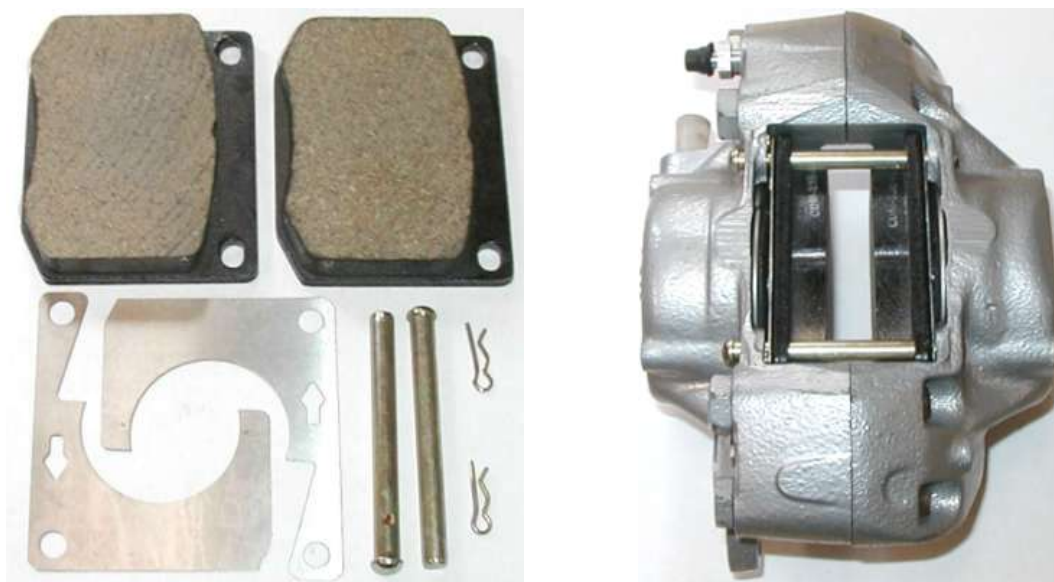
I found I had a new pad retaining pin kit so I used it rather than cleaning up the old pins. The pads, anti-squal shims come in sets that do both sides. The components for one side are shown in the left photo below. The assembled rotors are shown in the right photo. Assembly is straightforward with the caution that the shims must be oriented such that the arrow points in the direction of rotor rotation (when going forward). Apparently the anti-squal kit doesn't help much when braking while traveling backwards. I applied the brake grease to both sides of the anti-squal shims.

Replacement Pads & Shims: The pads removed from the calipers had plenty of life remaining. However, both the pads and shims are heavily corroded. The concern I had was that the corrosion might have weakened the bond between the pad and the steel backing so I purchased new pads. I've always used the standard pads from TRF and have encountered no problems. Some suppliers sell higher priced pads and well as cross-drilled rotors, etc. I've never felt a need to use anything but the standard OEM product. However, if I were racing or had encountered brakes problems due to unusual usage I would investigate those products.
