Powder Coating ZS Carburetors

The carbs for my '76 TR6 were overhauled last winter. Before the carbs were installed I got interested in powder coating and put together a power coating setup. (There are notes on this website describing both the carb overhaul and the powder coating equipment.) I decided to powder coat the carbs after observing how great the powder coated clutch master cylinder looked in comparison to the stained appearance of the carbs. Before jumping in and screwing up my good set of carbs it was decided to do a test run on an old carb. It went pretty well. The major problem was a few bubbles probably caused by out gassing from the castings when they were heated. This showed up most on the bypass valve castings. This was avoided on the real carbs by baking the castings before doing the cleanup.

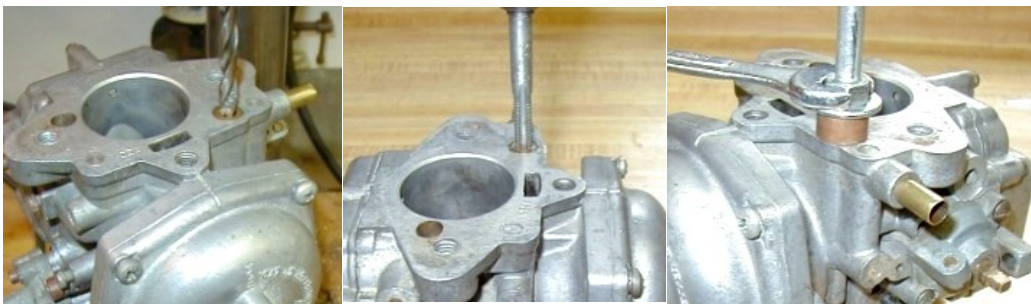
Because complete disassembly is required it was decided to do one carb at a time so the other carb could serve as a model as to where everything goes. The first challenge was to deal with the float chamber vent valve provided on '73 and later carbs described in Part II of the carb overhaul notes. It is impossible to seal the passages well enough to keep the small beads out of the valve and the valve won't operate properly if there are any beads in it. (I know this from experience because I blasted the trial carb without removing the valve and plugged everything up). I hadn't seen any documentation on how the valve operated or how to disassemble it. My guess was that the brass sleeve was pressed into the carb body so the first step was to press the sleeve out. Unfortunately there is no access to the back side of the sleeve to press it out. The technique used to remove the sleeve was to enlarge the sleeve ID with a 17/64 inch drill to a depth of about 1/4 inch and then thread the sleeve 5/16-TPI deep enough so that a bolt can be screwed in about 3 turns. The taps are tapered so a little torque is required to get the last couple turns on the bolt. The bolt was then removed and a nut, washer and spacer placed on the end of the bolt and the bolt was then screwed back in. The nut was then tightened to draw out the sleeve. See photos below.

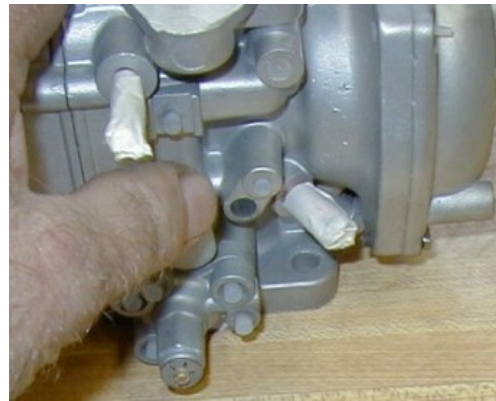
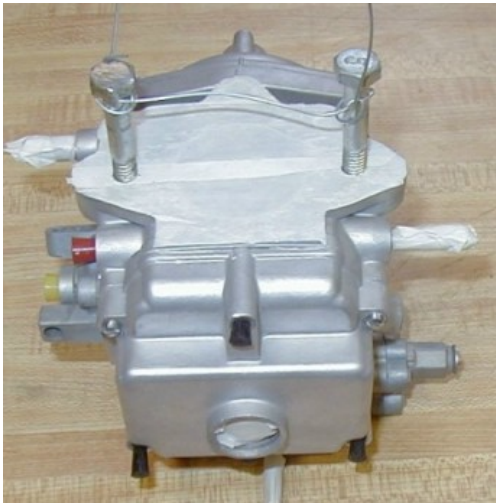
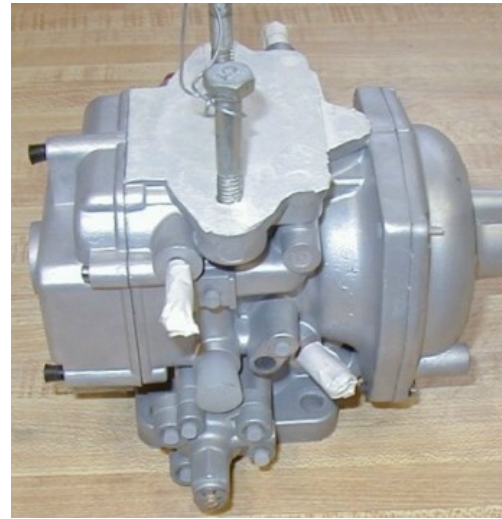
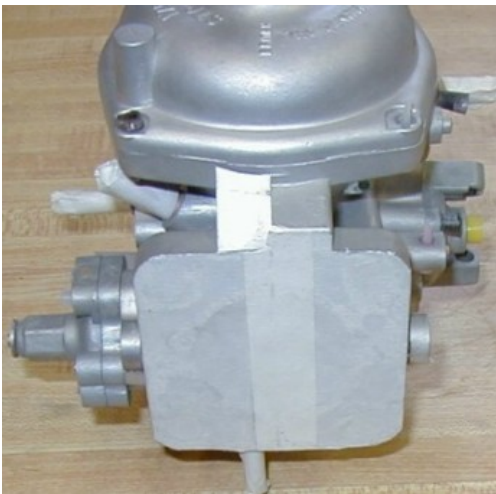
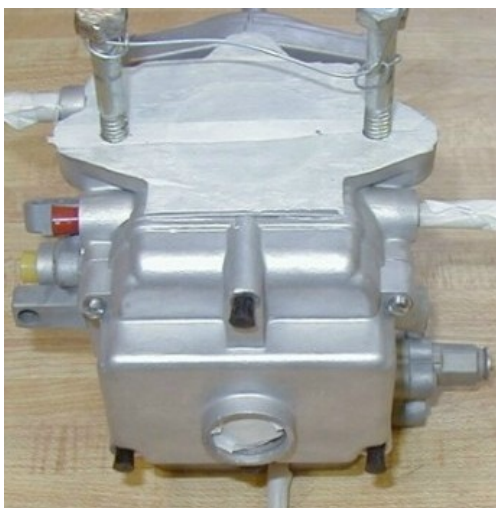
These parts were attached using one round head screw per part. The regular screws were not used. The attachment of these parts served to cover and protect the mating surfaces from the blasting and painting. Next, the very small vacuum ports adjacent to the manifold were plugged and covered with duct tape to keep the glass beads out of the small chambers. Plugs were inserted in the throttle bushes and a rag was stuffed into the main carb passage. The unit was then bead blasted until shiny bright over the entire exterior surfaces. The inside and plug portion of the temperature casting was covered with tape and also blasted. The vent lever was also blasted separately.

After the blasting, the castings were separated and washed in metal prep and then rinsed in clear water and blown dry. The small castings were then reattached to the main body using the one screw per part. The surfaces that mate with the manifold and air filter were then masked as were all brass tubes and the vent lever shaft ('73 & later). All ports and screw holes were then plugged with silicone plugs. The photos below shows the masked carb. The 5/16 inch bolts with wire between were used to suspend the carb while powder coating and curing.

The last photo on the right above shows the carb after powder coating and before curing. The temperature compensator (everything masked except visible exterior) and vent lever castings were also powder coated and cured at the same time as the main castings.

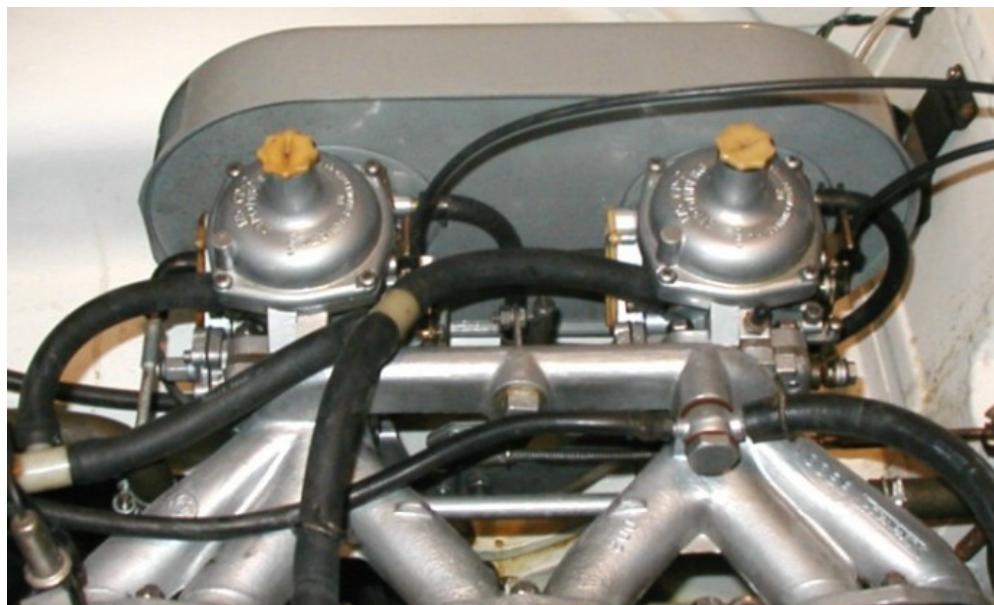
The photos below show the finished carbs installed on my '76 TR6.
