## Gearbox Cover Overhaul

The cover for my '76 TR6 gearbox was overhauled a few months ago before putting the engine & gearbox back in the car after new paint. I took a few photos planning to complete the series on overhauling the gearbox. I recently overhauled a TR3 gearbox cover and also took some photos. Now it's time to do a little documentation.

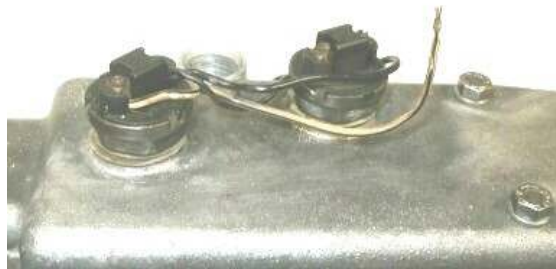
The switches in the photo below are Overdrive Isolator Switches on the TR3 cover. The switches screw in to threaded holes in the cover. These switches have a hex section near the surface of the cover that requires a large thin open-end wrench (spanner) that I don't have. However, a small pipe wrench works well (don't ever let a real mechanic see you working on an auto with a pipe wrench). Later switches have a larger hex section that matches well with are crescent wrench.

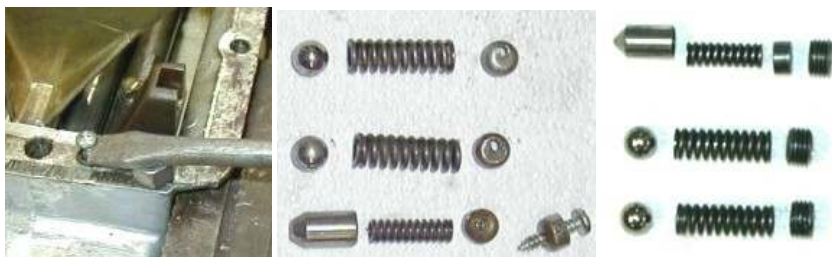
The pressed-in plugs for my '76 were removed by drilling small holes in the plugs and the screwing in sheet metal screws and then prying up on the screw head as shown in left photo below. The spring under the first plug removed flew halfway across the workshop. The other two plugs were covered with a rag before they were pried out. The detent parts for the '76 TR6 are in the middle photo and those from the TR3 in the right photo below. The two forward speed selectors use the large spring and ball and the reverse selector has a plunger, a smaller spring and a thick spacer called a distance piece. It looks like I drilled through the distance piece in the middle photo. (Update 2/02: I took apart a TR250 cover and found that a pointed plunger with smaller spring and distance piece rather than a ball on the 3rd/4th detent. The Moss catalogues indicates that they changed from the ball to the plunger in the TR4 after gearbox CT9899 and changed back to a ball after TR6 gearbox CD 22039).

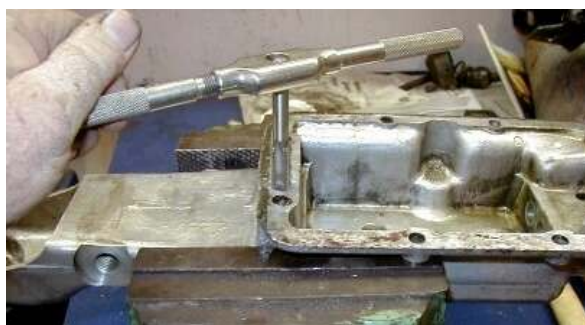
I was unable to get replacement pressed-in plugs for the '76 but was able to get the older threaded style from TRF, which were used. After the selectors were removed, the three holes were tapped 7/16-20. The existing holes were the correct size so all I had to do was find the tap and use it. The photo below shows a hole being tapped. This occurred much later in the process but I thought it better to show here to wrap up this subject.

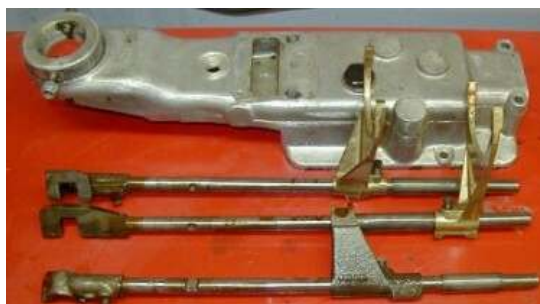
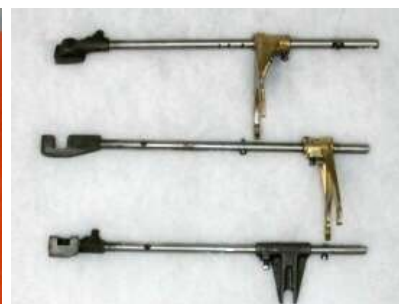
The 1st/2nd gear selector shaft is removed next followed by the 3rd/4th gear selector shaft. In each case, the fork and sleeves/setscrew are put back on the shafts in the correct position and orientation. The removed selectors are shown below; the 76 TR6 on the left and TR3 on the right.

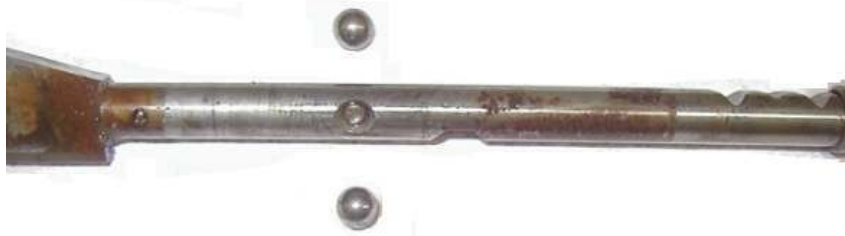
**Interlock:** The interlock consisting of a short pin and two steel balls is located between the detents and the gearshift. There is a hole bored in the casting between the three cylinders housing the selectors at the point of the interlock. The 3rd/4th gear selector shaft has a small hole bored through it to hold the pin. The steel balls are located in the hole in the casting between the shafts, one between reverse and 3rd/4th and the other between 1st/2nd and 3rd/4th. There are also detents bored into the sides of all three shafts. The photo below shows the 3rd/4th gear selector shaft (the

middle shaft) from the TR6. The three notches on the right are the detents that work with the spring and steel ball. The notch to the right of the steel ball is for the overdrive switch in the top of the cover. The two balls and the pin just visible in the recess in the shaft are the interlock.

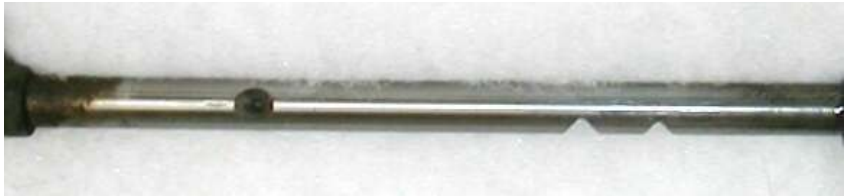
The photo below is of the reverse selector shaft from the TR3 gearbox. The two notches on the right are for the dents, in this case, the spring and plunger. The recess towards the left side is part of the interlock: one of the steel balls fits into the hole.

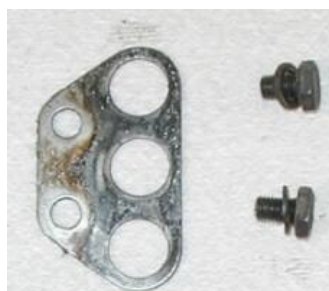
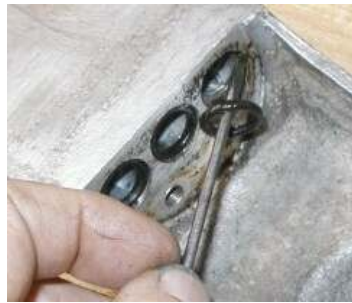
**Cover Plate:** The final thing to remove is the cover plate that exposes the three O-rings I wanted to replace. The left photo below shows the cover plate with screws. The right photo shows an O-ring being removed from one of the recesses. Standard Buna O-Rings can be used here size #112, 1/2" ID, 11/16" OD, 3/32" cross-section.

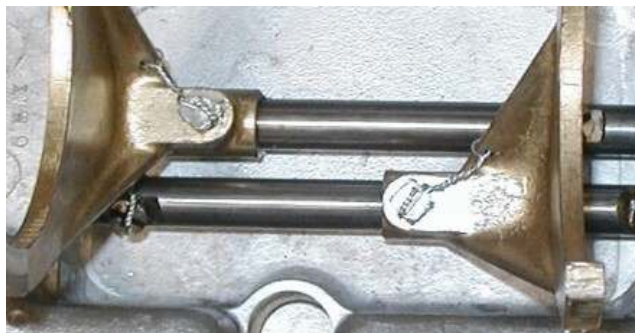
**Reassembly:** The reassembly is the reverse of disassembly. First, the three O-rings were put in the recesses and then the cover plate installed. The interlock balls were then coated with grease to both lubricate them and to hold them in position during reassembly. A screwdriver was then used to push each ball down the center shaft cylinder and into the side hole. The interlock pin was then positioned in the middle (3rd/4th gear) selector shaft which was then inserted through the center hole in cover plate and on into the casting. The shaft was pushed into the associated fork and, if on the later cover, into the sleeve. The orientation of the fork and sleeve was double checked and then the tapered screw inserted and tightened. The setscrew was inserted in place of the sleeve on the earlier cover and then both the tapered screwed and set screw were secured with safety wire. The other to selector shafts and associated components were then installed using the same procedure. The shafts already installed were placed in the neutral position before inserting an additional shaft. The photo below shows safety wire on a partially assembled early cover. (The safety wire is a real pain, fortunately, I didn't have to use it on the TR6 cover.)

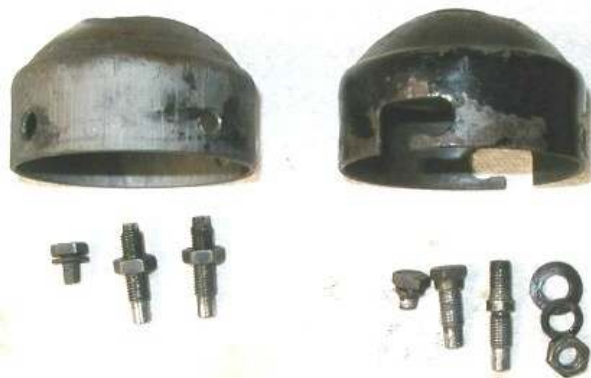
**Gearshift:** I usually remove the gearshift from the top cover before removing the gearbox from the car. The shift lever will side up and out of the top cover after the shift lever cap has been removed. Two designs of caps were used in on the TR6, the change occurring possibility in '73. The photo below shows the two cap designs. The earlier design on the left, also used on the TR250, has shift lever locating pins that pass through holes in the cap; both these locating pins as well as the small bolt at the rear must be removed before the cap can be removed. The later design on the right uses locating studs with shoulders. This cap can be removed by first removing the small bolt at the rear and then pushing the cap down and rotating it counterclockwise enough for the tabs to clear the shoulder on the locating pins. The cap can then be lifted up and off. There are two different locating pins shown for the later cap. The short one is used on the left side and the long one on the right. The long one has a threaded stud that retains the top cover steel support strap. The flat washer, lock washer and nut secure the strap. A thread locking compound similar to Loctite had been used on the longer stud removed from my '76 TR6.

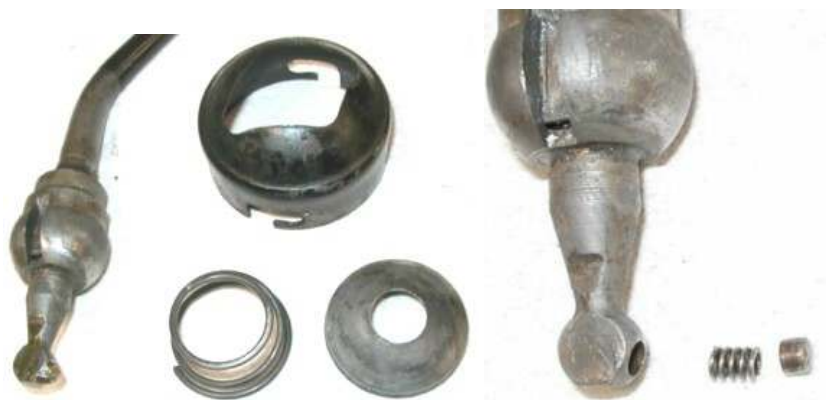
The photos below show the remaining parts for the late TR6 gearshift. The shifter is on the left, cap on the top and spring and retainer on the bottom in the left photo. The right photo shows the anti-rattle spring and plunger that fits in the hole in the bottom of the shifter. The Moss catalogue mentions that a rattling gearshift lever is a very common Triumph problem. They say the source of the problem is usually a worn or missing plunger and/or spring shown in the right photo. The plunger on the '76 shifter shown here was pushed in when it was removed from the gearbox. I at first thought the spring was missing. I had to tap the side opposite the hole with a small hammer to get the plunger to come out. There was a spring behind it, but in four pieces. The spring shown below is new.

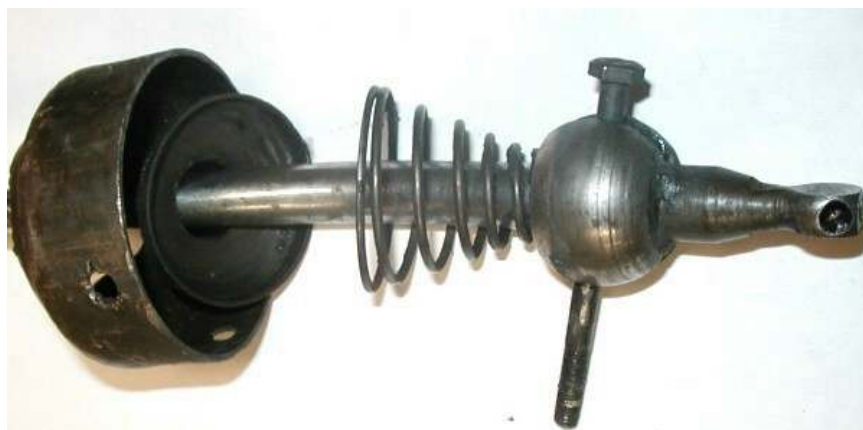
The TR3 & TR4 gearboxes used a different cap than the later gearboxes. The photo below is of parts from a TR4 gearbox and is similar to that on that for the TR3 except that the TR3 shifter is straight.. Note the bolt that goes through a hole in the bottom of the shift lever and both side holes in the cap.

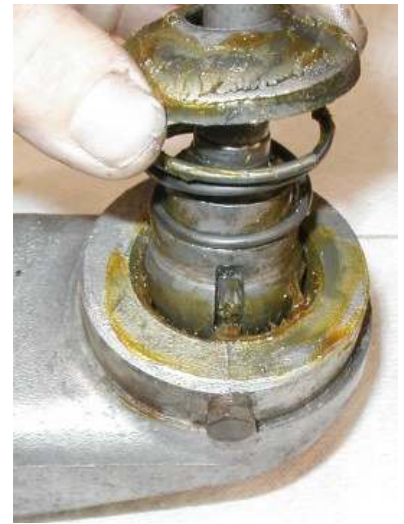
**Gearshift Reassembly:** The gearshift components and the mating surfaces of the cover were cleaned of all grease. Fresh grease (I use wheel bearing grease) was applied to the recesses in the castings at the end of the shifters that the end of the shift lever sets. Grease was all spread over the rounded bottom of the shift lever and the extension that contains the anti-rattle plunger and spring. The spring and plunger were

then fed into the hole and retained by the grease. The shoulder locating pins were then screwed into position on the later cover. This was deferred for the earlier cover. The shift lever was then positioned in the top cover as shown in photo on the right. Next, the spring was positioned on the shift lever (small coil on the bottom) and the spring retainer slipped into position. Notice that the retainer was coated with grease. The insides of the cover were then coated with grease and pushed down over the retainer. The slots were aligned with the shoulders on the retaining pins, and the cover was then pushed over the shoulders and rotated so that the tabs are under the shoulder. The small bolt in the rear was installed to secure the cap.

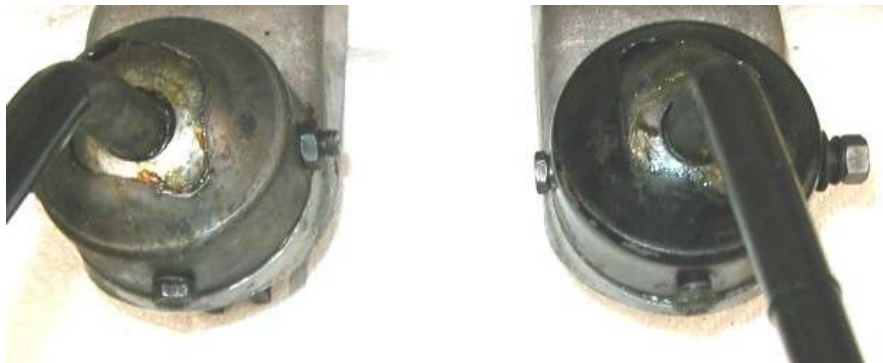
The following photo shows a cover that uses the adjustable retaining pins (left) and one that uses retaining pins with shoulders (right).
