# SHEAR AND ANCHORAGE FAILURE OF SCALE PRESTRESSED CONCRETE I-GIRDERS AND SCALE BRIDGE SECTION

**KEYWORDS:** Prestressed concrete, bridges, shear, anchorage, bond

## ABSTRACT

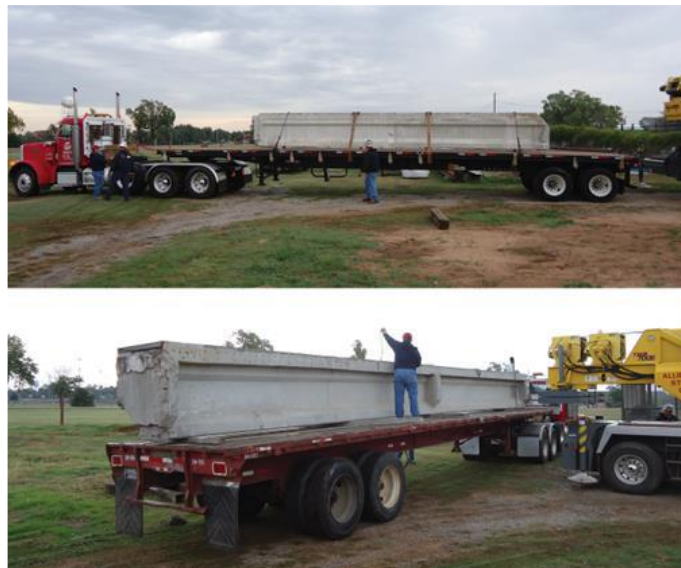
*Figure 1: Two full-scale girders being delivered for testing, Girder A (top) and Girder C (bottom)*

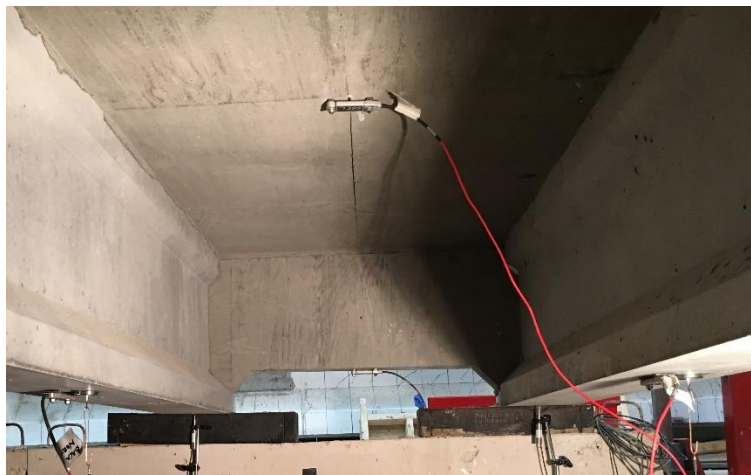
*Figure 2: View from underneath scale bridge showing connection between girders and slab and the end diaphragm connection*

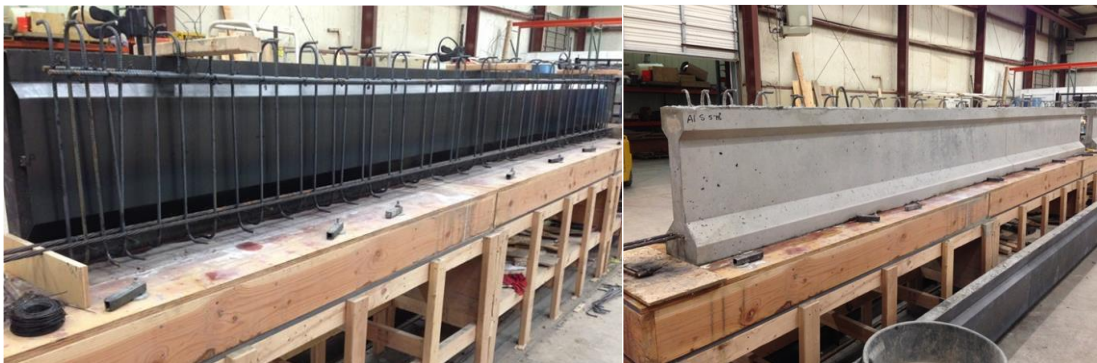
*Figure 4: Scale girder shear steel and prestressing strands (left) and completed girder prior to de-tensioning (right)*

Four half scale sections were constructed based on design details from the two full-scale girders (Girders A and C). These sections had slightly different applied prestress forces but were otherwise very similar in design. The concrete for these girders was made in Fears lab and all prestressing was performed by members of the research team on the prestressing bed at OU (Figure 4). Each girder was 5.5 m long.

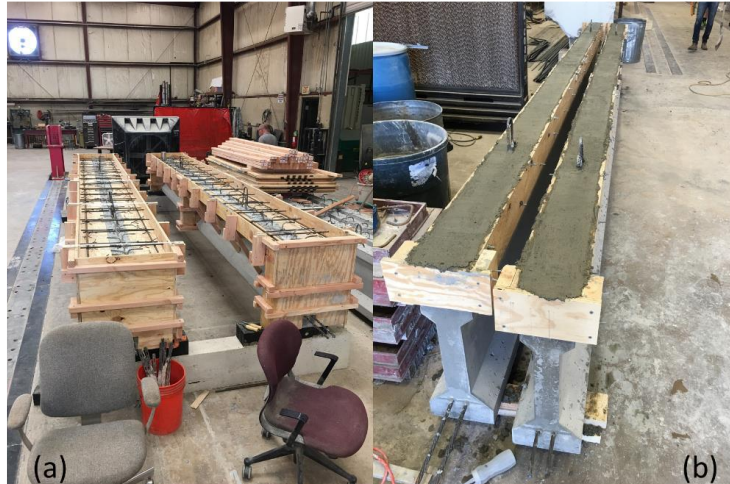
Figure 5: Completed scale girder specimens with sections of deck prior to and after casting

Once the scale girders were cast, an additional 108 mm thick deck section was cast separately atop the girders to match the dimensions of the remaining deck in the full-scale sections. Figure 5 shows the completed girder sections at different stages of deck casting. Figure 5a shows the sections with a wider portion of deck, to match the full scale Girder C dimensions, while Figure 5b shows the smaller deck (Girder A). The four individual scale sections were then tested using a single point load at varying distances from the support.

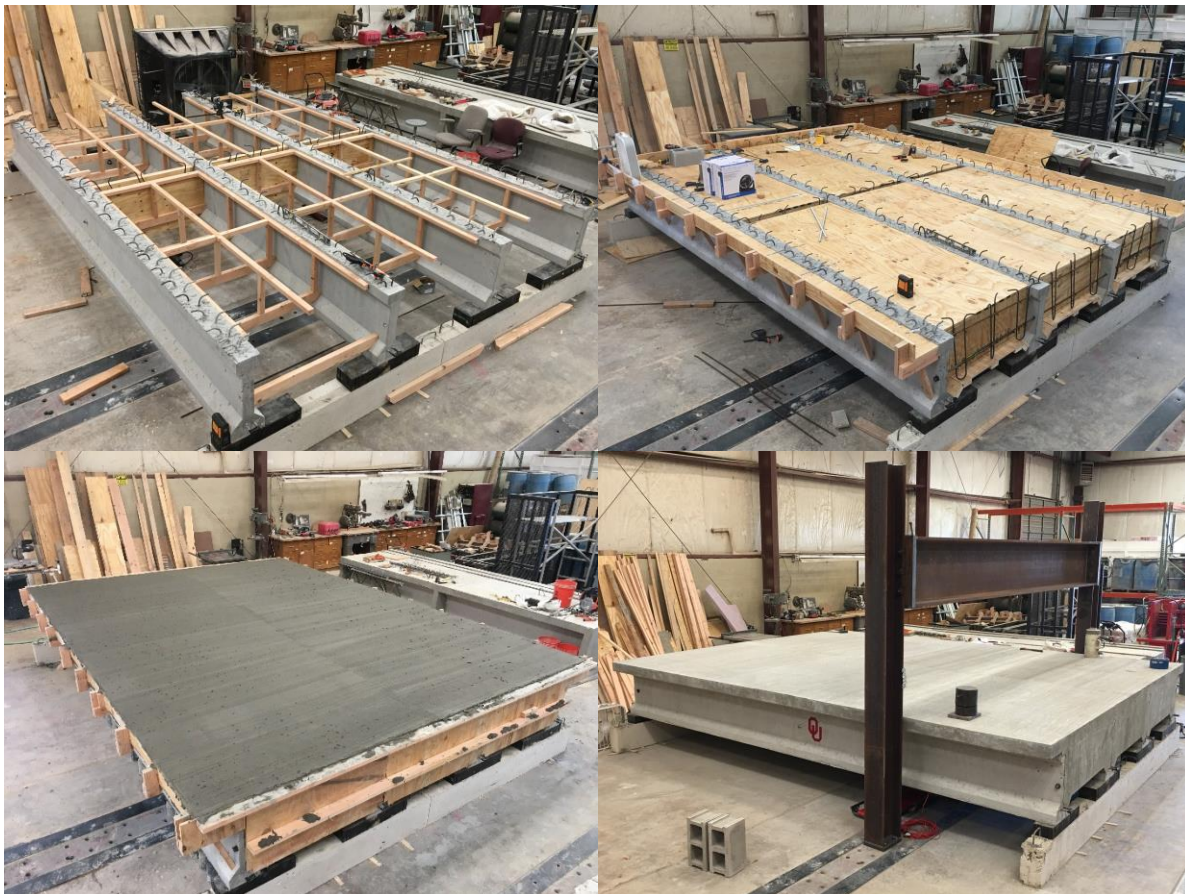
Figure 6: Scale bridge construction progress

Another four scale girders were cast using the same techniques to construct a scale bridge. The scale bridge was simply supported on neoprene bearing pads and consisted of four girders connected by a deck and middle and end diaphragms cast monolithically with the deck. Figure 6 shows the construction

steps for the scale bridge. It was constructed in much the same way as a real prestressed concrete bridge. The girders were arranged and formwork for the deck and diaphragms was constructed onto the girders. The concrete for the deck and diaphragms was poured, allowing the girders to carry the full dead load of the deck and diaphragms. The bottom right of Figure 6 shows the completed bridge with a special made load frame located at the quarter span point of the bridge. Several sets of tests were performed along the width of the bridge at the quarter span point to evaluate computer models of the scale bridge. Next the bridge was loaded to failure by increasing a point load located above an interior girder at the quarter span point. This location was selected to maximize shear demand in a region likely characterized by beam-type shear (not a discontinuity region) and to compare more readily with the scale individual girder tests and the full-scale tests.

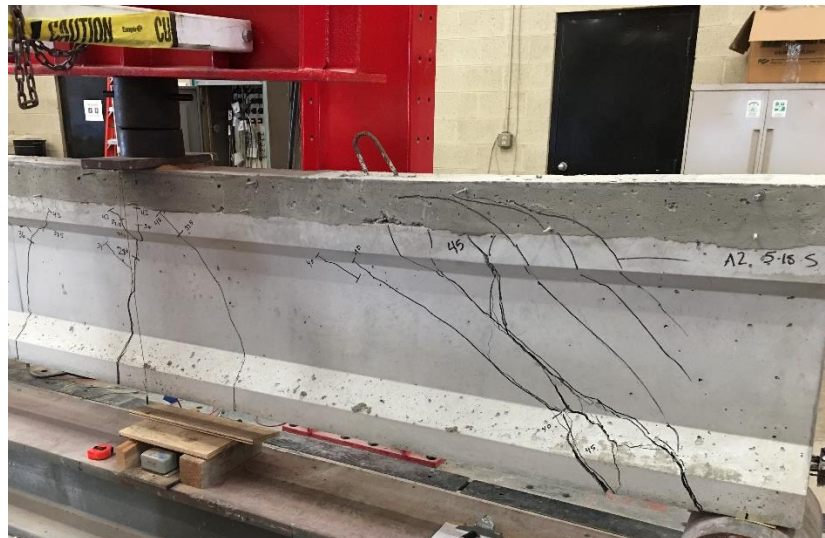
*Figure 8: Girder A2s failure*

*The final cracking of girder A2s is shown in*

Figure 8. Extensive shear and flexural cracking was observed, and there was limited ductility after initial cracking. The strand slip and shear cracking at 199 kN reduced the load carrying ability of the girder. Crushing in the deck was not observed but some shear cracks oriented themselves horizontally near the top of the deck. By the end of the test, a maximum slip of 15.0 and 15.5 mm was measured for the strands at the loaded end. The maximum point load for flexure at this location was 187 kN based on strain compatibility compared to a maximum load in the test of 199 kN kips. This is a difference of 6.7 percent. Again, this was good agreement despite bond failure, indicating that slip potentially occurred after some strand yielding occurred. Again ultimate load was limited based on slip in the strands despite locating the load further into the section.

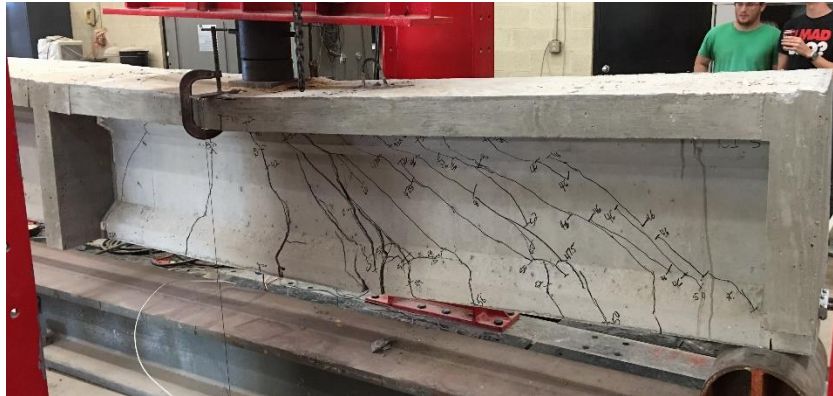
*Figure 9: Girder C1s failure*

Test C1s was performed at an  $a/d$  ratio of 3.0, corresponding to the  $a/d$  ratio of full-scale girder test C1. This  $a/d$  ratio resulted in a load point located at a distance of 1.82 m from the end of the girder. Initially the girder was quite stiff, with only 3.3 mm of deflection when the first flexural cracking occurred at a load of 185 kN. After initial flexural cracking, load was increased at 2 kip increments. At a load of 205 kN, shear cracks formed near the supports. The formation of these shear cracks led to strand slip of 0.51

mm for one strand on the south end of the girder. Slip increased from the point of shear cracking to the end of the test, resulting in a maximum slip of 13.2 and 18.3 mm for the strands on the loaded end. The test was continued to a maximum applied force of 277 kN, at which point the strand slip prevented any increase in load. The flexural capacity based on strain compatibility at this section corresponded to a point load of 240 kN. The shear capacity using the ACI method at this section corresponded to a point load of 329 kips. The predicted capacity was exceeded for flexure despite the large amount of recorded slip. The partial center diaphragm appeared to arrest cracking near midspan, but it is difficult to make definite conclusions on the effect of the partial diaphragms since the tests of scaled girders without diaphragms were for a slightly different design (smaller prestress force).

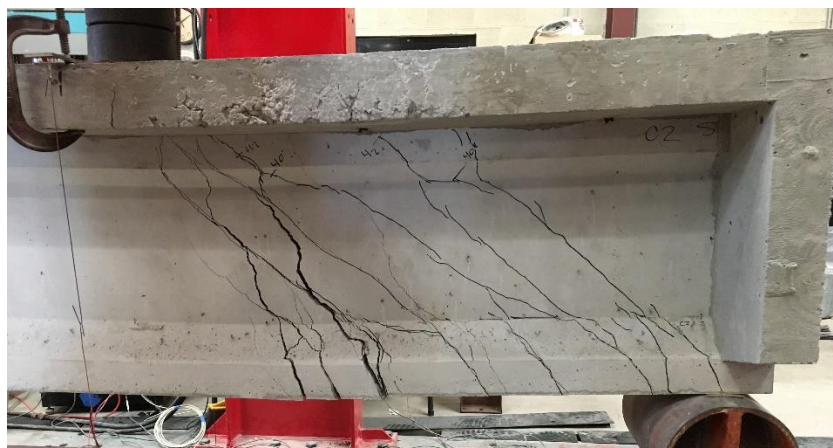
*Figure 10: Girder C2s failure*

Test C2s was performed at an  $a/d$  ratio of 2.4, corresponding to the quarter-point of the girder. This location was chosen since this is the location where the scale bridge would be tested and was the location of full-scale test C2. The load point was located at a distance of 1.37 m from the end of the girder for this configuration. As with test C1s, little deflection was measured before cracking. A large shear crack formed at the support at a load of 180 kN and 2.29 mm of deflection. When this shear crack formed, slip of 0.79 and 0.94 mm was observed for the strands on the loaded end. Because of the proximity of the initial shear cracks to the support, slip increased with applied load after cracking, which prevented any increase in load. The maximum load reached in this test was 189 kN and the test was stopped when some crushing was observed in the deck. The maximum deflection was 46.4 mm. The cracking pattern from this test is shown in Figure 10. Loss of bond between the prestressing strands and the concrete prevented the girder from reaching its estimated capacity. The girder's nominal moment capacity corresponded to a point load based on strain compatibility of 288 kN. The shear capacity by the ACI method corresponded to a point load of 365 kN. The capacity of the girder was reduced due to strand slip that began with initial shear cracking.

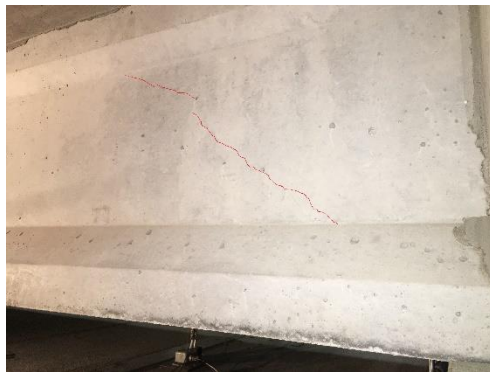
*Figure 11: Initial crack during scale bridge test*

The scale bridge was composed of the girder A half-scale designs. Load was placed at the quarter span point of an interior girder for the destructive test of the bridge ( $a/d = 2.4$ ). Initial web shear cracking in the girder was observed at a load of 245 kN. The initial observed crack is marked on this figure and the location where slope changed is also marked. The initial web shear crack occurred at a load 191 kN and is shown in Figure 11.

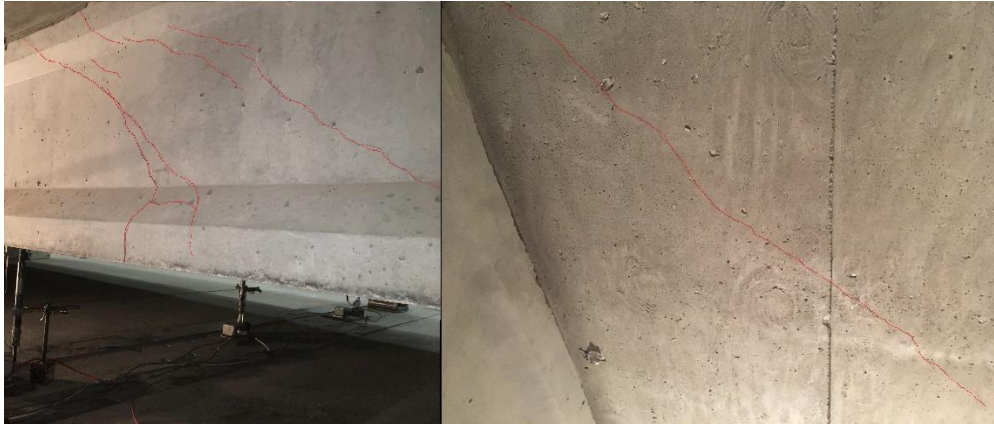
*Figure 12: Bond shear cracking in loaded girder (left) and two way type cracking in deck slab (right)*

Shear cracks extended into the bottom flange at a load of 254 kN, and a flexural crack was observed beneath the load point at a load of 280 kN. It is very likely that this crack appeared before this load, but direct observation was difficult due to the crack's interior location. At this load, there was approximately 0.51 mm of slip in the strands of the loaded girder. It is possible that the apparent slip measurements were affected by shifting concrete at the end when the diaphragms cracked and separated from the girders. At a load of 298 kN, another shear crack appeared roughly 0.61 m into the span from the previous crack. Between 298 and 334 kN of load, a bond-shear type crack appeared on the loaded girder and a diagonal crack indicative of two-way slab bending behavior appeared in the deck (Figure 12). The slab crack extended from the southeast corner of the bridge where the diaphragm and slab meet to the load point. At a load of 347 kN, cracking in the exterior girder occurred where the diaphragm connected to the girder. Load was applied up to a maximum of 429 kN, When the load point punched through the bridge deck. This was accompanied by extensive cracking in the loaded girder.

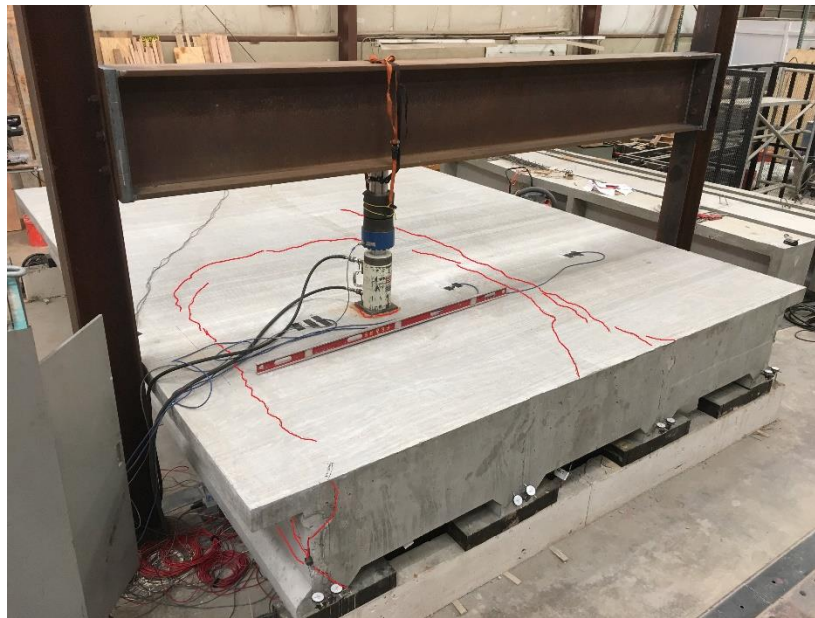
*Figure 13: Cracking in scale bridge deck after testing*

The final state of the bridge is shown from above in Figure 13. The cracking is indicative of two-way slab bending. The cracks form a roughly circular pattern about the load point terminating at the middle diaphragm and adjacent girders. The cracking at the end diaphragm is different, likely because there is less stiffness – the diaphragm rotated away from the bridge during the test resulting in less fixity at the end of the slab. This two-way behavior implies greater load resistance than the one way bending typically assumed for a bridge deck in this configuration. This may explain the much larger resistance found in the bridge compared to the individual girders tested.

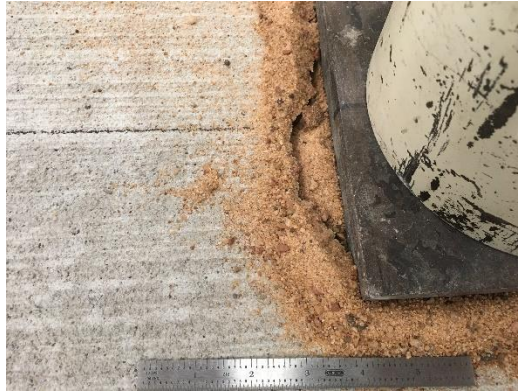
*Figure 14: Punching shear failure in deck*

Figure 14 shows the punching shear failure in the bridge deck. The loaded girder in the scale bridge experienced a failure that was very similar (Figure 15) to the individual scale section A1s (tested at the same  $a/d$  ratio). Cracking and slip was observed at a higher load for the bridge section than for the individual section. Cracking occurred at a load of 151 kN in A1s, but at 191 kN in the bridge test. Slip was observed at a load of 169 kN in A1s and 222 kN in the bridge test. The ultimate capacity was also increased 102%, from 213 kN in the individual section, to 429 kN in the bridge deck. This is a significant increase, particularly when the predicted ultimate loads for the two cases were 209 kN for A1s and 222 kN for the bridge (assuming a tributary width equal to the girder spacing). The girder had much larger post cracking and post slip stiffness due to the transfer of load through the diaphragm and the slab to the adjacent girders. Based on the results of the scale bridge test, the diaphragms and their connections to the girders provides additional load distribution after a loaded girder fails.

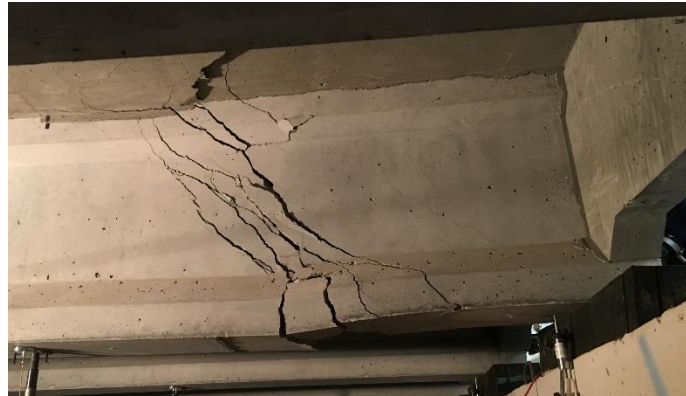
*Figure 15: Final cracking in loaded bridge girder*
