New Horizons in the Conservation of Wooden Built Heritage 21st IIWC Symposium, York 2018

12 - 15 September 2018, York, UK

Proceedings Editor: Dr. Tanya L. Park, IIWC Vice-President (Oceania), Southern Cross University, NSW Austalia

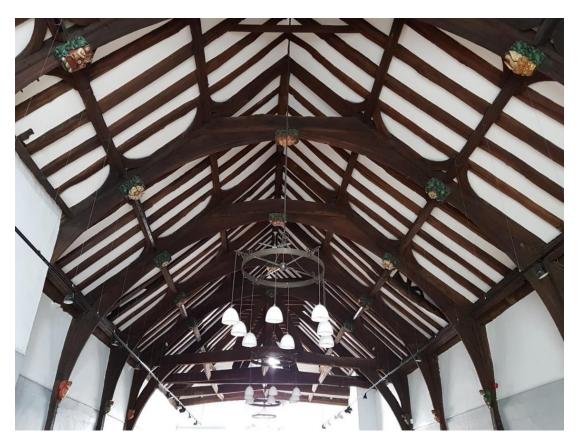
Mid-15th century timber roof structure, St Anthony's Hall.

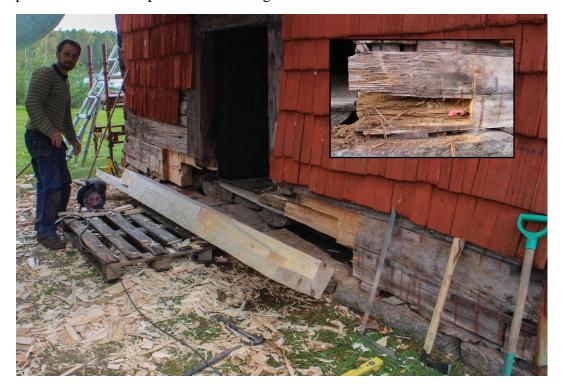
Fig. 4. Example of surgical repair of the front sill. The pasted photo shows the decay during cleansing. A pdf about the more complex conservation of the junction between tiebeam, rafter and wall plate can be found on the blog timmermanskonst.se. Photos Karl-Magnus Melin.

When necessary, modern tools and techniques has been used to make surgical repairs in order to preserve as much as possible of the original material and surfaces.

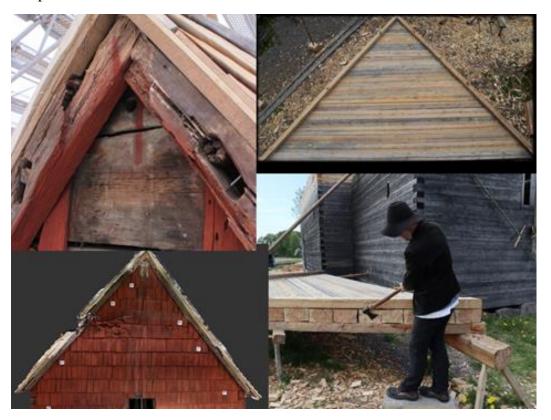
Fig. 6. To the left, above a detail of the gable and the rafters with oblong holes. Left below screendump of 3D model by Camilla Melin of the barns gable. Above right, Ingatorps gable reconstructed on the Södra Råda reconstructions chancel. Photos Karl-Magnus Melin.

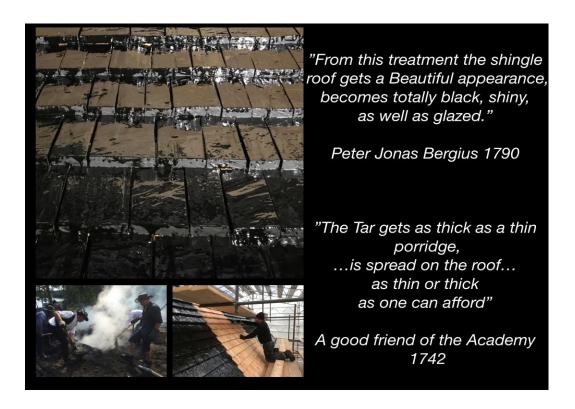
Fig. 7. Above, the shiny shingles after tarring. Below left the making of the tar. Below right, the tar is applied in "stripes" with minor changes of the recipes to be evaluated. Right citations from the used recipes.

applying tar does not work so well. Therefore we decided to use recipes from the 18th century that had not been tested in modern times. It was not granted that it would work since the recipes seemed to contradict almost everything in the modern procedure. The tar should not be of fine quality, a lot of crushed charcoal should be added, it should be applied as thick "as one could afford¹⁴". From a modern point of view there seemed to be a risk that the heat from the sun would make the tar to melt and stain the walls. Even if the tar would melt we could not foresee any actual harm to the barn excluding aesthetic values, so all involved decided to try the recipes. The tar application was done in the autumn. In the hot summer of 2018 I visited the barn and climbed up and put my hand on the tar. It was very hot but not sticky at all. There was not one single tar stain on the walls. The 18th century author was more right than us when he wrote "The tar produced in this way becomes a fixum, which then forgets to melt.¹⁵" The use of the 18th century tar recipes has been continued in other projects in Sweden. Hopefully these experiments, involving old tar recipes and techniques of application, will help to save large amounts of money in reduced cost for maintenance and reroofing of shingle roofs on the Swedish churches.

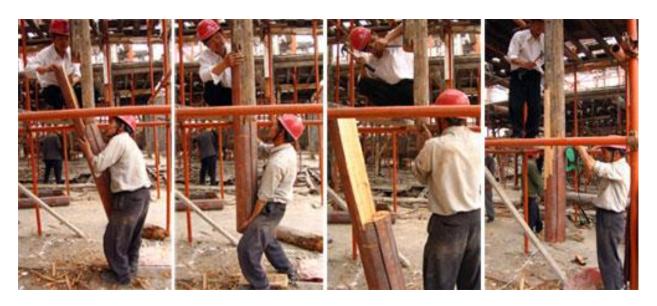
Fig. 3. Process of "Change column" (self-photography)

"Change column", the common wooden post in the photo maintenance, is also to maintain the originality as much as possible, cut off the next part of the decay, splicing a new piece of wood, the joint will use this cross or simple slap In the traditional way, we will add two more hoops. In the repair of the former residence of Ganxi, we used the process of wrapping carbon fiber cloth at the joint, which not only satisfies the structural strength, but also does not affect the appearance after the water-mixing paint. In principle, the replacement of the wooden components is different from the appearance of the original components, and the same lacquering is not performed, and the recognizability is emphasized.

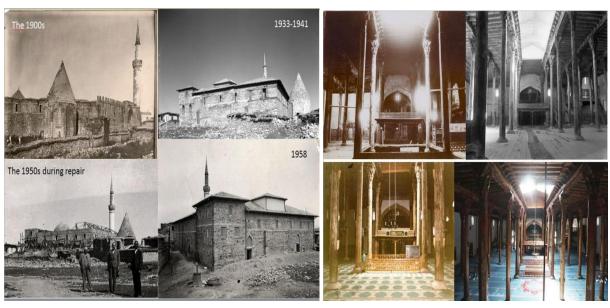
Fig. 5. Repair of façades (VGM Archive)

Fig. 6. Repair of inner space (VGM Archive)

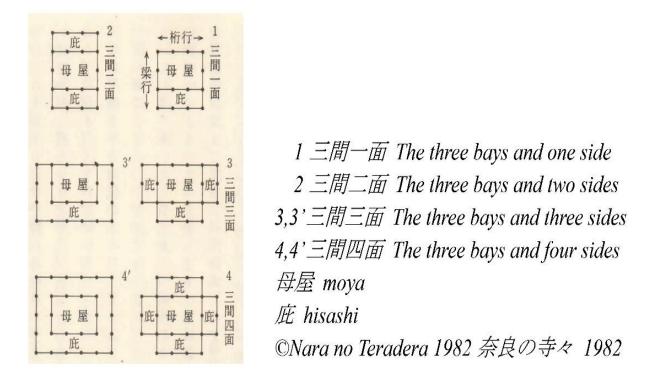
Fig. 2. Plan description method based on the number of lengthwise bays and that of open aisles kenmen-kihou, the linguistic expression

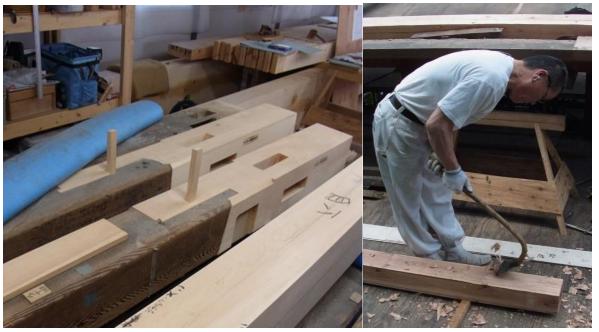
Fig. 3. Repair of pillars with woodwork joints

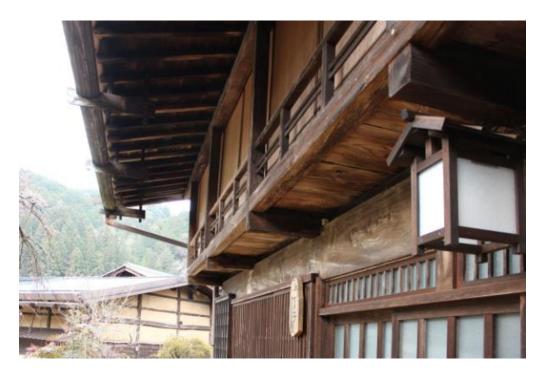
Fig. 5. Restoration of Edo vernacular building details in Tsumago-juku. Photo by author.

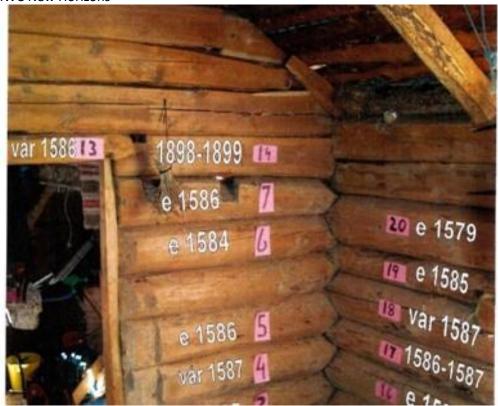
Fig. 3. Examples from the dendrochronological analyzis of the Ljones storhouse, built 1589.

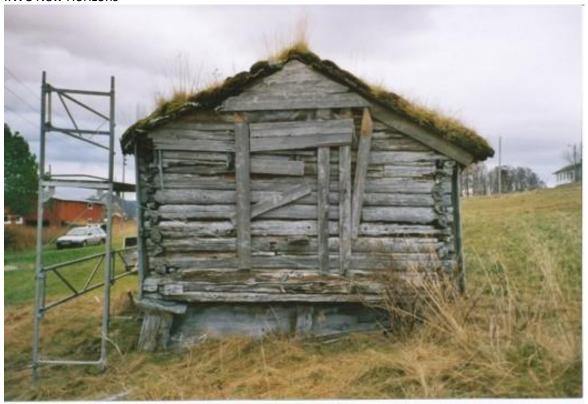
Fig. 4. The Ljoenes storhouse when conservation started, in 2006. Hard wind and rainfall from west had damaged the short wall.

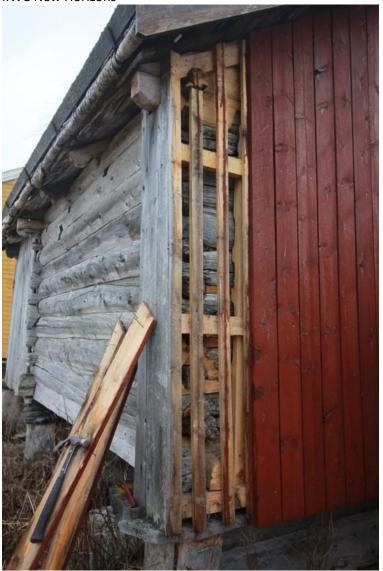
Fig. 6. The storhouse at Ljones was given a climate shell, to protect the damaged short wall against west. In 2017, ten years after the conservation and the boards was put up, the old wall was controlled and it was in a very good condition.

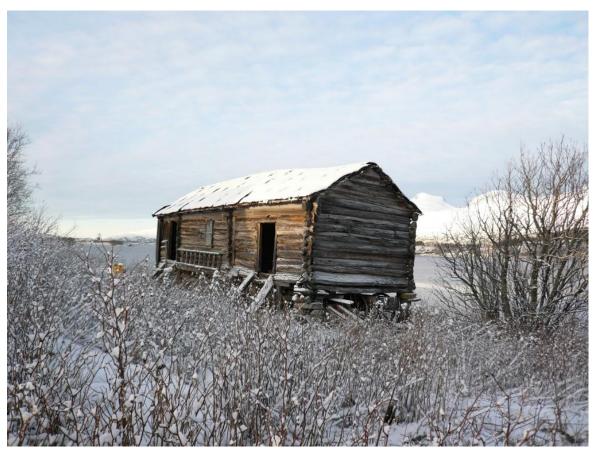
Fig. 8._Typical storhouse, dated 1637, with the short side orientated and twisted against the predominate wind. In the short wall against the soutwest there is a timber frame «sval».

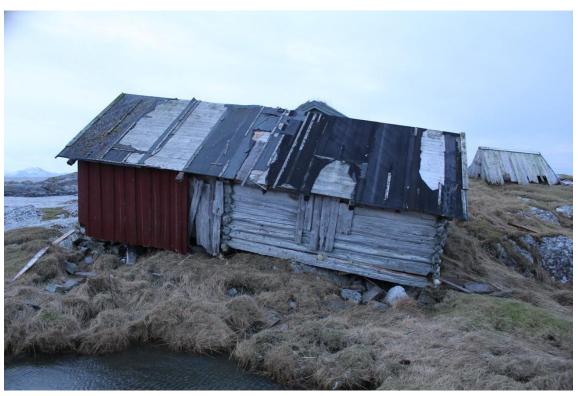
Fig. 11. Fishermans cabin dated 1601, damaged by the sea in 2010, later restored. The Givaer Island, Bodo municipality.
