1st IIWC Course on Wooden Heritage Conservation

3rd - 5th October 2019, San Sebastian

Proceedings Editors: Dr Tanya L. Park , AUS & Teresa Artola-Guijarro , SP
ISBN 978-0-64 85799-2-2

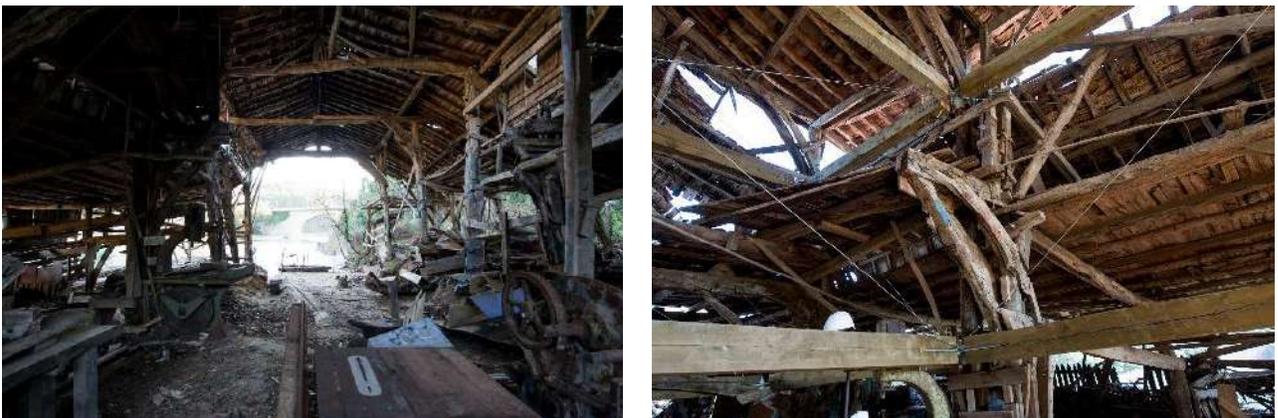
Image 3. Left: Interior view of the main nave of the Mendieta shipyards. The fragility of the structure and its deformations can be seen. Right: The stabilizers already placed in the building, respect all the main, secondary and minor elements of it.

The Mendieta shipyards in Lekeitio were built in 1917 and were in operation until the 90s of the last century and showed generalized and multidirectional deformations that endangered the stability and survival of the building and its subsequent conservative intervention. In this previous phase, the objective was for the building to stand upright at the moment when it could be intervened.

Once the diagnosis had been made, it was found that despite the fact that the stability of the ensemble was compromised, the quality of the pillars was sufficient to bear forces, so a stabilizer was devised, which, supported by said pillars, and using them as part of the stabilizer itself, horizontal wooden bars and diagonal stainless steel bars were introduced. While waiting for the intervention project, no action was taken on any element of the building.

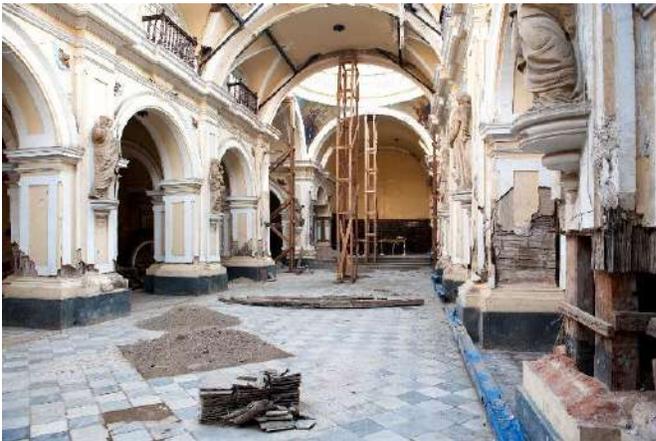
Image 4. Left: Interior view of the main nave of the cathedral in Ica, Peru. The damage caused by two earthquakes, the one in 2007 and the other in 2011, can be seen. Right: Construction drawing of two transverse arches, with the meeting of the lunette beams and the reinforcing pins of the cracked arches.

The work was very short and required intensive work in situ, studying the different aspects of construction and wood, and the existing pathologies. In its conclusions, it determined the reasons why the main dome had fallen and the failure that had occurred in the supports of the lunette beams.

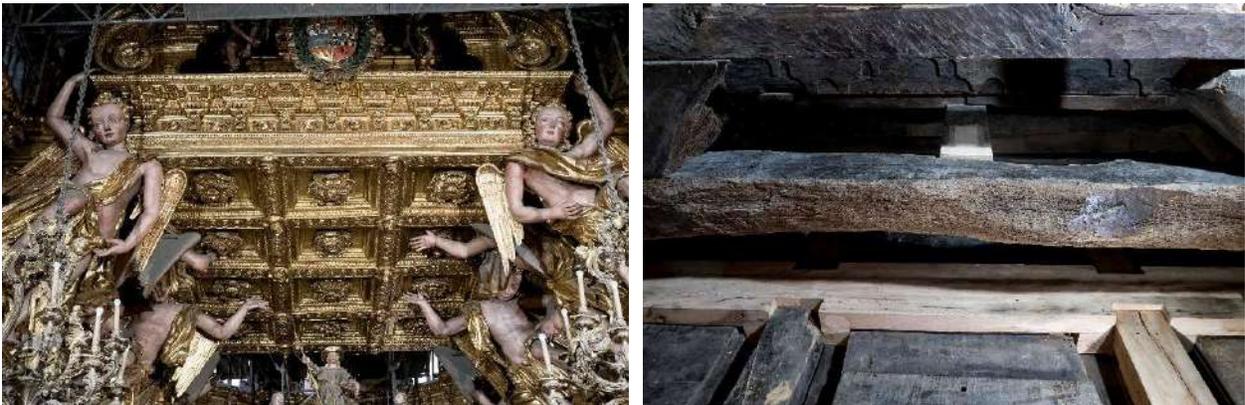
Image 5. Left: Santiago the Apostle, kindly, points out with his stick the point where the solivos had lost their support. The seat of the coffered ceiling is obvious to the naked eye. Right: Inside, the support of the solivo on the left is, seen from above, the same as the one indicated by the apostle. The planks between solivos are the troughs that, in the image on the left, are carved and covered with gold leaf. The repair had to be carried out with grafts, to avoid disassembly. Both the repaired and supplied wood is chestnut, of similar origin and age: approximately 350 years.

A solution based on replacing the damaged beams with new ones was unfeasible, as well as unnecessary, so a solution was designed consisting of making a series of combined grafts, which would allow the gradual reconstruction of the two beams from inside the baldachin, in order to have the beams completed, repaired, and structurally functional. The final This beam is formed in one half, by the original beam, and the rest by wood provided for the occasion, joined in the appropriate way to allow the beam to recover its original resistance capacity.

The wood used in the repair comes from another building in Santiago de Compostela, the Bonaval convent, and is also made of chestnut, with a similar age, that is, three and a half centuries. The concept of minimal intervention, in this case, is based both on avoiding any disassembly, carrying out the repair in situ, and on the use of wood with the greatest technical and historical compatibility.

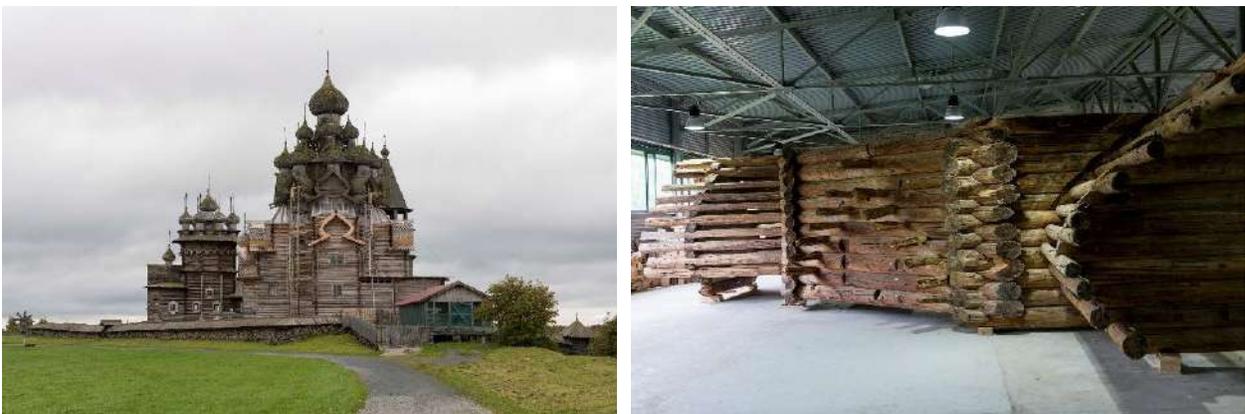
Image 6. Left: Exterior view of the building and the area to be intervened in 2016. The corresponding strip of logs has been dismantled to proceed with the repair of the damaged elements and the replacement of the irrecoverable ones. Right: The same strip, reassembled in the workshop, to check the adjustments, before being disassembled again and finally reassembled on site, before the arrival of winter.

Can it be called minimal intervention, that consisting of dismantling the building completely? This is the case with the restoration of Kizhi Pogost, begun in 2011 and completed in 2019. After several previous restoration processes, of lesser magnitude, and due to serious structural problems, the building was lowered with a metallic structure in 1982. Subsequently, and for the current restoration, the shoring was modified, to allow the upper part of the building to be supported, while annually a strip of it was dismantled, to carry out the necessary repairs in the workshop. The process, recently completed, has involved repairing the damaged logs, replacing the unrecoverable ones, and keeping all the others in their original position. It has also been an important source of knowledge, both in the documentation and intervention processes, including traditional techniques for building construction with wood and repair techniques for wooden structural elements made with wood.

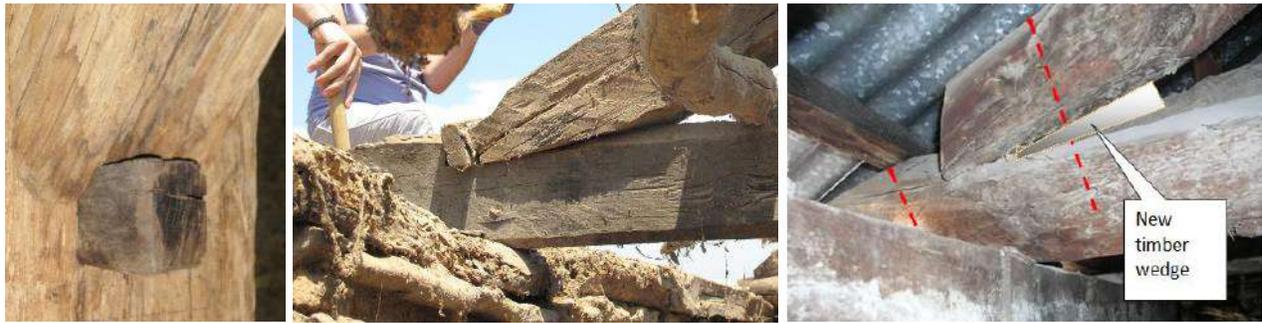
Figure 1. (a) Tenon and mortise joint: additional wooden wedge used to ensure a tight contact between the tenon and the mortise, (b) additional wooden piece to ensure the contact of the timber elements (c) Proposal for the reinforcement of a poorly constructed heel joint. Addition of a new wedge and screws.

Pinned tenon joints also have a very low bearing capacity in tension since only the wooden pin acts. If it is possible (eg. replacement of the member), a traditional technique can be used which consists in fashioning the new joint with a dovetail tenon increasing the strength in tension. If the element remains in place and in service, a binding metal strip may be used as reinforcement in tension. In order to avoid cracks, the strip can be screwed or bolted under the supporting beam and the spacing, the distances from the end and the edges of the connected timbers must be respected.

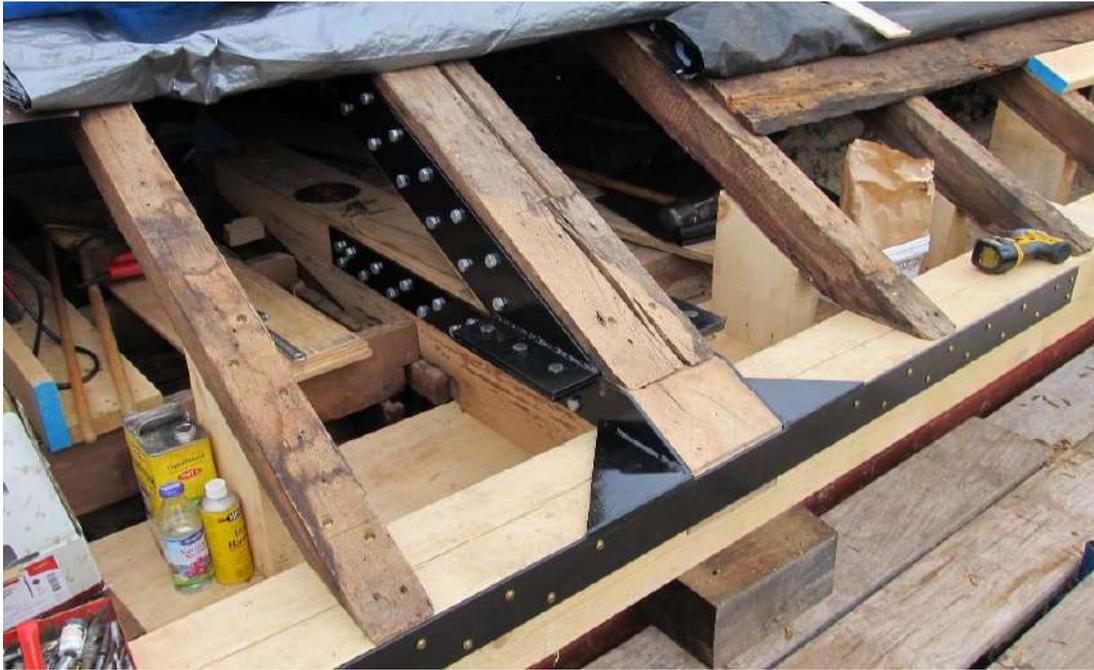
Figure 1. Modern high-tech materials may have their place in repairs to timber framed buildings, but only after all other traditional carpenter's techniques have been considered. The decayed eave end of this early nineteenth century roof truss required some custom fabricated steel reinforcing to make the wooden repairs structurally sound.

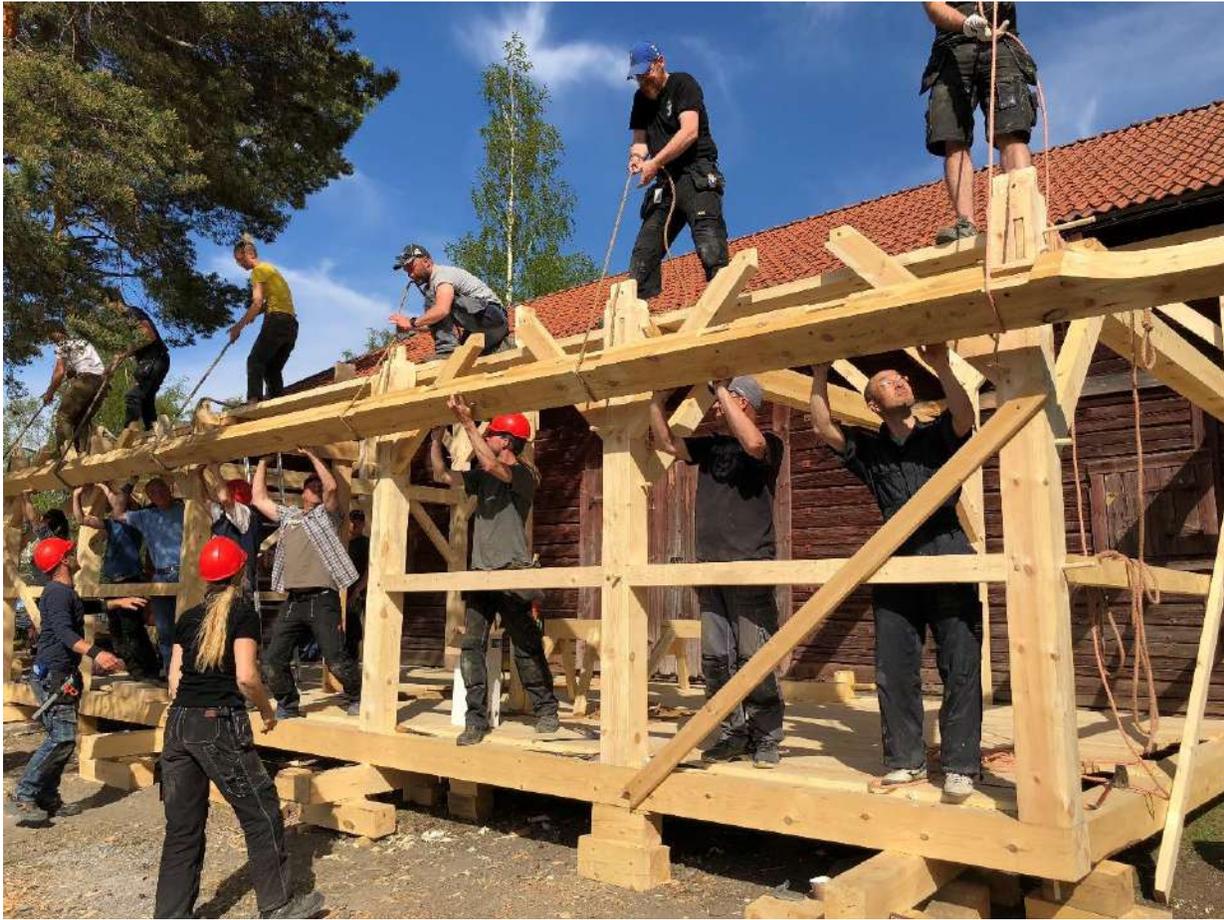
Figure 2. “Hands-on” courses should be required for all professionals involved with repairing old timber framed buildings as well as constructing new ones. Here at Jamtli Museum, Sweden, students with a variety of professions and trades are learning the timber framing craft. The long plate timber is being raised using an efficient and safe traditional technique called “parbuckling”.

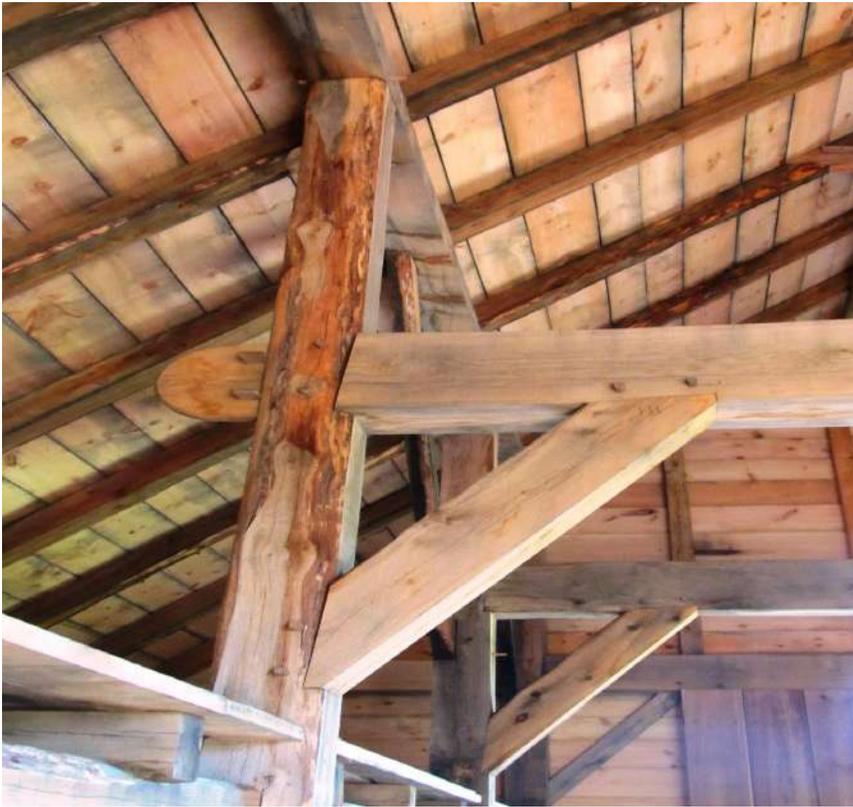
Figure 5. Virtually all of the timber, siding, and flooring for this barn was harvested out of the farm's woodlot, matching species as much as practical. Traditional scribing methods and hand tools were used to fashion the joinery.

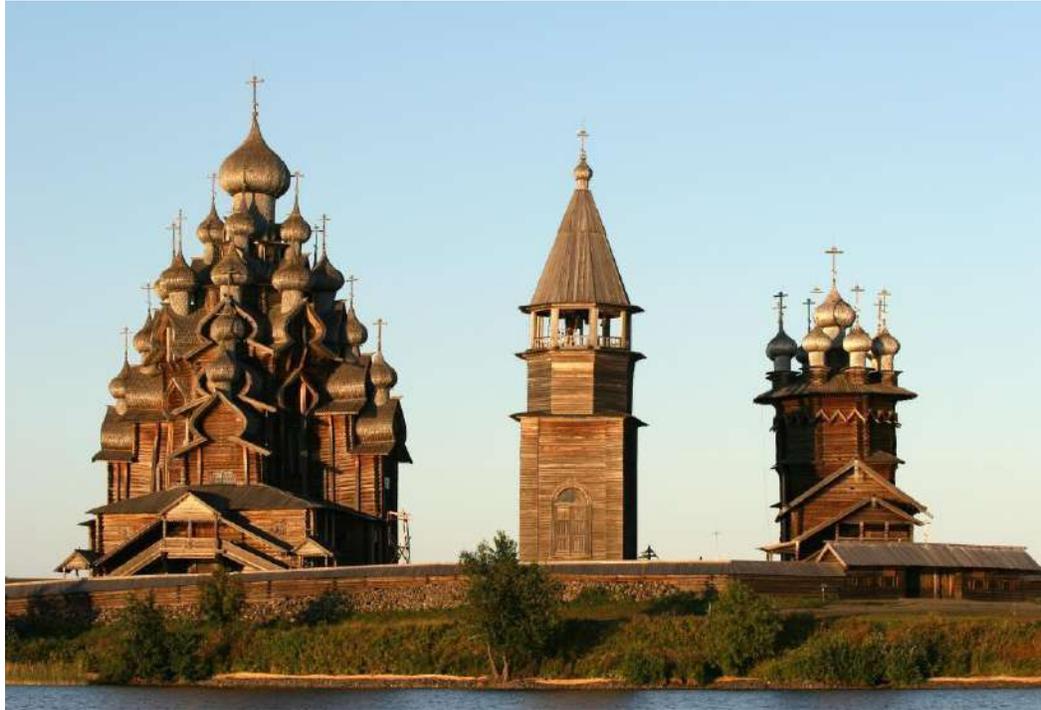
Figure 1. The Kizhi Pogost. The Church of the Transfiguration (1714), bell tower (1864), the Church of the Intercession (1694-1764) in the enclosure (mid-XX cc.).

According to the historic documents the previous Kizhi Ensemble was struck by lightning and burnt down in the end of the 17th century. The current architectural ensemble of the Kizhi *Pogost* had been formed during two and a half centuries. The winter church – the Church of the Intercession (Fig. 1) was built after the fire in 1695 and reconstructed in 1764. It represents a traditional type of northern churches built in the form of a ship. The summer church – the 22-domed Church of the Transfiguration (Fig. 1) shook the people of the area with its magnificence and beauty in 1714. The erection of the Bell Tower in 1864 completed the Kizhi Architectural

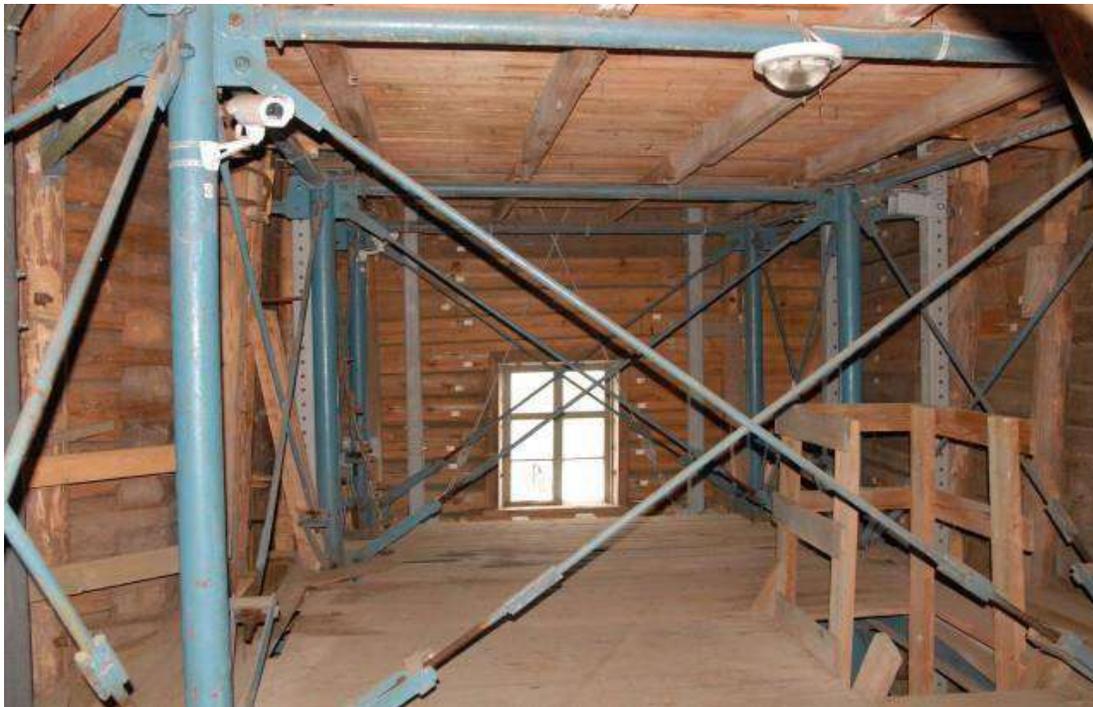
Figure 3. Metal scaffoldings in the interior of the church

All researchers who studied the Church of the Transfiguration were unanimous in that the deformations that arose as far back as the 18th century appeared due to the fact that the structure, set on an insufficiently strong and rigid foundation, sagged unevenly, since its central part is more loaded than adjoining annexes (Gusev, 1999). In 2005, it was found that the soils on the north, east, and south sides of the temple differ in their composition and properties, which cannot but affect the stability of the structures (Simagin). Undoubtedly, the destruction of logs by wood-destroying fungi and insects also had an effect on the occurrence of wall deformations. At that time the researches estimated, that 30-40% of logs in different parts of the church should be replaced.

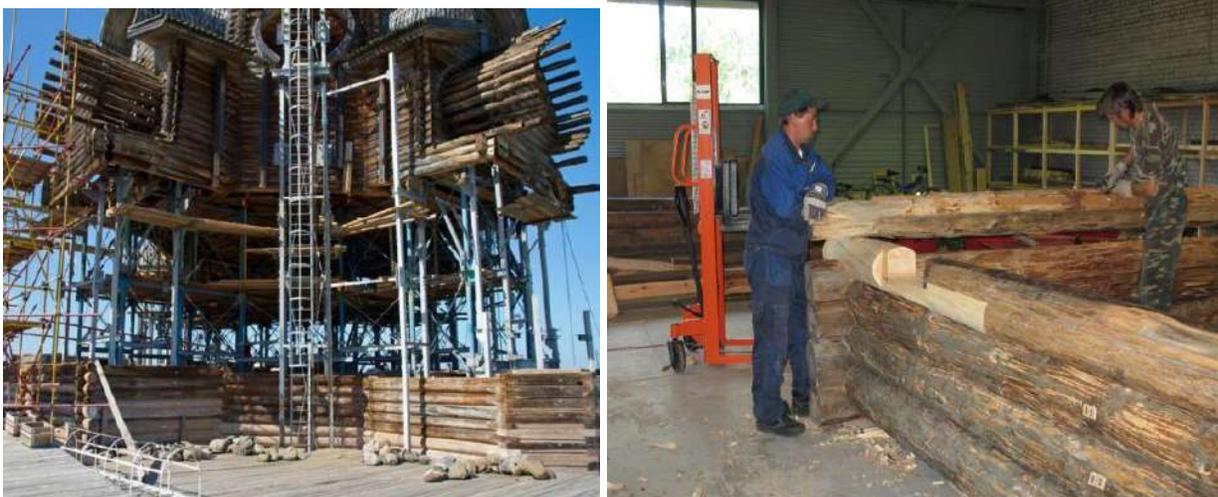
Figure 4. The Church is under the reconstruction

The restoration project aimed at regaining structural strength, dismantling the steel supporting structure inside and re-establishment of the interior started only in 2008/ A long period from 200 to 2008 was needed for preparing the lifting equipment, logs and other facilities for the restoration.

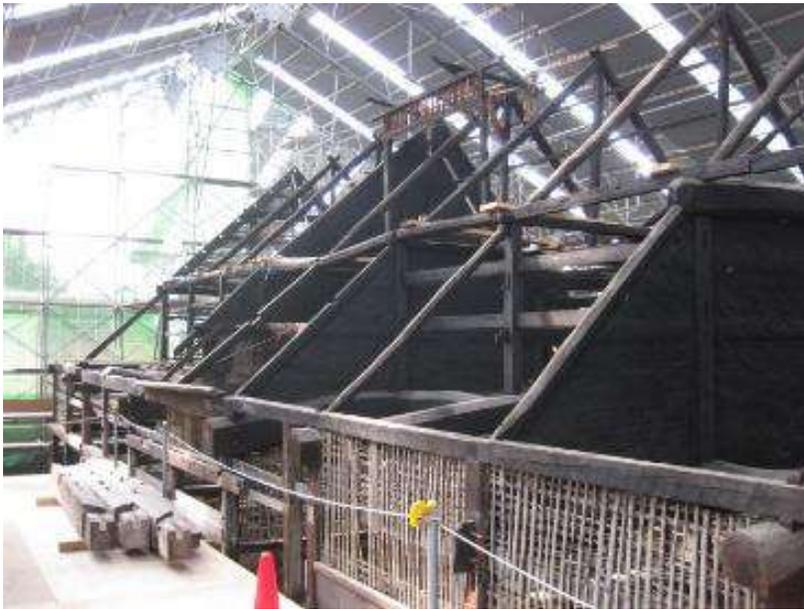
Image 3. An example of partial disassembly

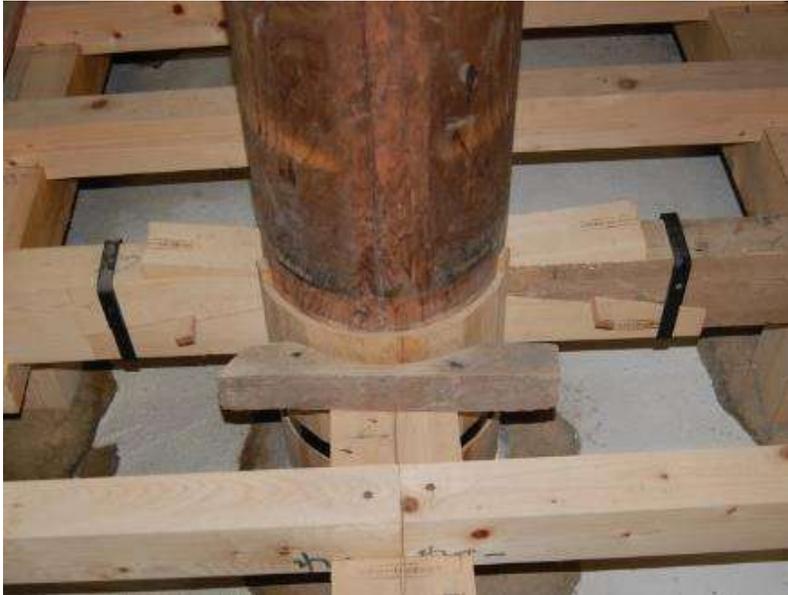
Image 4. A repaired pillar

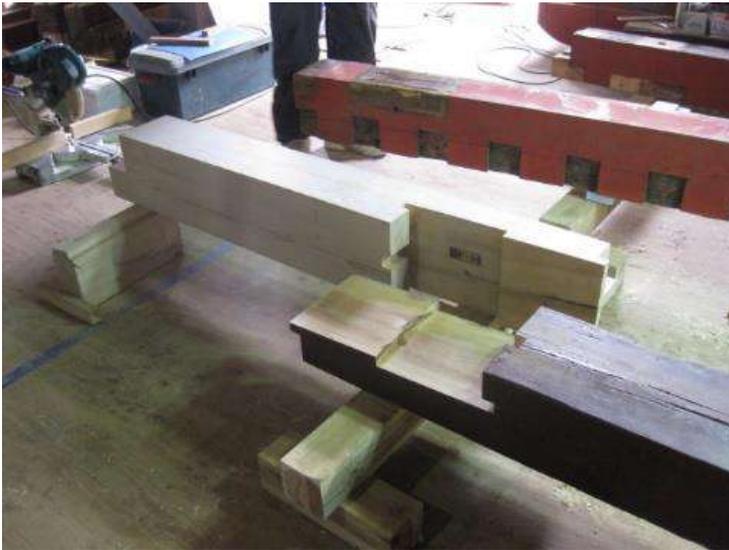
Image 5. A traditional method of replacing weathered part of a timber

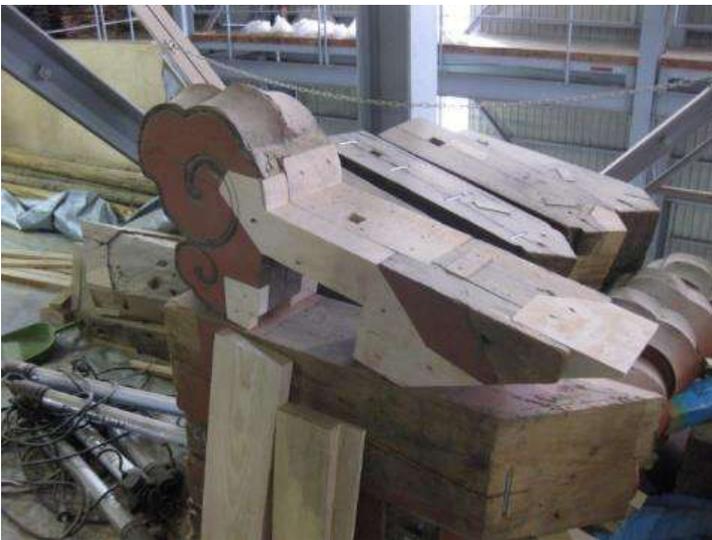
Image 6. A repaired member

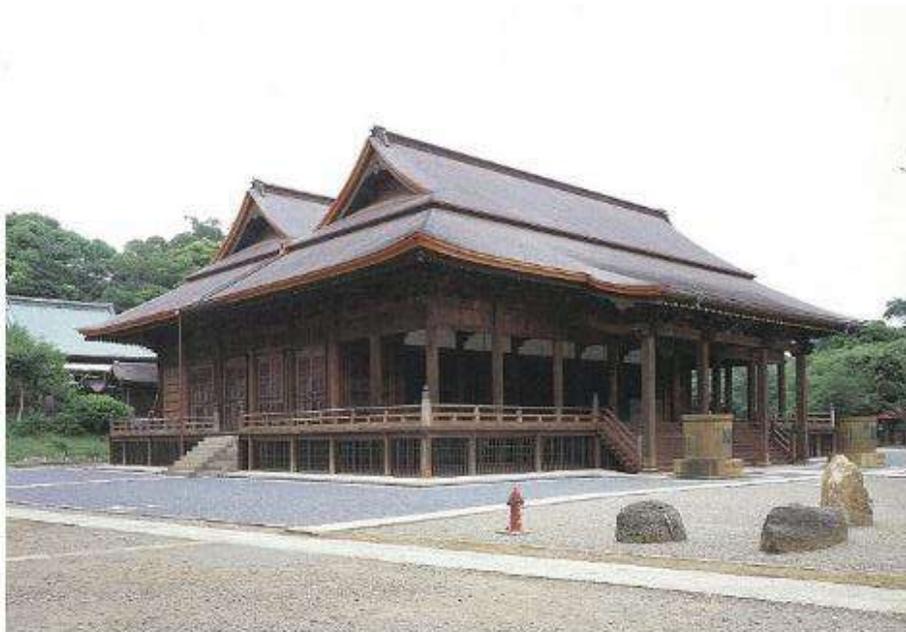
Image 8. The same building after restoration to the original design

After removing roof, wall and other fixtures, only the wooden structural frame remains. The process of the disassembly work follows the reverse order to that of the construction. Every single piece of the members is marked with an identification tag and its current position and details recorded. Then, starting from roof foundation, roof structure, eaves structure, beams, floor structure and pillars with their connecting members are disassembled. Finally, only pillar base stones remain. As the most vulnerable parts of a wooden building are around roof edges and bottom of pillars, the area of disassembly is sometimes limited only up to the eave level and then the deformed structural frame is adjusted, or the whole structural frame is raised to repair the bottom parts by using jacks.

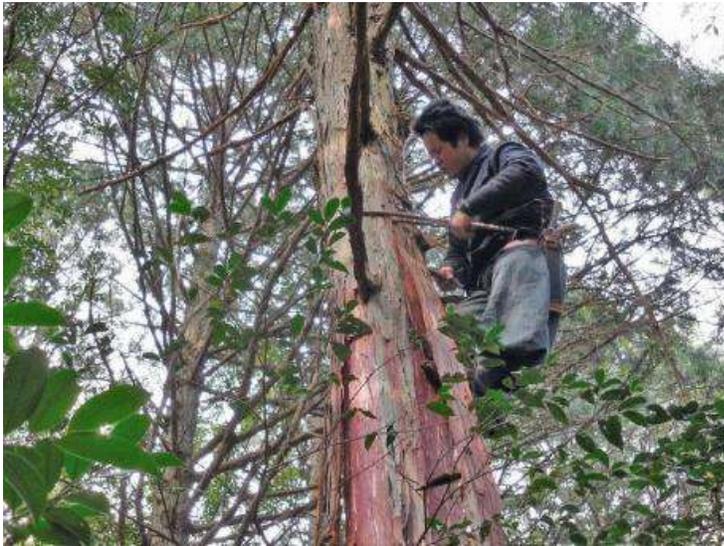
Image 11. Collection of cypress bark for roofing

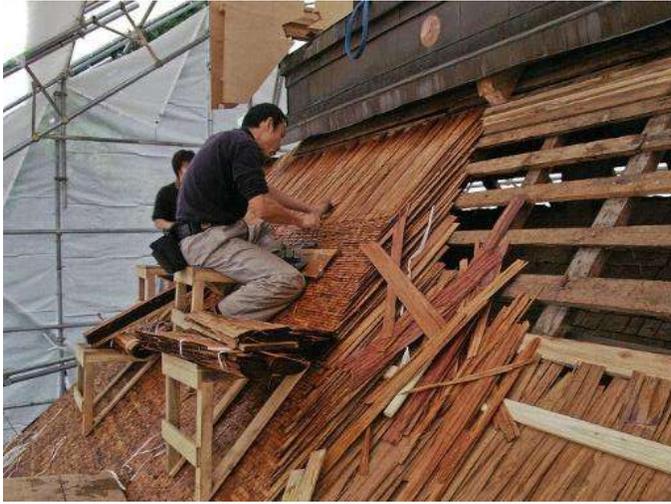
Image 12. Reroofing work with cypress bark

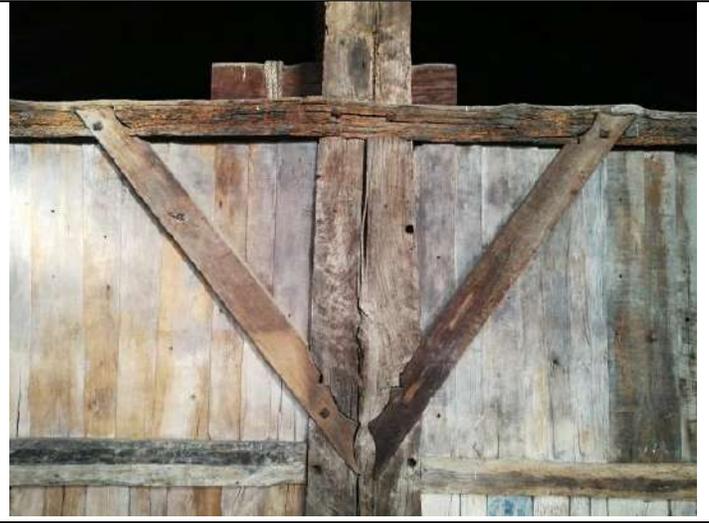
Figure 5. One piece rafters and the cladding (Bengoetxea txiki) Figure 6. “swallow joint”

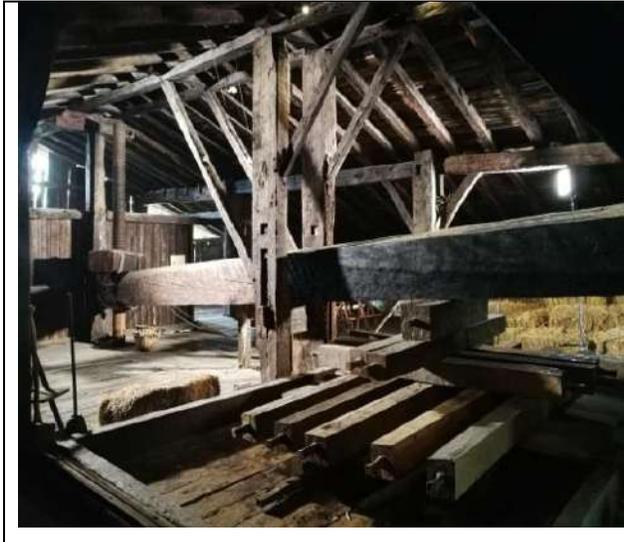
Figure 7. Cider press-lever press (Igartubeitia)

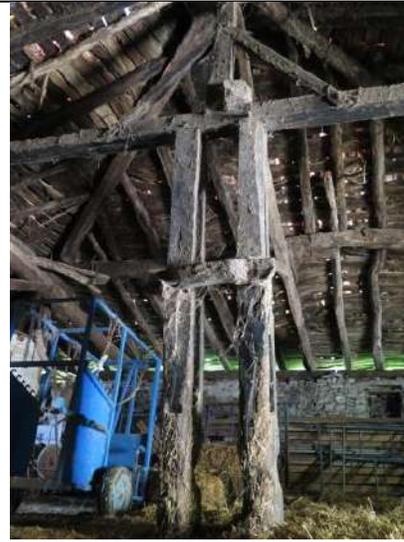
Figure 8. A pair of post "bernia" (Ernataitz)

Regarding typology, today we can still find farmhouses with remains of the wooden presses from the 15-16th century, especially the two pairs of posts, with their side holes, or the large beams that reinforced the pressing area. These fixed parts of the press have been preserved because they are an inseparable part of the structure: The two pairs of *bernia*, the *masera*, the *sobigaño*... are elements that have been maintained in some farmhouses in spite of the modifications suffered over the time (fig.8).

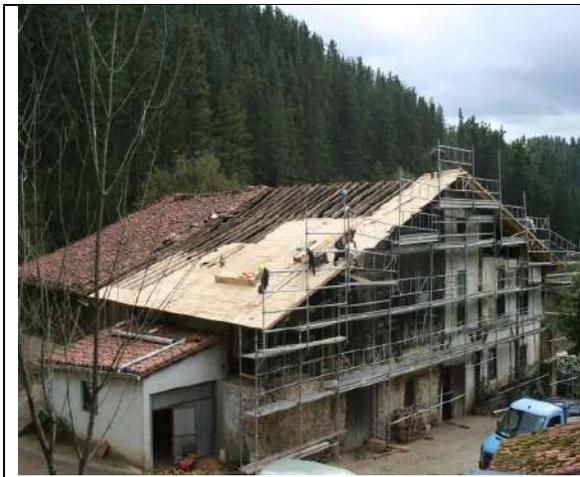
Figure 9. Rafters are preserved (Zelaa)

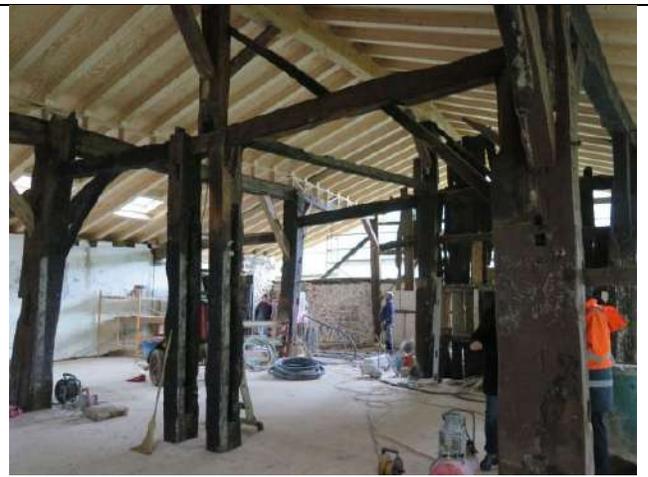
Figure 10. Complete renovation of roof (Loidi Azpi)

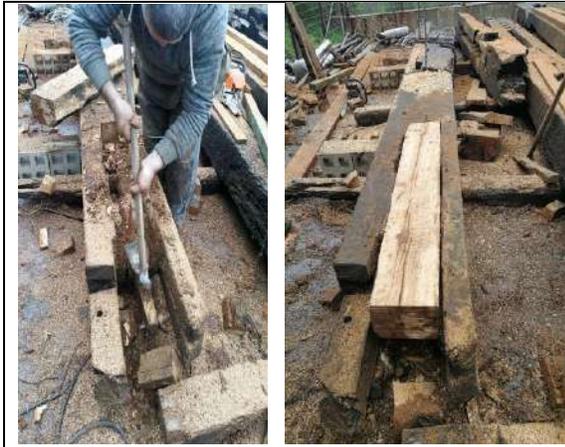
Figure 11. Grafts (Garaikoetxea)

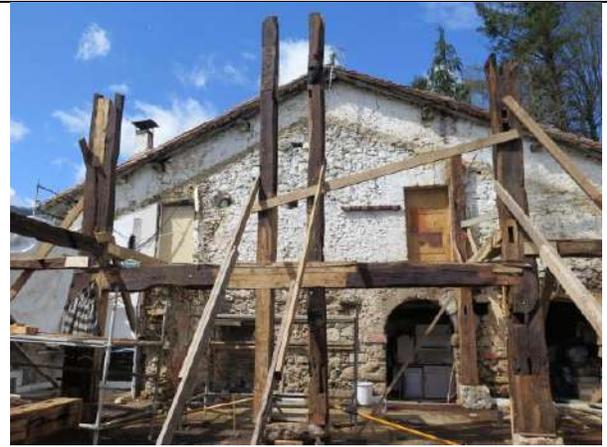
Figure 12. Reassembling (Garaikoetxea)

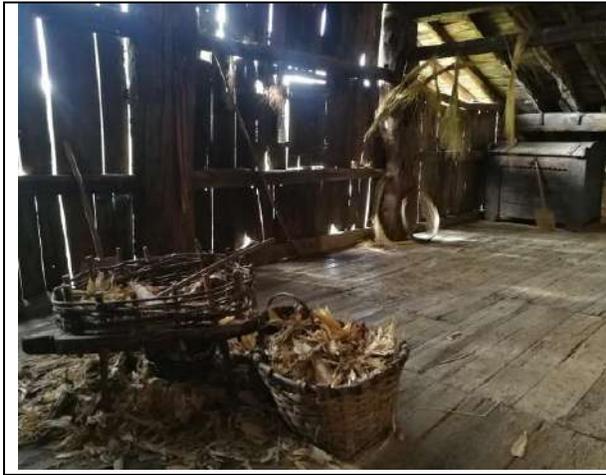
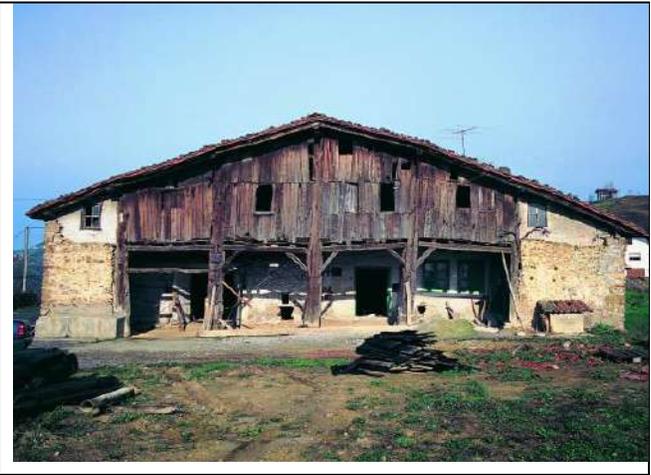
Figure 13. Ventilated space under the roof

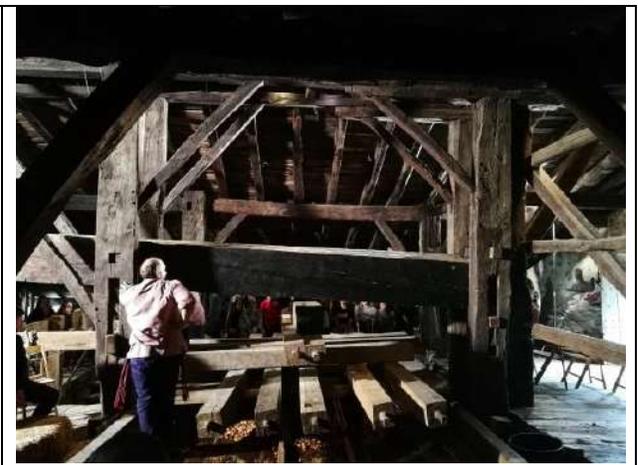
Figure 16. Igartubeiti Museum-cider press

Dissemination was the final objective of the project, so the farmhouse became a museum (fig.15). To enhance the value of the museum, original furniture from the 16th century, belonging to the collection of the Council, was placed. And as a novelty, to verify the effectiveness of this impressive machinery, it was decided to put it to work. In this way, the Igartubeiti farmhouse is today one of the most interesting farmhouses in the Basque Country, and for one week a year the public can enjoy the exceptional experience of seeing the farmhouse producing cider as Basque farmers used to do in the 16th century (fig.16).

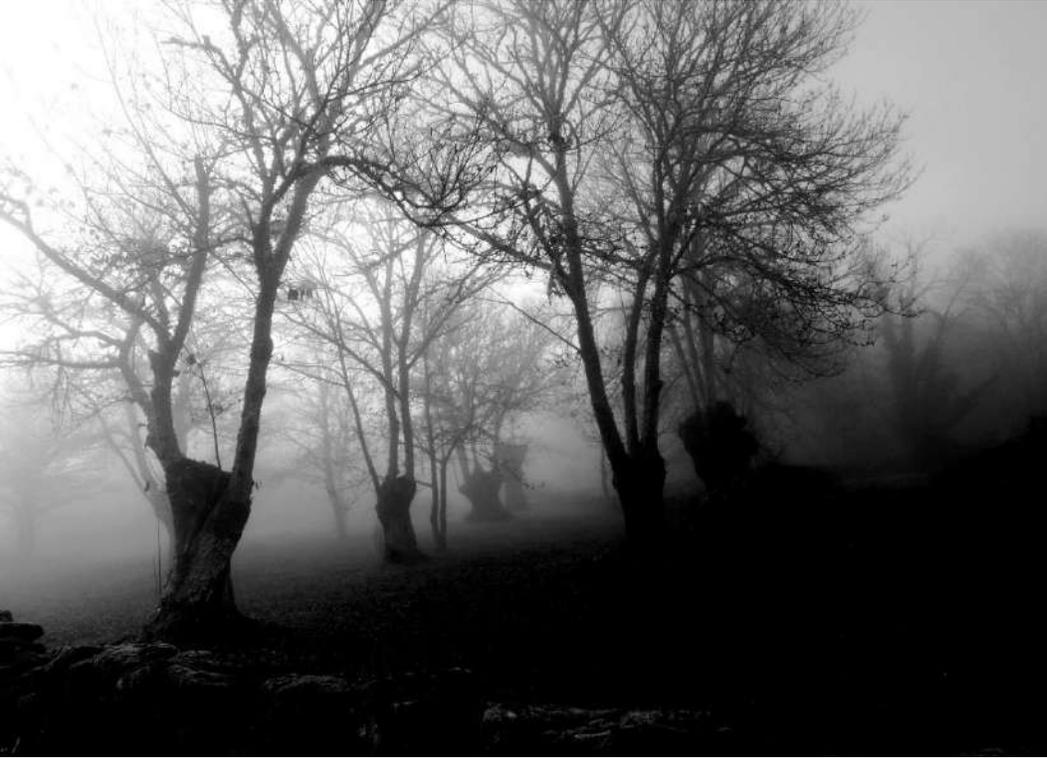
Image 1. Aspect of an old Galician “souto” of pollard sweet chestnuts.

In this mixed system of forest management, the chestnuts were cut at 2-3 m high from the ground and the production is done at the expense of the new branches formed on the crown. These branches can be ordered to allow a staged production of wood and cut periodically, every 20 to 30 years, when they may reach lengths between 7 and 10 m (Vieitez et al., 1997).

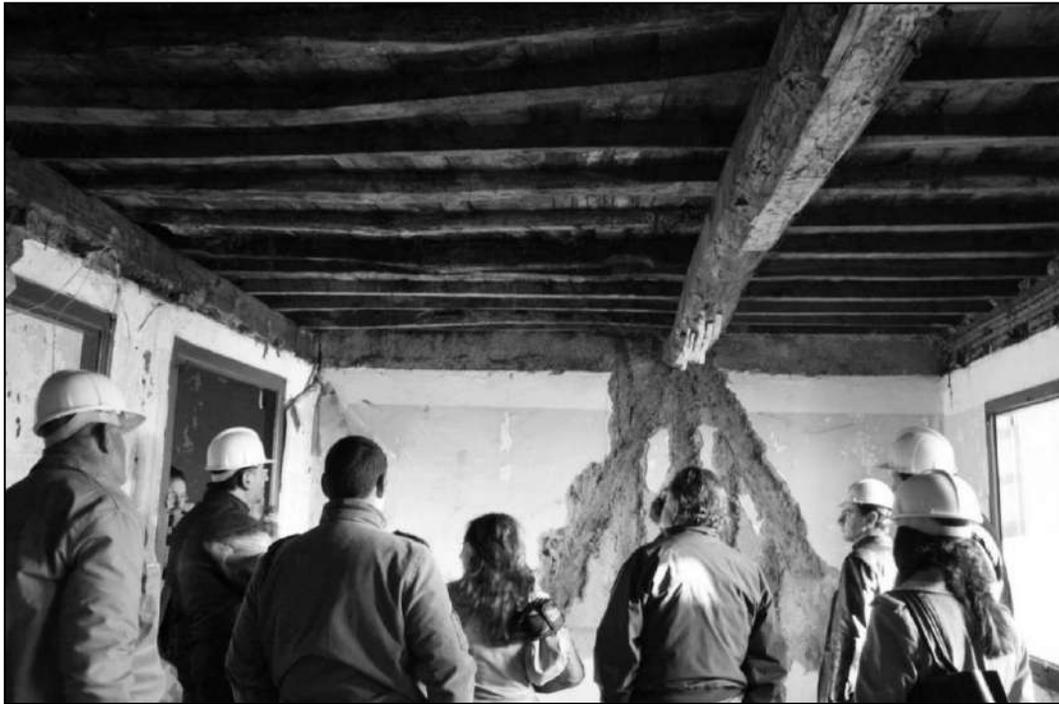
Image 2. Galician house with “air beams” from pollard chestnuts. The beams, joist (“pontones”), pavement and the timber frame walls are all made from sweet chestnut wood.

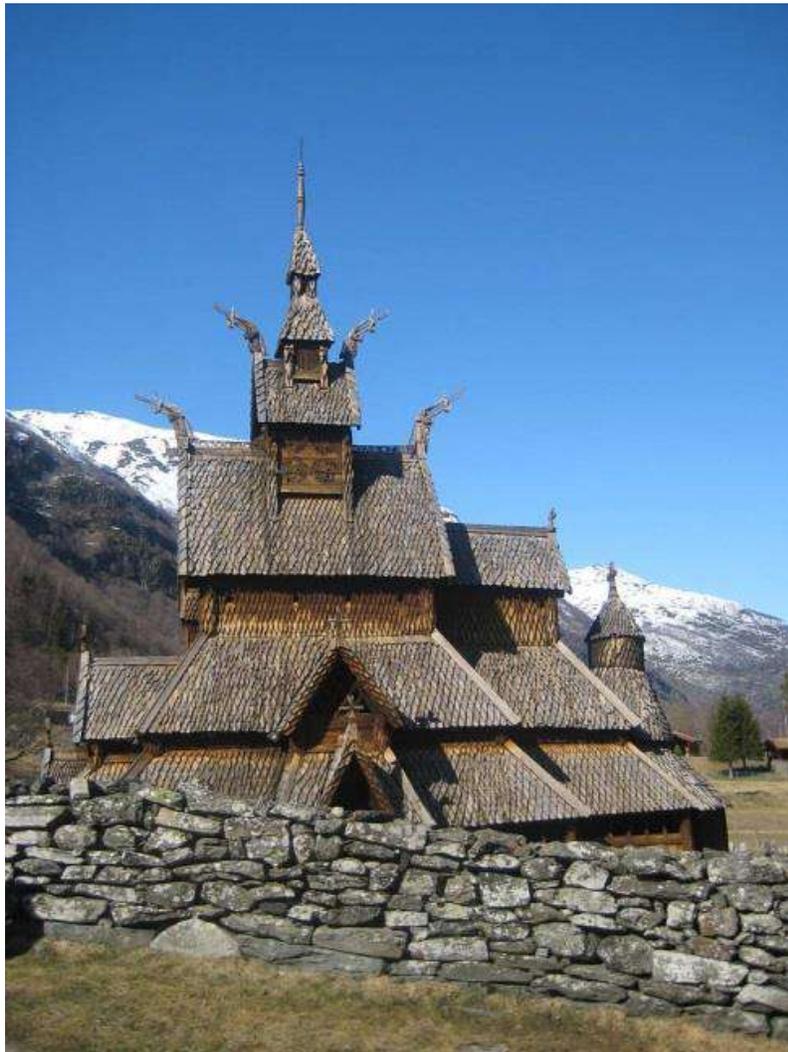
The roof shingles were of different sizes and their condition varied considerably. Most of the shingles were made using an axe. Only in smaller areas, newer shingles had been made using a saw; a production method which first became usual around the second half of the 19th century.

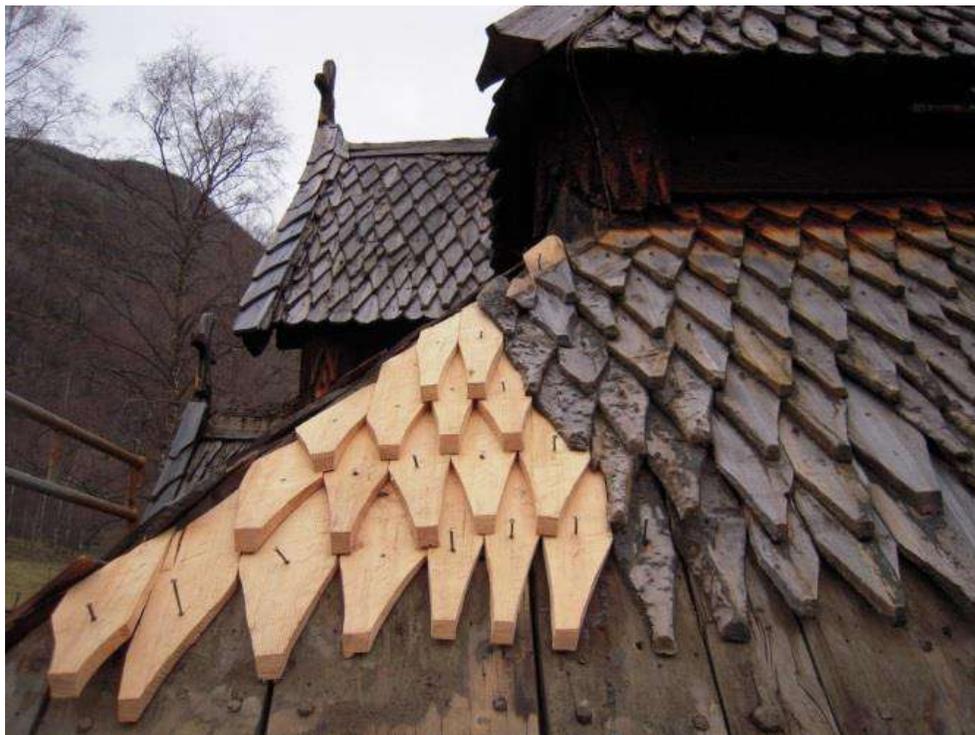
During the work on the test areas, different methods of working were tried. In this early stage of the work, the project manager was often on site to discuss the different solutions. Through close dialogue with the craftsmen, a preferred method was chosen where they could reproduce new shingles while at the same time secure the usable existing ones. In this type of work it is important to find the right balance between conserving and renewing as it is vital to have a weatherproof roof, also over time. Conservation principles can't be too rigid where roof shingles are concerned; the shingles are placed directly on the underlying wooden sheathing without any additional materials and if water gets in rot can quickly occur.

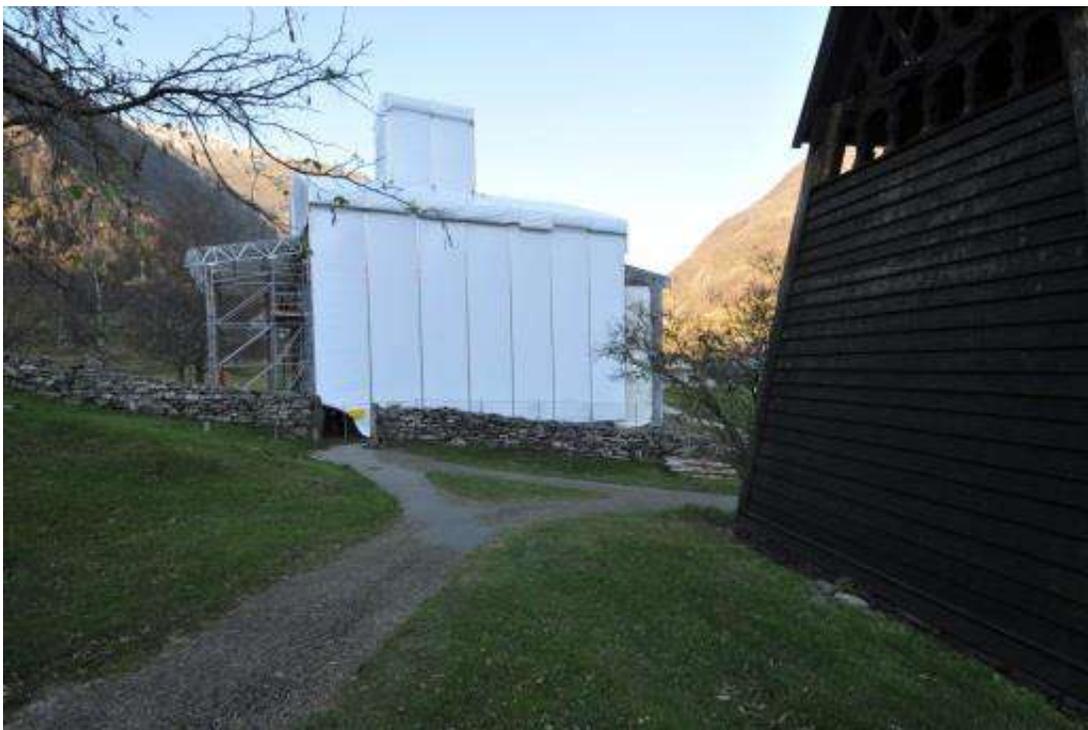
When the work changing the shingles was started, the craftsmen used the test areas as a reference to the work they were doing, regarding both which shingles were to be kept and how the new ones should be adjusted. The test areas had also given a good indication as to how many shingles would have to be changed. This proved to be an efficient and effective way of continuing the work as most of the major decisions had been made during this earlier phase. After many months of work, the shingles were treated with wood tar. In total, about 8000 shingles were replaced.

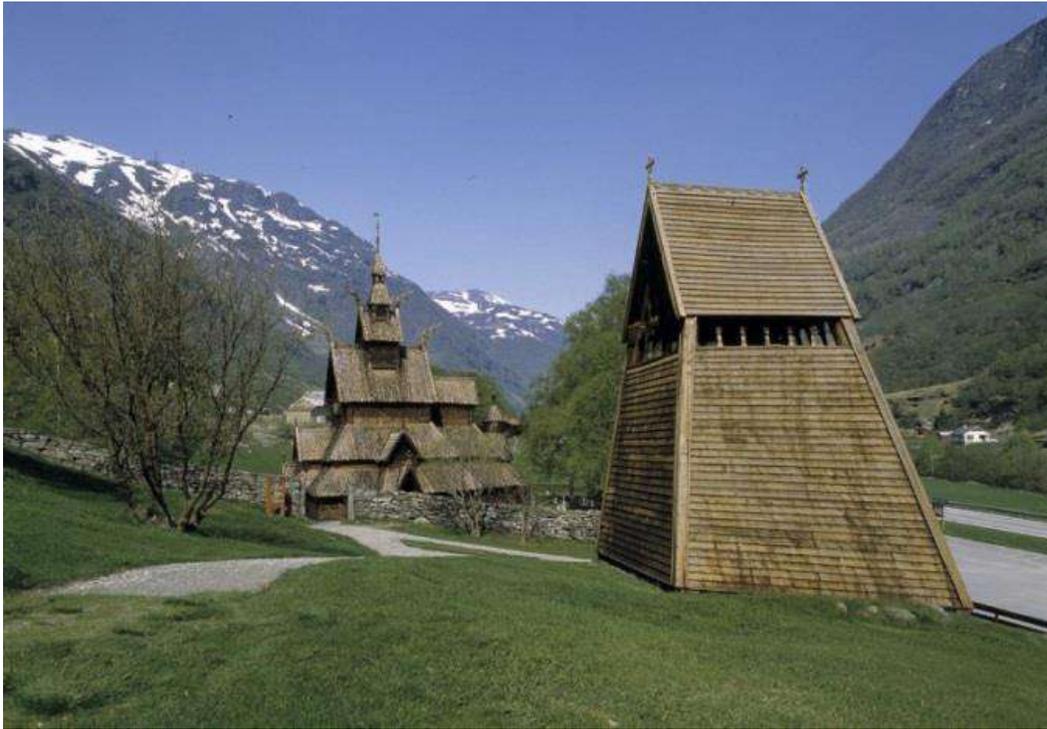
Significant parts of the belfry are medieval but it has undergone changes and additions in the 17th, 19th, and 20th centuries. Condition assessments determined that the belfry was in critical shape. It was only the part above the bell room which was in relatively good condition, while the other parts had significant damage. The “staves”, or poles, had such a high degree of rot that several were completely hollow. The ground beams and joints were also full of rot.

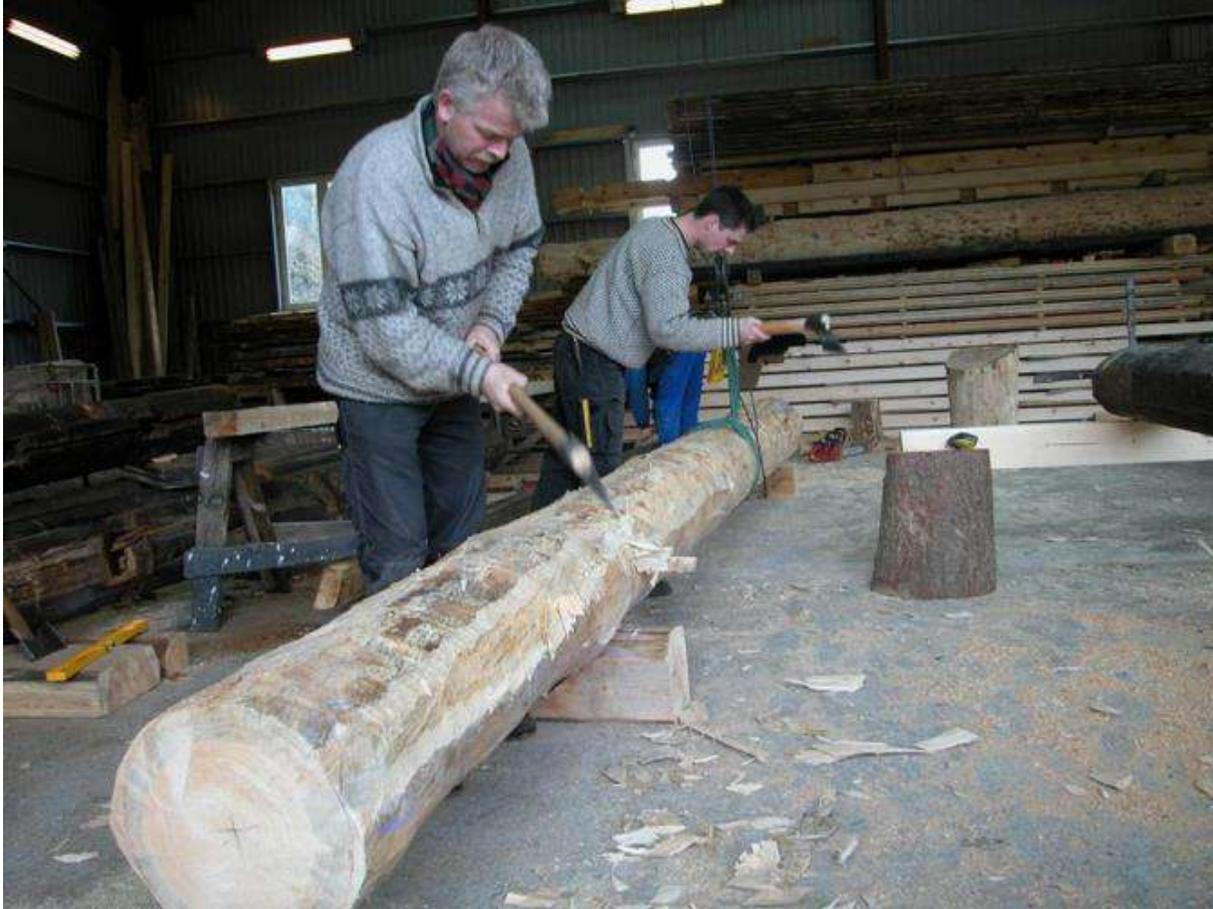
was hoisted down first, followed by the stave construction which was dismantled piece by piece and transported to a workshop where the work was done. An advantage with the dismantling was that every single piece could now be thoroughly examined by the craftsmen who made detailed reports on joins and tool marks.

These studies formed the foundation in the work involving the remaking of building parts. Large amounts of original material had to be replaced, and it wasn't until all the pieces were examined that the extent of the damage became apparent. In the same way as the work on the churches, great emphasis was placed on locating replacement material of similar quality to the original wood. The craftsmen also used the same type of tools as far as possible.
