1st IIWC Course on Wooden Heritage Conservation

3rd - 5th October 2019, San Sebastian

Proceedings Editors: Dr Tanya L. Park , AUS & Teresa Artola-Guijarro , SP
ISBN 978-0-64 85799-2-2

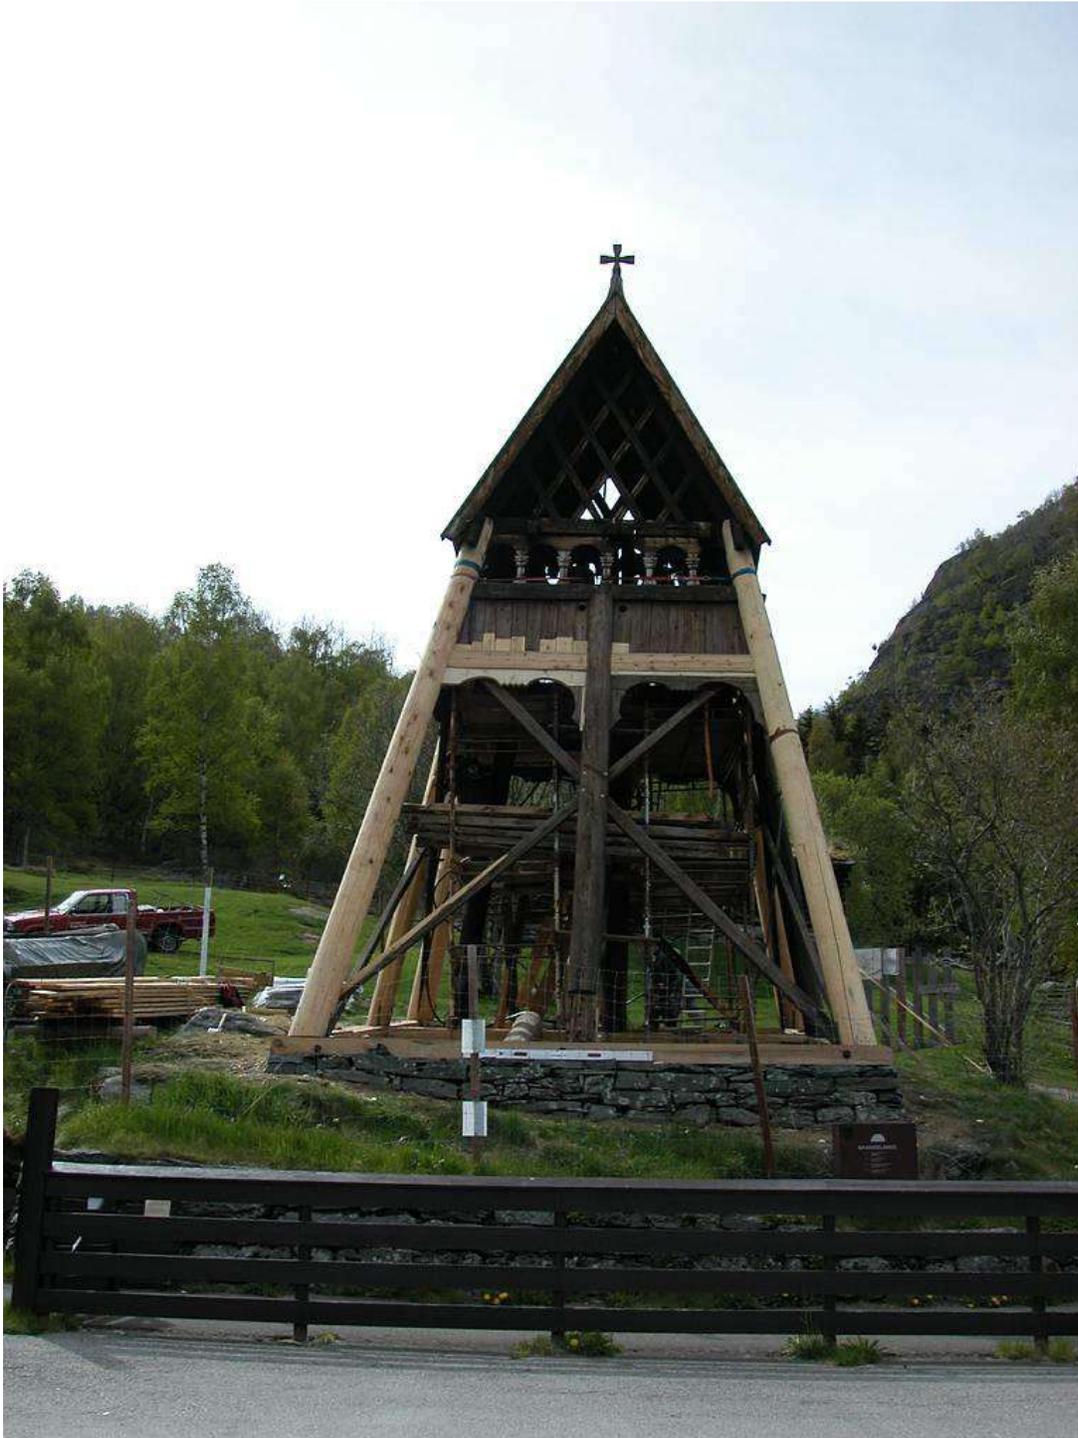
Not just the visible elements were exact copies of the originals, but also all the hidden elements were recreated down to the smallest detail. For the belfry, it was of great importance that several of the load bearing elements were changed so the stave construction retained its load bearing function.
