Barrier Beach Systems

Background

This case study highlights perspectives on the threats to Norton Point, a barrier beach and potential adaptation options available to adaptively manage this coastal landform in the face of rising sea levels and larger storm systems. Norton Point is a 2.5-mile-long barrier beach strip of sand and dunes sitting between Katama Bay to the north and the Atlantic Ocean to the south, on the Southeastern side of Martha's Vineyard. It provides vital shorebird habitat, OSV access for recreation and, when not breached, it is the only way to reach Chappaquiddick Island by land. Norton Point also provides natural storm surge protection for the homes and lands surrounding Katama Bay. However, sea level rise, wave action and storm events threaten to inundate and eliminate this fragile and dynamic sliver of sand.

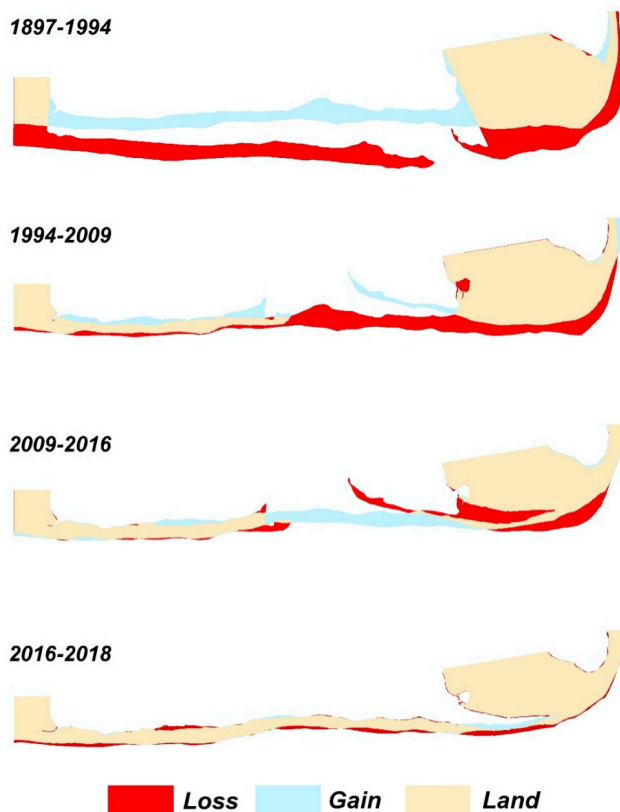
Erosion of shoreline over time

The WHG team confirmed Norton Point’s highly dynamic nature, pointing out that the barrier beach has been migrating landward toward Katama Bay since at least 1897. But it is also shrinking. In the fifteen years between 1994 and 2009, the barrier beach lost 70 acres of area. Losing 70 acres in fifteen years is significant considering that 74 acres of area were lost during the 100 years prior to 1994. This suggests that coastal change is accelerating, and sea level rise and inundation is likely to exacerbate the erosion. Considering only the impacts of sea level rise (and not including the impacts of storm events or potential sediment dynamics), models predict Norton Point Beach will be

Coastal geologists from Woods Hole Group assessed the vulnerabilities and potential impacts at Norton Point and shared their insights and potential interventions with participants¹. The WHG team confirmed Norton Point Beach’s highly dynamic nature, pointing out that the barrier beach has been migrating landward toward Katama Bay since at least 1897. But it is also shrinking. In the fifteen years between 1994 and 2009, the barrier beach lost 70 acres of area. Losing 70 acres in fifteen years is significant considering that 74 acres of area were lost during the 100 years prior to 1994. This suggests that coastal change is accelerating. Sea level rise and inundation is likely to exacerbate the erosion. Considering only the impacts of sea level rise (and not including the impacts of storm events or potential sediment dynamics), models predict Norton Point Beach will be increasingly inundated over time and by 2070 it will be nearly nonexistent. The area where Norton Point is today will be open ocean. Norton Point Barrier Beach is also repeatedly breached, with the most recent breach occurring in 2007. These breaches typically occur from the bay side when storm events create hydraulic pressure that pushes the bay water over the beach toward the ocean.
