# Coastal Banks

## Background

This case study highlights perspectives on the threats to Wasque Reservation's coastal banks and potential adaptation options available to coastal bank property owners. Situated on the southeasternmost corner of Chappaquiddick Island on Martha's Vineyard, Wasque Reservation is part of a coastal ecosystem characterized by barrier beaches to the west and to the east. Erosion of the coastal banks at Wasque is not uncommon. In fact, it has some of the highest erosion rates in the Commonwealth, resulting in a loss of natural storm protection, increased risk to infrastructure, loss of recreational beach area and habitat, and diminished public access. As a result of the dramatic erosion of coastal banks on this property and the potential negative impacts from bank stabilization approaches, The Trustees adopted a 'Shoreline Stabilization Policy' which states that The Trustees would consider bank stabilization options only if there was a conservation benefit.

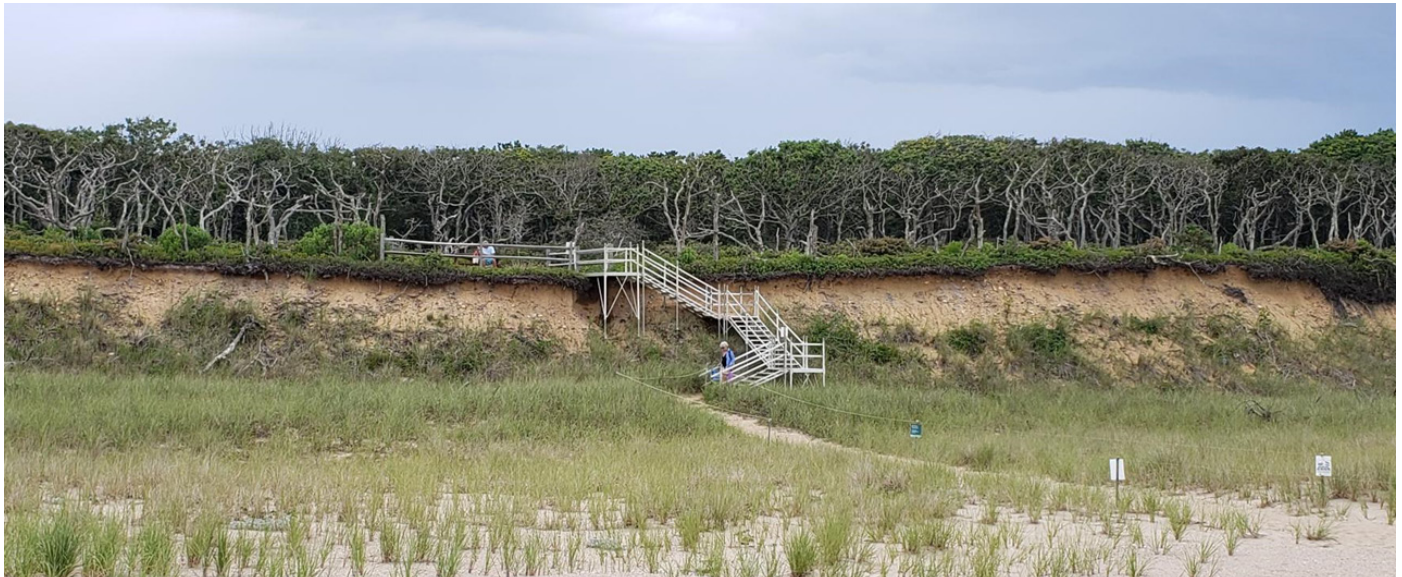
Portable modular aluminum stairs can be removed before major storms. Stairs allow safe visitor access without eroding the banks.  
Photo credit: Tom O'Shea

Participants suggested additional adaptation options for managing risk in dynamic coastal bank areas in addition to comprehensive planning within a littoral cell, as previously mentioned. One suggestion was to install modular technology for all infrastructure needs. The lightweight, modular materials could easily be relocated prior to storm events and/or over time as the bank erodes.

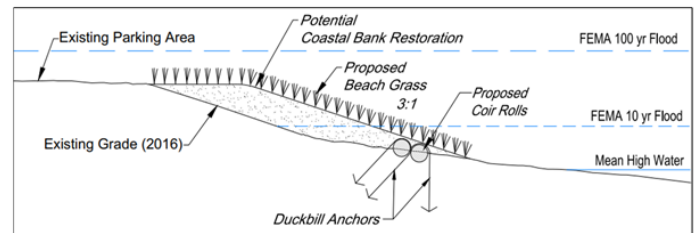
*Bioengineered intervention for bank stabilization and restoration at Wasque Point*

Vegetating coastal banks involves decreasing the bank slope, installing erosion control blankets, and planting native vegetation. The blanket biodegrades over time and the roots of the native vegetation hold the soil in place. This approach can stabilize coastal banks, enhance wildlife, and be completed concurrently with invasive species management. In areas where the toe of the bluff is exposed to increased wave and wake energy, vegetated banks can protect the toe of the bank. In these instances, the toe of the bank is constructed with coconut fiber logs or sand filled tubes, which are then covered with additional sand and planted with native vegetation.
