MELLON PARK PRESERVATION & MANAGEMENT PLAN

Final Draft
May 2000

prepared for
Western Pennsylvania Conservancy &
R.K. Mellon Foundation

prepared by
LANDSCAPES
Landscape Architecture • Planning • Historic Preservation
Charlotte, Vermont & Westport, Connecticut

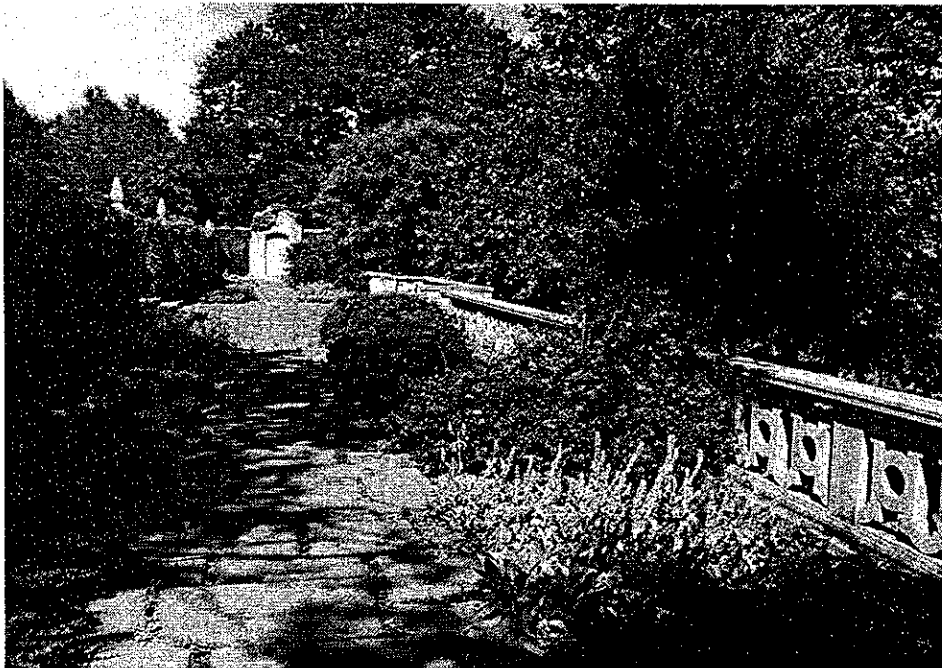
Figure III.10. Stone path, balustrade, and western terminus of the north terrace in the walled garden, 1999 (LANDSCAPES LA•Planning•HP).

Circulation in the walled garden runs primarily east-west, though this flow is intersected by a walk along a cross axis at the center of the garden which links the Garden Center to the scroll stair and Fifth Avenue. This stone walk is interrupted by the lawn of the central terrace. The stone walk on the south side of the garden has been reset and mortared in a different pattern, possibly with more recent stone. The other three east-west original stone walks and the north-south terrace along the western wall are deteriorated.
