The geology responsible for the recent slips on Maungakiekie/One Tree Hill

Bruce W Hayward

Feb 12 2023

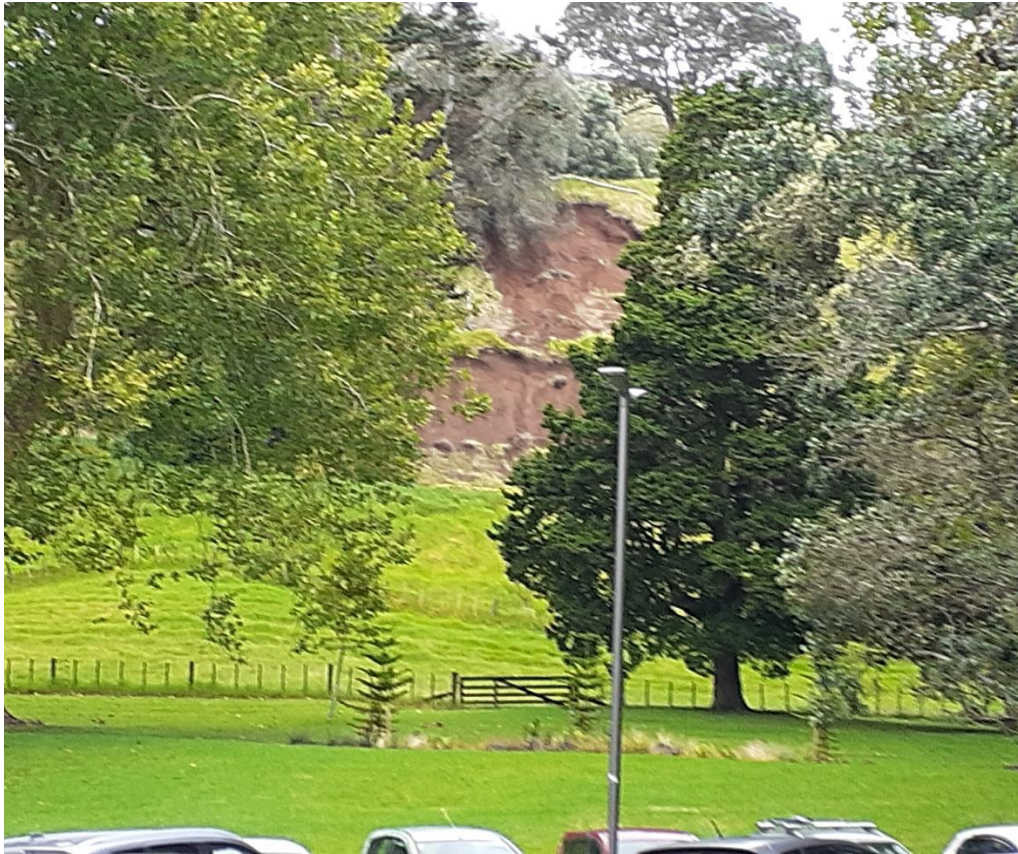
Fig. 2. Slips 12 and 13 on the northern slopes, close to the Cornwall Park kiosk.

The slips are most widespread on the northern and western slopes and all occur between 145 and 120 m above sea level on the steep (naturally 30°) slopes of the scoria cone. Nine occur on the outer slopes and six on the walls inside the two southern breached craters (Figs. 1-4). No slips are present where there is obvious lava flow fronts where viscous lava oozed out from the lower slopes of the cone, mostly around the southern, eastern and northwestern sides (Hayward, 2015).

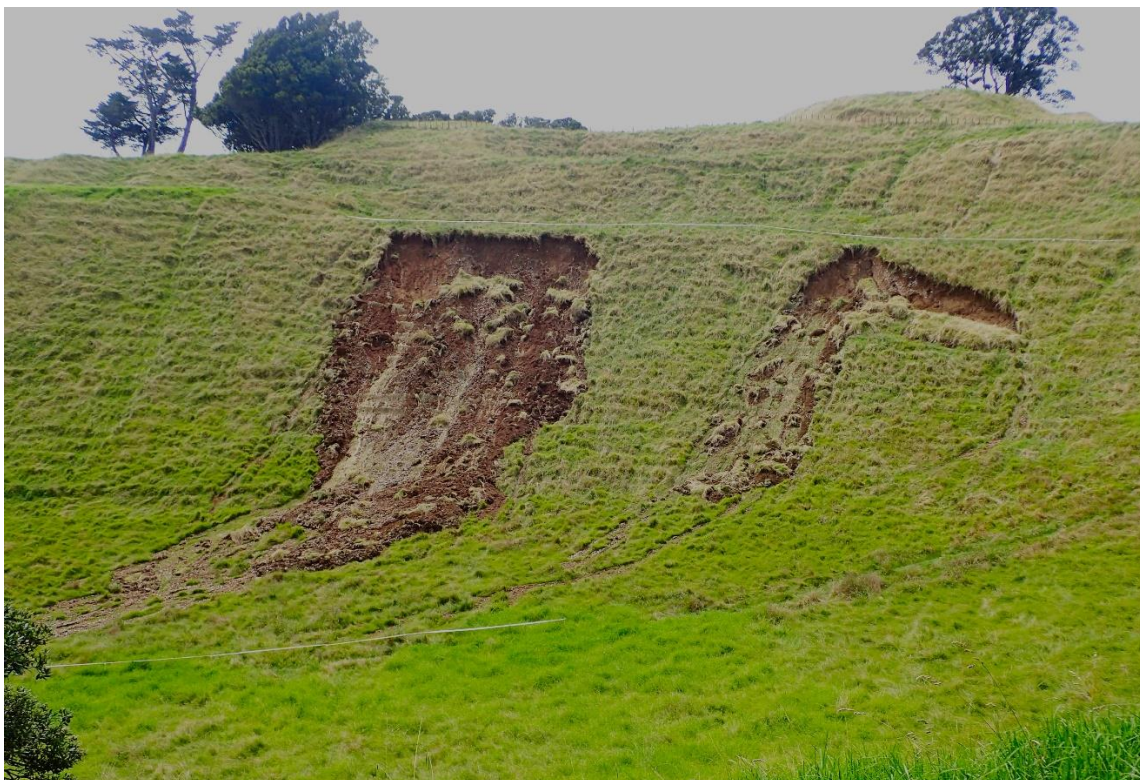
Fig. 3. The two largest slips (3-5) in the southwestern breached crater. Note how slip 3 (right) has started slipping at the top, just below the edge of the terrace above.

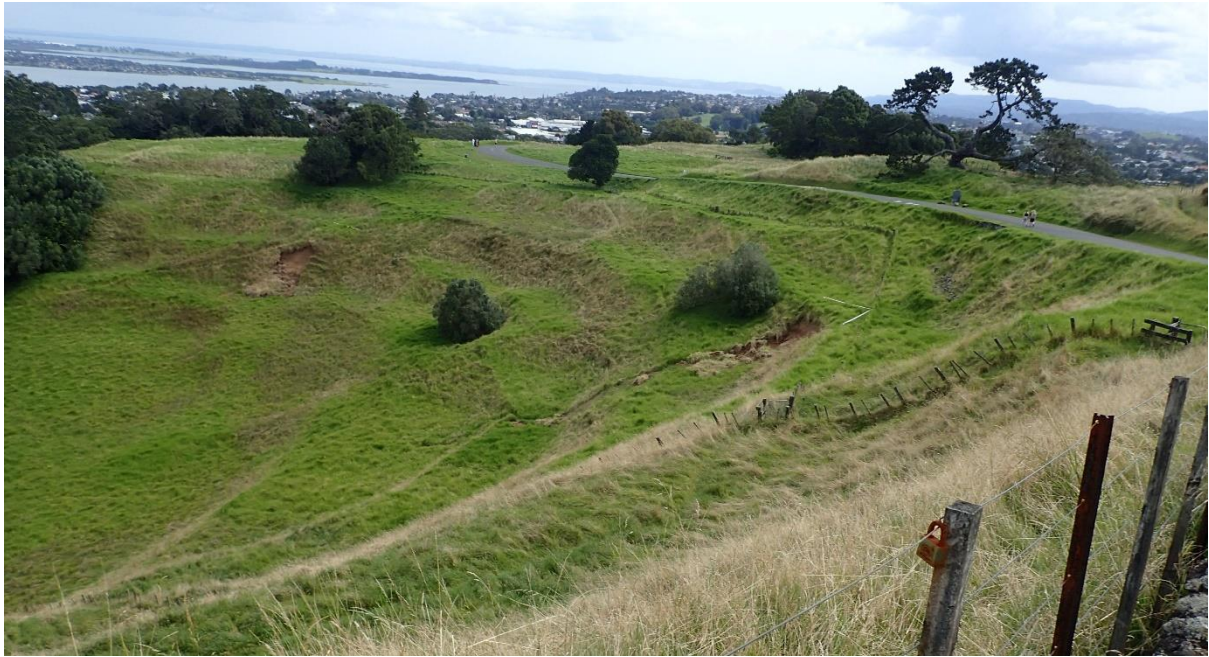
Fig. 4. The two small slips (14-15) in archery breached crater.

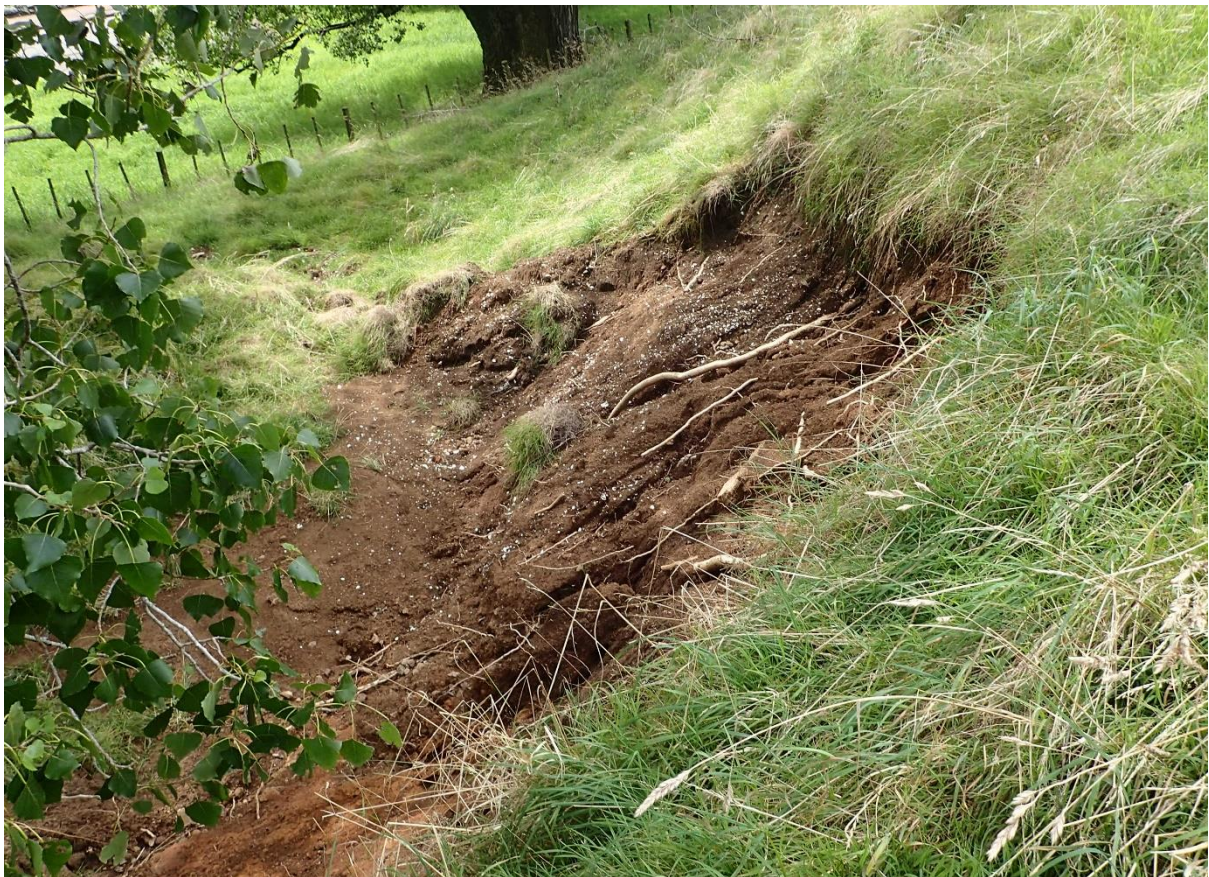
Fig. 5. Slip 9 is the only that has occurred near any tree, with some roots exposed by the slipping, which has started above and beyond the tree.

All slips appear to have occurred where there are no trees on the slopes, except slip 9 (Fig. 5), which started above a large tree and has slipped around it, exposing scattered tree roots. The depth of all slips is shallow, typically the top 0.5-1 m of the ground (rarely up to 1.5 m) (Figs. 6-7). The material that has slipped, or flowed, is the long grass and its root zone plus some of the underlying soil and shell midden (Fig. 8). Almost always the top of the slip is at the outer edge of a man-made terrace and from there the slip extends down the slope (riser between terraces) for 5-10 m, often stopping at the back of the next terrace down (Fig. 6). Examination of several of the better-exposed scarps at the back of slips 1, 2, 6 and 14 (Figs. 9-11) showed the following stratigraphy (sequence of deposits, from bottom to top): >1 m thickness of slightly weathered hard, impermeable, clayey ash with dipping 1-3 cm thick

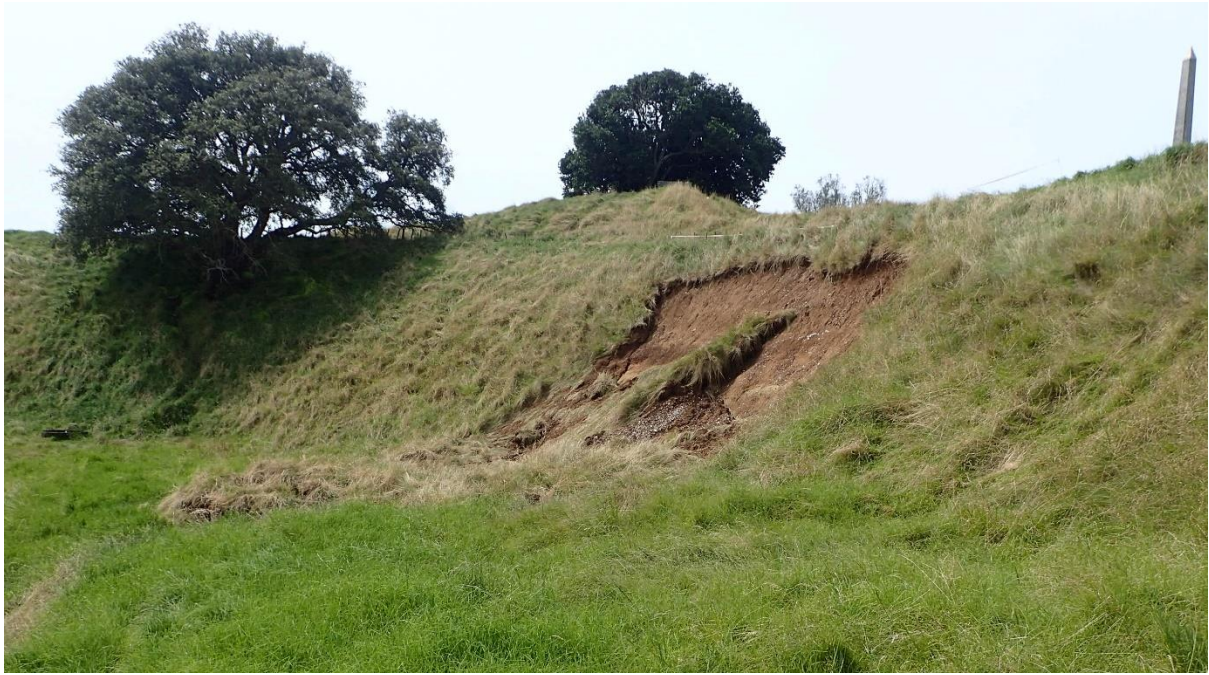
Fig. 6. Slip 1, in the southwest crater wall is an example of the kind of slips that have occurred on Maungakiekie, with failure of the rise between two terraces and only the upper 0.5-1 m of regolith failing and flowing down the slope with its toe extending across the lower terrace.

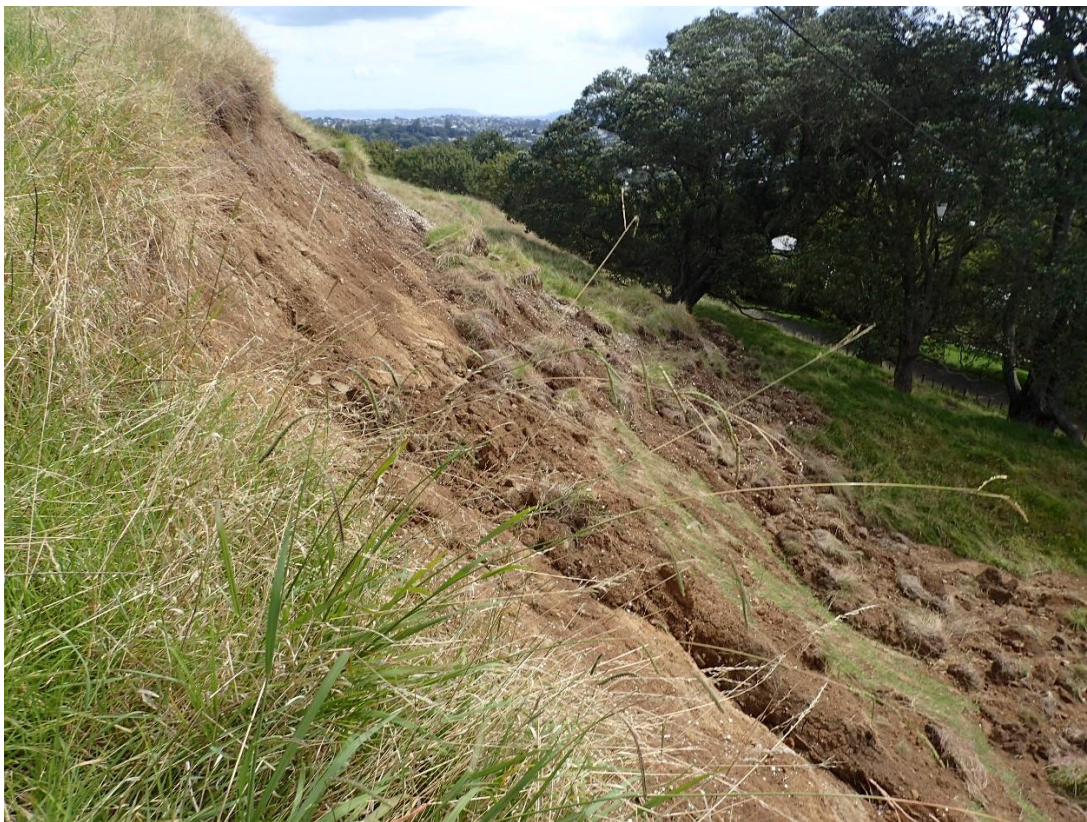
Fig. 7. Slip 6 shows the over steepened nature of the slope that failed and the shallow depth of regolith that has flowed down slope like a carpet of grass and topsoil developed in the terrace fill.

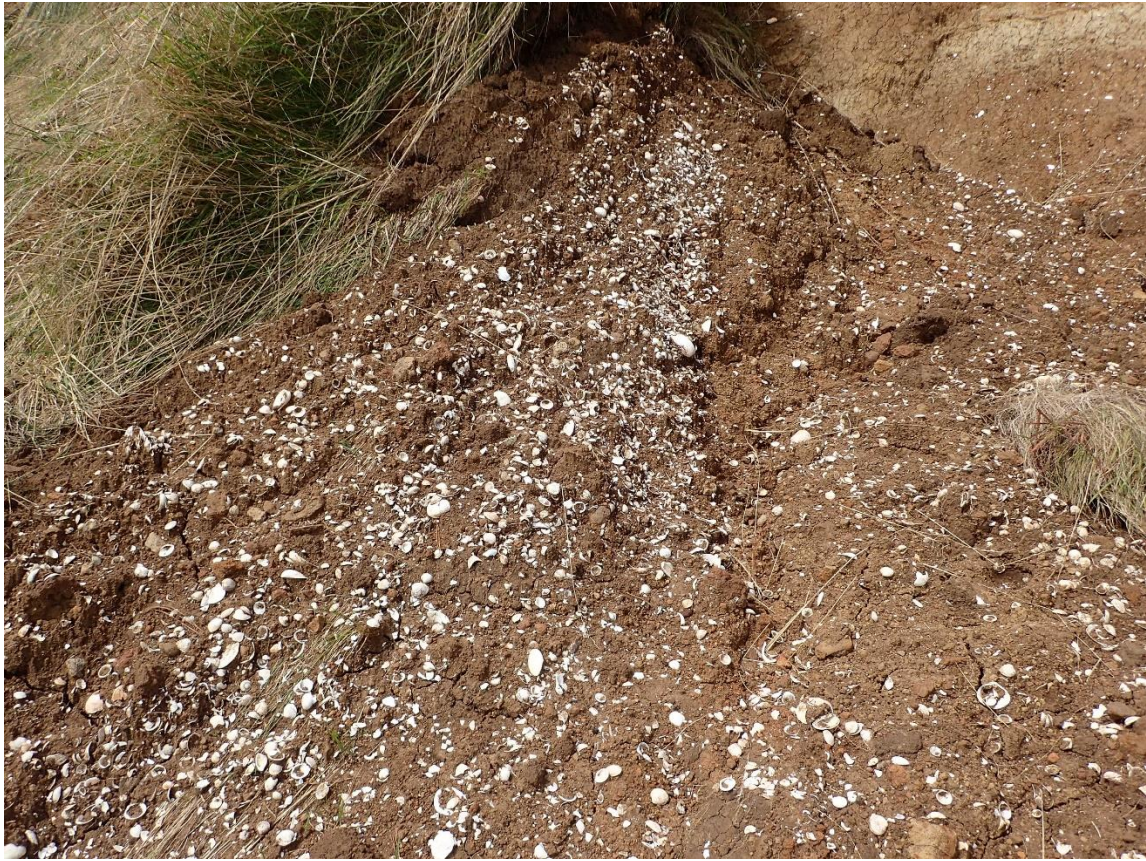
Fig. 8. Shell midden has been exposed and come down in most of the slips. Here in slip 1.

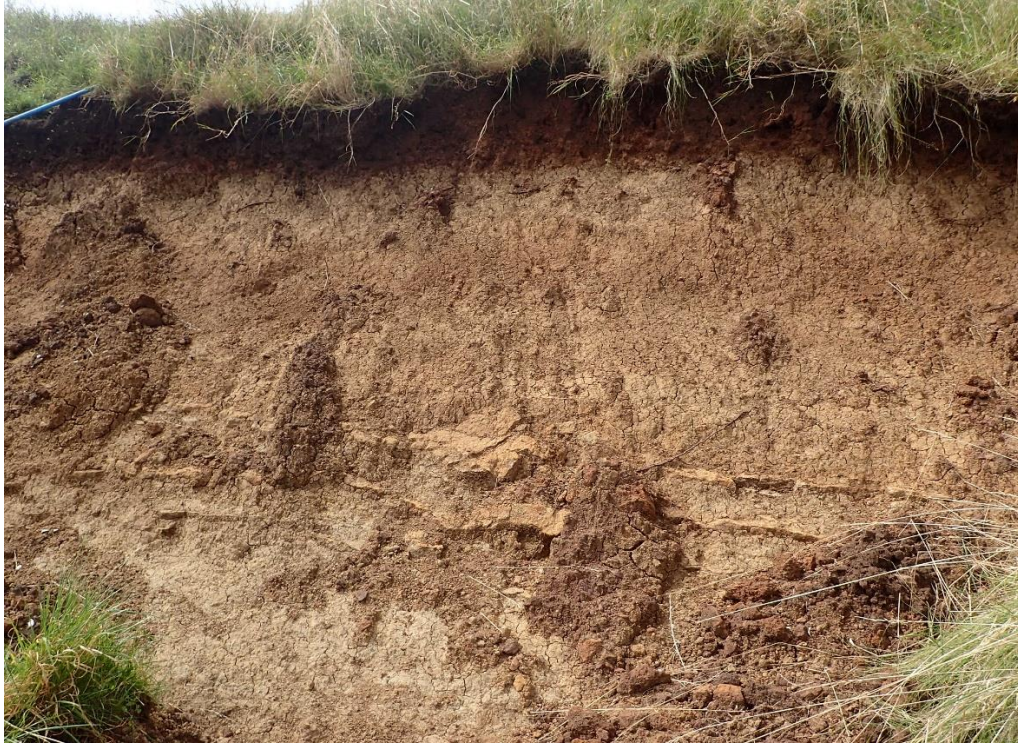
Fig. 10. Stratigraphy exposed in slip 2 with obvious beds of harder coarse tuff within finer tuff (all erupted from Three Kings Volcano) in the lower part of the scarp. This is overlain by a darker red-brown soil and at the top the lighter terrace fill.

beds of hard, coarse volcanic ash (Figs. 10-11); overlain by 0.3-0.6 m of dark red-brown soil (Figs. 9, 11). This soil is overlain by 0.3-1.5 m of massive, cobbly soil containing angular cobbles, pebbles and granules of the underlying tuff (Fig. 9). This layer was thickest at the top of the slips near the terrace edge and thinned downslope. It was capped with abundant shell midden and modern soil.

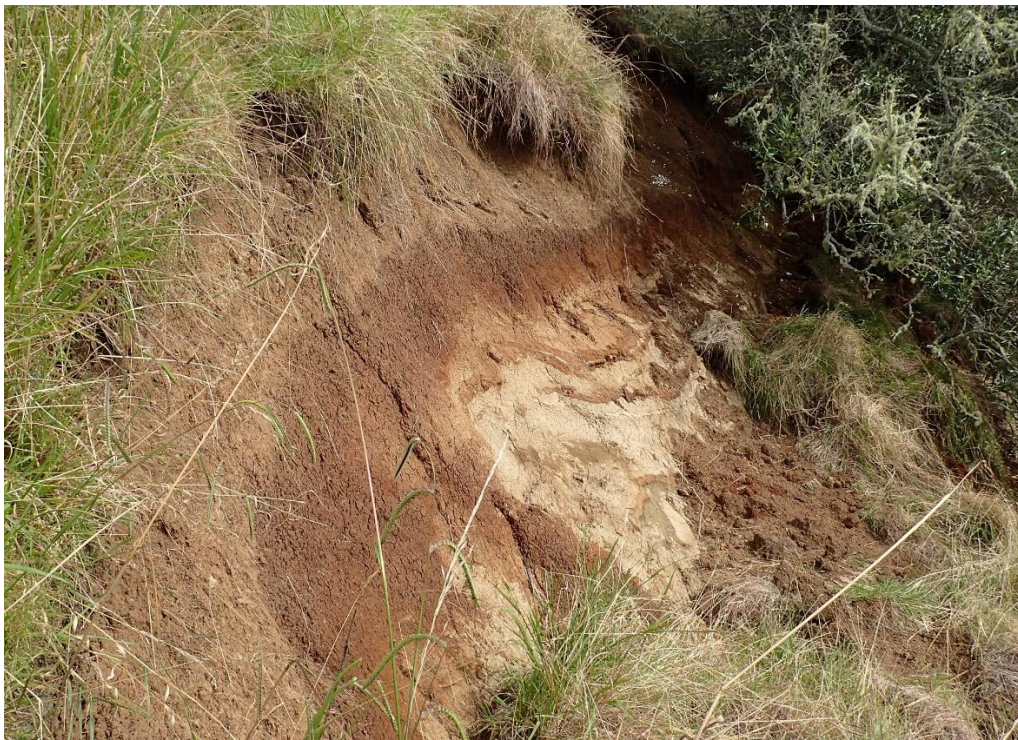
Fig. 11. Slip 7, on the western slopes, has exposed the freshest bedded Three Kings tuff (lower right) overlain by red-brown soil and then lighter brown terrace fill.

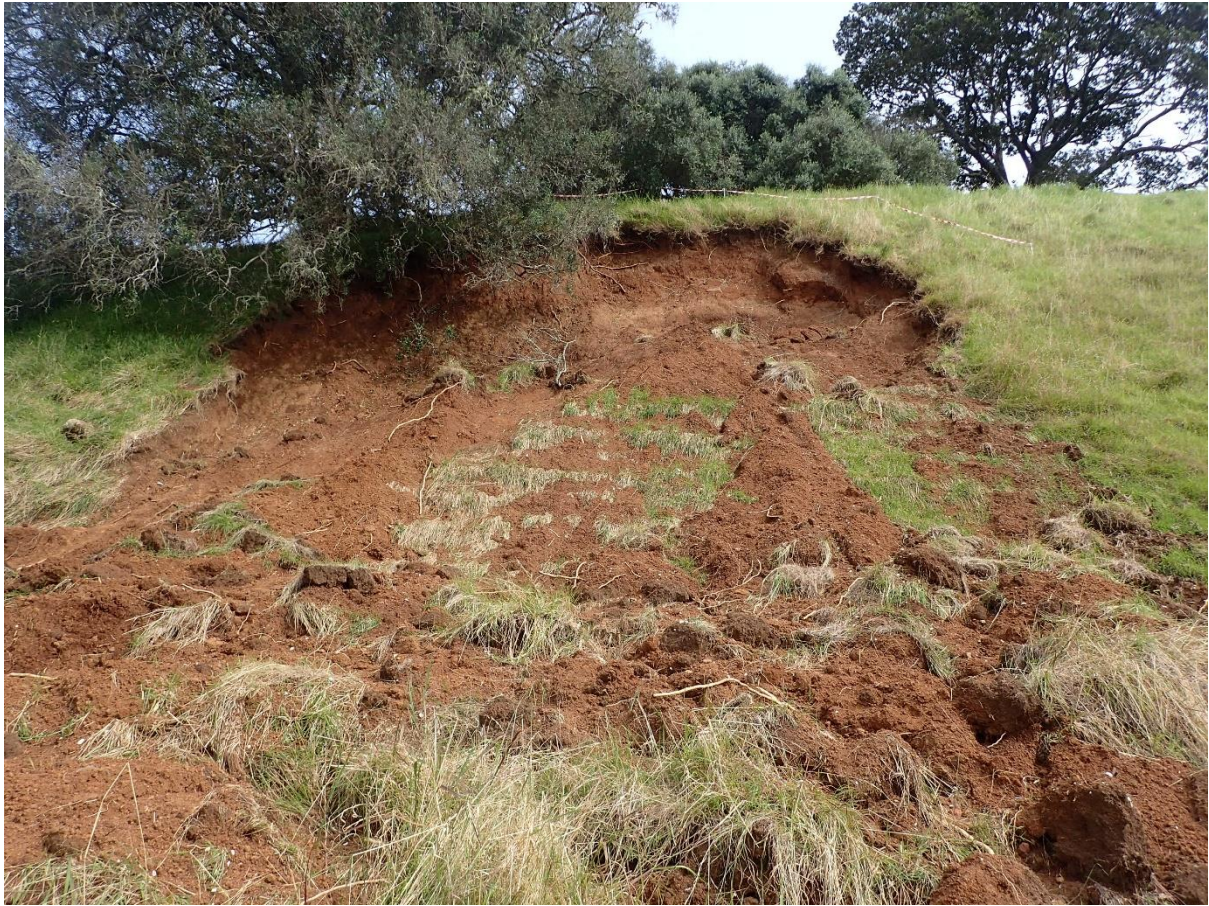
Fig. 12. Looking up slip 12 which is a slope failure on the riser between two terraces.
