Great expectations: treating both a colleague and a friend

Miles R. Cone,
DMD, MS, CDT, FACP

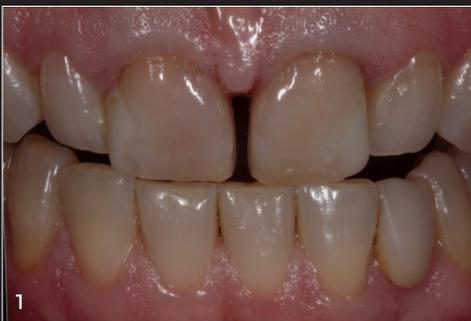
Fig. 1: Patient's initial presentation – discoloration of maxillary centrals resulting from trauma, non-surgical root canal therapy, and unesthetic composite resin restorations.

During the initial examination, it was noted that teeth #8 and #9 had both undergone non-surgical root canal therapy many years prior, following a traumatic injury. Additionally, the existing composite resin restorations on

all four teeth had recurrent caries present. Treatment planning ensued, and considering the patient's parafunctional habits, compromised resin restorations, short clinical crowns, and high esthetic expectations outlined in her chief complaint, recommendations for a surgical crown lengthening procedure and full-coverage layered zirconia crowns were made.

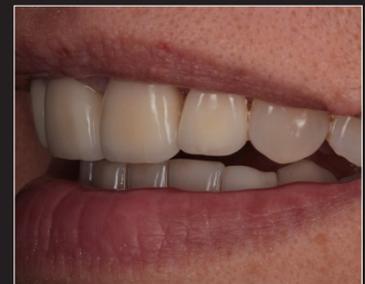
Fig. 3: Definitive full-contour porcelain fused to zirconia (PFZ) restorations, teeth #7-#10, demonstrating inappropriate opacity and value.

during the following weeks, which again, resulted in another unacceptable result. The third and final visit was also marked by significant disappointment, and out of desperation (due to the time factor), the patient finally conceded/agreed to the process and allowed the four crowns to be cemented, noting that the restorations were "...at least better than what (she) had" (Figure 3). The high hopes that the patient held for the dentist (me) treating her ran parallel to the expectations that the dentist held for the ceramist fabricating the restorations: the result would be nothing short of spectacular. The final photographs and a frustrated patient are a clear testament to the fact that this expected end was not achieved.

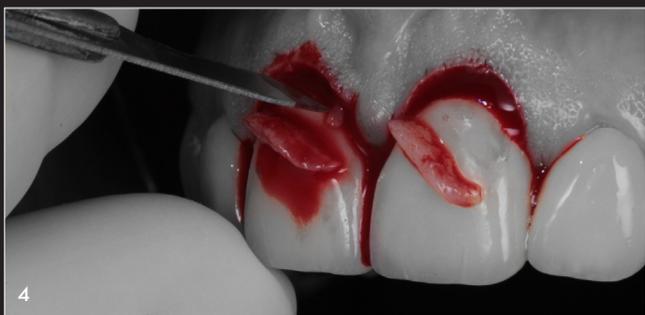
Fig. 4: Surgical crown-lengthening procedure being completed in anticipation of replacing the existing PFZ restorations with an improved esthetic result.

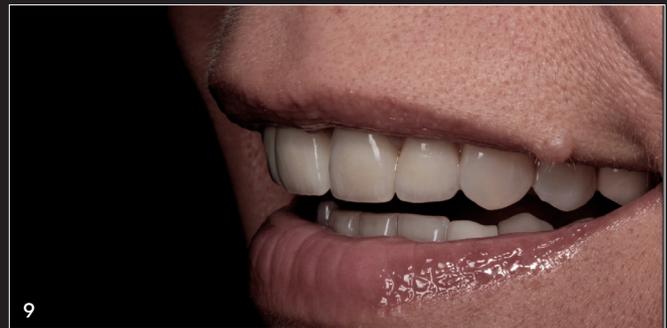
Fig. 8: Retracted anterior view of definitive PFZ restorations #7-#10 following placement.

At the placement appointment for the new crowns, the patient was extremely pleased with the improved esthetic result (Figures 8, 9), and the potentially disastrous ramifications of a failed treatment existing between colleagues and friends were avoided. ■
