Robust Internal Thermal Insulation of Historic Buildings

Deliverable no.: D3.1

Title of the deliverable: Closed Technology Loop of Laboratory Experiments and Simulation Models in the Field of Internal Insulation Testing

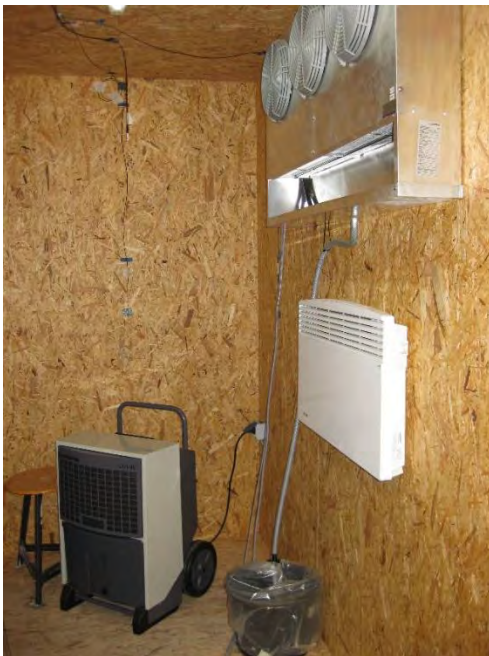
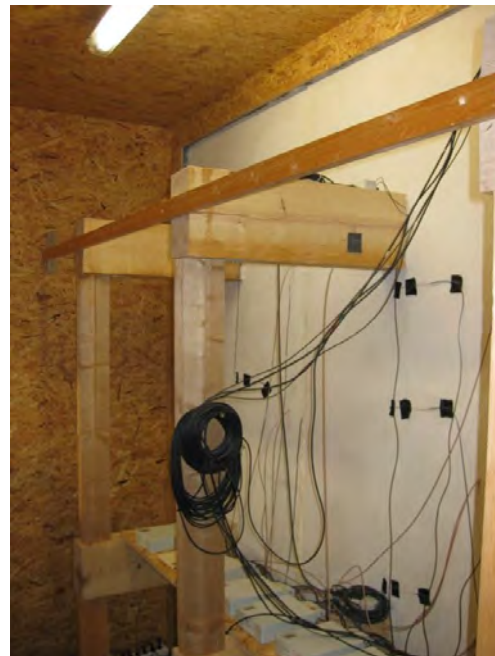
Fig. 4.: Cold-side chamber (left) with de-humidifier (dark grey device), air inlet (behind vents) and heating unit (white device). Warm-side chamber showing wires of the measurement equipment in the wall and with the beam ends supported by a wooden auxiliary construction.

The warm-side chamber is equipped with a radiant heater and a humidifier, which are temporarily put into operation. The heater was mainly used to accelerate the drying-out of build-in moisture at the beginning of the test phase and furthermore to provide hot and humid warm-side conditions during the regular operation of the test stand. The cold side chamber was equipped with a heating and cooling unit of 2.0 kW heating power and 2.2 kW cooling power, a humidifying unit, a dehumidifying unit and a number of vents for homogeneous air mixing. Achievable air temperatures range between -10°C and 25°C , relative humidity between 20% and 90%.

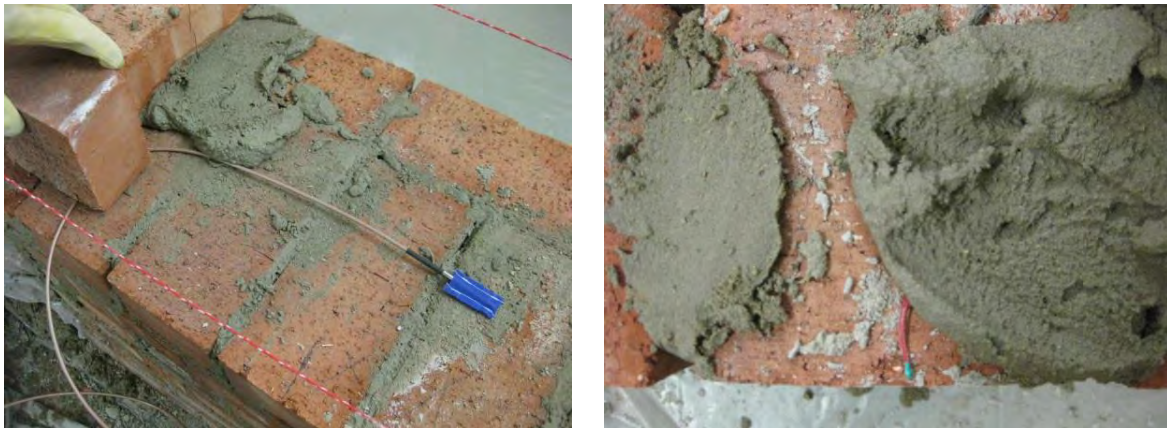
Fig. 5.: Combined temperature and relative humidity sensors in the masonry: sensor with protective casing in the middle of the masonry (left) and near-surface sensor (right)

Test strip 1 with hybrid PUR insulation boards (iQ-Therm) provides the basic set of sensors for each of the three measurement tracks. The middle part includes a heat flux board (WFP1) at the inner surface (covered with 2 mm of finishing plaster) and an inner surface temperature sensor (TIDO1). The interface between masonry and insulation, precisely within the adhesive mortar layer, is equipped with a combined sensor that registers temperature and relative humidity (TIDE1, HIDE1). The same type of sensor is used for recording the situation in the middle of the masonry, precisely within the bed joint of the masonry (TWM1, HWM1). This type of sensor is shown in graph Fig. 5.: for the middle of the

masonry (left) and for the near-surface situation (right). The casing around the sensor is a protective measure and made of a diffusion-open tissue.

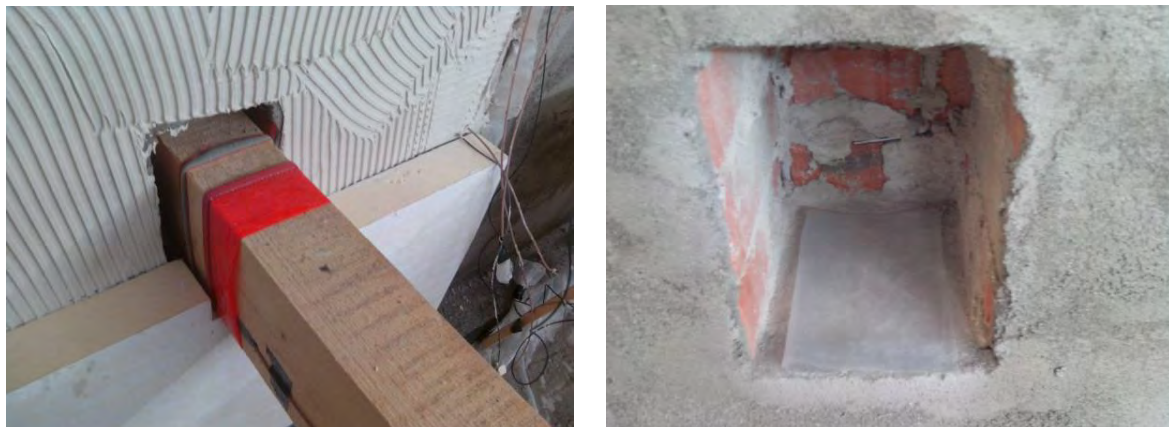
Fig. 8.: Double layer of pre-compressed sealing tape around the joist end prior mounting of the insulation boards (left) and PE-foil in the masonry block-out for the joist end (right), both in the first test strip of the test wall (iQ-Therm).

The beam-ends in the first test strip were tightened with a double layer of pre-compressed joint sealing tape in the gap between masonry and joist end as shown in the subsequent picture. In practice, usually a single layer of sealing tape would be realized. Below the joist end, a PE-foil is applied to avoid hygric contact at the contact face between wood and masonry mortar. The same decoupling technique was used for the other joist end contact faces as well.

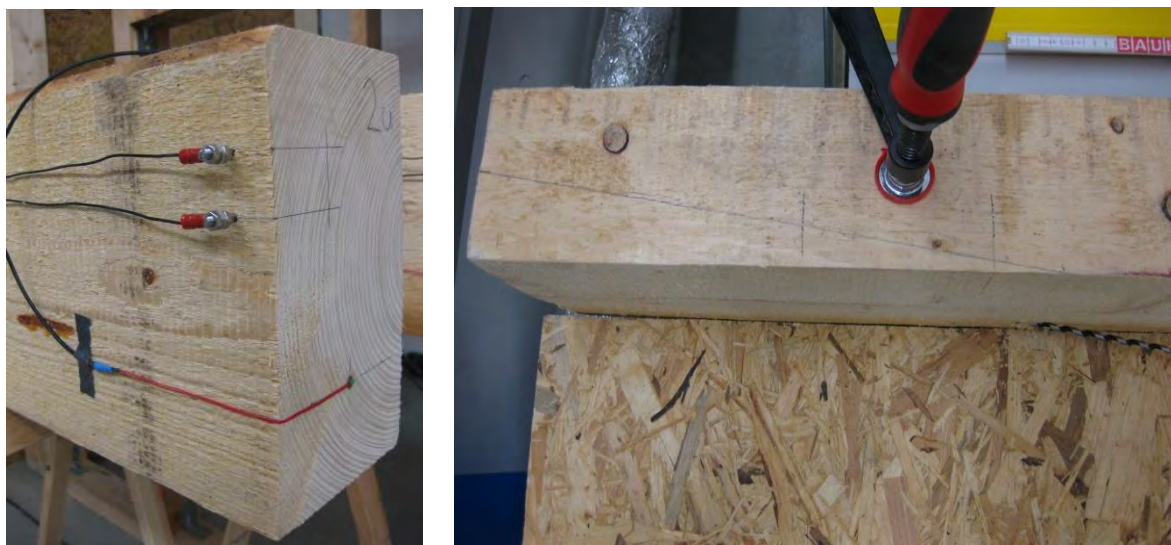
Fig. 10.: Mass-related wood moisture content measurement in the front end of the beam (left) and preparation of the combined sensors behind the front face of the beam (right).

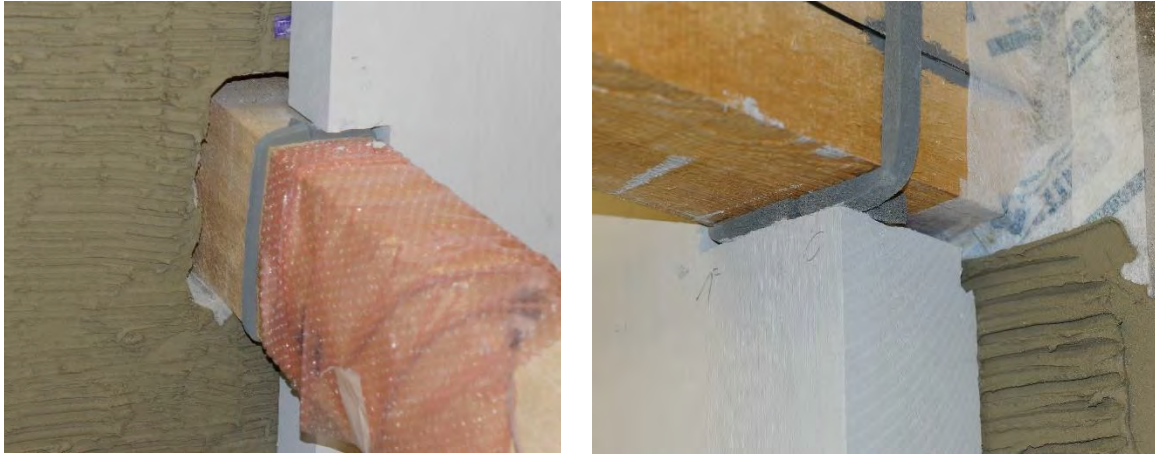
Fig. 11.: Sealing variants in test strip 2 (Calsitherm) for the lower joist end (left) and for the upper joist end (right).

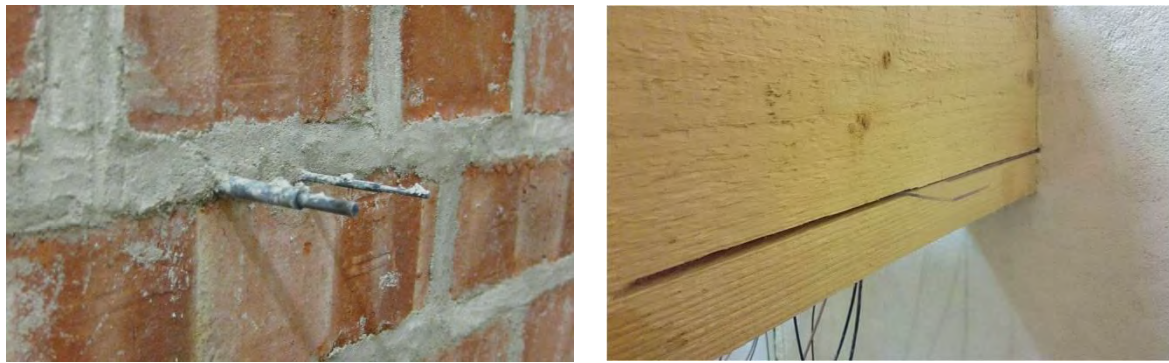
Fig. 14.: Inserted holes with test tubes in the bed joint of the masonry as seen from the cold side (left) and sawed cut in the joist end as seen from the war side (right).

Test field 3 extends the measurements for some more quantities and positions. A special interest was set into the airflow through the construction. Especially weak areas of the exterior wall, like pervasions via joist ends or other constructive parts, underlay a risk of unwanted airflow through the construction. This risk was evaluated in test strip 3, where defined cracks are inserted into the beam end (crack measures are a thickness of 3 mm and a depth of 40 mm) and defined holes were inserted into the masonry joints (diameter of the holes is 2 and 5 mm). Both can be closed down variably. The impact of these leakages were measured with additional temperature and relative humidity sensors sidelong the joist end (TLS3O/U, HLS3O/U) and in the contact face between masonry and joist end (TMB3O/U, HMB3O/U, TBO3O/U, HBO3O/U), furthermore with air velocity sensors in the upper part of the cavity (VAMLS3O/U, TAMLS3O/U).

The treatment of the upper and the lower joist end in this test field is much more permeable than in the previous test fields. An open, unsealed variant was chosen for the upper joist end and a hemp band was used for the lower joist end.

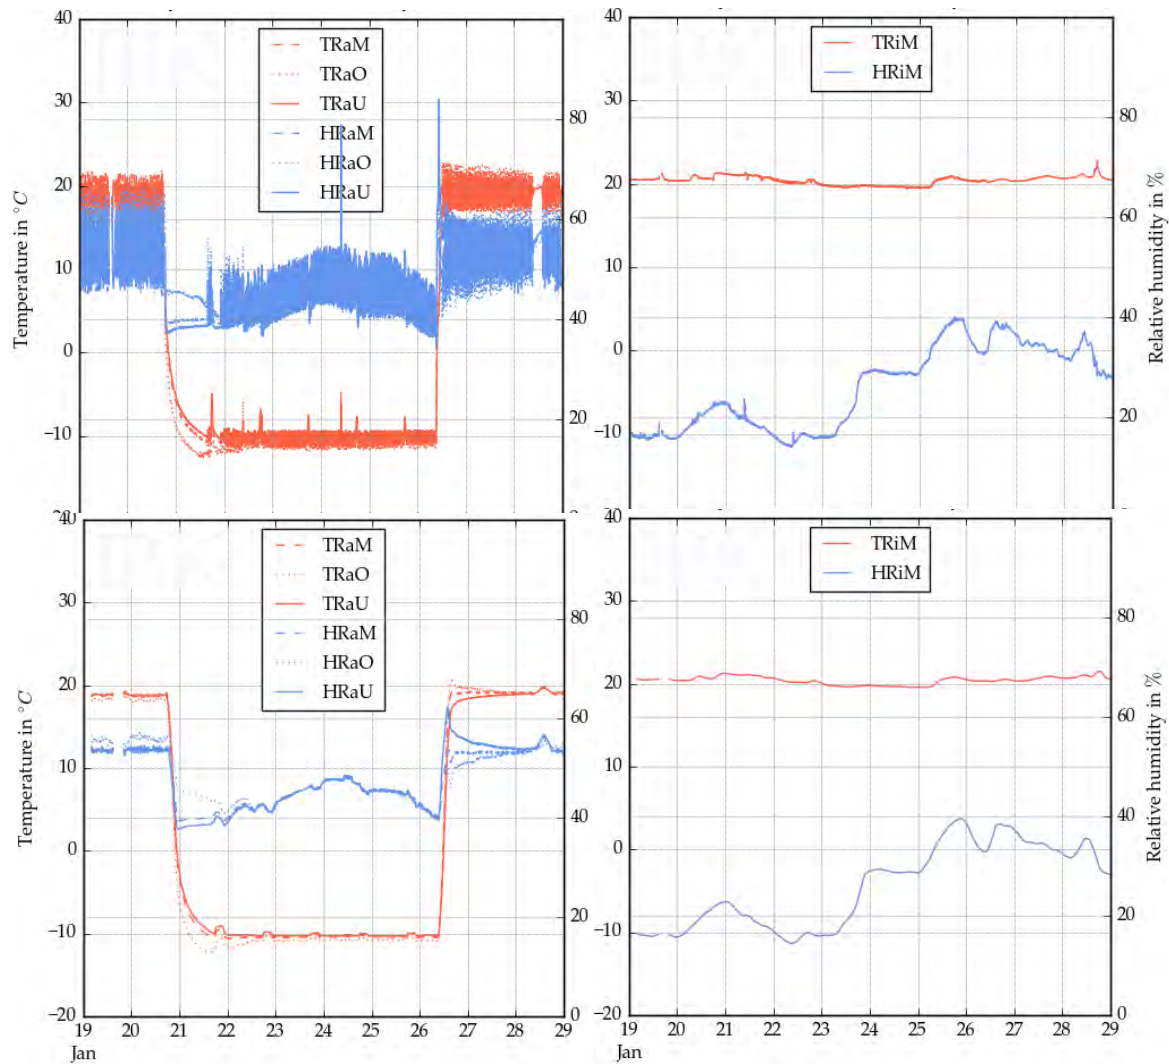
Fig. 17.: (Air) temperature (T) and (air) relative humidity (H) in the cold (left; Ra) and warm side (right; Ri) chamber during the steady-state period in January 2016, at top (O), middle (M) and bottom (U) position. The upper graphs show 5-Minute averages, the lower graphs show the rolling mean over 50 values.

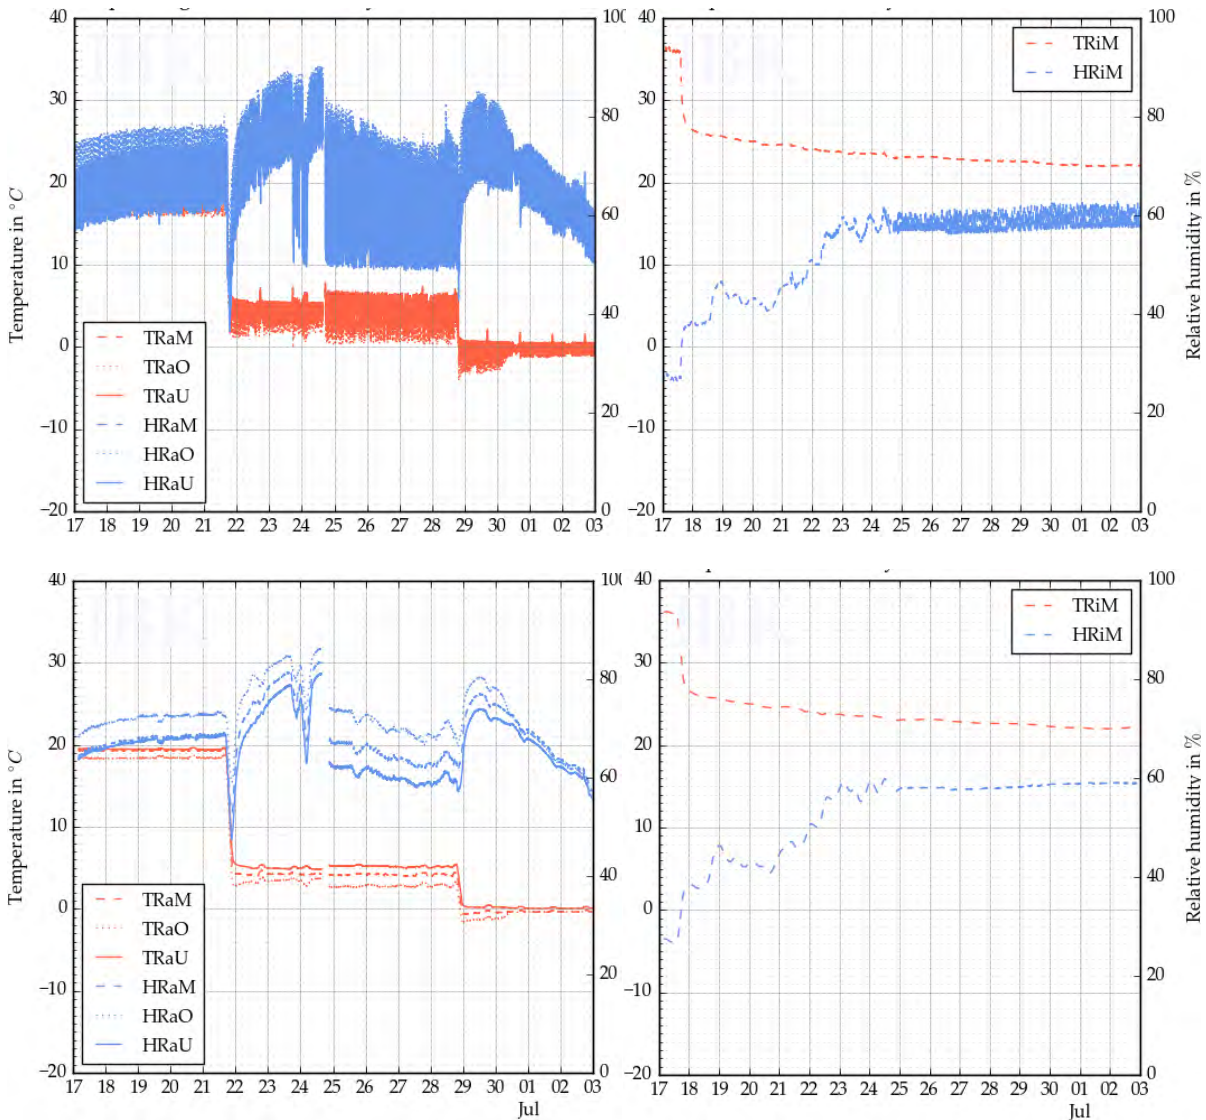
Fig. 19.: (Air) temperature (T) and (air) relative humidity (H) in the cold (left; Ra) and warm side (right; Ri) chamber during the step period in June/July 2016, at top (O), middle (M) and bottom (U) position. The upper graphs show 5-Minute averages, the lower graphs show the rolling mean over 50 values.

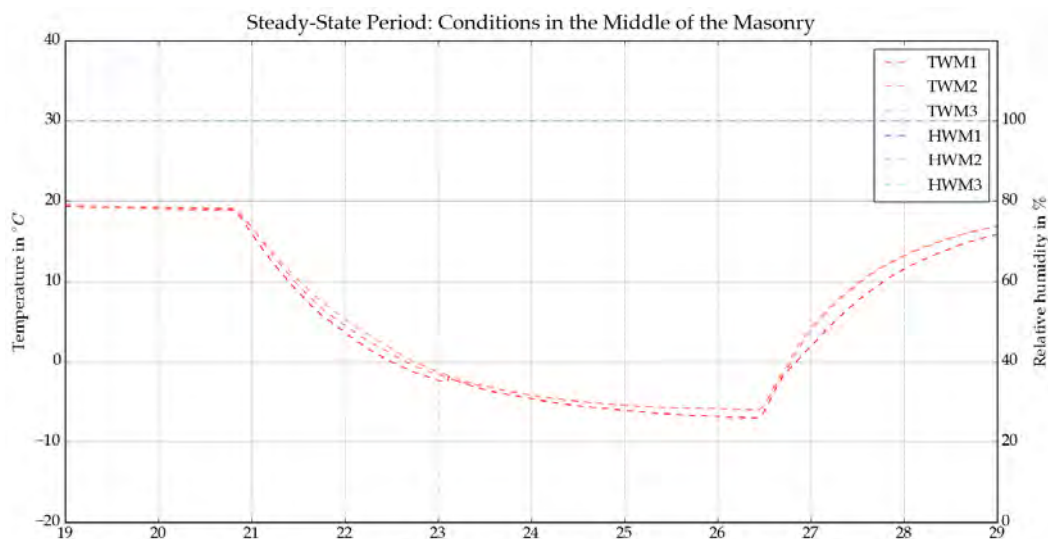
Fig. 20.: Conditions of the brick masonry during the steady-state test period in January 2016.

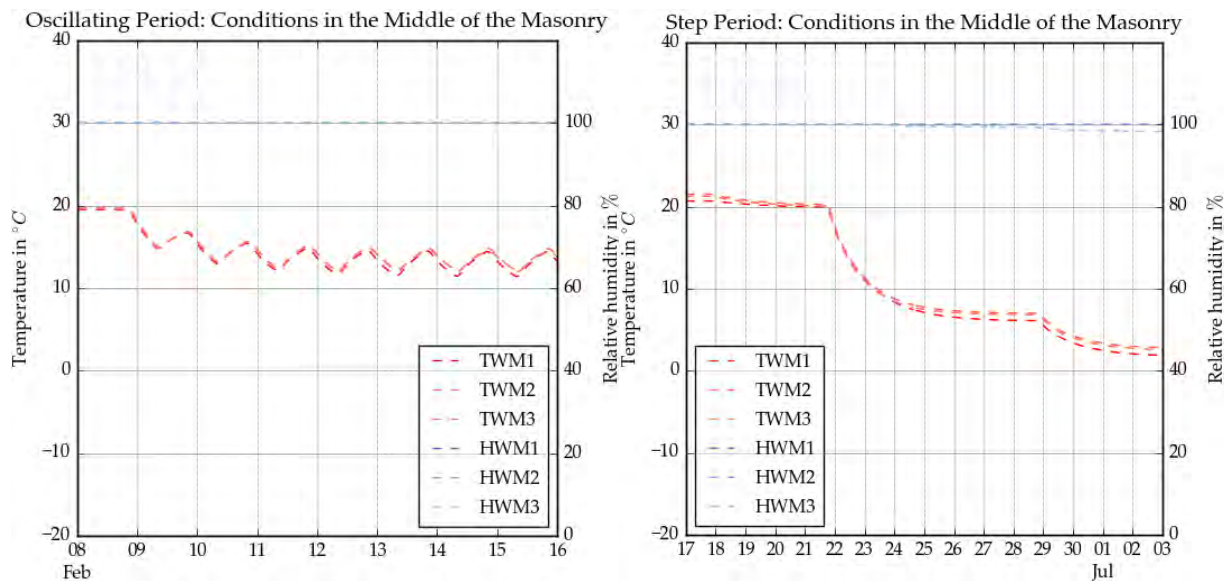
Fig. 21.: Masonry conditions during oscillating and step period 2016: red curves show temperature conditions in each of the three test fields in the middle of the wall, blue curves show relative humidity.

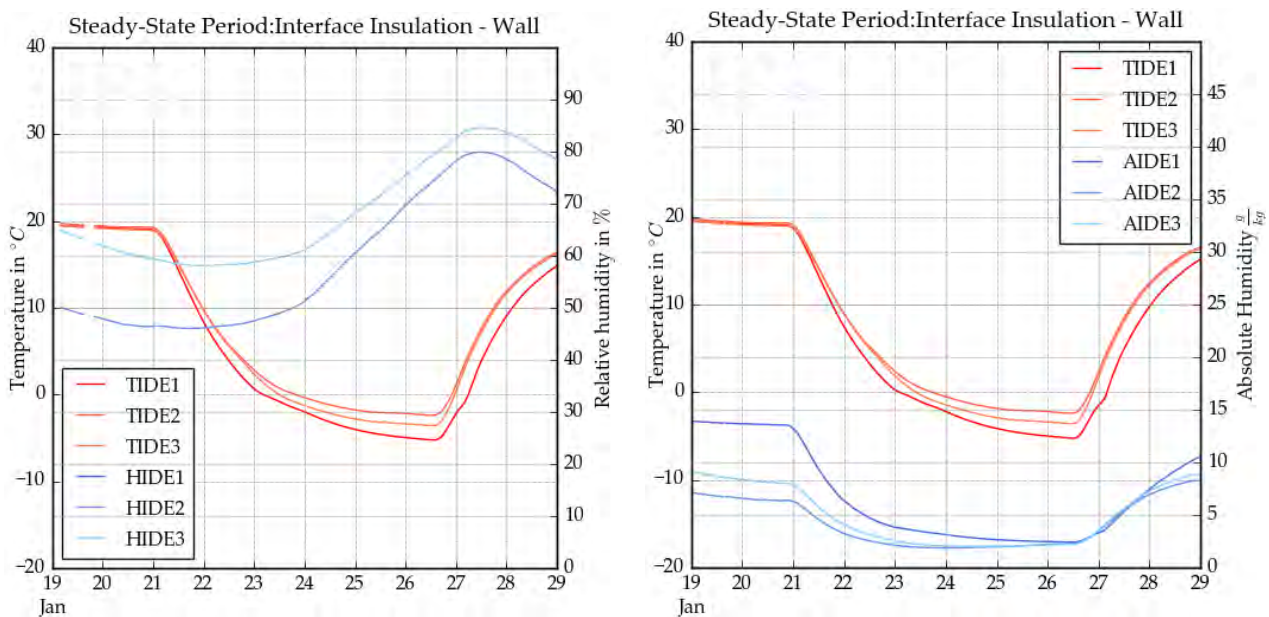
Fig. 22.: Conditions in the interface between masonry and insulation system for all three test strips in the steady-state period. AIDE is the sensor key for absolute water content, TIDE for the temperature.

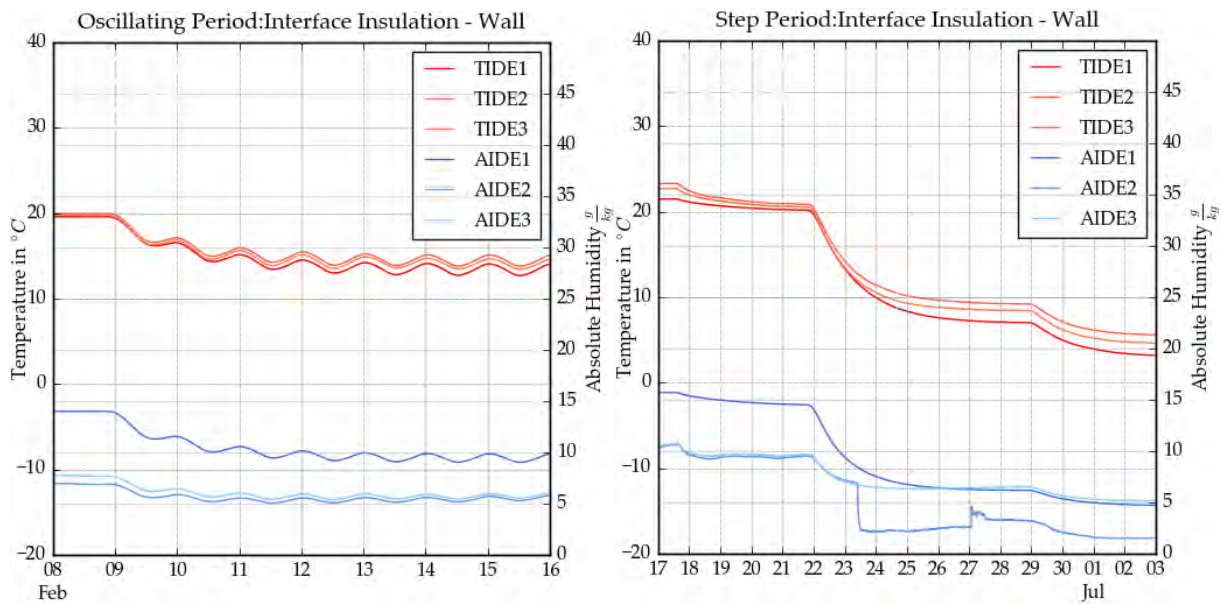
Fig. 23.: Conditions in the interface between masonry and insulation system for all three test strips in the oscillating period (left figure) and step period (right figure). AIDE is the sensor key for absolute water content, TIDE for the temperature.

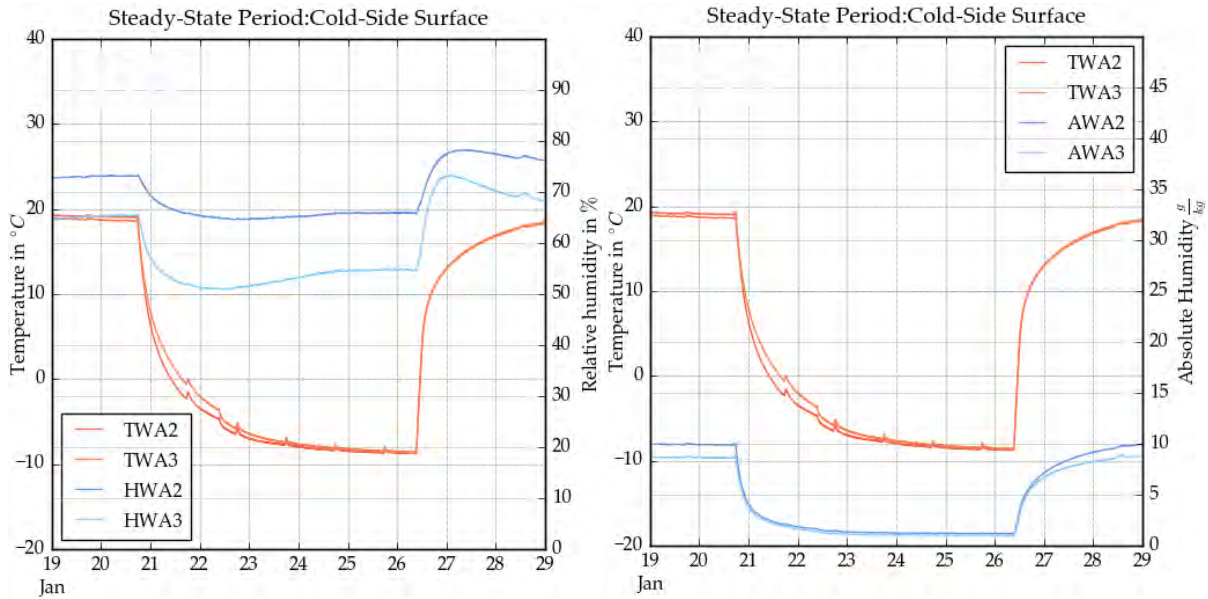
Fig. 24.: Cold-side conditions for the steady-state period in test strip 2 and 3 in January 2016. Left figure: temperature (TWA) and relative humidity (HWA). Right figure: temperature (TWA) and absolute humidity (AWA)

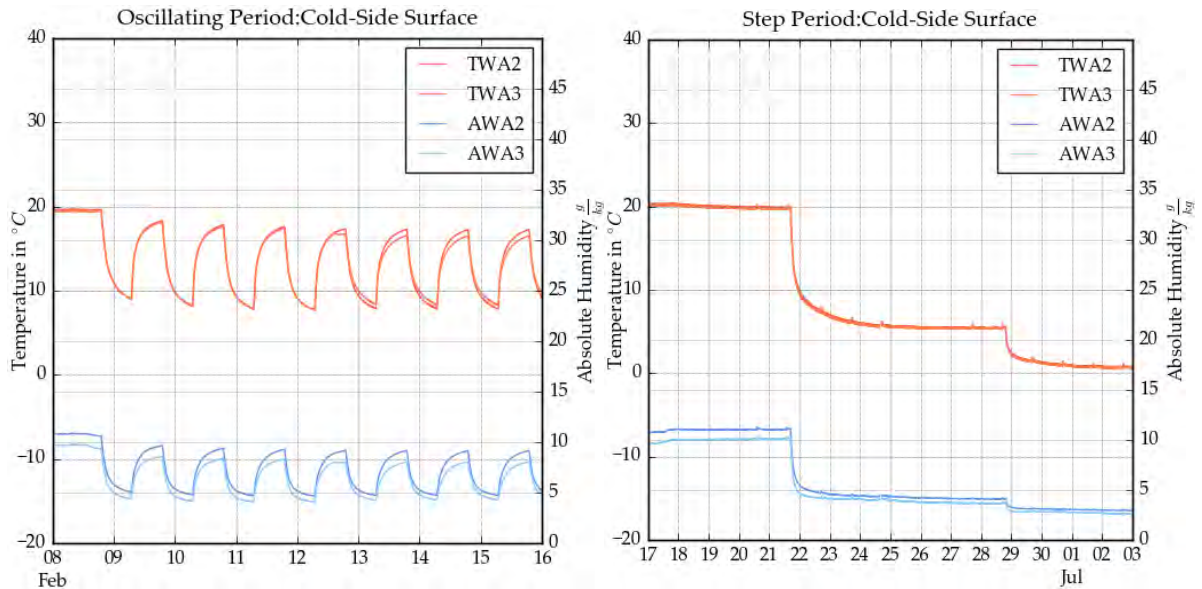
Fig. 25.: Cold-side temperature (TWA) and absolute humidity (AWA) conditions for the oscillating (left figure) and the step period (right figure): in test strip 2 and 3 in January 2016.

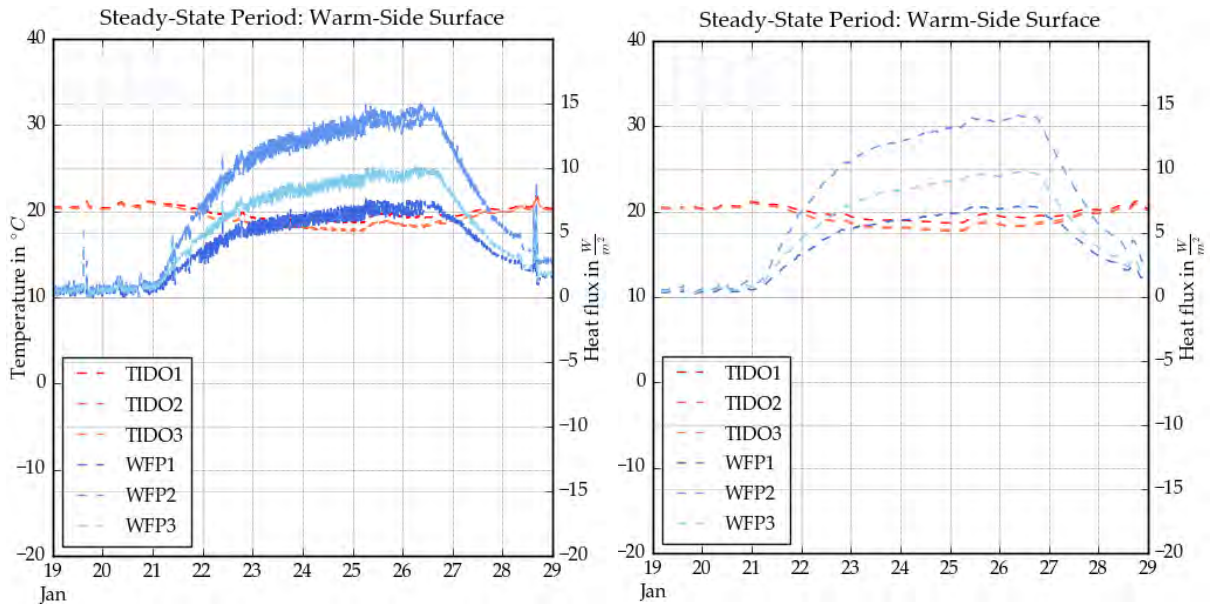
Fig. 26.: Warm-side conditions for the test period 1 (steady-state). Left figure: original curve. Right figure: smoothed curve with rolling mean over 50 values.

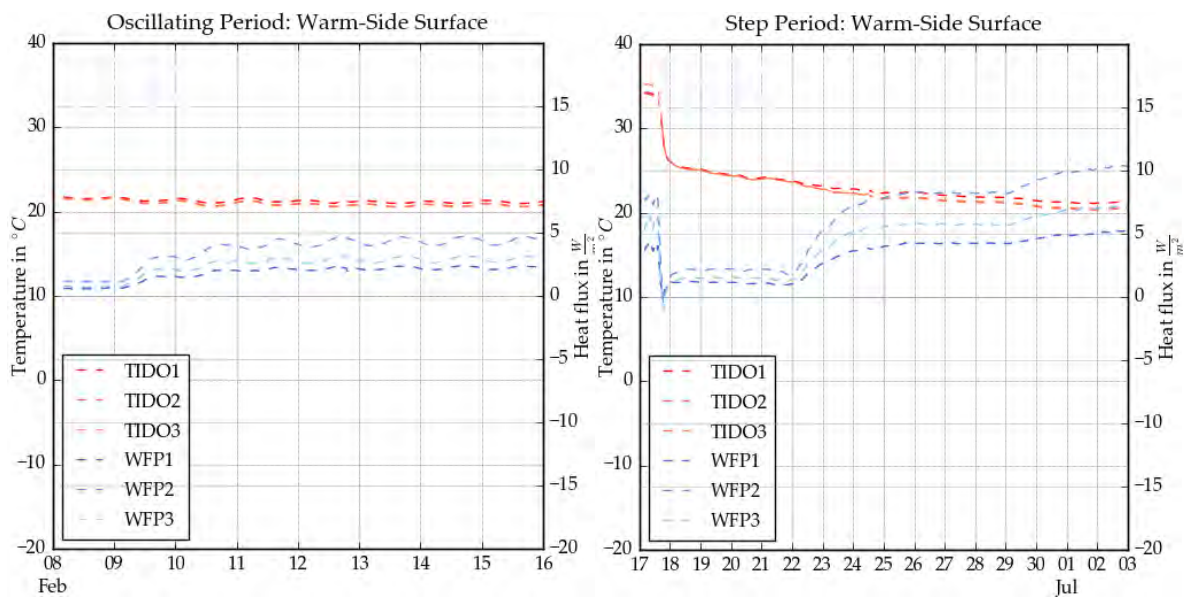
Fig. 27.: Warm-side conditions for the test period 2 (left) and 3 (right) as smoothed curves

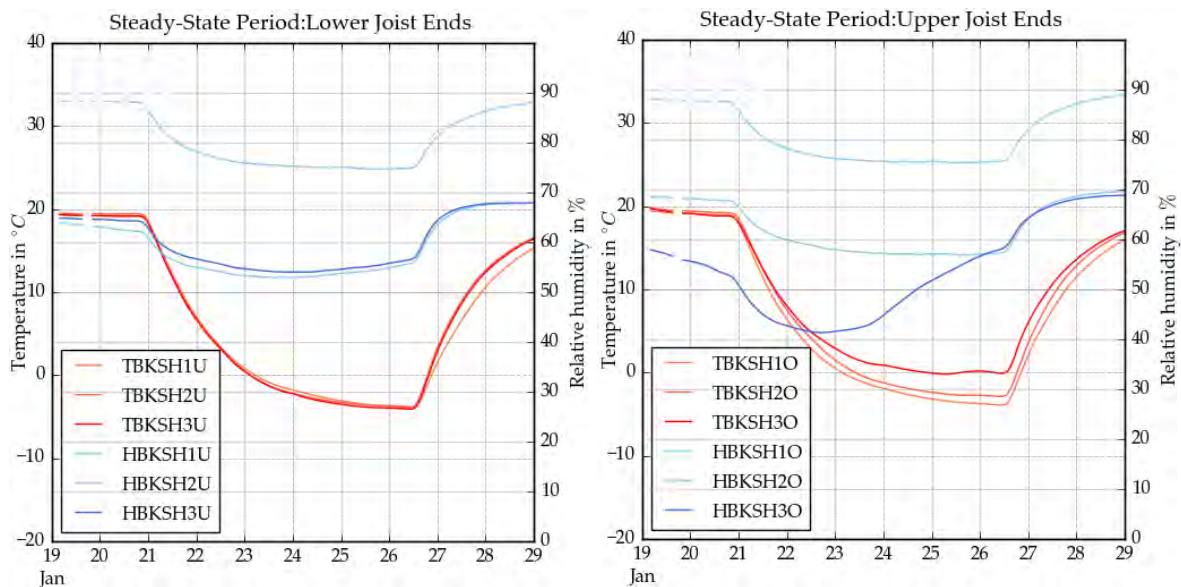
Fig. 28.: Temperature and relative humidity at the joist end front end. Left figure: lower joist ends in the test strips 1 to 3. Right figure: upper joist ends in the test strips 1 to 3.

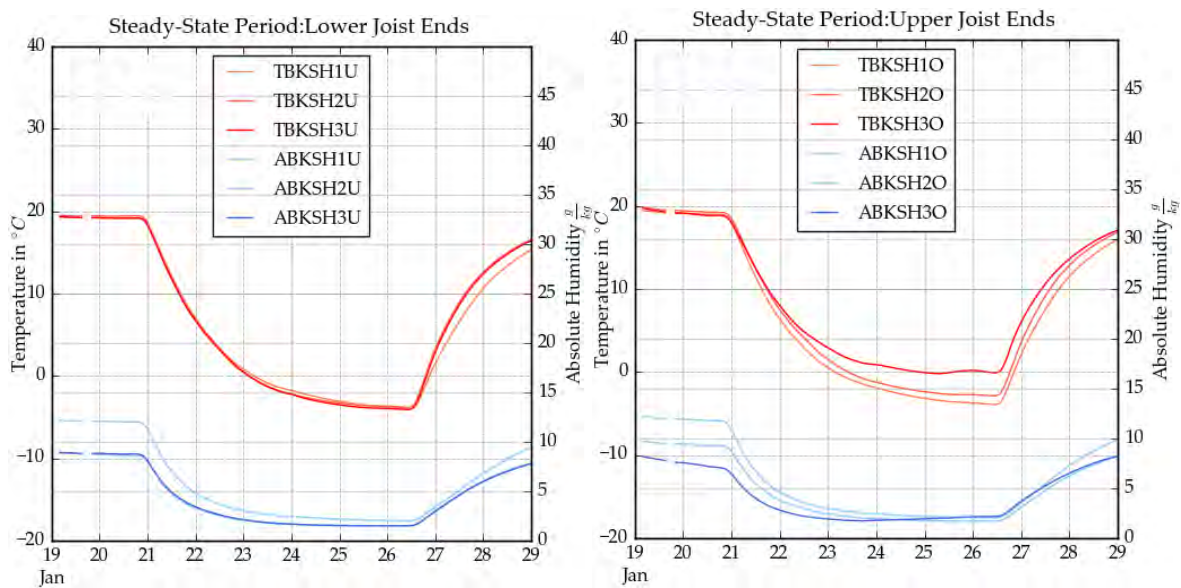
Fig. 29.: Temperature and absolute humidity at the joist end front end. Left figure: lower joist ends in the test strips 1 to 3. Right figure: upper joist ends in the test strips 1 to 3.

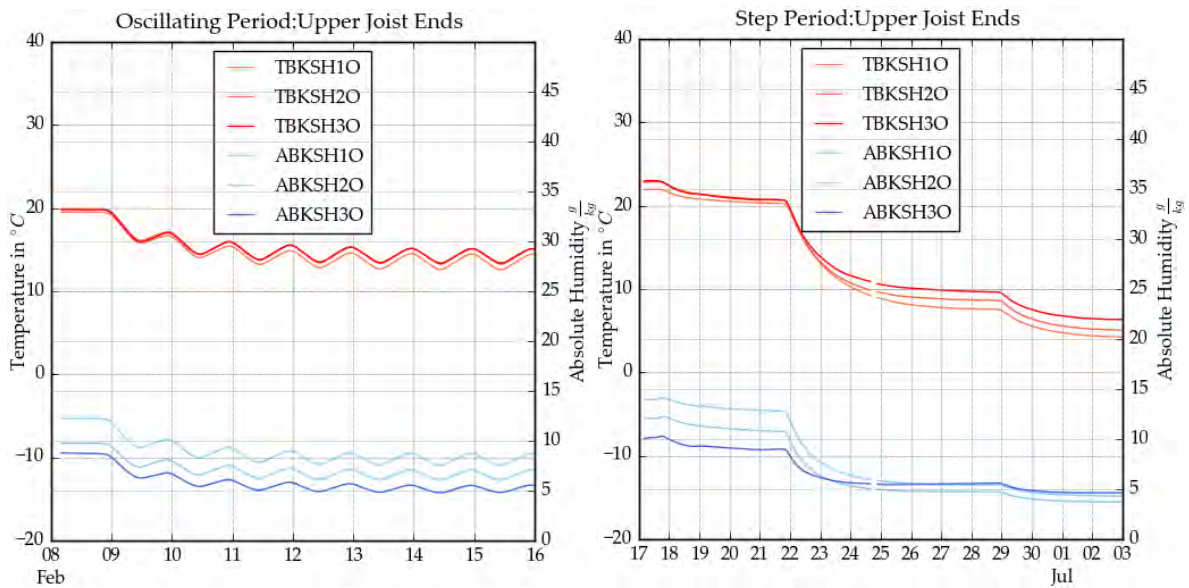
Fig. 30.: Temperature and absolute humidity at the joist end front end for the upper joist ends. Left figure: test period 2 (oscillating period). Right figure: test period 3 (step period).

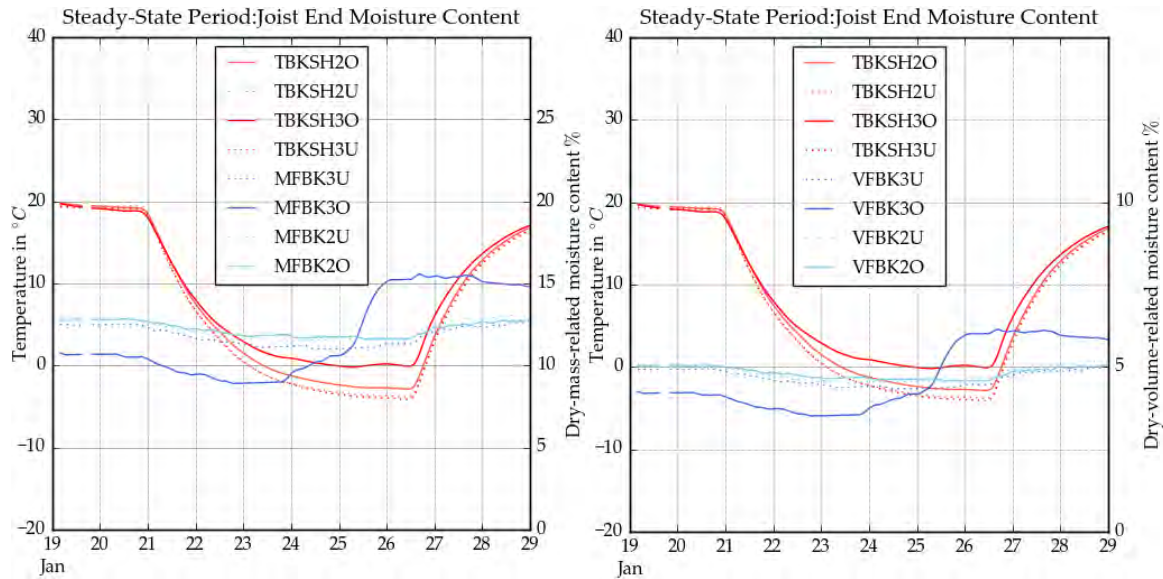
Fig. 32.: Measured wood moisture content (blue curves) and joist end temperature (red curves) for the steady-state period in field 2 and 3 (upper and lower test field) as smoothed curves. Left figure: mass-related water content. Right figure: volume-related water content

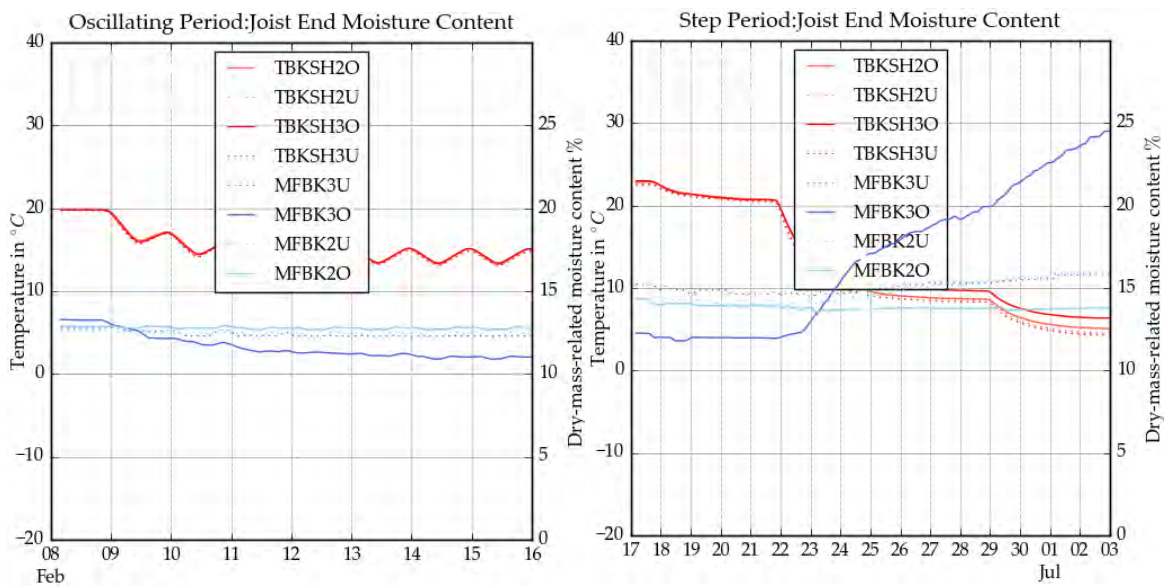
Fig. 33.: Measured wood moisture content (blue curves) and joist end temperature (red curves) for test period 2 (oscillating period) and test period 3 (step period)

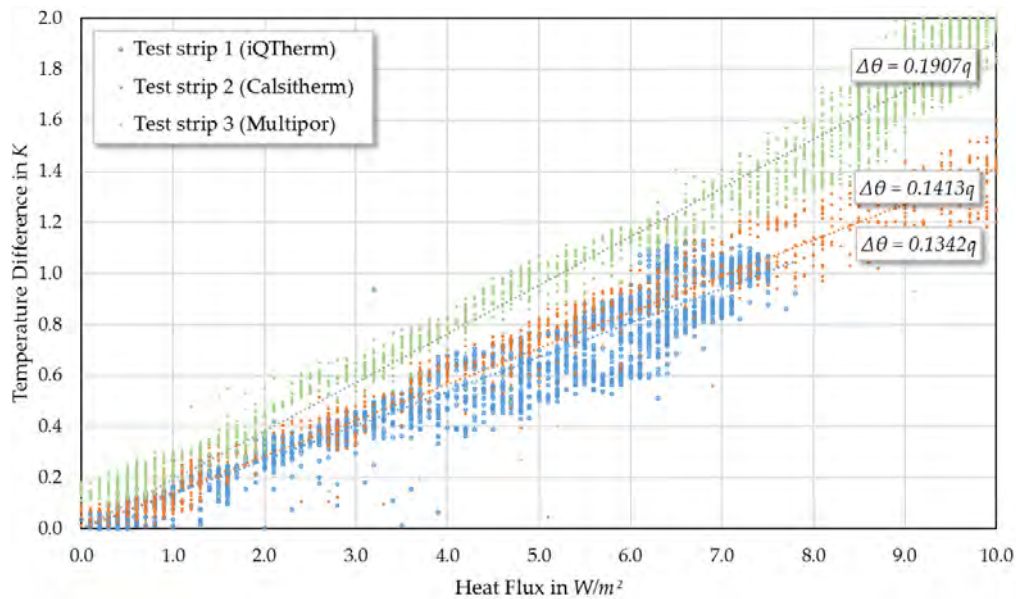
Fig. 34.: Approximation of the measured values with the linear function ending in the root point ($f(0)=0$) in order to identify the function slope resp. surface thermal resistance for the test period 1 (steady-state period in January 2016)

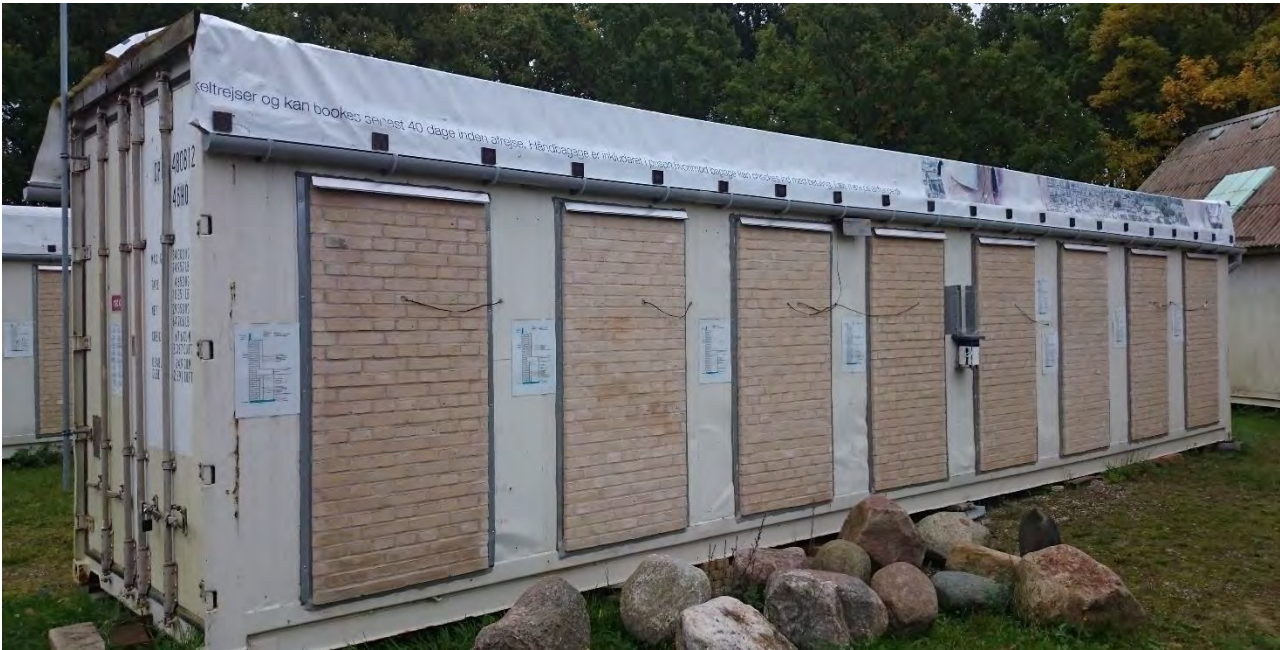
Fig. 50.: External view of the GI container.

The experimental set-up was designed around the use of two 40 feet insulated reefer containers, placed at the test site of the Department of Civil Engineering at the Technical University of Denmark in Kongens Lyngby, Denmark (55.79°N, 12.53°E). The insulated reefer containers have the external measurements of approximately 12.2 m in length, 2.4 m in width and 2.9 m in height, with an internal volume of 67.6 m³. For the experiment, holes of 1 m in width and 2 m in height were cut into the facades of the containers, which would accommodate the single leaf masonry assemblies. The holes were cut with a spacing distance of 0.4 m between the holes. In the first container, denoted as the GI container, 16 holes were cut, 8 facing towards west-southwest and 8 facing towards east-northeast. In the second container, denoted as the Xella container, 8 holes were cut, all facing towards west-southwest.

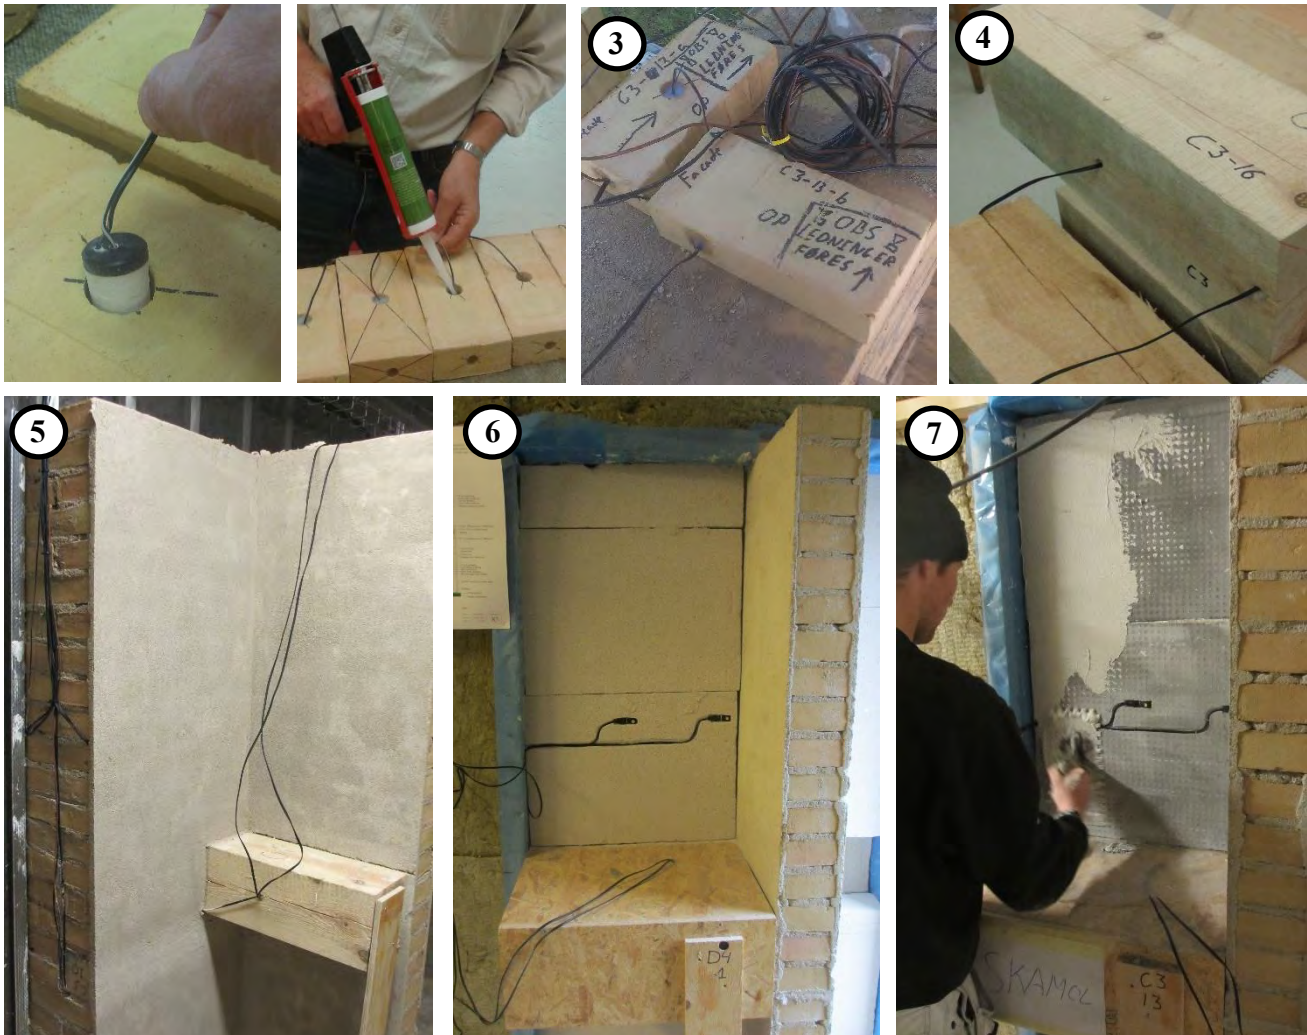
Fig. 59.: *Sensor installation. 1) Sensors installation in masonry brick. 2) Filling cavity around the sensors with silicone. 3) Sensors at location 1 and 2 being installed in the masonry assembly. 4) Sensors at location 6 and 7 in the wooden beam. 5) Reference wall with all the sensors installed. 6) Installation of sensors 4 and 9 in recesses in the Xella Multipor boards. 7) Covering up sensors 4 and 9 in Skamoplus boards with the interior finishing.*

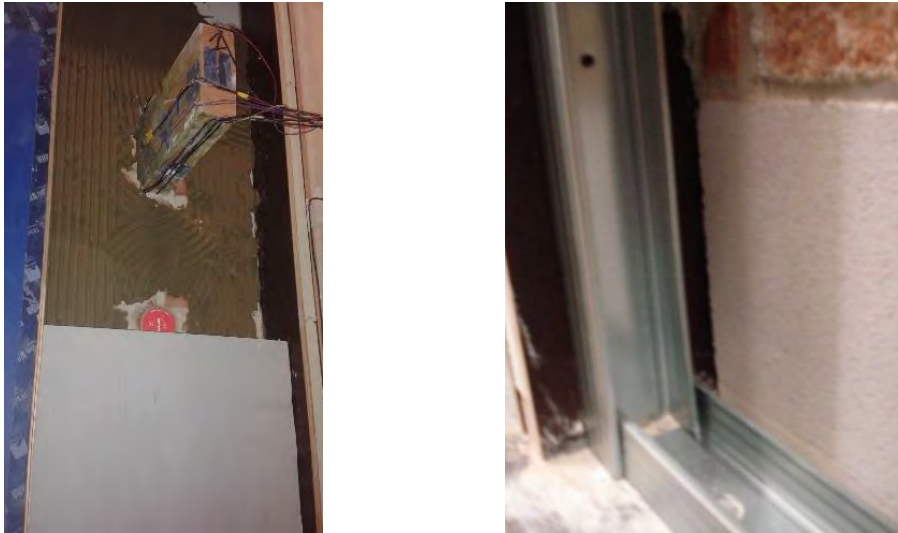
Fig. 86.: *Left: calcium silicate boards fully adhered to the wall. Right: The metal studs in the mineral wool system were positioned 4 cm in front of the masonry wall to avoid thermal bridges.*

A controlled IR-bulb in the middle of the warm chamber creates the desired temperature conditions. Fig. 86.: shows how the IR-bulb is covered with a reflective foil to avoid direct long wave radiation towards the test component. The cold chamber was provided with a liquid-to-air heat exchanger accompanied with a fan system to control and distribute the temperature. The fan system, which can simulate wind effects, allows a steady state air flow along the test wall with velocities between 0.5 - 10 m/s. The humidity in both the warm and cold chamber was conditioned with free evaporation of salt solutions. To create a total air pressure difference across the test section, a small ventilator is installed at

Both the calcium silicate and the EPS insulation were fully adhered to the masonry (see left picture of Fig. 86.:). The metal studs in the mineral wool system were positioned 4 cm in front of the masonry wall (right picture of Fig. 86.:). Two separate layers of mineral wool were applied; one layer of 7.5 cm between the metal studs and another layer of 4 cm between masonry and metal studs. In this way, the thermal bridge effect induced by the metal stud was reduced.
