# ROARING BROOK LAKE MANAGEMENT

Alejandro Reyes, CLM  
Northeast Aquatic Research LLC  
4/10/2021

SPECIFIC RECOMMENDATIONS FOR  
DRAINAGE SITES AROUND  
ROARING BROOK LAKE

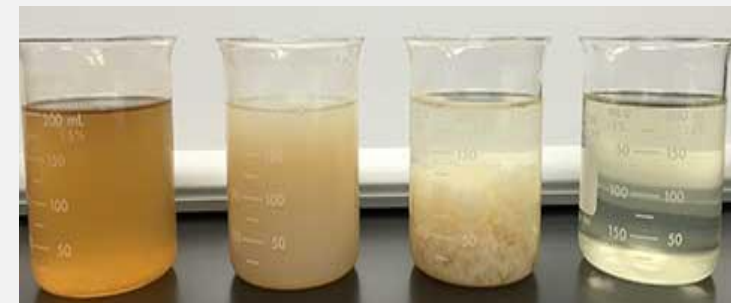
Photo demonstrates flocculation and water clarity process (<http://www.devrkenterprises.com/coagulant-chemicals.htm>)

- What is Alum?
  - Aluminum sulfate + water → aluminum hydroxide + hydrogen ions  
(lowers pH of water, which is why buffering solution needed to stabilize pH)
  - Aluminum hydroxide precipitates as a flocculent material, has a high capacity to bind free phosphate ions
  - Initially used as drinking water treatment technology
  - Also used to reduce phosphorus outputs from wastewater treatment
  - Has been used around the world in lake restoration for 40yrs but better technology and more successful treatments in last 15yrs.

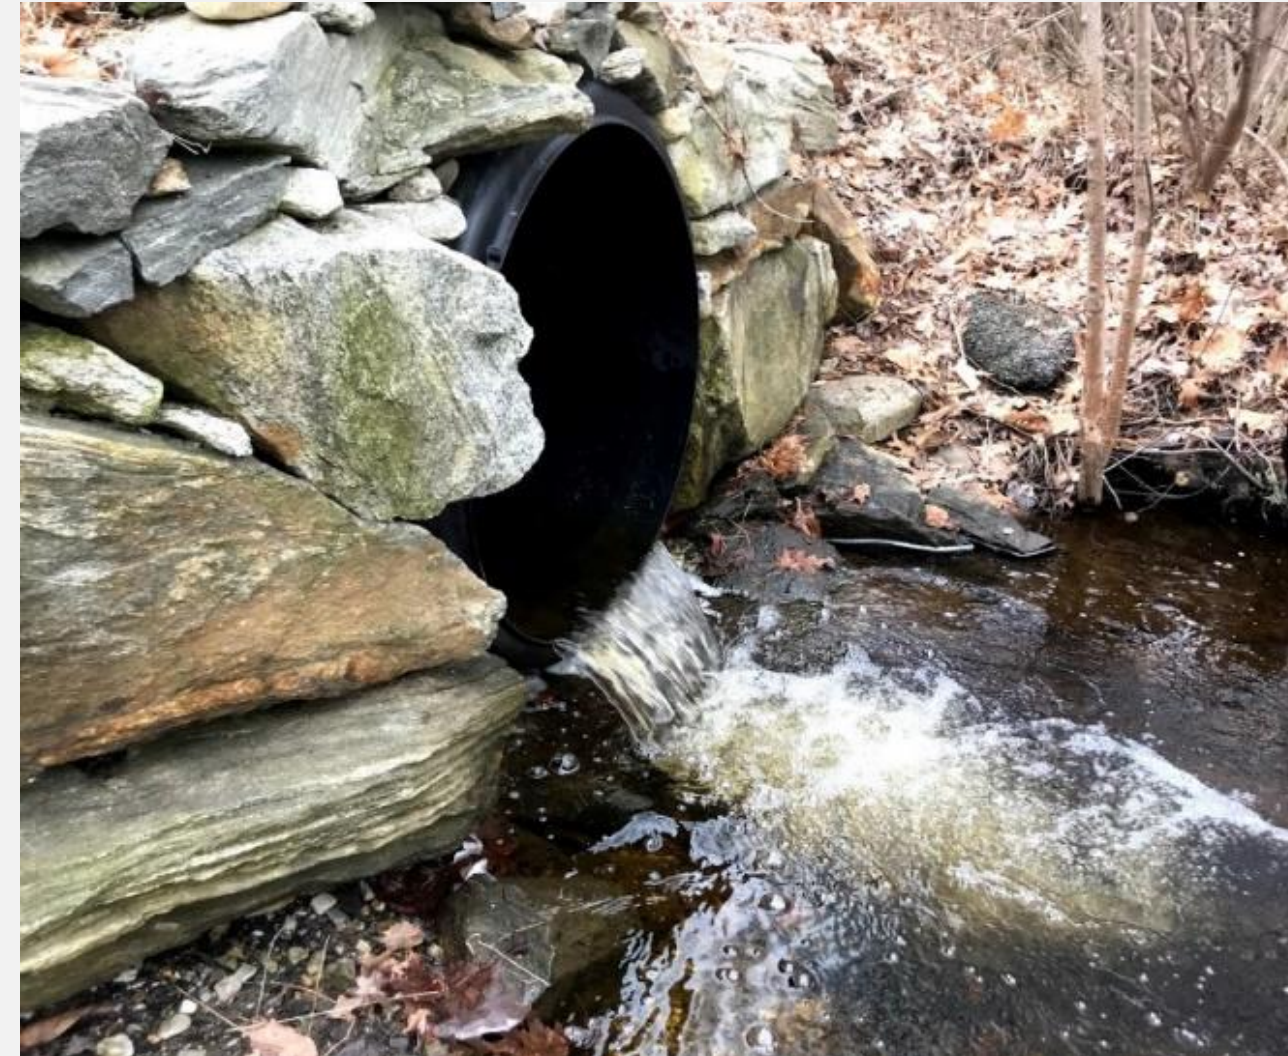
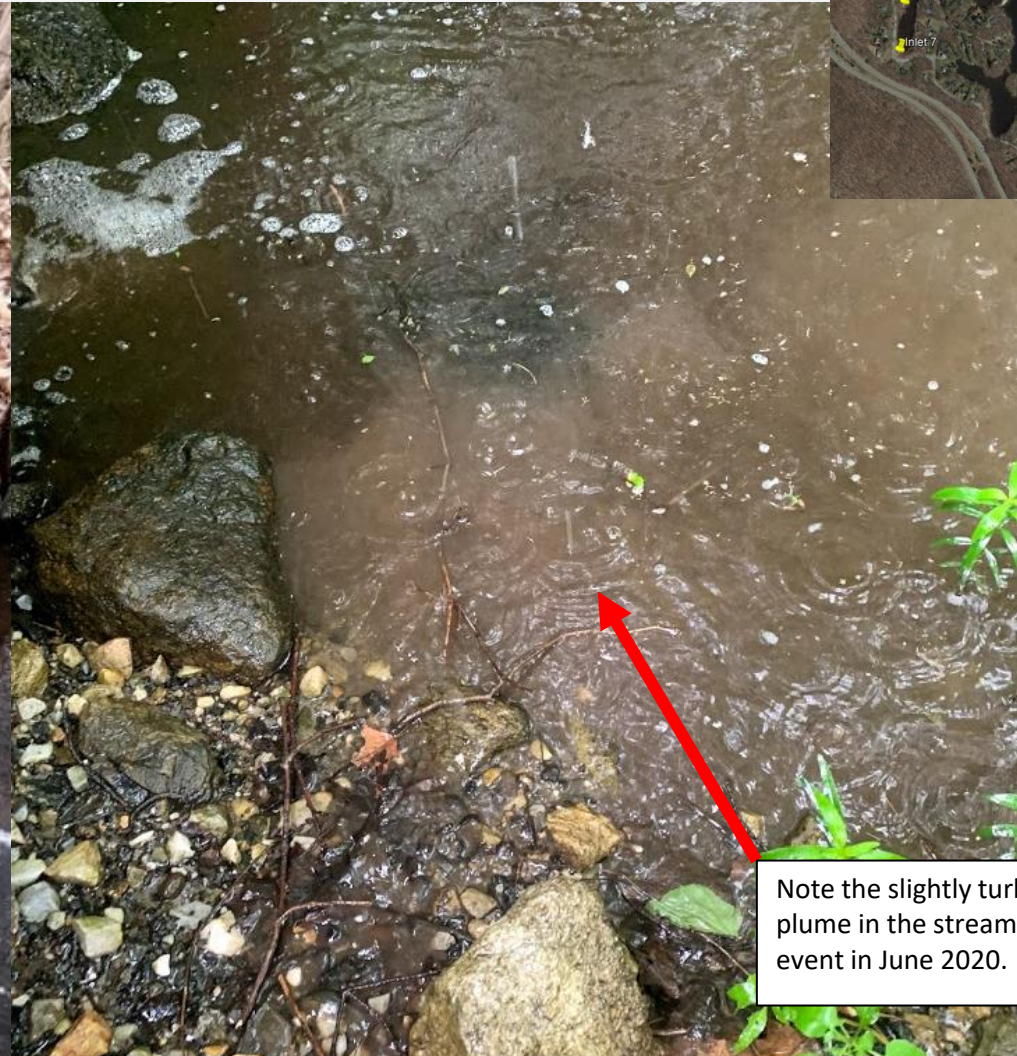
# INLET 1

Note the slightly turbid water plume in the stream during a rain event in June 2020.

**Suggested Action:** Look to mitigate runoff from the north and south sections of lakeshore drive. Take samples north of roaring brook rd. to further pin down sources of pollution.

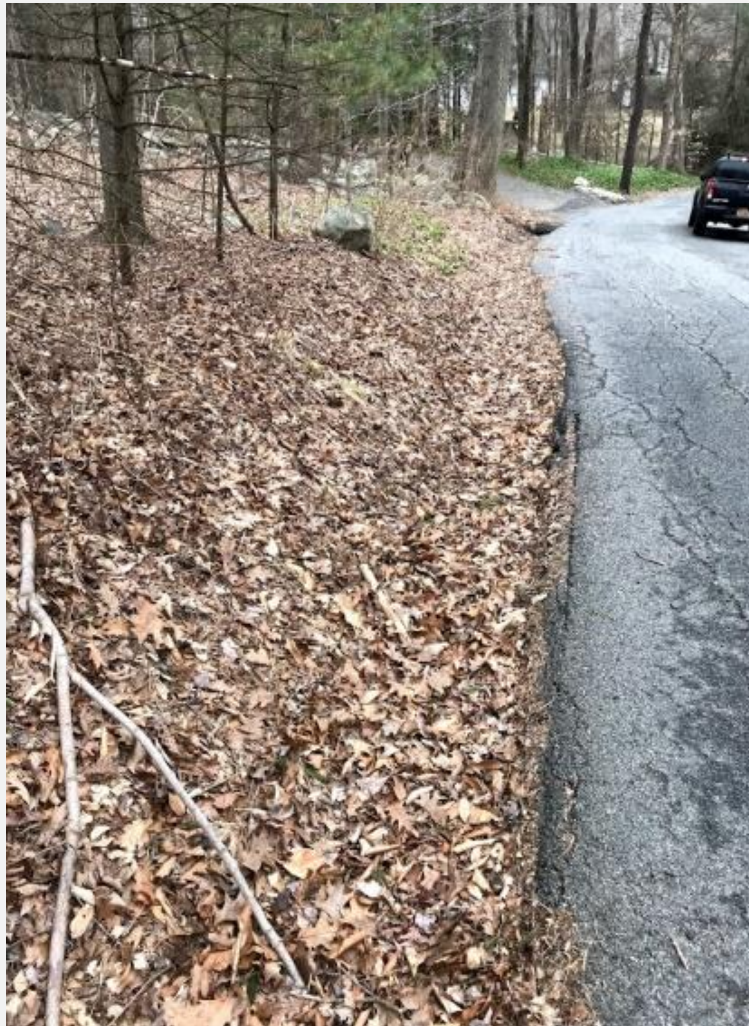
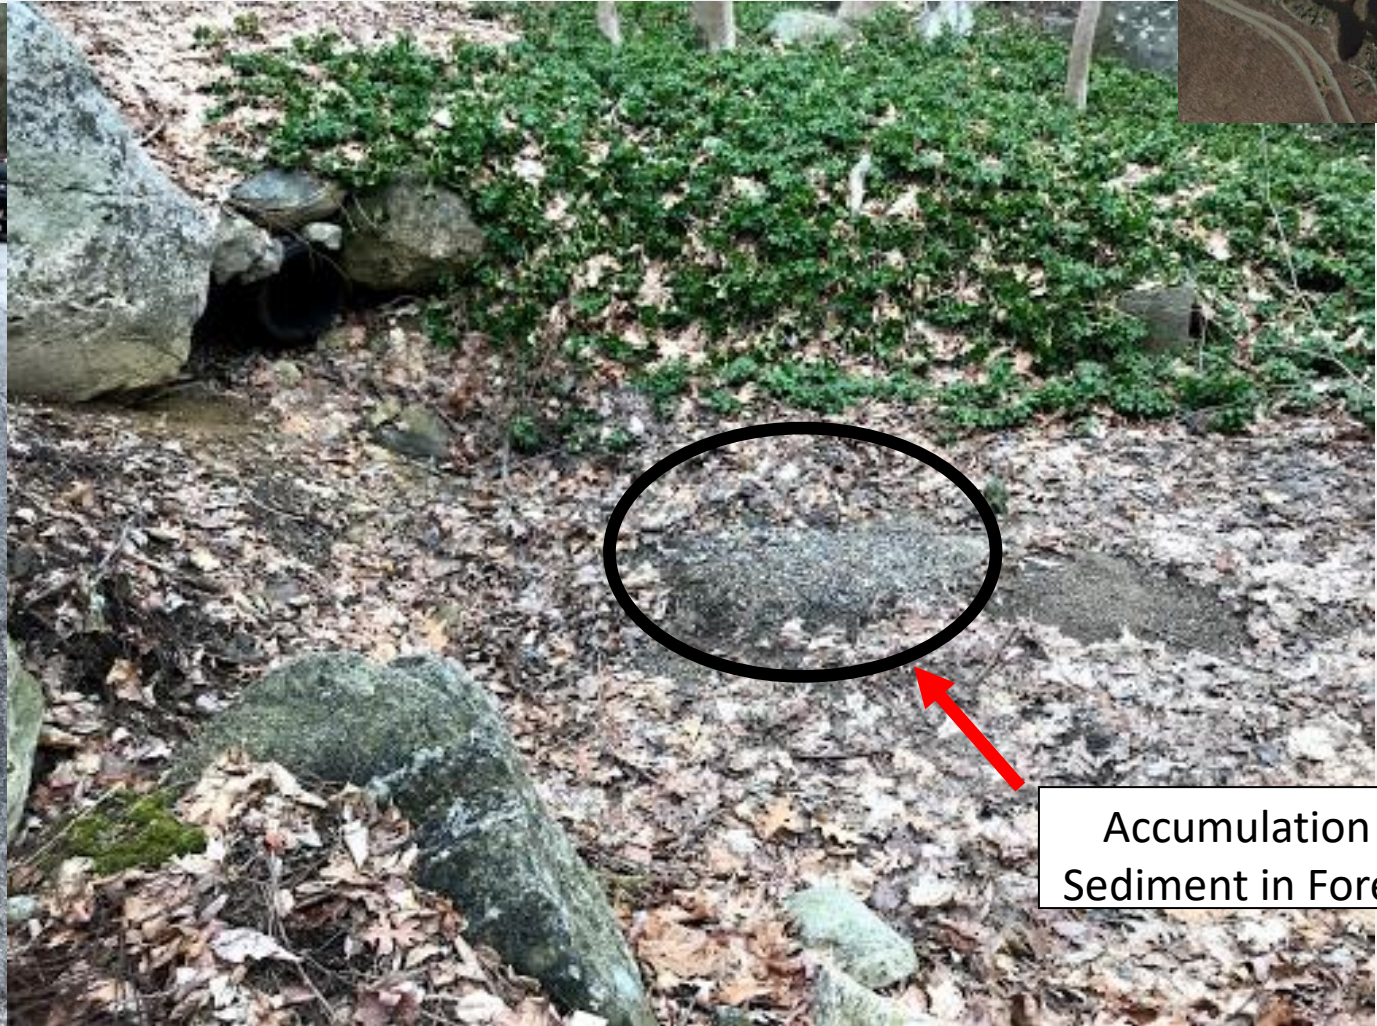
# ALPINE PLACE

**Suggested Action:** The catch basin across the street leads into a small dry detention basin before stormwater flows into the lake. Currently, the basin has a significant amount of sediment buildup that can compromise infiltration. This basin should be cleaned out to increase storage capacity.

Accumulation of  
Sediment in Forebay

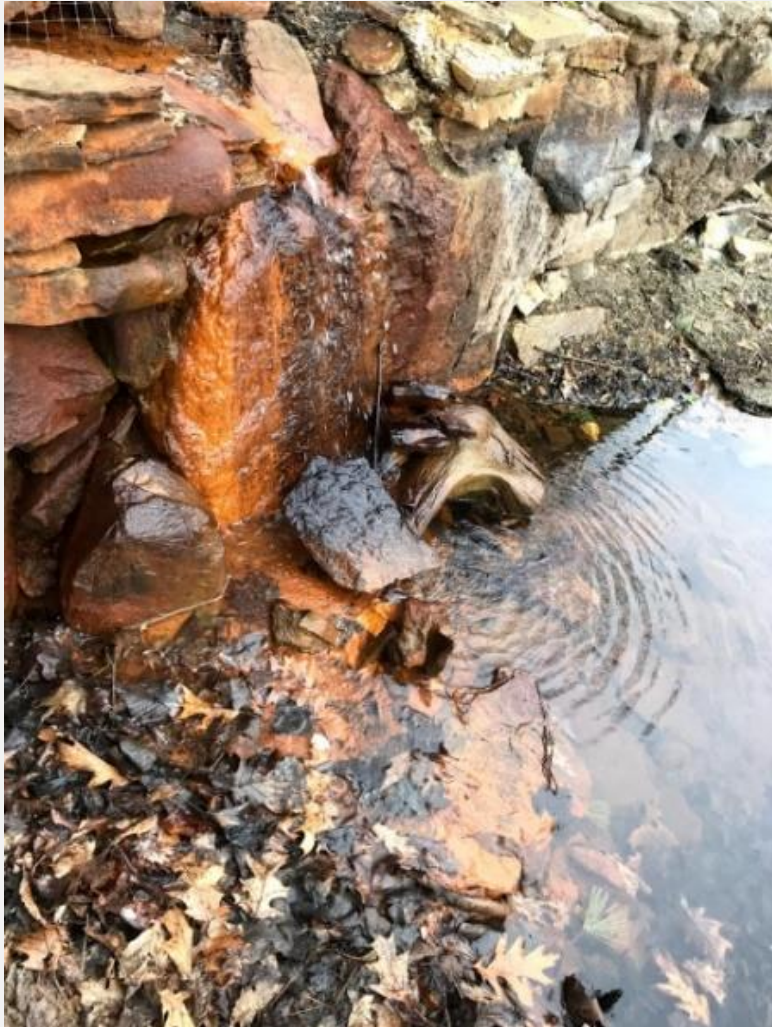
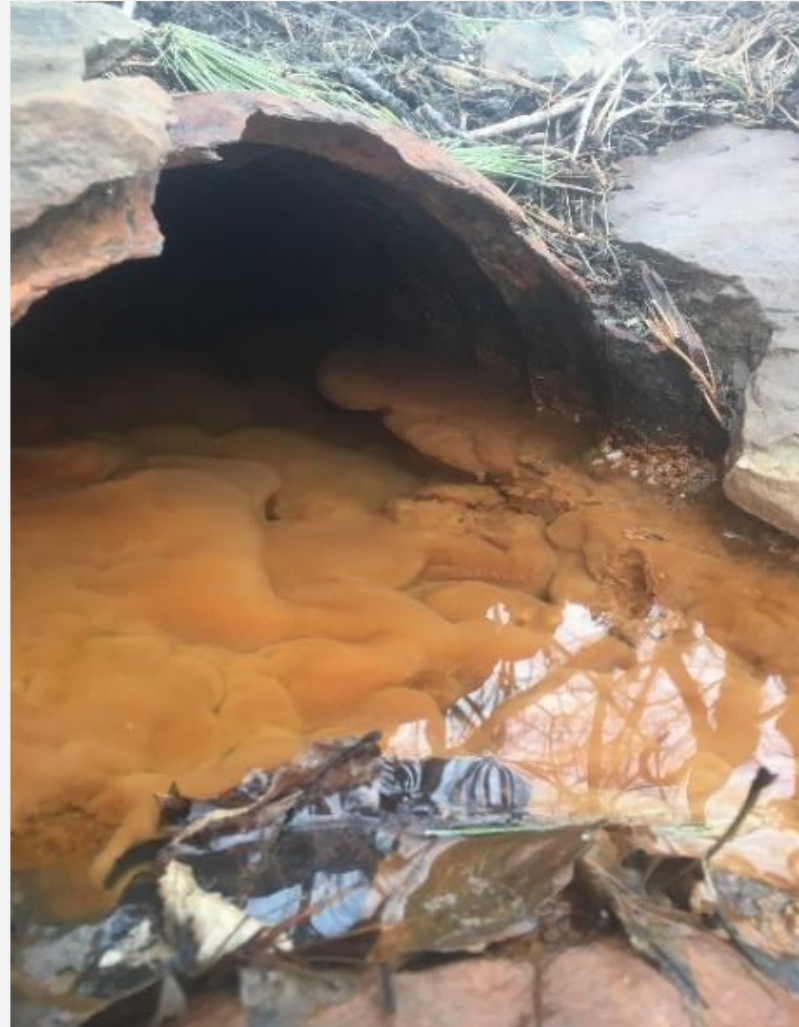
# MOON BEACH

Slightly to the north of moon beach, a pipe with flowing water directly in the lake was discovered with iron flocculant. Most likely this floc is from the pipe corroding over a long period. Water with either high nitrogen or phosphorus concentrations were found flowing out of the pipe on three separate occasions.

**Suggested Actions:** Contact homeowner where pipe is located to discuss possible remediation actions.

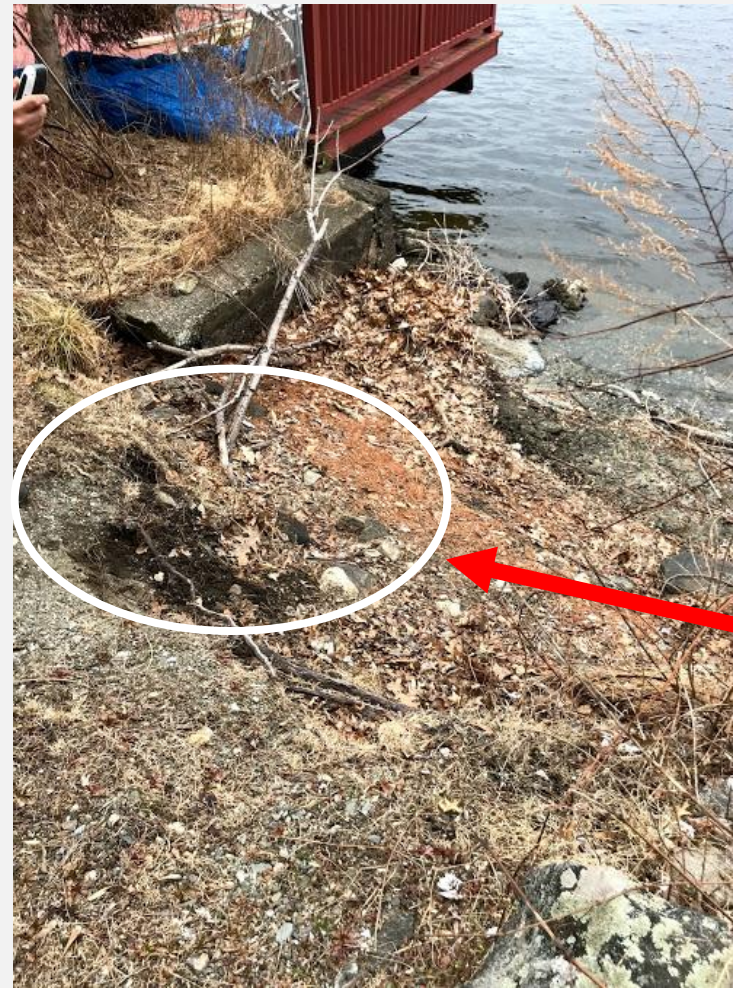
## *District Access at Inlet 2*

The district access at inlet 2 has a bank that is eroding. High water levels and wave action has carved out a part of the bank which will add more sediment into the lake.

The slope of the beach also lends itself to high stormwater flows, especially in early spring, when ground vegetation is not thick and cannot slow down water.

Erosion at bank is accelerating sediment transport into lake.

**Suggested Action:** Repair this erosion by either grading out the slope or putting some sort of retaining wall (stone or earthen) to limit erosion.
