## Beaver River Watershed Assessment

**FINAL**

April 1, 2021

### Town of Richmond, Rhode Island

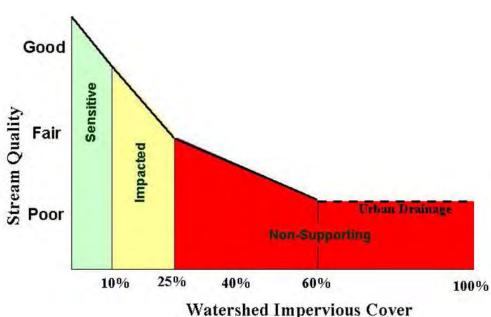
Figure 4. Impervious Cover Model predicting relationship between watershed impervious cover and stream quality (Schueler, 1994).

Impervious cover refers to any land surface that prevents water from soaking into the ground, and instead, creates "runoff" that flows downhill when it rains, warming up and collecting dirt and other pollutants as it goes. It includes many forms of developed surfaces such as parking lots, driveways, roads, and rooftops. Research has shown that the level of impervious cover in a watershed can be a good indicator of small (1st, 2nd, or 3rd-order) stream quality (Schueler, 1994). High impervious cover often indicates low forest cover, leading to impacts such as less habitat, warmer stream temperatures, and less groundwater recharge, to name a few. Impervious surfaces also create more turbid, polluted runoff with higher flows during storm events than forest soils and other pervious surfaces where rainfall can soak into the ground. Increased flows then lead to streambank erosion, channel incision, tree falls and loss or degradation of riparian habitat. This inverse relationship between impervious cover and stream quality, referred to as the Impervious Cover Model, predicts an important threshold at 10% impervious cover, above which the associated stream quality is impacted (Figure 4).

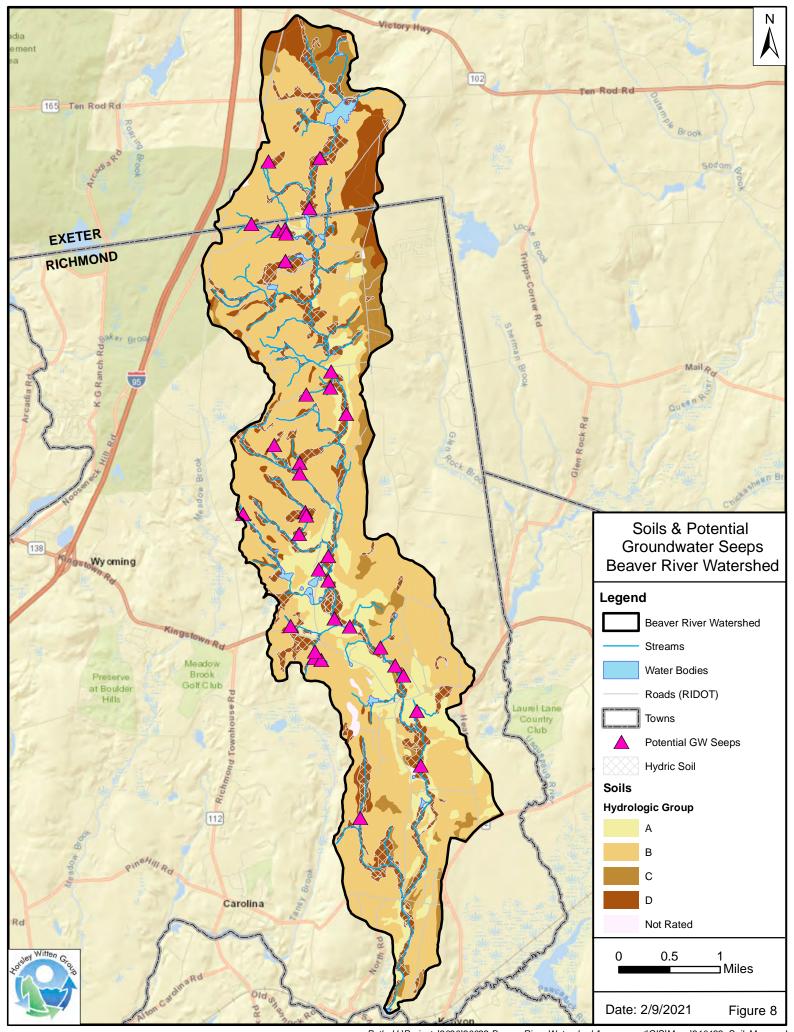
Path: H:\Projects\2020\20022 Beaver River Watershed Assessment\GISWaps\210122\_SoilsMap.mxd

In the Beaver River Watershed, the soils range from loamy fine sands to mucky peats, many that are very to extremely rocky. **Table 4** provides a summary of soils in each subwatershed, broken down by HSG per the NRCS "Soil Survey of Washington County ("South County"), Rhode Island," and **Figure 8** shows the spatial distribution of each HSG and hydric soils. A majority of the soils are HSG B (61%), with HSG A soils mostly along the river corridor.

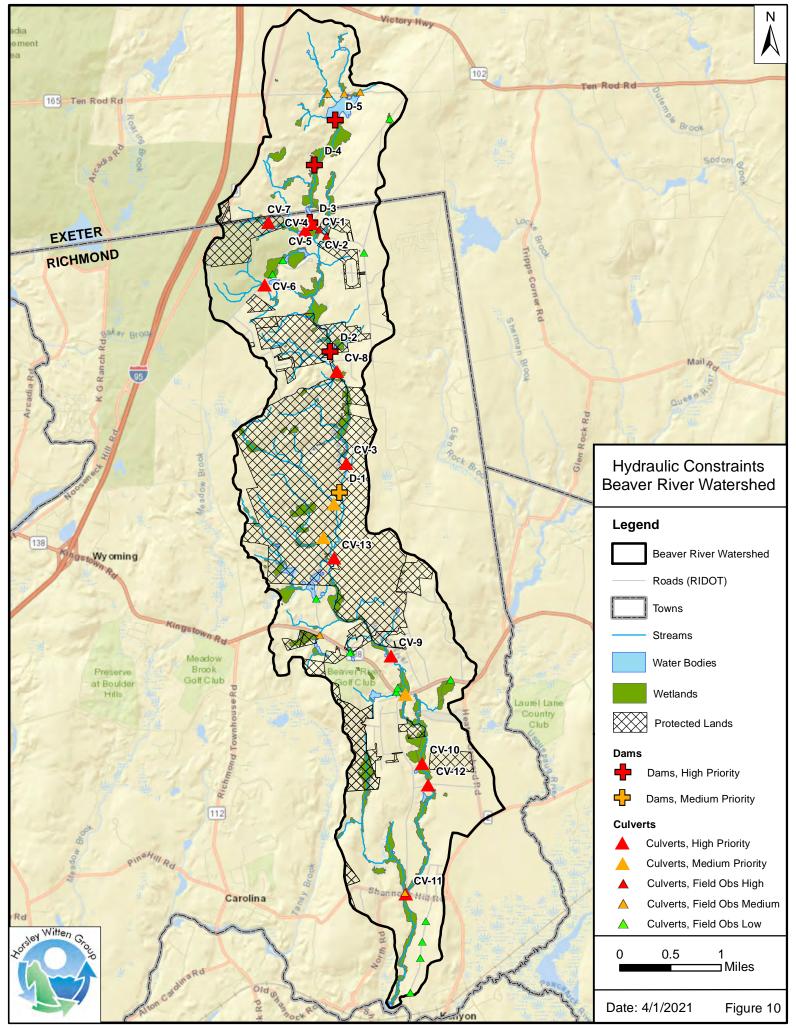
Path: H:\Projects\2020\20022 Beaver River Watershed Assessment\GIS\Maps\210124\_HydraulicConstraints.mxd

Beaver River Watershed currently has a number of hydraulic constraints, historical, modern, and even natural in the form of old mill dams, undersized culverts, and beaver dams. While a complete survey of the stream channel was not performed as a part of this work, many of these hydraulic constraints have been mapped and analyzed by previous work (Fuss & O'Neill, 2017) and most locations were observed/confirmed by our fieldwork. Additional dams and culverts observed in the field are indicated ("Field Obs") along with those from previous work on **Figure 10** below and dams in **Table 6**.

This previous study did assess many of the culverts in the watershed; however, during our field reconnaissance, additional culverts were observed. For the most part, these were just recorded to identify hydrologic connections. However, in a few cases, critical culverts with obvious impacts were observed (eg., crushed ends, filled with sediment/debris, etc.); since these were not part of the previous study, additional fieldwork and analysis may be needed to confirm conditions and preliminary ranking. In particular, culverts on Tug Hollow Pond Road, in addition to beaver activity, have a large impoundment<sup>4</sup> on a tributary where high temperatures were recorded on an otherwise very cold stream. While not part of the secondary dataset, stream habitat, connectivity, and water quality would benefit from addressing these culverts as well.

Two dams were identified and ranked in the Flood Resiliency Management Plan (Fuss & O'Neill, 2017): D-1 and D-3. The dams were ranked based on a detailed analysis of a variety of factors such as conditions, capacity, hazard rating, impact on aquatic organisms, etc. Then, management recommendations were provided to either remove/breach the dam, repair, repurpose, add an aquatic organism structure, or no action. Both dams assessed were recommended for dam removal - see **Appendix F** for the original dam field sheets from the Fuss & O'Neill study. Three additional dams were identified during this project during field observations. These dams were also near temperature loggers and all showed warming impacts from their impoundments.

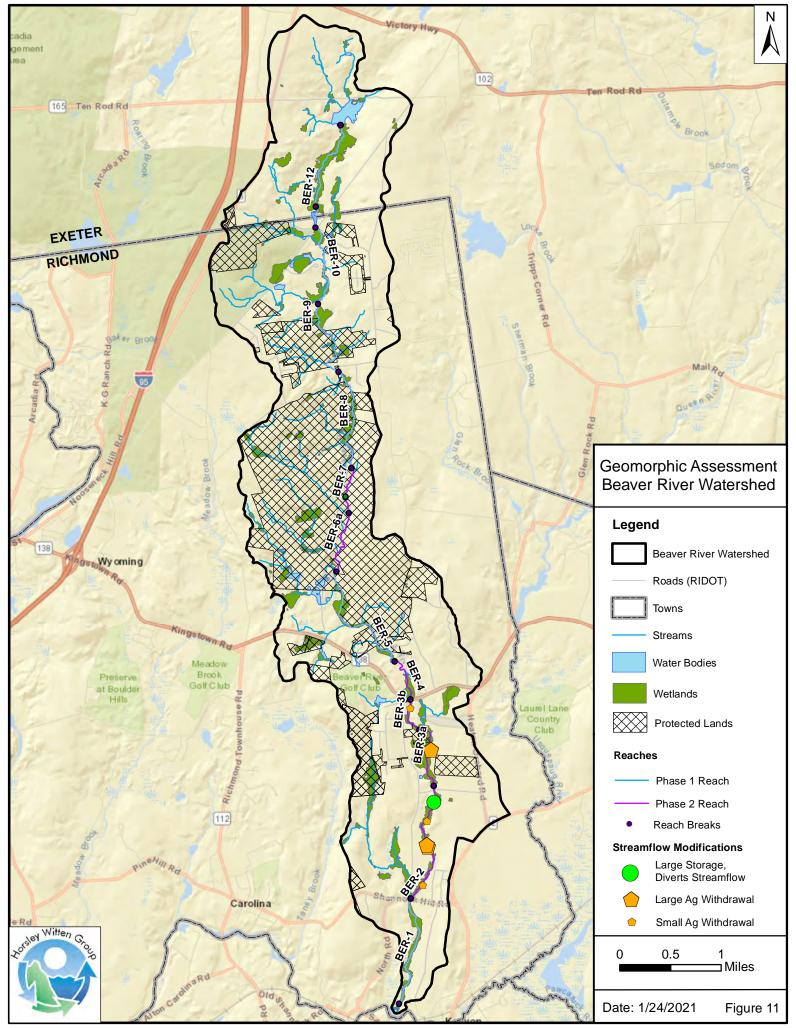
Path: H:\Projects\2020\20022 Beaver River Watershed Assessment\GISWaps\210124\_Geomorphology.mxd

The reaches are shown on **Figure 11**; a Phase 1 or desktop assessment was performed on Reaches 1-12, while a Phase 2 or field assessment was performed only on Reaches 2-4 and 6-7. Phase 2 reaches were chosen as the highest priority focus areas based on results from the Phase 1 assessment. Data on a range of geomorphic features were collected, including meanders, scour pools, eroding stream banks, areas of channel straightening, stream flow withdrawals, encroachment, to name a few. Management recommendations for these reaches include: restore straightened or incised channel, replant encroached buffers, add large woody debris (LWD) to add habitat complexity, and remove water withdrawals. See **Table 7** for a summary of the major recommendations for the focus reaches and **Appendix F** for the original field sheets from the Fuss & O'Neill study. This geomorphic data should be cross-referenced as watershed restoration opportunities are pursued to address not only the main project (e.g., dam removal or culvert replacement) but also nearby issues such as streambank erosion.

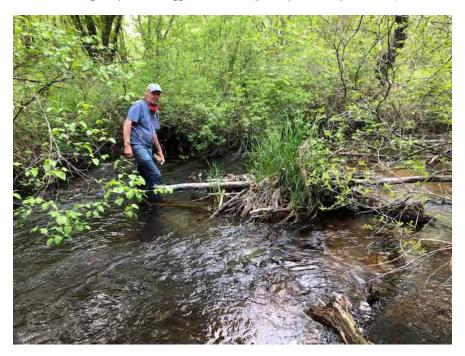
Volunteer during temperature logger installation (photo provided by Jim Turek).

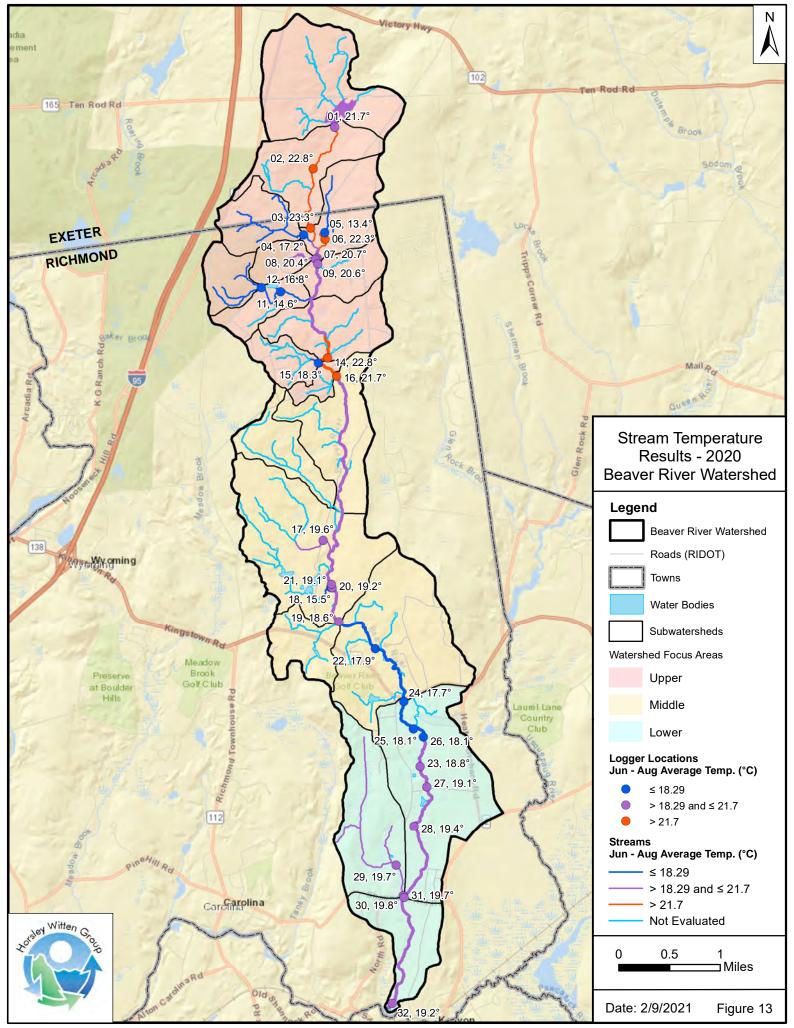
The data and analysis provided by RIDEM Fish & Wildlife staff focused on the stream temperature averages for the typical warm season period (June – August) (**Table 10**). This data was used to create **Figure 13**, showing the logger results color-coded for the three key temperature thresholds for brook trout (cold - <18.3 C, cool – between 18.3 C up to and including 21.7C, and warm - >21.7C). These results were applied to the surrounding stream segments and/or impoundments using best professional judgment based on direction of flow. Stream segments where a temperature class could not be applied with great confidence are indicated separately.

This temperature dataset creates a much more detailed picture of conditions in the Beaver River system than earlier efforts. In a mostly wooded, undeveloped watershed, there are surprisingly several locations where "warm" measurements were recorded. However, while this analysis is effective for comparing relative stream temperatures from many logger locations measured in the same season, these data are just a snapshot of one particular year. Summer 2020 was hotter and drier than usual. In fact, at the end of September 2020, 99% of Rhode Island was in extreme drought and the U.S. Drought Monitor called the week of Sept. 29 "the most intense period of drought" for Rhode Island since 2000, when the Drought Monitor was started. Even so, the relative temperatures do provide an indication of where the warmest waters are and additional insight into their potential causes. A detailed discussion of the results is included below by watershed focus area.

From Figure 13, you can see that right from the first logger location at James Pond, an impoundment from a manmade dam, water temperatures were right at the threshold between "cool" and "warm." Between the pond and the next dam (TL 2), temperatures warmed to 22.8 C, and warmed again at the next dam (TL 3, Tug Hollow Dam) to the highest average measured, 23.3 C. On a nearby tributary, an impoundment created by damaged and undersized culverts as well as beaver activity also shows high water temperatures (TL 6, average 22.3 C), particularly when compared to the coldest water measured in the watershed (TL 5, average 13.4 C) just upgradient of the impoundment. A small tributary to the northwest of New London Turnpike brings coldwater into the system (TL 4, average 17.2 C), which helps to bring the Beaver River water temperature down to "cool" at TL 7 (average 20.7 C). A small tributary brings in warm water at TL 8 (average 20.4 C) from a large wetland, keeping the main stem cool at TL 9 (average 20.6 C). The next logger locations were placed on a tributary to the west of the main stem, both upstream and downstream of the crossing at New London Turnpike. "Cold" water was measured at both locations (TL 11 – average 14.6 C and TL 12 – average 16.8). TL 10 was eliminated as not needed, and TL 13 was missing in the fall, most likely due to beaver activity. The next logger was just downstream of a large impoundment created by an old stone dam with additional beaver activity, TL 14. The stream temperature at this location is "warm," at an average 22.8 C. TL 15 collected water temperature data from a tributary flowing through the TNC's Beaver River Preserve, which showed an average temperature right at the "cold" threshold, 18.3 C.

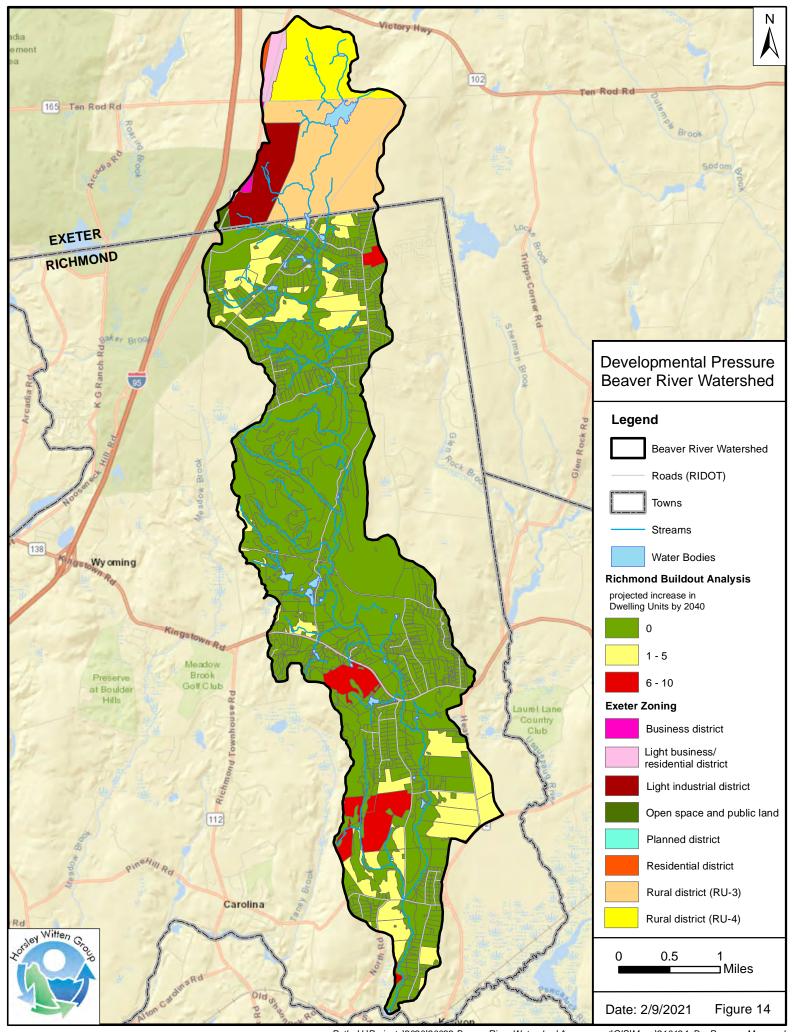
In the Beaver River Watershed, 40 parcels in Richmond were identified to gain 1 to 10 additional dwelling units by the year 2040. These locations where development pressure is expected are shown on **Figure 14** below, separated by those parcels with lighter pressure (1-5 additional units) and those with greater pressure (6-10 additional units). The only change to the buildout analysis data for this project was to remove the recently RRPLT-acquired land from the lighter pressure category, as it is no longer facing further development. Not surprisingly, the majority of parcels with development pressure are located in the Upper and Lower Watersheds, given that much of the Middle Watershed is protected. In particular, the parcels with greater pressure are concentrated in the Lower Watershed.

For the portion of the watershed located in the Town of Exeter, no buildout data were available for this project. However, Exeter's zoning data are shown on **Figure 14** to indicate the type of possible future development.

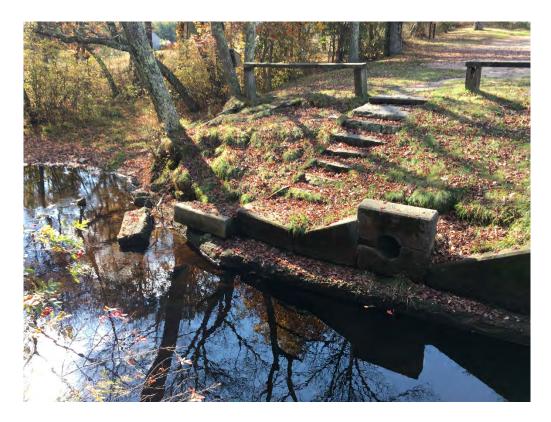
#### **Beaver River Fishing Access (RIDEM)**

Opportunities for stormwater management, erosion control, bank restoration and buffer enhancement were observed along this section of Beaver River where fishing activities and access to the river have resulted in complete removal of shrubs and trees. Sedimentation from the unpaved parking lot has migrated along the banks and into the river. This location is a great opportunity to work with RIDEM to address these issues as well as provide public education about the importance of Beaver River and its watershed.

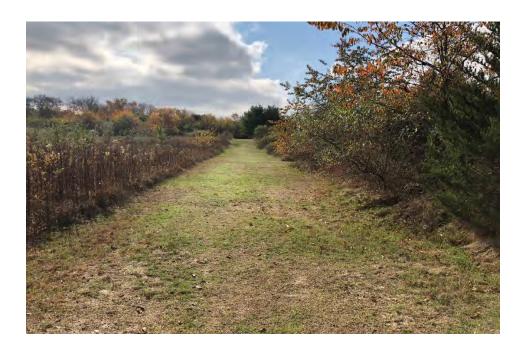
#### **Beaver River Park & Playground**

Located east of Beaver River Road between the intersections of Anthony Drive and Rocky Way, the Beaver River Park & Playground has wide open trails with points of interest overlooking the Beaver River and its associated wetland communities. Unfortunately, the trail edges have become overgrown with non-native invasive species such as autumn olive (*Elaeagnus umbellata*) and multiflora rose (*Rosa multiflora*) with dense entanglements of Asiatic bittersweet (*Celastrus orbiculatus*), as well as lesser amounts of shrub honeysuckle (*Lonicera* sp.) and European buckthorn (*Frangula alnus*) which have begun to colonize along interior trails traversing wetland areas. The proximity of non-native fruit-bearing shrubs to the river creates the potential for downstream spread of invasives to otherwise pristine freshwater wetland communities. The centrally located fields have become overgrown with invasive shrubs and weedy herbaceous vegetation. In addition, direct access to the river is open and nearly devoid of woody vegetation and subject to erosion and further spread of invasive species downstream.

Opportunities to restore wetland buffers, improve habitat for local wildlife, and public education regarding invasive species are numerous at this location. The wide trails allow for easy access to problem areas. These efforts would be intensive and on-going for many years. It may be productive to first manage a test plot, removing non-native species and revegetating with native species to help refine the long-term management plan.

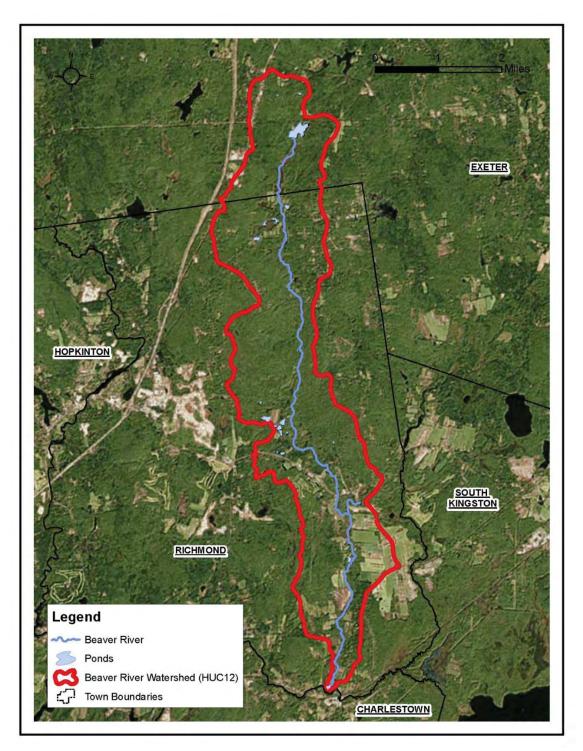
Figure 2. Map of the Beaver River Watershed Assessment Study Area.

The Beaver River watershed, an approximately 12-square mile area situated almost entirely within the limits of Richmond, a suburban-rural community in Washington County ("South County"), Rhode Island. Approximately 15 % of the watershed area is located in the Town of Exeter, RI and 85% is located in the Town of Richmond, RI (Figure 2). The 11-mile long Beaver River is one of 8 tributaries of the Wood-Pawcatuck River watershed that was recently designated as part of the Wild and Scenic River system.

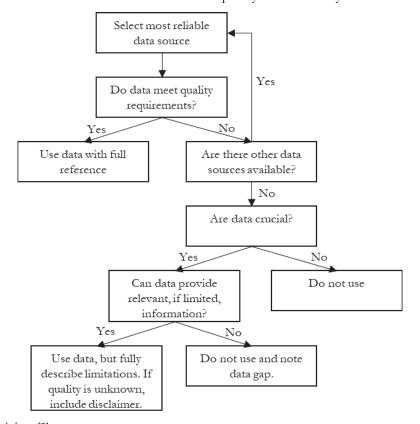
The following decision tree will be used to assess the quality of secondary data:

Figure 3. Data Decision Tree

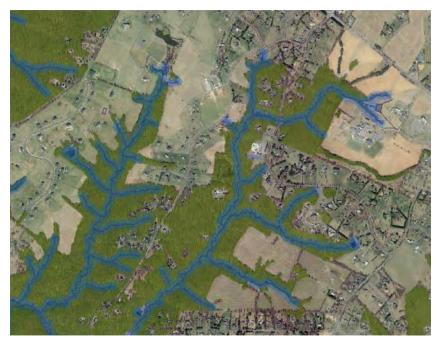
Figure 3-2 Example of Vegetated Riparian Buffers.

The green area in the figure represents the vegetated riparian buffer and the shaded blue area indicates a buffer zone of 100 feet on either side of the stream. (HW graphic)

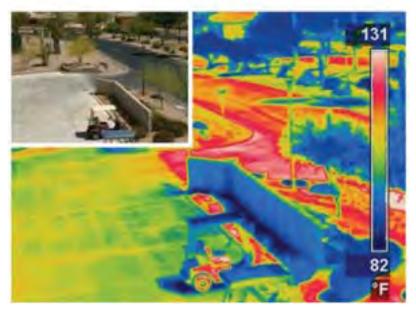
Figure 3-3 Thermal Imaging of Pavement.

This infrared imagery shows how hot the surface of impervious cover can get, creating a situation where any subsequent stormwater runoff will have dramatic temperature impacts on adjacent streams. (Kaloush, Kamil; Pavements and the Urban Heat Island Effect)

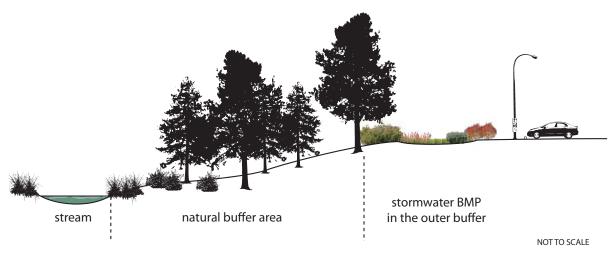
Another potentially acceptable use within the buffer is for stormwater treatment; however, it is important to note that small scale LID practices located upgradient of buffer areas are preferable. Stormwater Best Management Practices (BMPs) should not be used in buffers where they significantly compromise the buffer's existing functions, and should only be used when no practical alternative exists. The outer portion of buffers can be utilized for stormwater management facilities, as long as sites are chosen carefully, located outside of State jurisdictional areas, and clearing of vegetation is minimized. One potentially effective way to use the edge of the buffer areas is to disperse channelized stormwater flow, which can be accomplished with small amounts of grading. Stormwater facilities should be designed with LID techniques and use the natural topography and undulating features that incorporate existing trees. See the RI Stormwater Manual for more information on how to properly design stormwater treatment practices.

Figure 3-4 Example of Stormwater BMP in the Outer Buffer Zone.

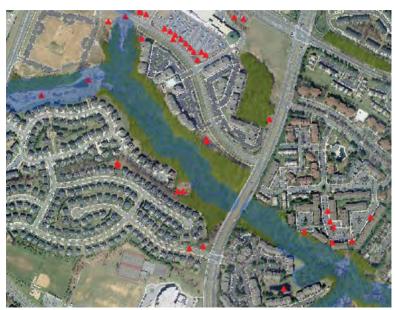
Figure 3-5 Locations of Stormwater BMPs Relative to Stream Buffers.

The red triangles in the graphic below represent the location of stormwater BMPs. Some of these have been effectively implemented in the very outer edge of the vegetated buffer (green area) along the riparian corridor in Montgomery County, MD. The shaded blue area indicates a buffer zone of 100 feet on either side of the stream as a reference.

The red triangles represent stormwater BMPs; the green area represents the vegetated riparian buffer; and the shaded blue area indicates a buffer zone of 100 feet on either side of the stream as a reference. (HW graphic)

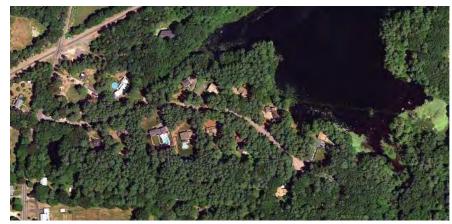
Figure 3-6 Typical Subdivision Design Impacting Wetlands.

Uniform requirements for lot size and setbacks cause subdivisions like the one in this aerial photo to consume far more land than necessary. This subdivision has encroached into wetland and pond buffer areas causing visible signs of eutrophication as indicated by the light green algal bloom. (Google Maps)

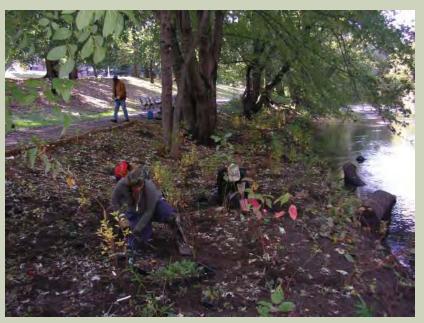
Figure 3-8 Buffer Zone Planting.

Careful placement and installation of native vegetation is required for restoring buffer areas that were cleared. (HW photo)

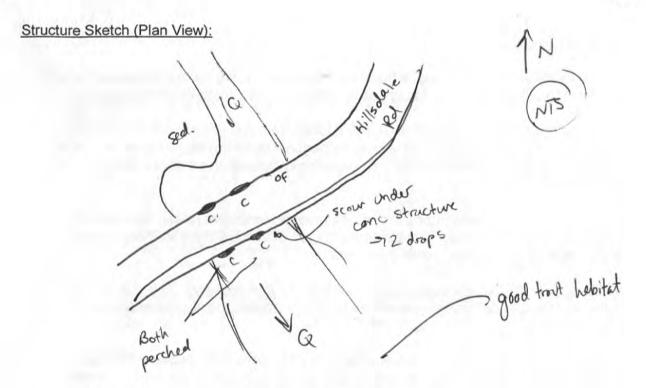
<u>Upstream Channel Cross Section Sketch (including horizontal measurements of top and bottom widths of upstream channel):</u>

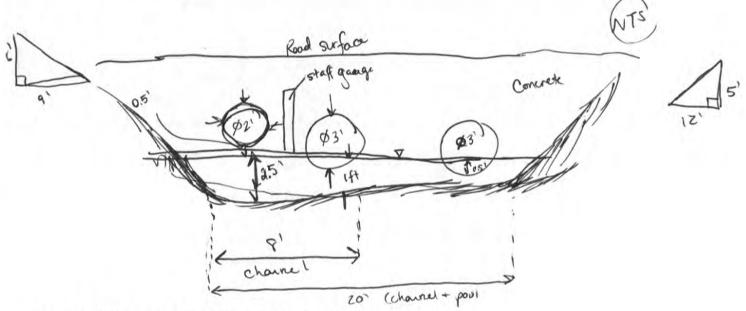
Height from Structure Upstream Invert to Roadway:

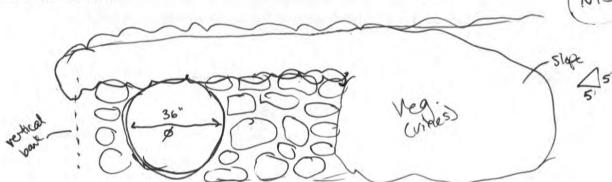
Upstream Channel Cross Section Sketch (including horizontal measurements of top and bottom widths of upstream channel):

U/S 9,47'

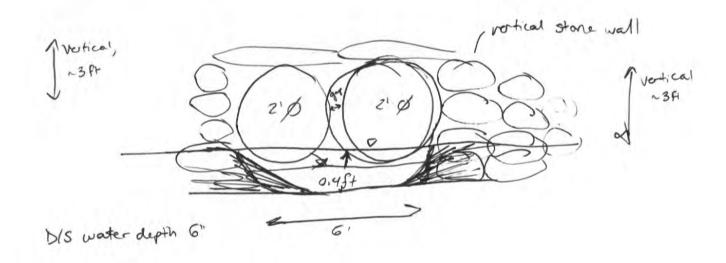
Upstream Channel Cross Section Sketch (including horizontal measurements of top and bottom widths of upstream channel):

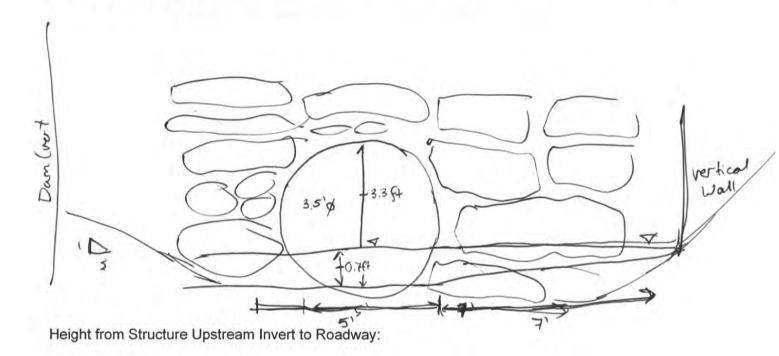
<u>Upstream Channel Cross Section Sketch (including horizontal measurements of top and bottom widths of upstream channel):</u>

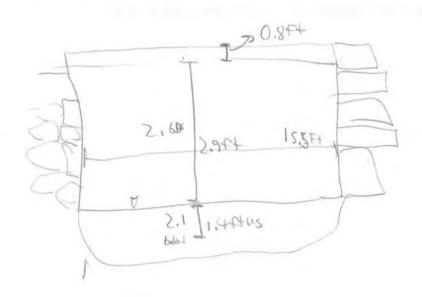
# <u>Upstream Channel Cross Section Sketch (including horizontal measurements of top and bottom widths of upstream channel):</u>

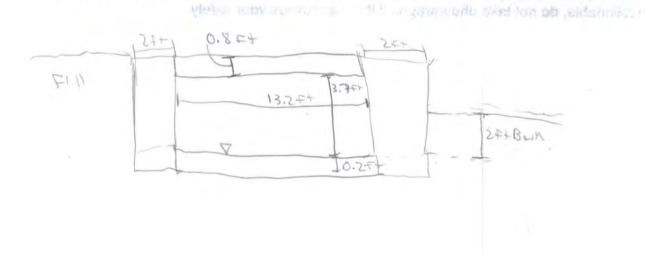
Upstream Channel Cross Section Sketch (including horizontal measurements of top and bottom widths of upstream channel):

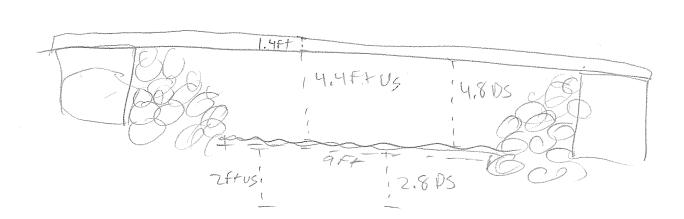
<u>Upstream Channel Cross Section Sketch (including horizontal measurements of top and bottom widths of upstream channel):</u>
