Production Marks on the outside of the cabinet

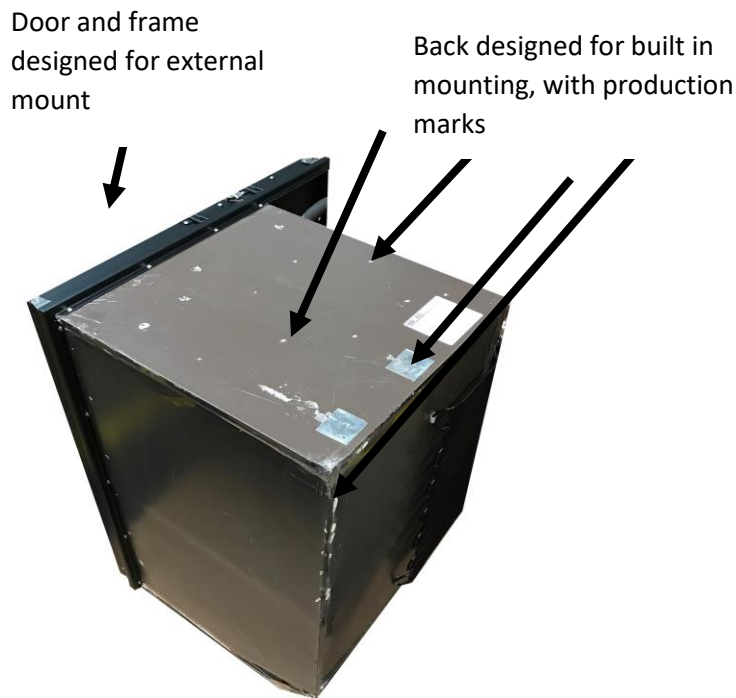
You may notice some marks on the outside of the fridge cabinet when you take it out of the shipping box. These are from our production process.

The small holes are vent holes which allow air to escape and be replaced with the insulation foam we inject into the cabinet. The silver tape covers the larger holes where the foam machine enters the cabinet.

The Scratches which may be noticed are from the foaming process also. When the cabinet is foamed the cabinet is placed in a strong metal mold to hold the shape during the foaming process. When the mold is opened under pressure some marks may be left on the cabinet.

The cabinet is designed to be mounted in an enclosure and is not visible after the unit is mounted.

The front of the refrigerator which is exposed after installation should not have any of these production marks

The reliability and performance of the unit is not compromised with these marks.
