# Restoration Advisory Board Meeting Minutes Naval Research Laboratory – Chesapeake Bay Detachment

MEETING DATE: May 18, 2021

# **Site 10 (Fire Testing Area) Site Inspection Update**

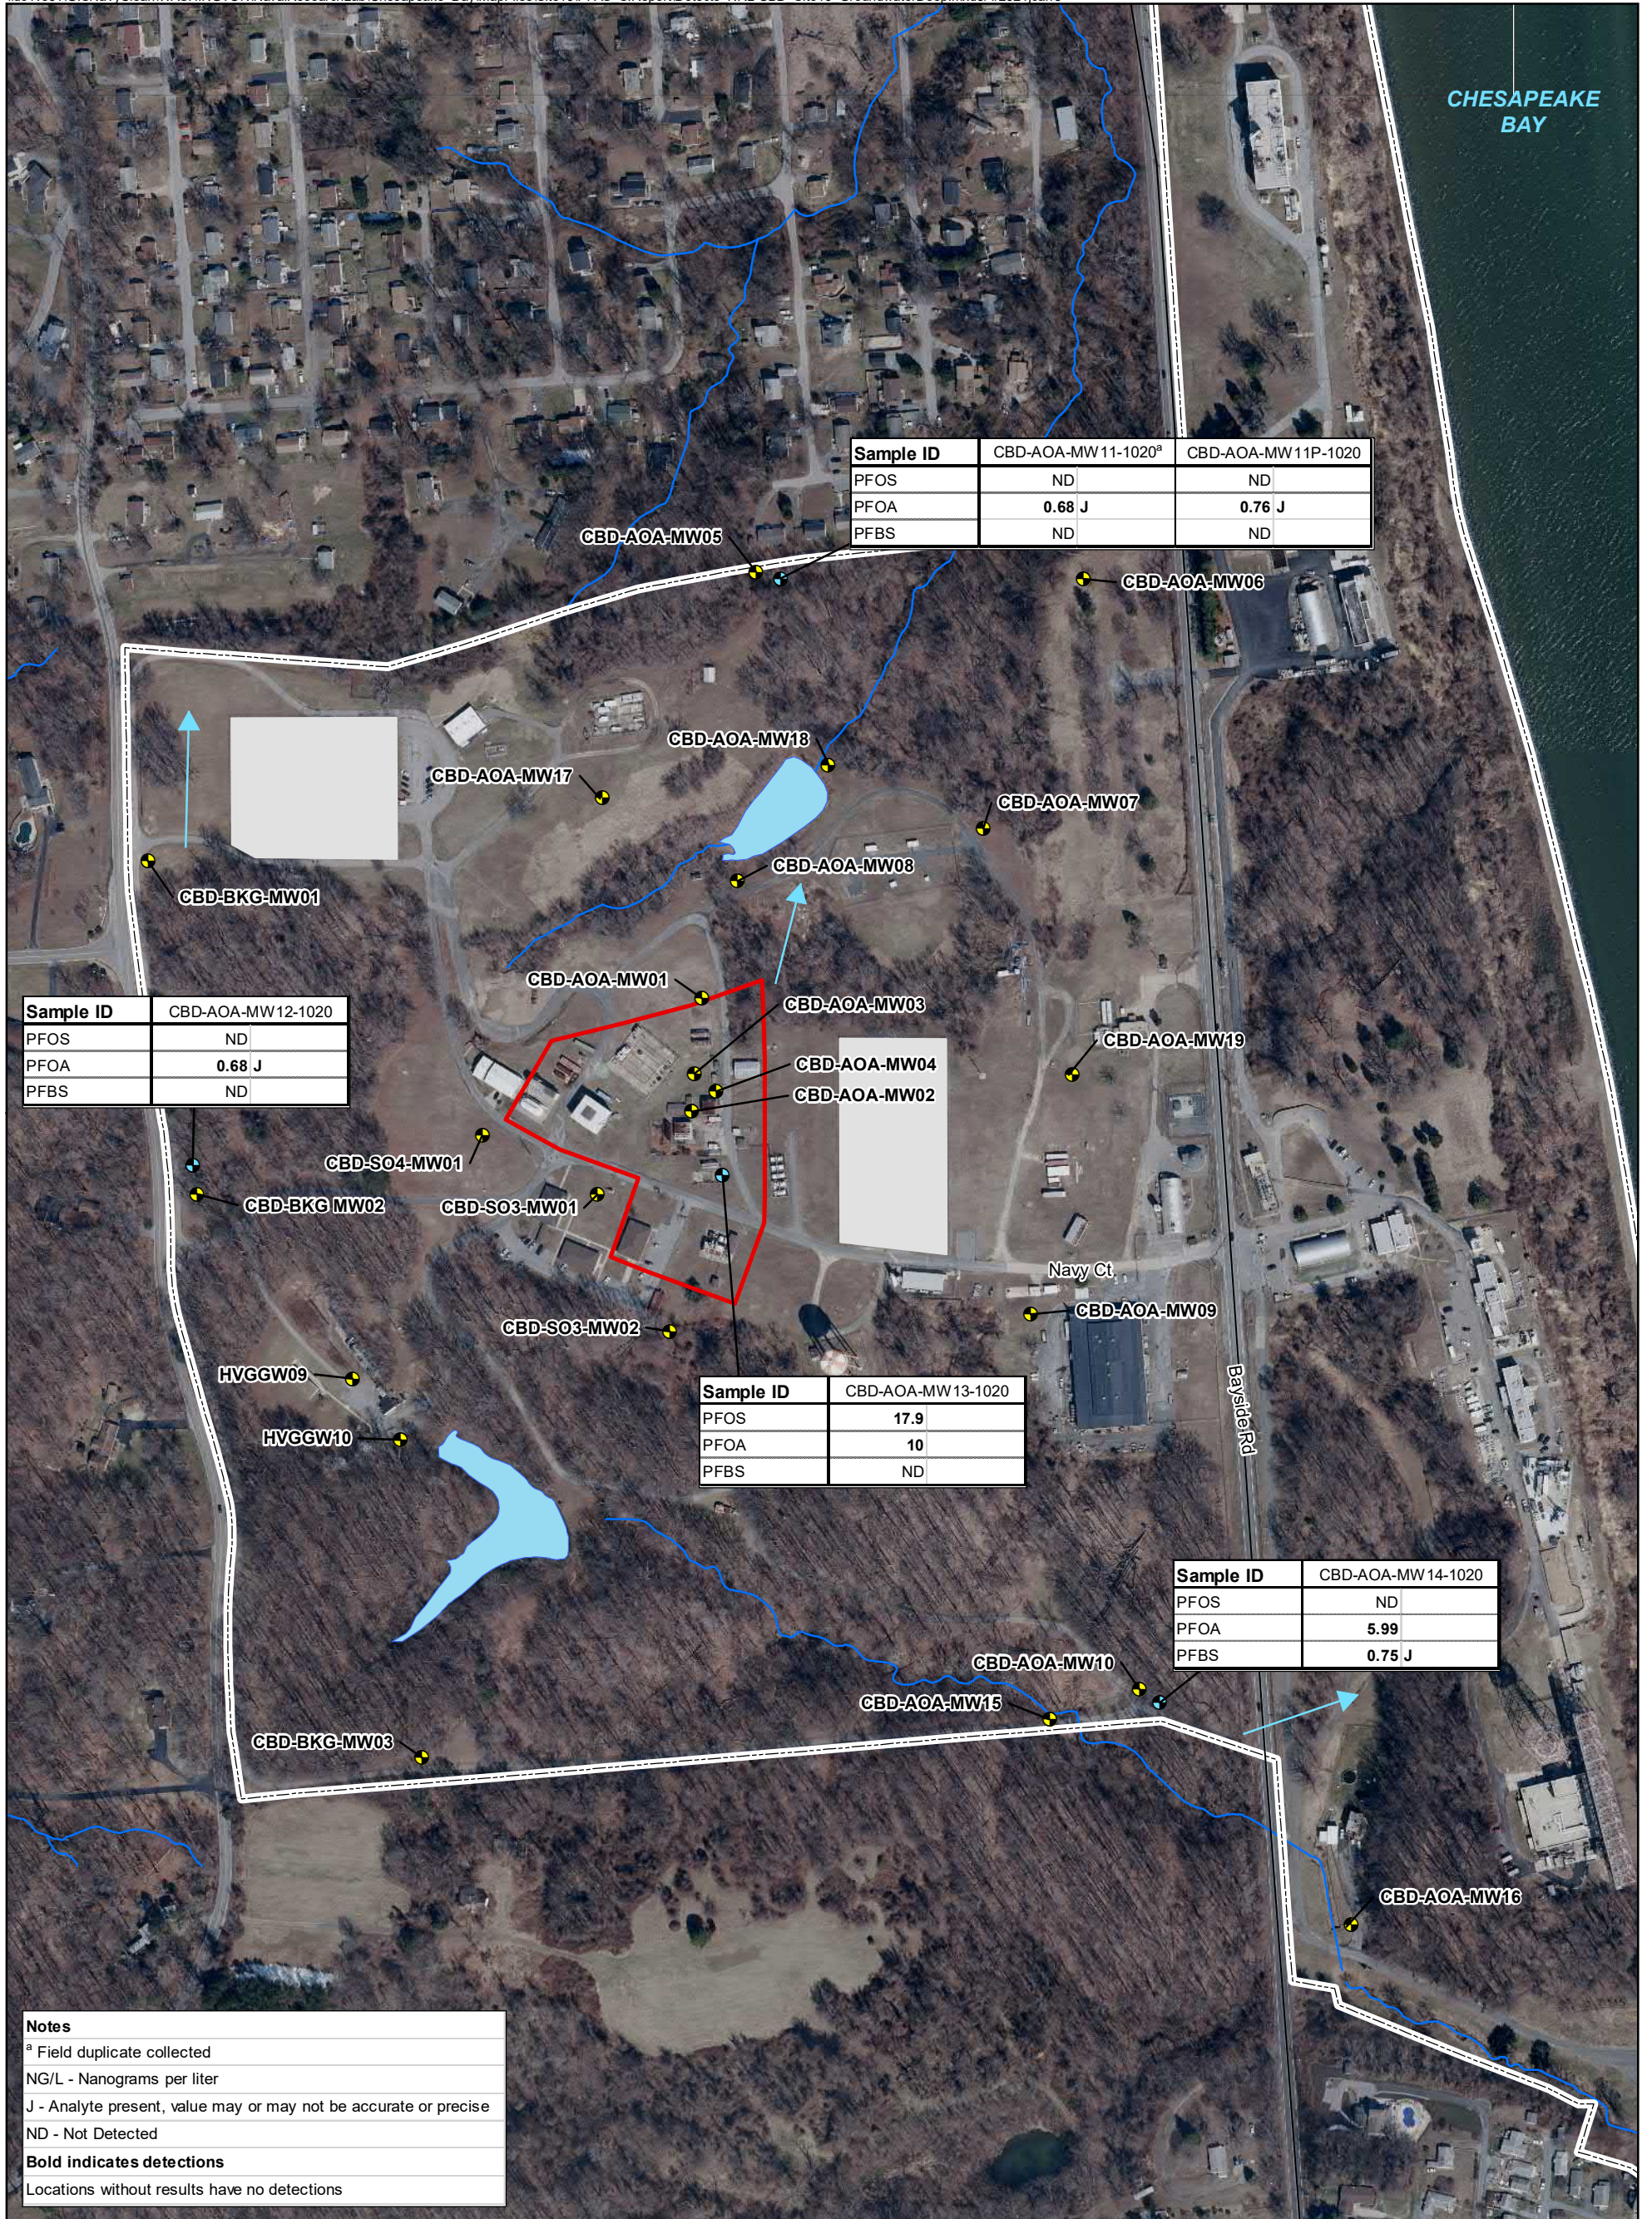
**Deep Monitoring Well Locations**  
 Site 10 PFAS SI  
 NRL-CBD  
 Chesapeake Beach, Maryland

- Deep groundwater was collected from wells screened generally between 200-300 ft below ground surface
- PFAS concentrations were low level suggesting minimal migration through soil
- Highest concentrations were found in the area of the old burn pad which is the primary source area based on the historical use of the site.
- Detections in base perimeter wells were generally either non-detect or low-level estimated “J-flag” values

Regarding surficial groundwater, there were 23 monitoring wells sampled, that were generally screened between 20 to 30 feet bgs. The highest concentration of PFAS was detected in monitoring well MW02 (PFOS at 171,000 ng/L), (“equivalent to ppt – parts per trillion”) and the pattern of PFAS detected in groundwater indicates it’s migrating along the direction of groundwater flow to the northeast, as well as to the southeast. For the deep aquifer (Piney Point aquifer), there are four deep monitoring wells on base, generally screened between 200 to 300 feet bgs. Detections of PFAS in these deeper monitoring wells were fairly low, suggesting minimal transmission from the sources coming from the old fire test pad. The highest concentration of PFAS in the deeper aquifer was detected at MW13 (PFOS at 17.9 ng/L).
