# Snapshot<sub>2</sub> NIR

### Saving a partially gangrenous foot

Using Snapshot<sub>NIR</sub> and a wound biologic to preserve a limb.

#### Adam Landsman, DPM, PhD

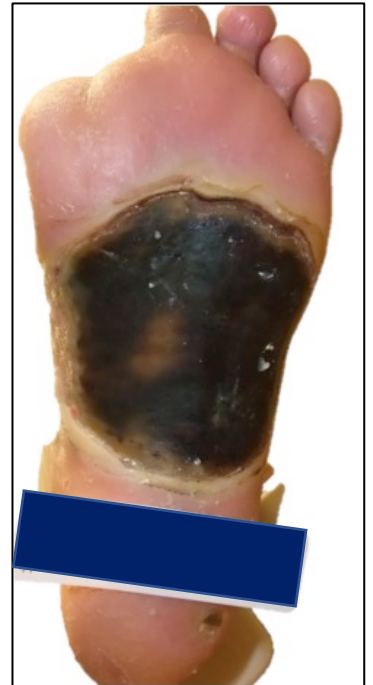
**Figure 1:** Diabetic foot with large plantar ulcer.

The large eschar over the ulcer, as seen in Figure 1, was removed using sharp and enzymatic debridement until a pink granular bed was present.

With the black eschar over the wound, there was no visual indication of the depth of the necrosis. Using Snapshot<sub>NIR</sub>, we were able to image through the edges of the eschar as it was slowly chipped away. The information captured with the device was used to gauge the depth of the ischemic tissue.

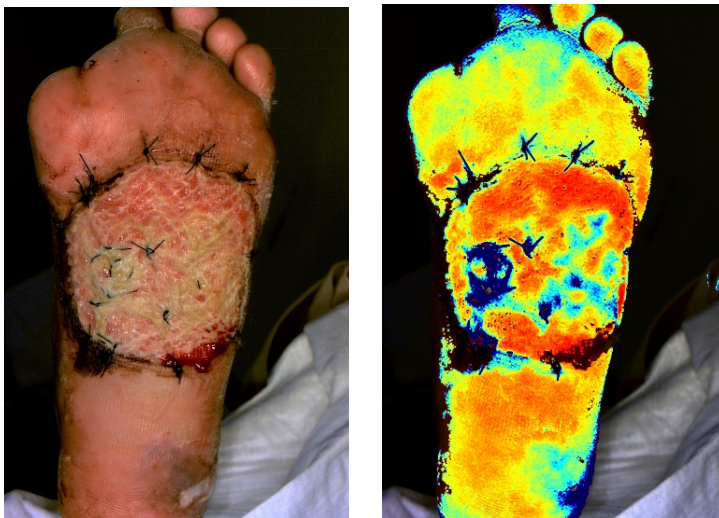
**Figure 2.** Clinical and S<sub>t</sub>O<sub>2</sub> images showing skin graft **one-week** after first application. Fine wispy edges are noted around the perimeter of the graft which generally indicates that a wound is progressing towards closure.

The periwound areas showed good oxygenation and the 'wispy' edges of the S<sub>t</sub>O<sub>2</sub> images illustrated adequate blood flow in the area.<sup>1</sup>

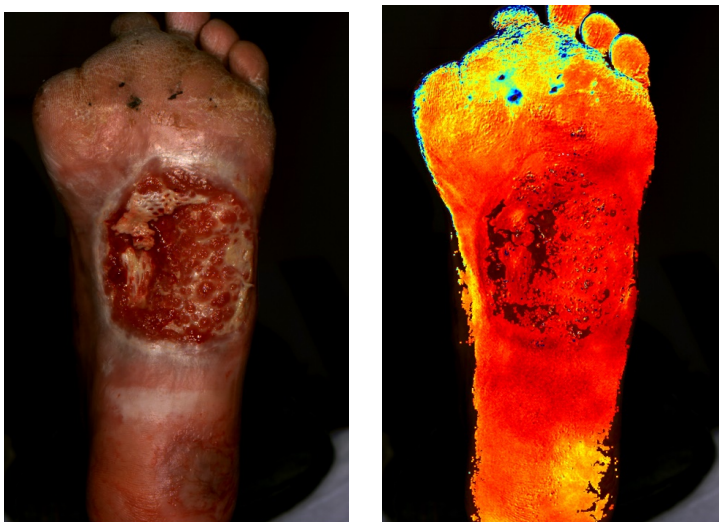
**Figure 3.** Clinical and S<sub>t</sub>O<sub>2</sub> images showing skin graft **28-days** after first application. As the graft becomes incorporated into the wound bed and angiogenesis progresses, the increased oxygenation of the surrounding tissues is apparent.
