BAIT IBRAHIM HASHEM

A DOCUMENTATION REPORT

Report Prepared by Columbia University Graduate School of Architecture, Planning and Preservation

2010

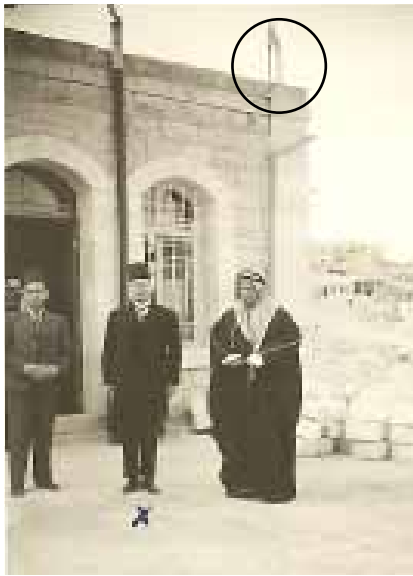
Fig. 2.2. (Left) Exposed rebar (circled) as it existed shortly after the construction of the house.

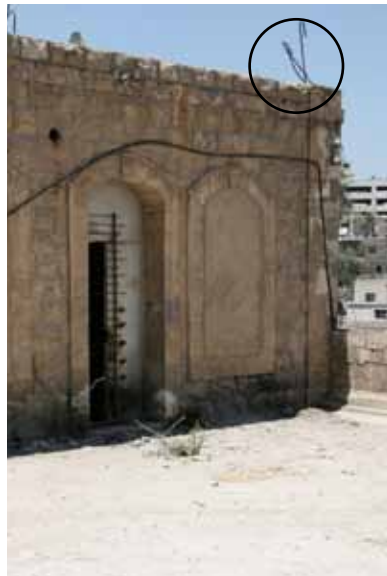
(Right) Exposed rebar still in existence in July 2009.

have been developed as part of a single building program, exposed steel rebar protruding from the roof suggests that its builder provided for the subsequent upward expansion of the house, if needed. This remains a highly common practice for buildings of all kinds throughout Amman and the region. Many three-aisle villas in Jabal Amman and Jabal al-Weibdeh were indeed expanded with new upper floors stacked in succession one atop the other. In some cases each successive level can be read chronologically as a distinct expression of the typical architectural design of its period of construction.

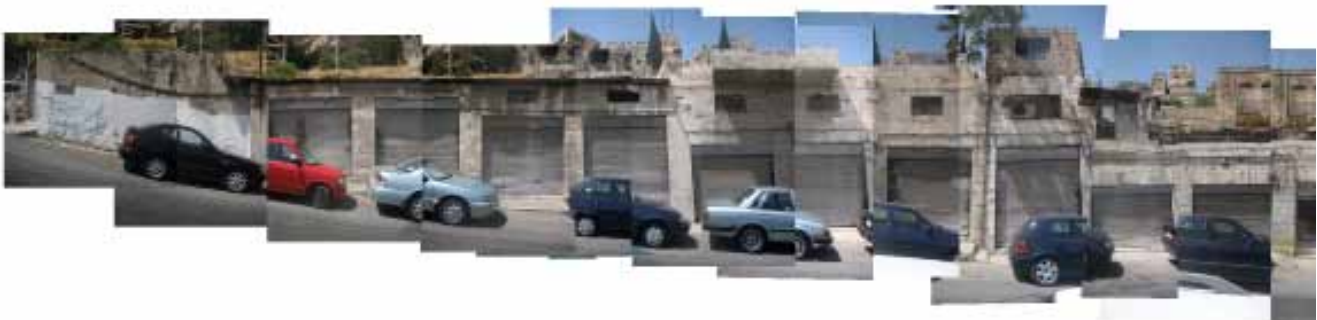
Fig. 2.3. East elevation

elevation of the main (floor (Fig. 2.3). It is flanked by two narrow windows forming a tripartite ensemble highly characteristic for houses of this type. The main doorway ensemble is situated between a single window opening to the left, and a secondary entrance door and window opening to the right. Historic photographs show wood paneled double doors installed in both door openings (these may still exist in storage within the house; see Existing Hardware Inventory).

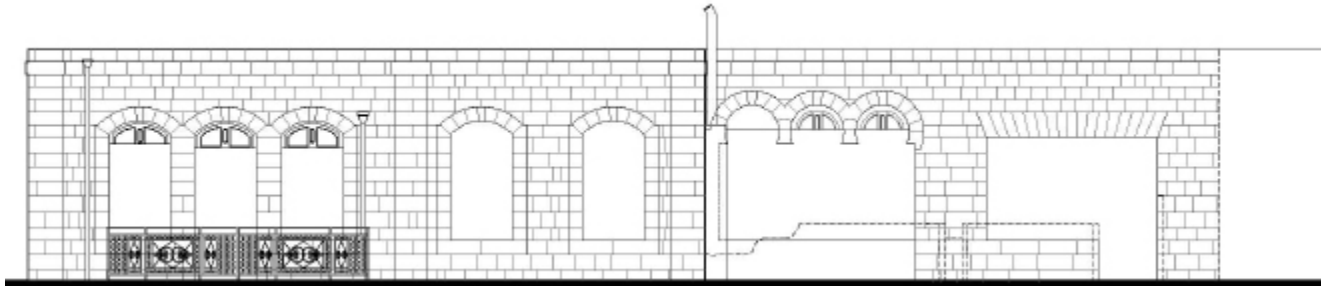
Fig. 2.4. North elevation of the upper level of the house.

balcony at left, and a pair of windows to the right (Fig. 2.4). An ornate metal railing lines the edge of the balcony. As noted above, this elevation is surfaced in tooled *musamsam* block, indicating the builder's acknowledgement of this as the building's most prominent façade. The side (south) and rear (west) elevations of the original part of the house are surfaced in un-tooled stone with window and door openings asymmetrically dispersed.

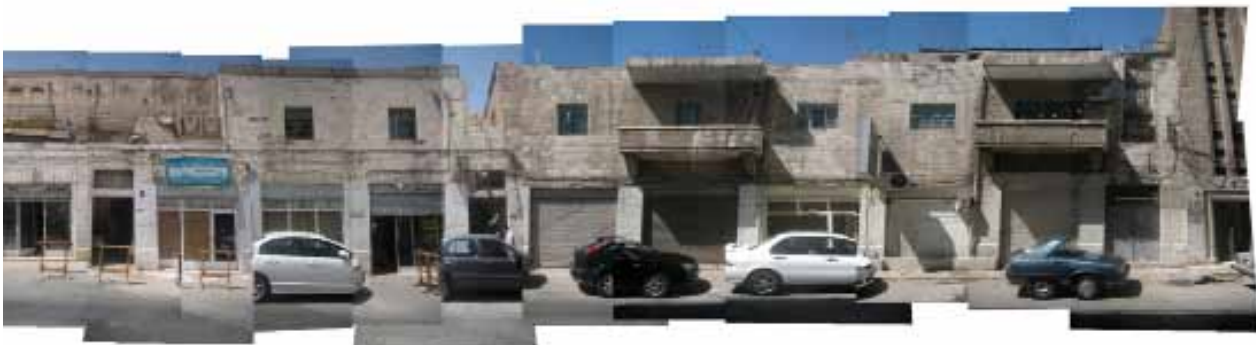
Fig. 2.5. (Continued from previous page) North elevation along Yazeed Bin Abi Sufan Street

The elevations of the first floor and ground level are exposed only on the north and part of the west facades. The north facade of the first story level of the original part of the house embraces four masonry openings (two windows centered between two doors) with typical segmental arches above. These now face out onto a terrace over the roof of storefronts below, and are accessed by means of a stairway leading up from the sidewalk at ground level. The other portions of this elevation are largely obscured by later additions. The ground level elevations of the original part of the house are almost entirely obscured behind storefronts on Yazeed Bin Abi Sufan Street, except for one portion at the approximate center of the north elevation of the original house where an open stairway provides access to the level of the first floor (Fig. 2.5).

situated near the main access point to the site, at its eastern tip. A series of nineteen storefronts, likely built in at least two phases, occupies the entire northerly boundary of the property along Yazeed Bin Abi Sufan Street (Fig. 2.5). This addition included two exterior staircases leading from the street level to apartments at the first story level of the original house. The new apartments were located over the storefronts and within the house itself. The roofs over the apartments formed two separate terraces accessible from the main floor of the house proper, one for the family and one for servants. A small addition to the rear of the wing off the main story of the house provided additional space for tenants in the rear apartment. Two masonry booth-type structures in the area to the east of the house were constructed after the property left the control of the Hashem family.

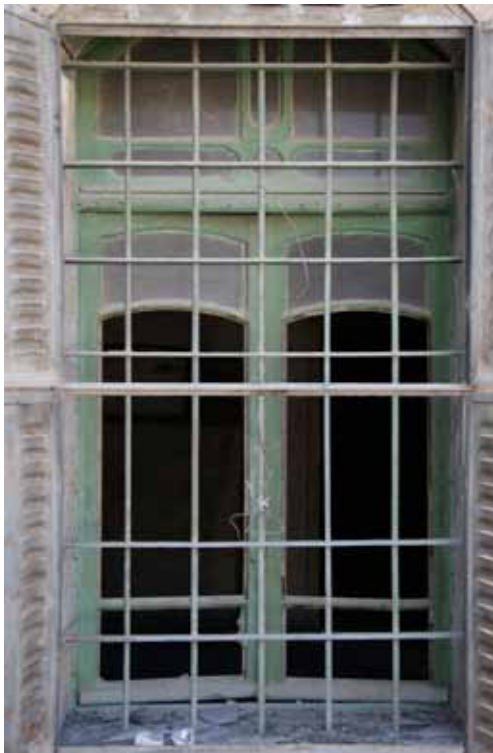
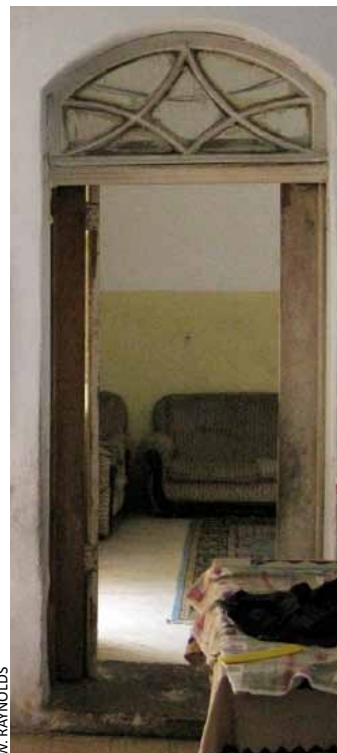
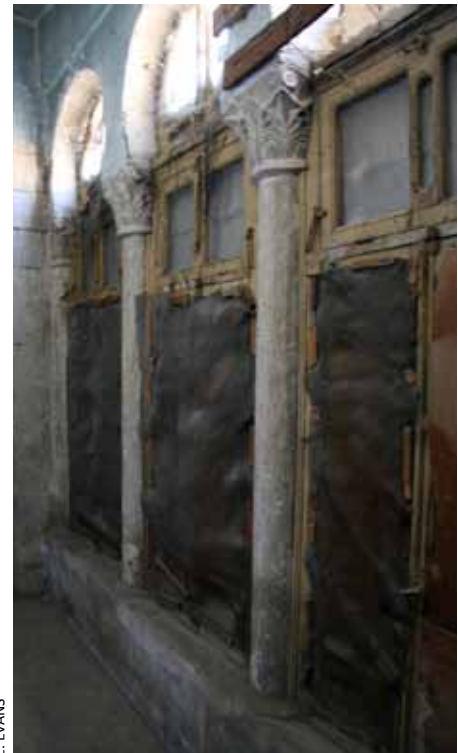
(From left to right) Fig. 2.6. Master bedroom window, east elevation, main level, with typical transom sash; Fig. 2.7. former exterior door or window opening, west elevation, first story, with typical interlocking diamond pattern transom; Fig. 2.8. Arched openings to loggiai.

transoms on the main floor of the original portion of the house are composed of six panes arranged in a distinctive inverted “T” pattern typical among houses of the period (Fig. 2.6). The corresponding transoms of the first floor level are of a different design, with curved muntins forming an interlocking pattern (Fig. 2.7), also typical for the period. Steel bars protected all window openings of the main part of the house from the time of its construction. One louvered steel window shutter remains in place in the southernmost window opening of the main façade. Historic photographs suggest that this shutter dates to the 1950s and that it may have been the only such shutter installed on the main portion of the house. The other windows of the unoccupied portion of the main floor of the house have been blocked with masonry fill.

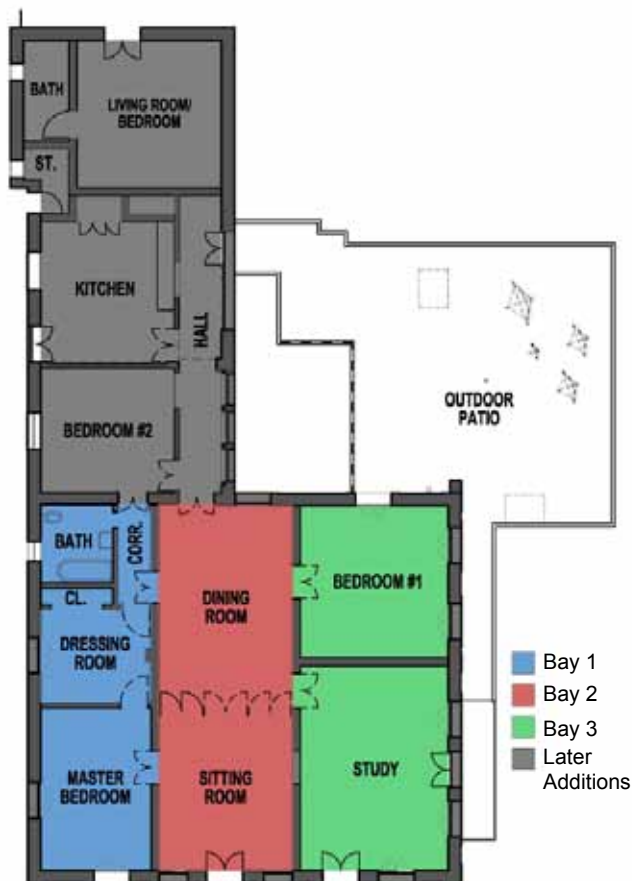
Fig.2.9. (Above) Speculated original floor plan showing three aisle design. (Left) Current layout as of July 2009 showing later alterations.
Fig. 2.10. (Below) Decorative floor tile in central hall.

The interior plan follows the central hall scheme typical for urban villas built throughout the region in the 19th and early 20th centuries. Houses of this typology are known variously as “central hall” or “three-aisle” villas. The main entrance leads directly into a large, central space used for dining, entertaining and circulation (Fig. 2.9). This hall is sometimes known as a *liwan*. Decorated terrazzo tiles pave the floor of this space (Fig. 2.10). Similar tiles, providing the effect of a carpet, are found in almost all contemporary villas in Amman. The room is divided by a glazed wood framed partition that is a later alteration. Double doors with transom lights overhead provide access to other rooms of the house from the central hall. These openings were originally symmetrically positioned around the room; one door opening was moved during a subsequent alteration (probably at the time the partition was installed).

Ibrahim, by all accounts, was serious by nature, working long hours in his study in the house when he was not at his office in the Parliament building. Though he kept all of his bookshelves permanently in his study, he would rotate the position of his desk and his bed depending on the season.² In the summer, he would sleep in the part of the building that we have labeled "study," and in the winter he would sleep in the "bedroom" (Fig. 6.3; see Fig. 2.9).

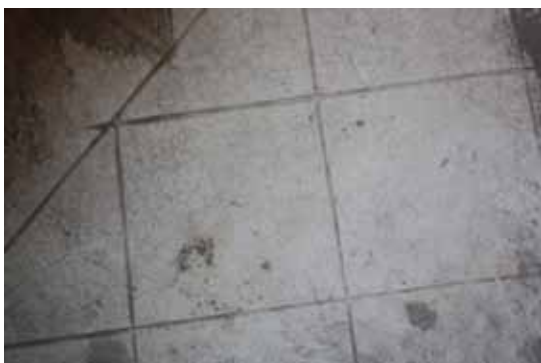
Fig.2.11. Burnished plaster floor scored to imitate tile

The main hall was flanked by a study and bedroom to the north, and by a bedroom, dressing room, bathroom and hallway to the south. The hallway facilitated circulation between the dressing room and bathroom without passing through the main hall (or disrupting the room's symmetrical arrangement). All of these spaces are paved in polished plaster scored to imitate tile (Fig. 2.11). Walls throughout the interior are finished in painted plaster. Beaded wood moldings over

The scored plaster floor surfaces of the secondary rooms of the original part of the house (see Fig. 2.11) are relatively common particularly among earlier houses of the mandate period. In addition to those at the Hashem house, a typical example survives at the restored Dar Khalid house (c. 1920s) at the Darat al-Funun contemporary art center in Jabal al-Weibdeh. The outdoor paving tiles (see Fig. 2.15) that survive at the Hashem house are of interest as comparable exterior paving tiles are rare. Double-sized patterned clay paving tiles of the same design as those in the formal garden at the Hashem house can be found on the platforms of the station of the Hejaz Railway in Amman (Fig. 3.15).

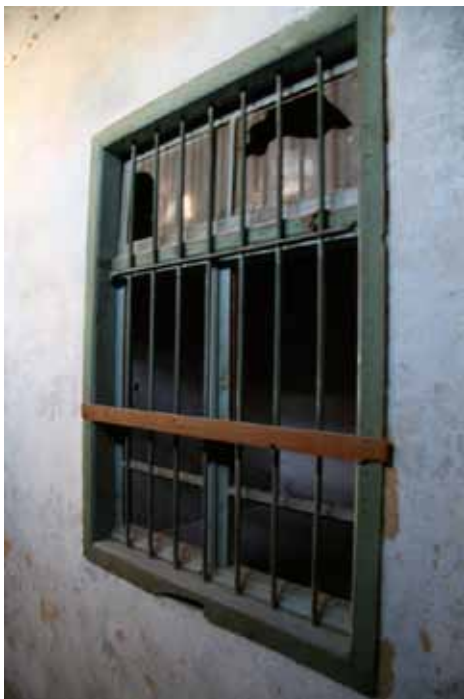
Fig. 2.12 Hall side of the interior window of Bedroom#2.

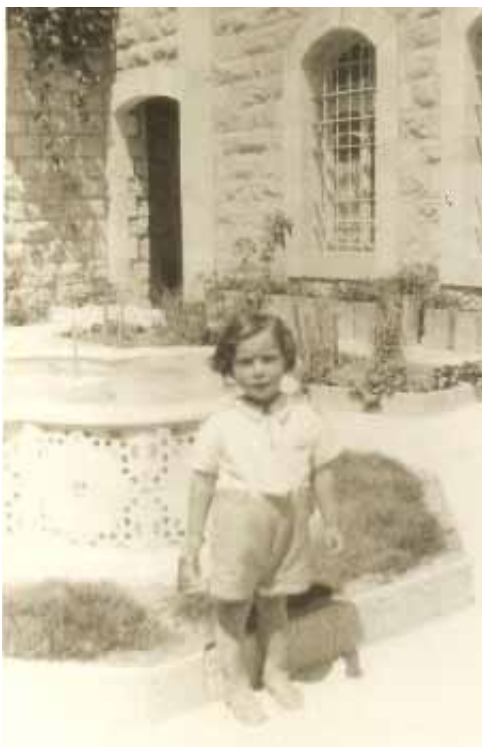
Fig. 2.16. (Left) Photograph of the decorative tile fountain, various planting beds and planters, and the archway that led to rear terraced garden.

A second stone archway at the southwest corner of the formal garden provided access to a narrow walkway leading towards the rear of the house (Fig. 2.16). The walkway lay sandwiched between the house to one side and a tall retaining wall to the other, and was sheltered beneath a trellis supporting grape vines. At the rear of the house, a small wooden gate provided access to a curving staircase ascending towards a terraced garden situated atop the retaining wall above the south façade of the house. Information gleaned from oral histories indicates that this garden supported fig, pistachio, and cherry trees and was a favored place of repose for Ibrahim Hashem. The family also maintained another garden, farther up the hill (now the site of Wild Jordan) that Ibrahim Hashem planted with cacti.

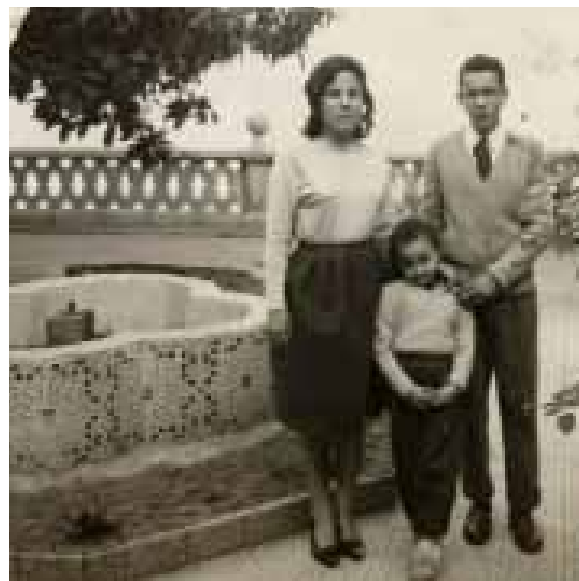
Fig. 2.17. (Right) Photograph showing octagonal planting bed with quatrefoil-shaped fountain; garden balustrade behind.

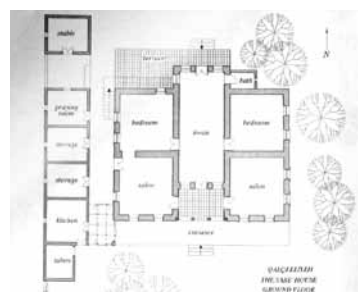
Fig. 3.2. (Above left) Schematic diagram illustrating evolution of the three-aisle or central hall villa in plan.
 Fig. 3.3. (Above center) Plan drawings of typical three-aisle villas in Palestine.
 Fig. 3.4. (Above right) Plan drawings showing typical three-aisle villas in Lebanon.

arched opening centered in the main façade. This typology may itself have evolved from earlier houses in which the central space would have existed as an open courtyard (Fig. 3.2). As this building type became adapted for modern urban environments in the 19th century, the large central arch evolved into a characteristic tripartite grouping of tall arched openings that enclosed the central hall and became the signature exterior detail for these buildings throughout the region. In Palestine, the central hall itself is sometimes referred to as a *liwan*.

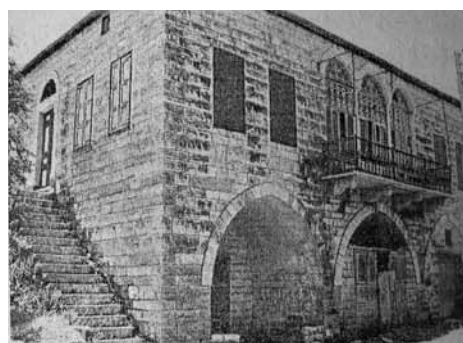
Fig. 3.4. (Right) Typical 19th century three-aisle urban villa in Lebanon..

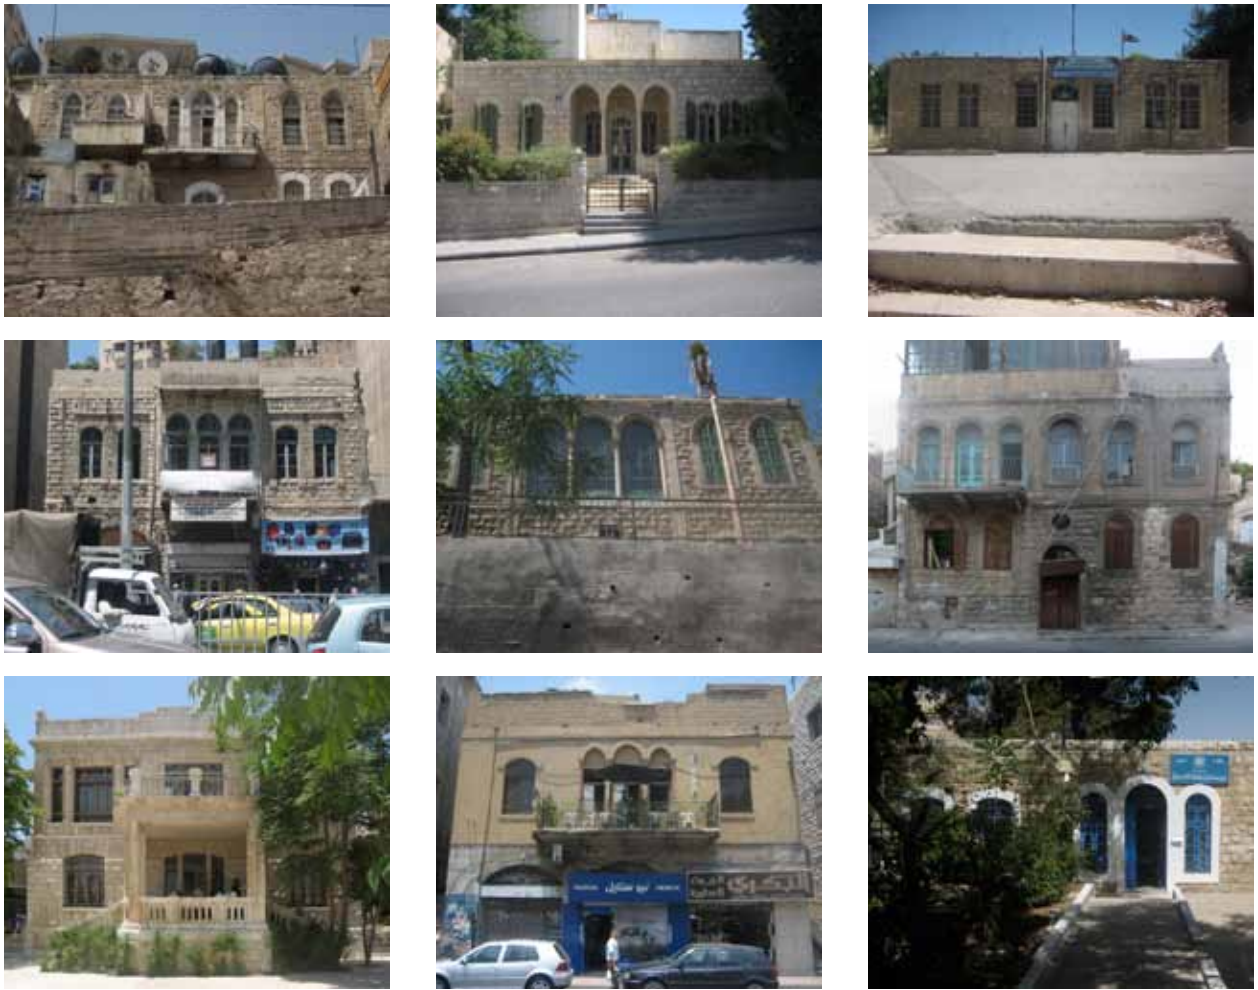
Fig. 3.12. Tripartite masonry opening ensembles are perhaps the most characteristic exterior architectural detail of typical villas and commercial structures built in Amman during the mandate period.

The three-aisle villas of Amman span a broad spectrum in terms of the sophistication of their design (Fig. 3.12). While some were carefully patterned after typical urban villas

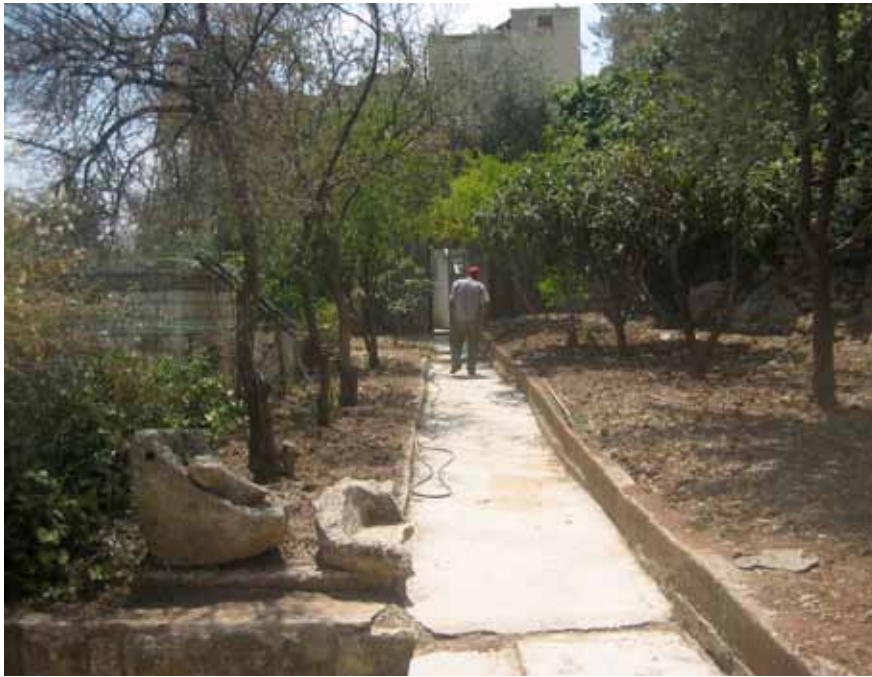
Fig. 3.16 (Above left) Kawar house, Othman bin Affan Street, Jabal Amman. Typical arrangement of a terrace garden.

Narrow terraced gardens similar to those that may have existed at the Hashem house are a common feature of hillside villas throughout the older neighborhoods of Jabal Amman and Jabal al-Weibdeh. Several of these gardens survive to suggest the character of the landscape that may have existed at the Hashem house (Fig. 3.16).

Owing to the extreme slope of the hillsides, these gardens typically lie over stone retaining walls or embankments of exposed bedrock sometimes offset little more than one meter from the house proper. Small fountains of the type that existed in the formal garden to the immediate east of Bait Hashem were common elements of these designed landscapes. Two such fountains survive in the gardens of the houses at Darat al-Funun (Figs. 3.17-3.18). Another exists at the home of Salim al-Odat (c. 1920s, now home to the Bani Hamida Weaving Project).

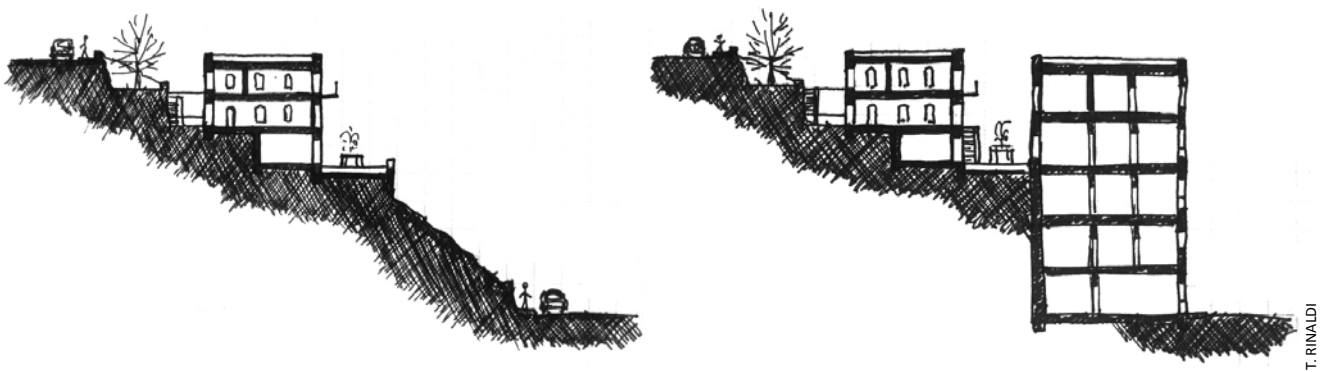
Similar scenarios of commercial development played out at other properties throughout the neighborhood (Fig. 3.19). By the 1970s and 80s, many of the old villas of Jabal Amman served various marginal uses or were abandoned and left to deteriorate as empty shells. The storefronts and commercial buildings developed in their gardens meanwhile continued to accommodate an active residential and business community, with a notable presence of furniture makers and upholsterers. This community remains established in the neighborhood in the early 21st century.

Fig. 3.19 Schematic section representation illustrating pattern of typical commercial encroachment in Jabal Amman during the 1950s and 60s.

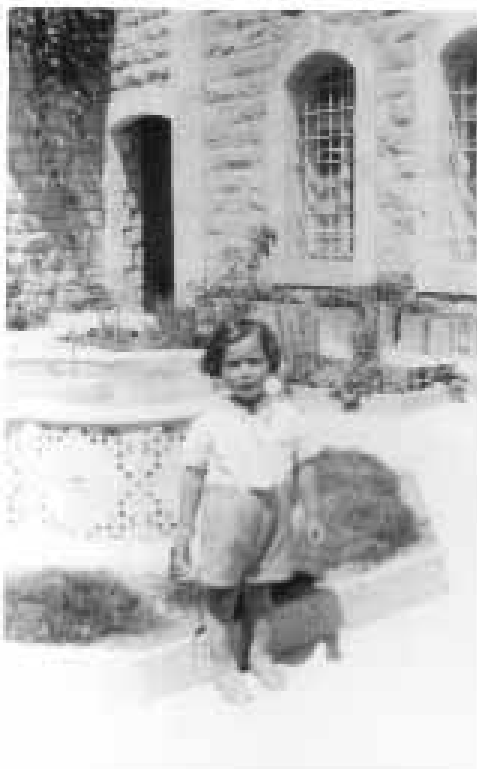
Fig. 4.2a. (Left) Wai'il, youngest child and son of Ibrahim Hashem. Note the quatrefoil fountain, flower boxes, retaining wall and arched passage entry.

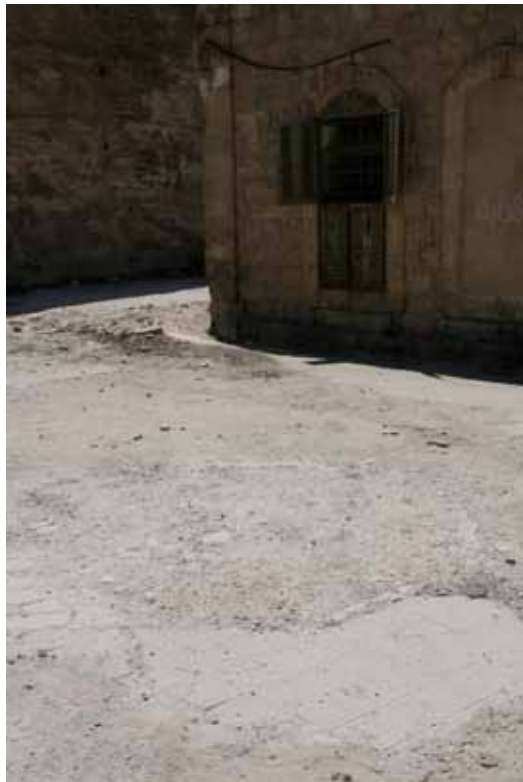
Fig. 4.2b. (Right) The same area in July 2009. Note the outline of the fountain can still be seen.

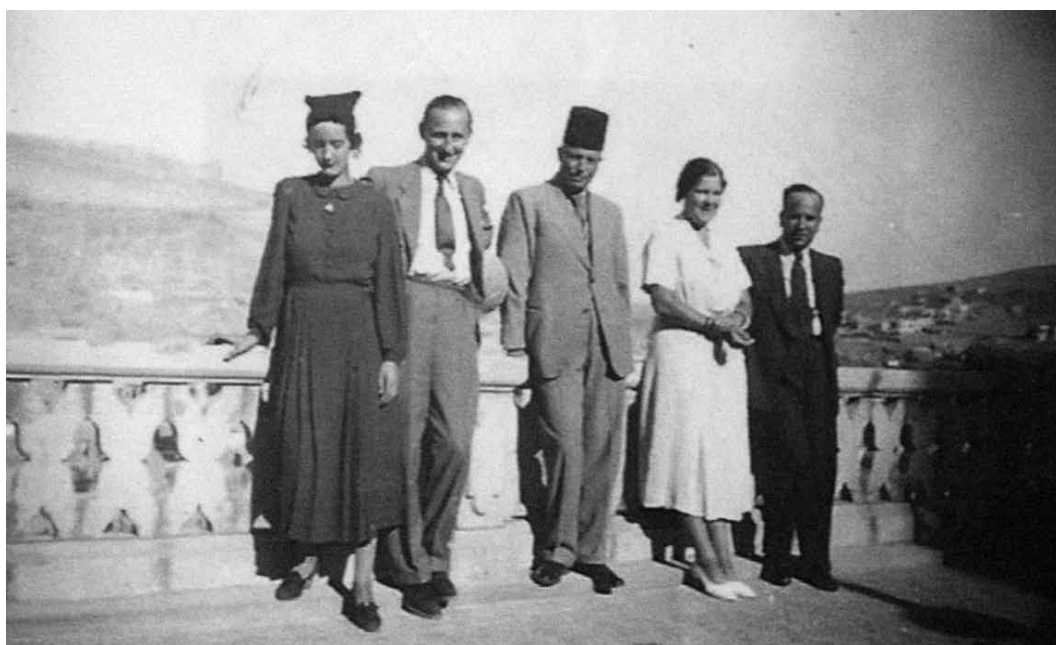
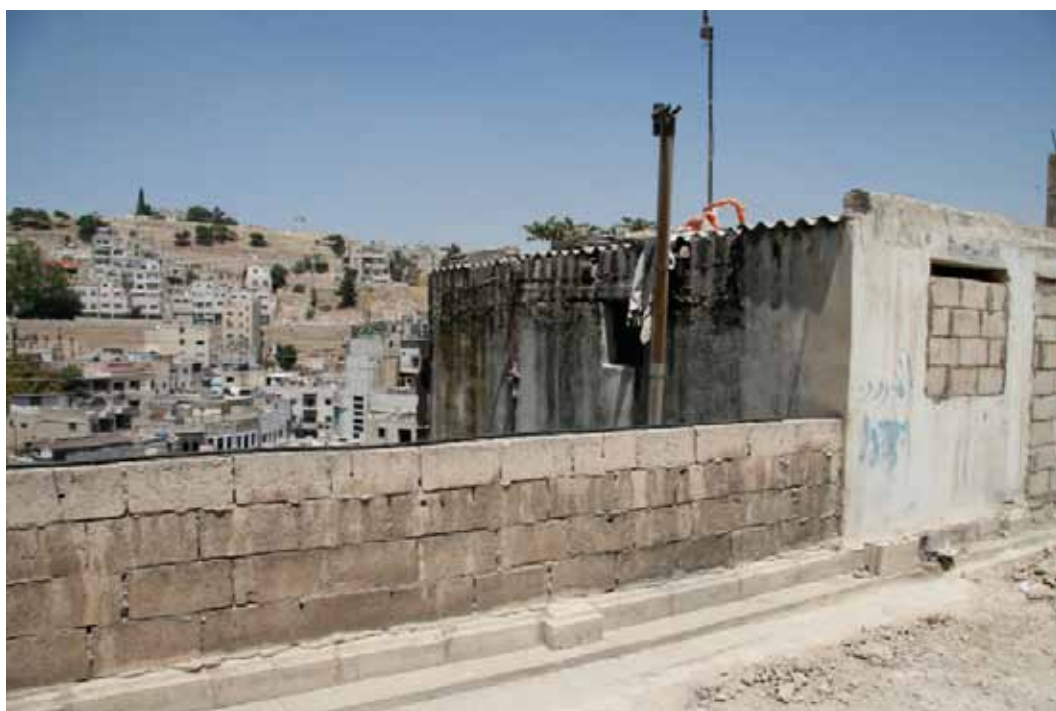
Fig. 4.4a. (Top) Ibrahim Hashem, center, posing against the balustrade at the north end of the central garden with Ehsan Hashem (far right) and British guests.

Fig. 4.4b. (Bottom) The view in July 2009. Note the decorative balustrade has been removed but its base remains. The small enclosure was erected sometime after the family sold the house.

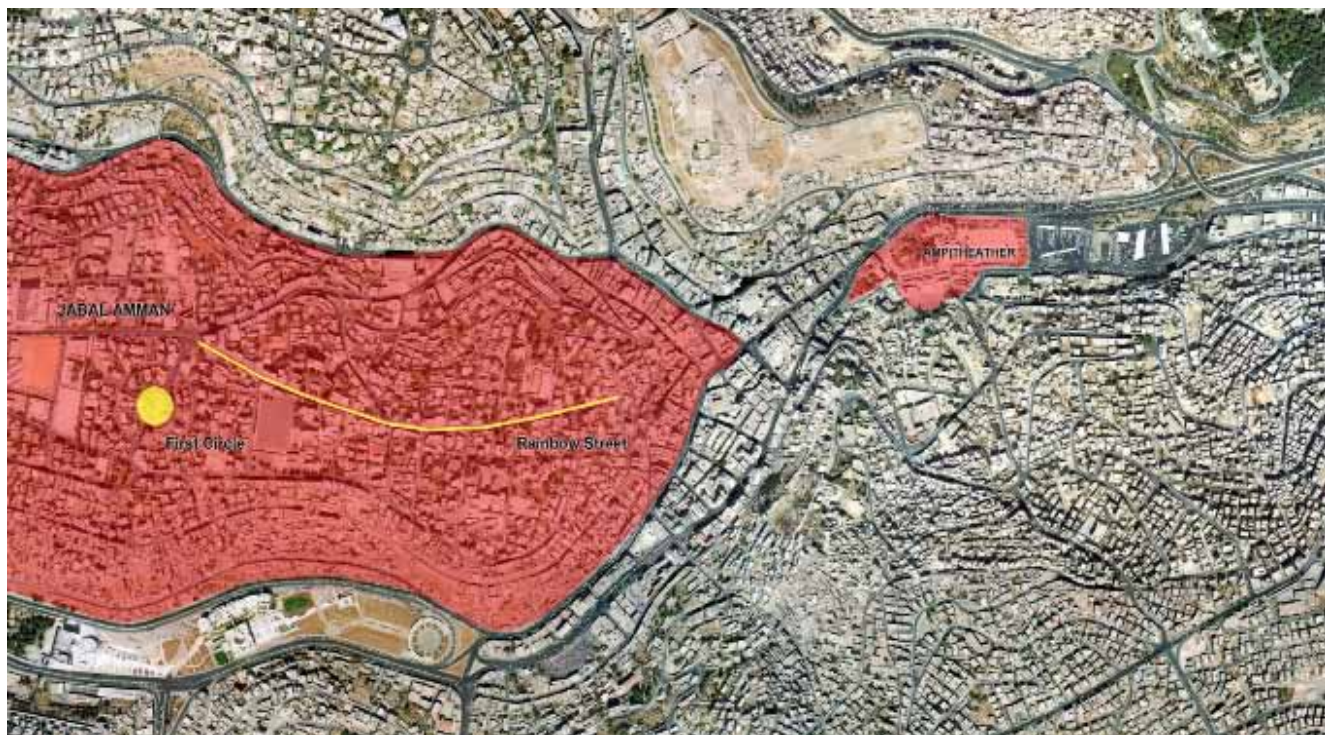
Fig. 7.6 (Top) City center aerial view, with Jabal Amman highlighted in red on left side of the image and 1st circle and Rainbow Street highlighted in yellow. The Roman amphitheater is shown in red on the right side of the image.

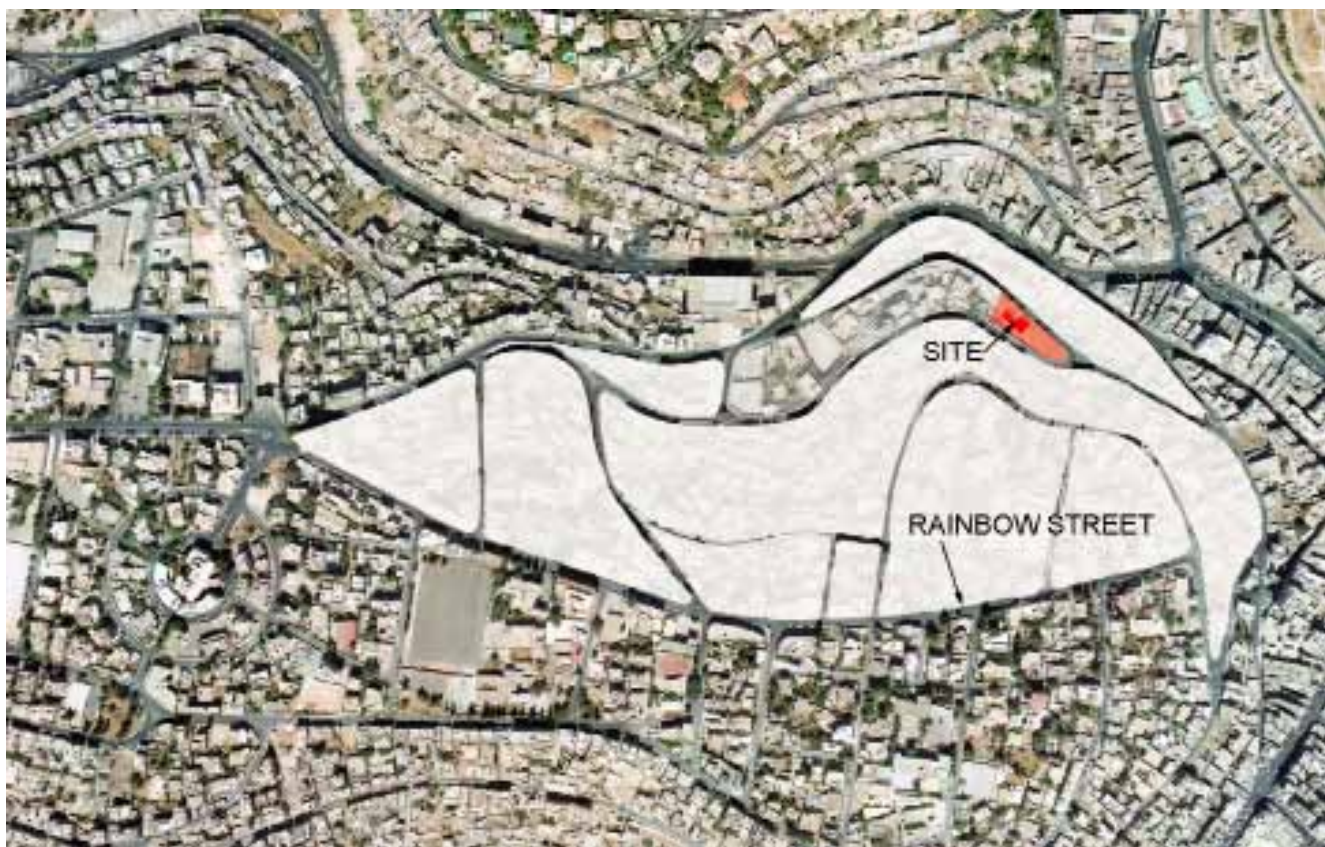
Fig. 7.7 (Bottom) Bait Ibrahim Hashem (highlighted in red) and surrounding neighborhood.

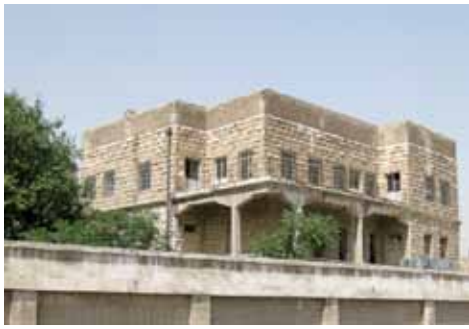
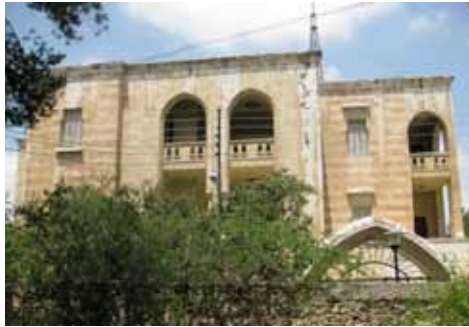
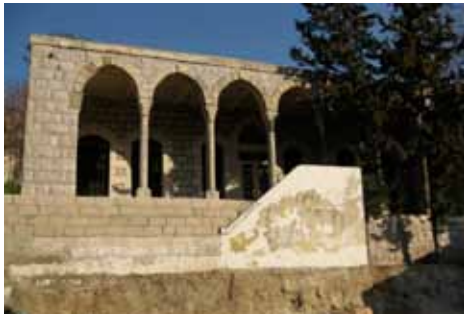
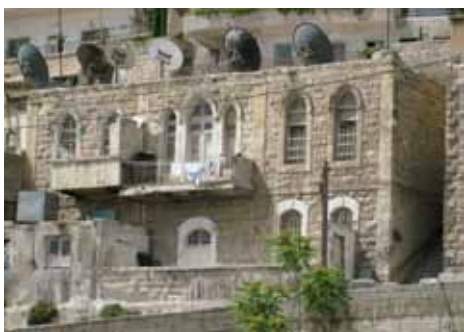
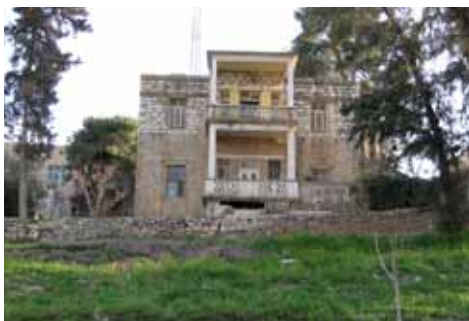
Fig. 7.10 Prominent examples of architecture in the neighborhood. (Top to bottom) A former Prime Minister's house adjacent to Bait Hashem; Bilbesi Mansion; Murtada house; similar structure uphill from Bait Ibrahim Hashem; mansion of commercial merchants across from the Bilbesi Mansion.

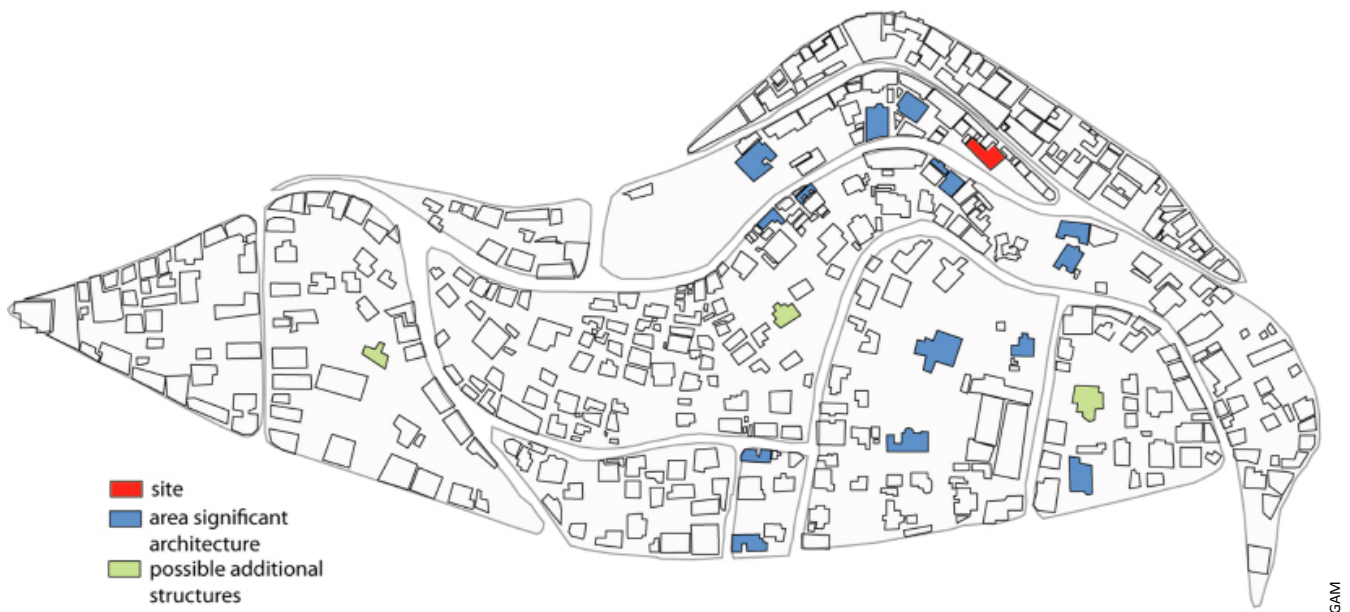
Fig. 7.11 Neighborhood houses considered to be of architectural significance. Source: 2K Architects.

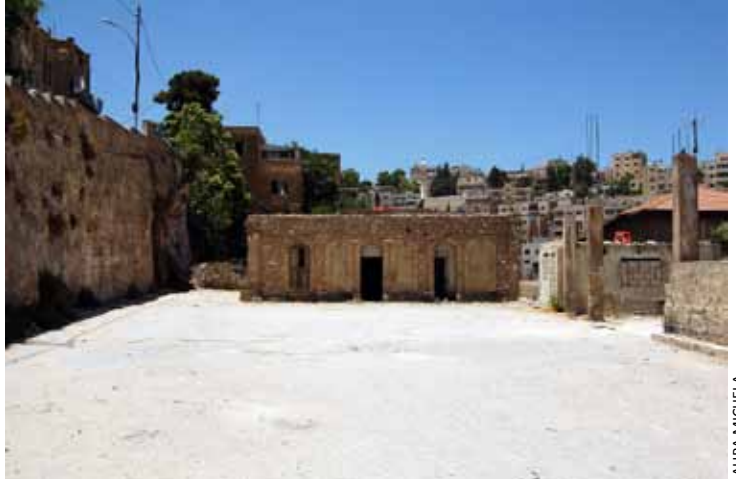
Fig. 9.1 East elevation showing front lot where diwan once stood.

In the space between the west façade of the now demolished diwan and the east façade of the house is the remains of an octagonal planting bed within which stood a quatrefoil shaped fountain. Original tiling around the area is seen and corroborated with historic photographs.

Along the south runs a retaining wall that angles so as to widen the property as it moves west. The area to the south of the house along the wall was once a high terraced garden. At some point, likely in the mid to late 1960s, this terraced garden was razed to make a wider open space along the house and the area was paved over. The paving throughout the lot is uneven and deteriorated.

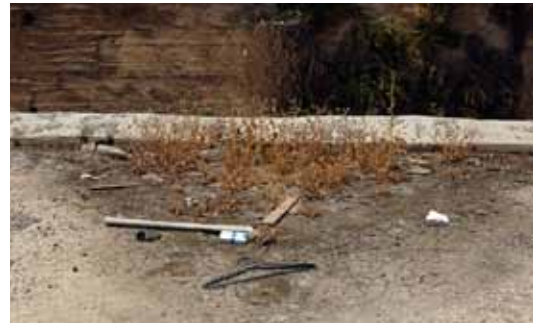
Fig. 9.2 Biological growth at south roofline

The roof of Bait Ibrahim Hashem consists of a poured-concrete flat slab with a tar membrane. There is evidence of locations where water has ponded, particularly along the south roofline near the front of the house (Fig. 9.2). Significant biological growth is visible in this area, which has clogged the scupper and inhibited adequate drainage. A cascading biological formation has formed from that scupper down the south elevation (Fig. 9.3).

The first step should be roof repair. Water infiltration is compromising the interior walls and further damage could affect original flooring and wooden window and door frames. Once the building is watertight, interior ceiling repairs can be performed to repair and seal exposed rebar.

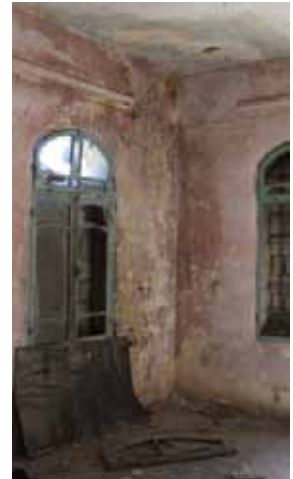
Fig. 9.4 Study

This ponding corresponds with the internal water damage along the southern walls of the master bedroom and the dressing room. Damage has compromised the plaster and mold is growing in these areas (Fig. 9.4, 9.5).

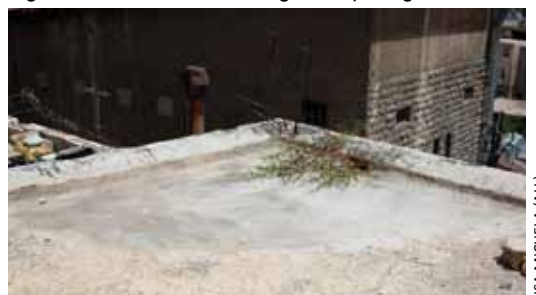
Fig. 9.7 Previous roof repair at northwest roofline

Previous roof repairs are visible (Fig. 9.7) though no dates for those repairs are available.

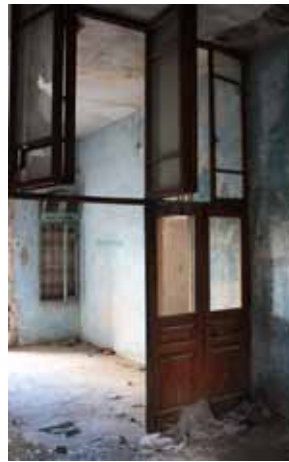
Fig. 9.8 Wooden partition dividing sitting and dining rooms

Original door frames, window frames, transoms and hardware are present in nearly every room (Fig. 9.8, 9.9). The wood elements are in remarkably good condition and would improve with refinishing. Each wooden window frame is painted and samples were taken to determine the interior and exterior colors of the frames from each room.

- Restoration of wooden window and door surrounds
- Original flooring should be cleaned and repaired
- Replacement of plaster as necessary with in kind material
- Metal hardware should be restored
- Exterior and interior paint colors should be chosen based on the results of the sample analysis conducted at Columbia University

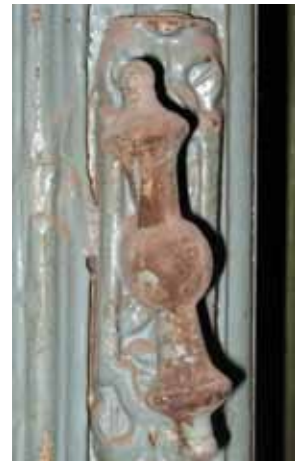
Fig. 9.9 Window hardware, sitting room

Metal units such as the operating window hardware and security bars are also in good condition (Fig. 9.10). The interior and exterior doors were all removed at an unknown time, with the exception of the door between the hallway and bedroom #2 as well as the rear hallway exterior door (leading to the roof terrace), which was cemented in. A stockpile of doors and windows was stored in an interior storage area above the dressing room and bathroom. These were pulled down and inventoried. Some appear to be original to the house and others are presumed to have originated from the diwan. See inventory list for conditions of each item.

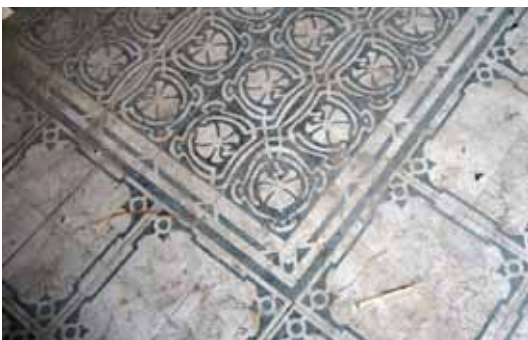
Fig. 9.11 Original tiles in sitting room

Floor tiles in the sitting and dining rooms are in good condition (Fig. 9.11). Rust staining is visible and a melted rubber substance is pooled in one location but appears easily removable. Flooring for the study, bedrooms, bathroom, and dressing room appears to be a burnished plaster finish, scored to look like tiles. Rust stains are visible in cleaned areas and the surface has crazed. Some large but isolated areas of damage exist. In the dressing room is a hole approximately one meter

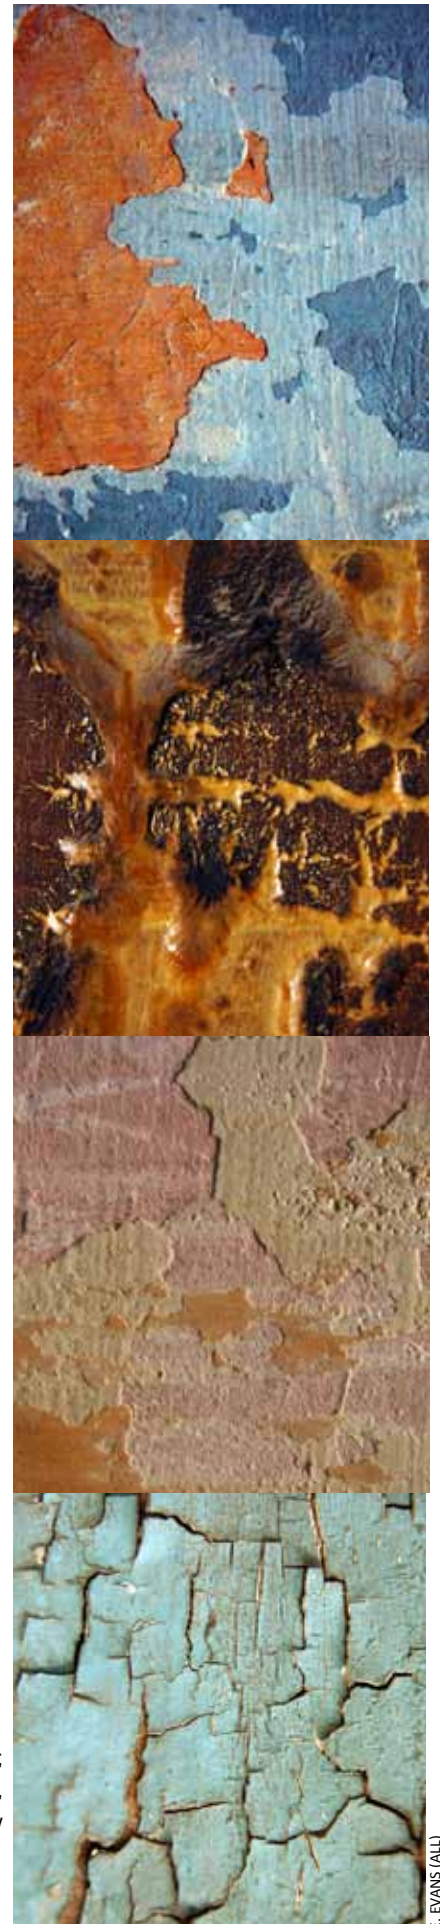
(Top to bottom) Paint from bedroom #1 plaster wall;
Corpuscular reaction on wood finish of door frame,
bedroom #1; Paint from study wall; Paint from window
frame, Bedroom #1

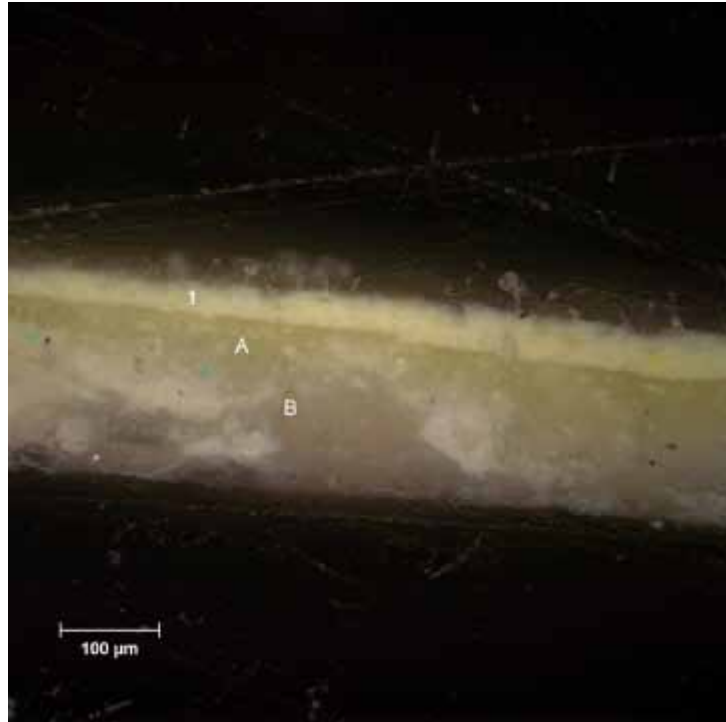
Master Bedroom

The main wall color of the master bedroom is creamy white shown above as layer number 1.

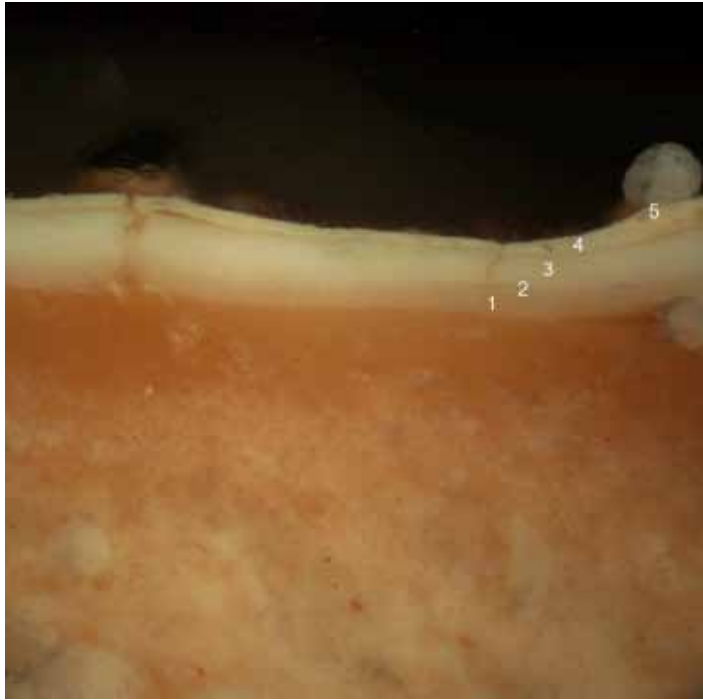
The exterior window frame paint for the master bedroom is a light tan color that is similar to the color of the limestone cladding of the building.

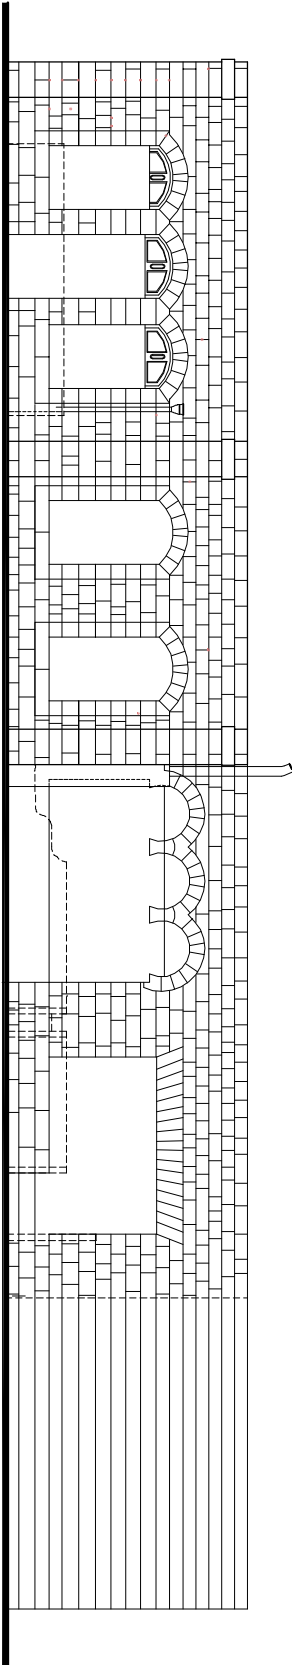
EAST ELEVATION

Some large losses—up to around 4" wide—are visible. Spalling, pitting and erosion are primarily seen along the east (front) elevation. Chipping and erosion are seen around areas where blunt impact has occurred.

After the front area of the property was paved and made into a parking lot, the east (front) elevation sustained a great deal of impact damage from vehicular traffic. Additionally this façade is open and most easily accessible to public interaction and therefore has taken the most abuse. Graffiti and scratches are pervasive throughout the building elevations but are most concentrated on the east elevation.

BAIT IBRAHIM HASHEM STAINING, SOILING AND COATINGS - JUNE 2009
