BAIT IBRAHIM HASHEM

A DOCUMENTATION REPORT

Report Prepared by Columbia University Graduate School of Architecture, Planning and Preservation

2010

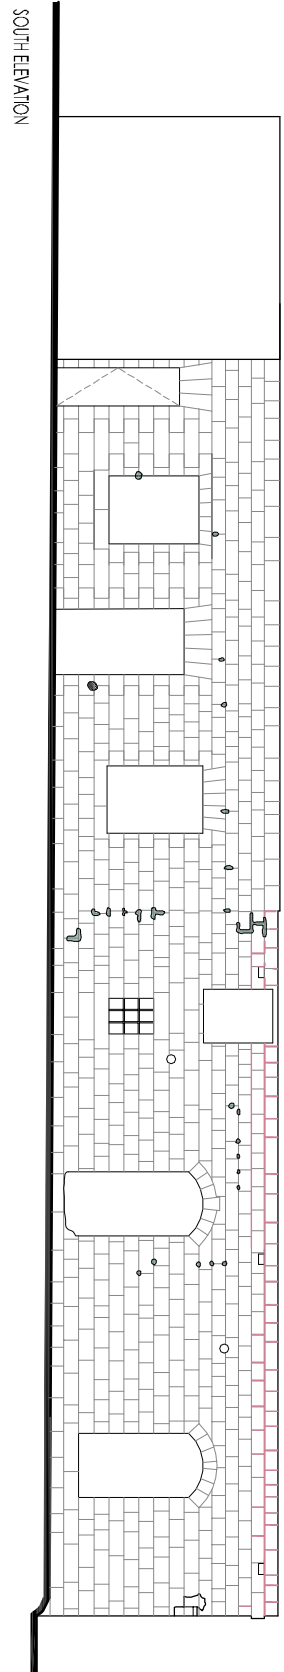
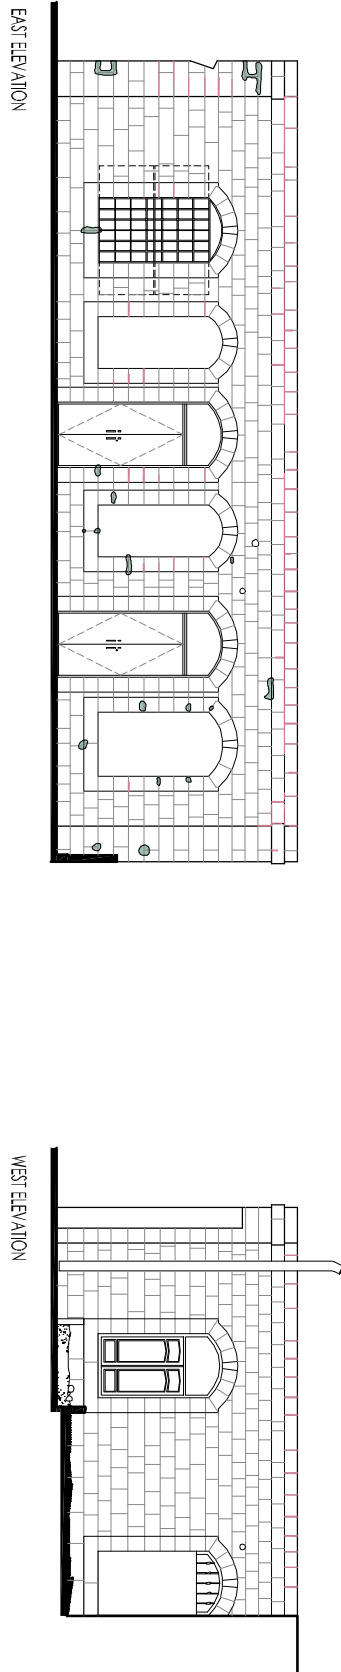
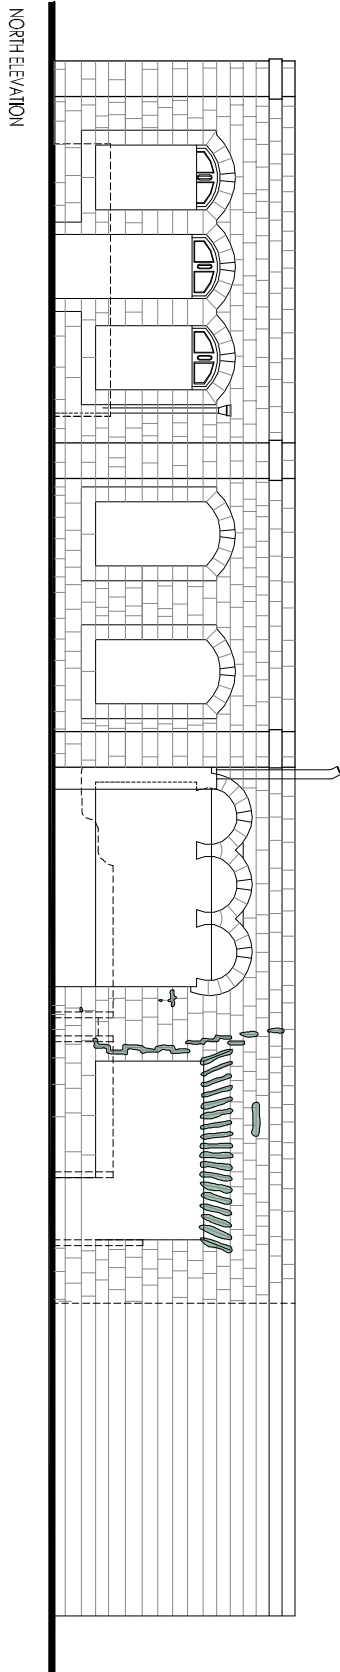
BAIT IBRAHIM HASHEM MORTAR CONDITIONS - JUNE 2009

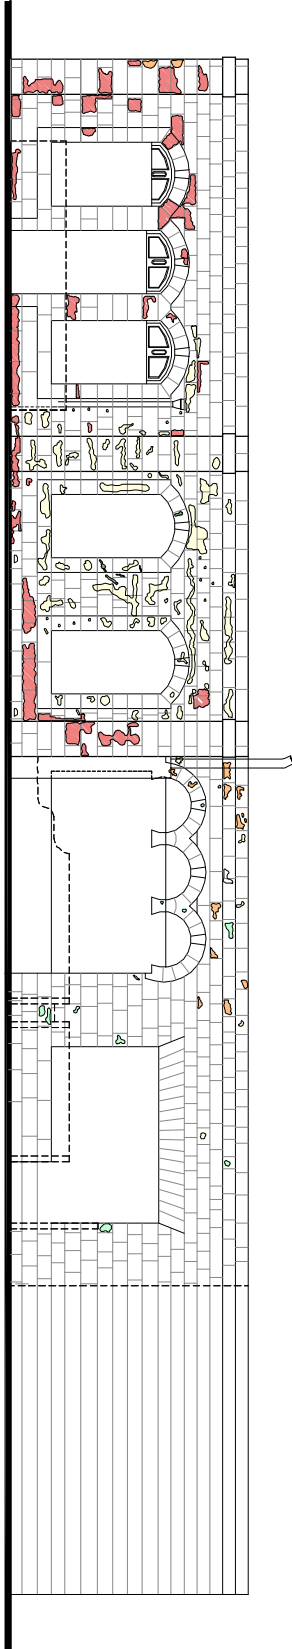
BAIT IBRAHIM HASHEM
LOSSES AND REPAIRS - JUNE 2009

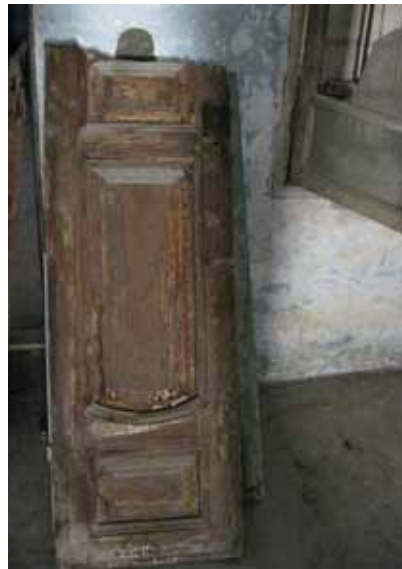
Item: Exterior Door, top half

Quantity: 1
Color: blue paint/wood stain
Hardware: mortise lock
Other: with item #0002

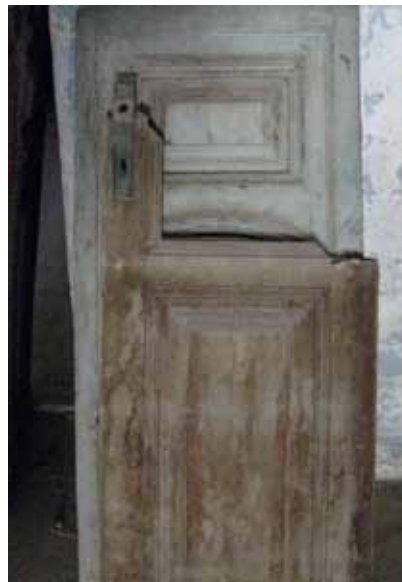
Number: #0002
Location: Attic
Image #: 176

Item: Exterior Door, bottom half

Quantity: 1
Color: blue paint/wood stain
Hardware:
Other: with item #0001

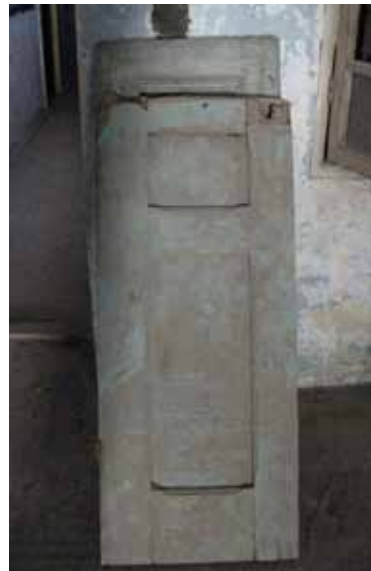
Number: #0005
Location: Attic
Image #: 178

Item: Door, Exterior

Quantity: 1
Color: yellow paint/yellow paint
Hardware: slide latch, mortise lock
Other:

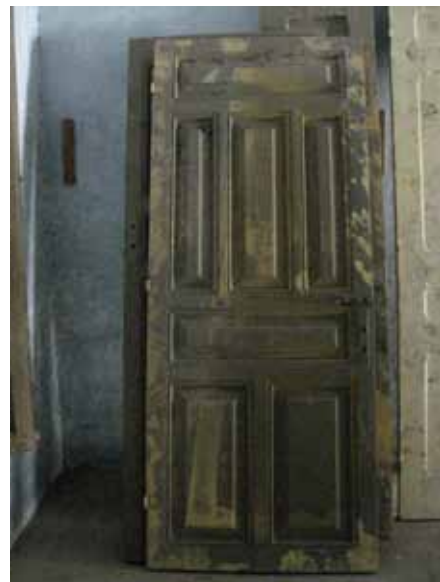
Number: #0006
Location: Attic
Image #: 179

Item: Door

Quantity: 1
Color: wood stain/wood stain
Hardware:
Other:

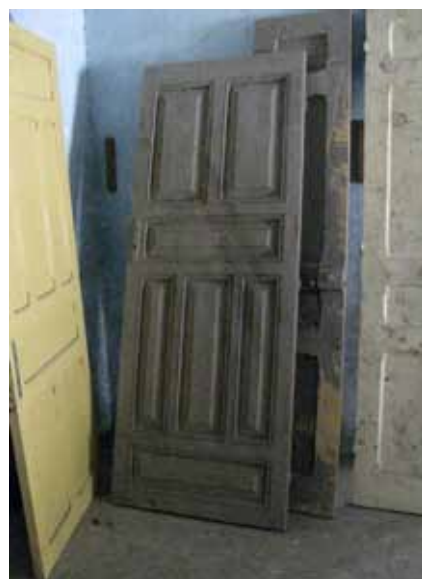
Number: #0013
Location: Attic
Image #: 192-194

Item: door, pantry

Quantity: 1
Color: cream paint/cream paint
Hardware: mortise lock (male)
Other: green first coat

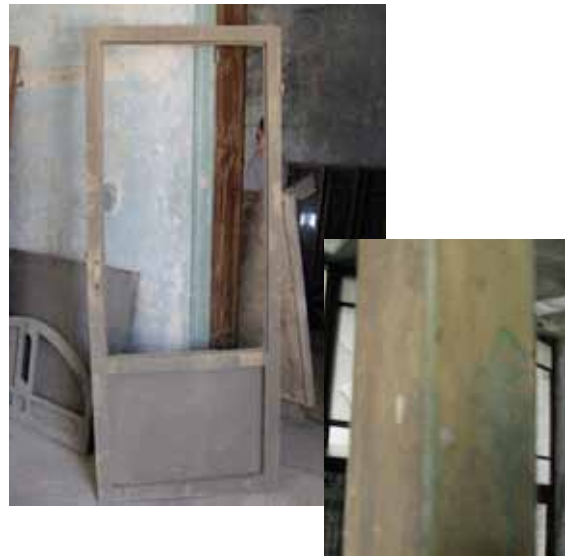
Number: #0014
Location: Attic
Image #: 195, 196

Item: window frame, arched with fold down transom windows

Quantity: 1
Color: yellow paint/ wood stain
Hardware: window straps
Other:

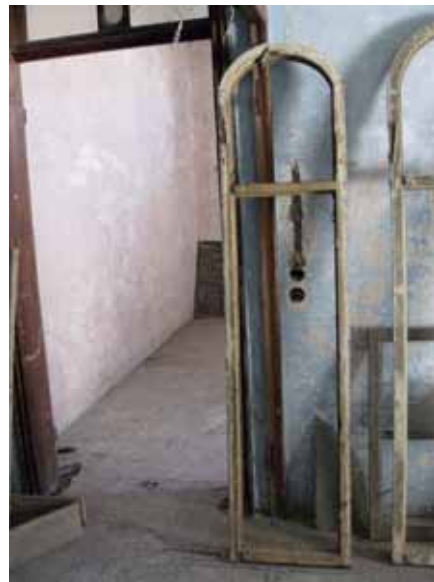
Number: #0015
Location: Attic
Image #: 197

Item: window frame, arched
1

Quantity: cream paint/wood stain
Color:
Hardware:
Other: larger than item #0014

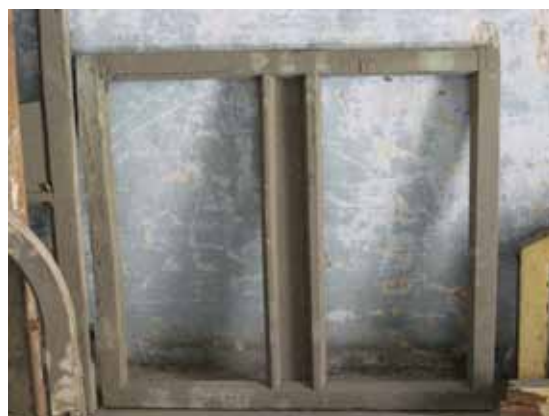
Number: #0019
Location: Attic
Image #: 201

Item: window frame, rectangle

Quantity: 2
Color: green paint/green paint
Hardware:
Other: one with broken glass, one with no glass

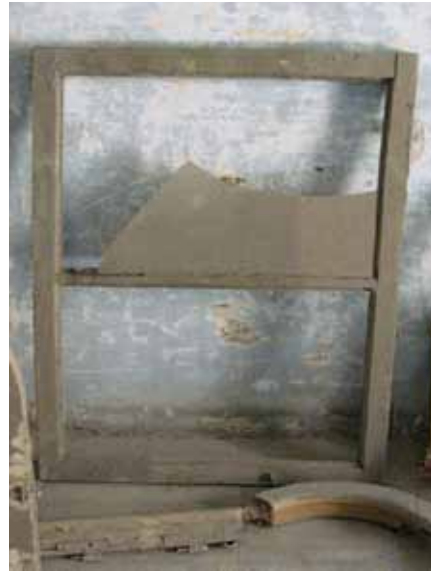
Number: #0020
Location: Attic
Image #: 203

Item: window frame, rectangle

Quantity: 2
Color: yellow paint/cream paint
Hardware:
Other: no glass

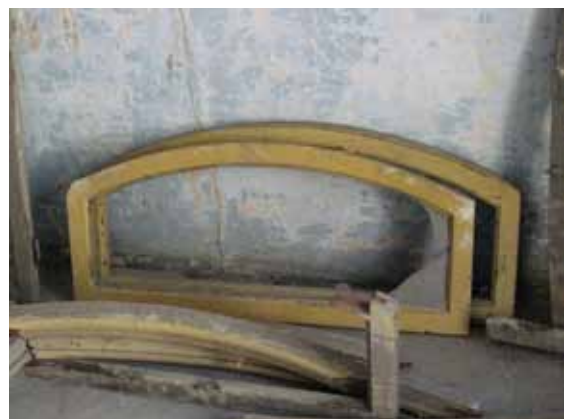
Number: #0022
Location: Attic
Image #: 205

Item: window frame, slight arched

Quantity: 3
Color: cream paint/cream paint
Hardware: hinges and latches
Other: broken glass

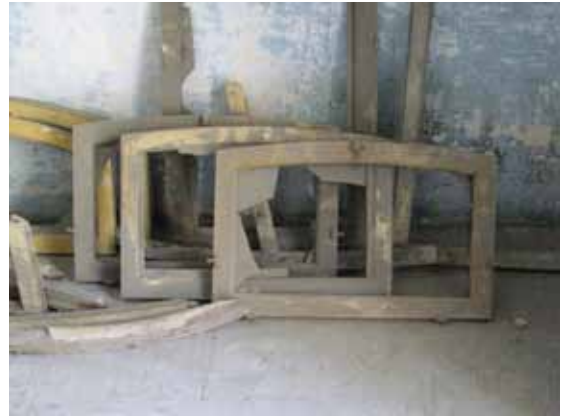
Number: #0023
Location: Attic
Image #: 206

Item: window frame, slight arched

Quantity: 1
Color: yellow paint/yellow paint
Hardware: hinges and latches
Other: broken glass, larger than item #0022

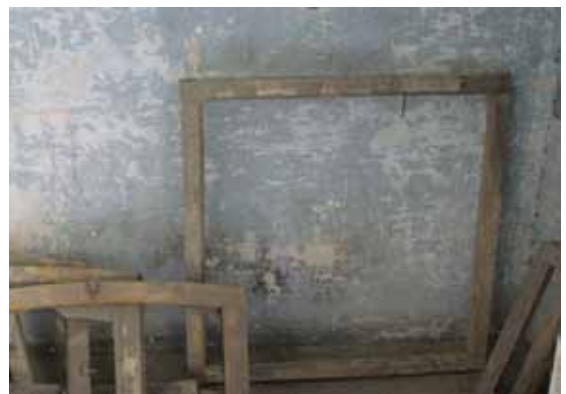
Number: #0025
Location: Attic
Image #: 208

Item: window frame, small half arch
window both sides
Quantity: 1
Color: yellow paint/yellow paint
Hardware: window straps
Other: no glass

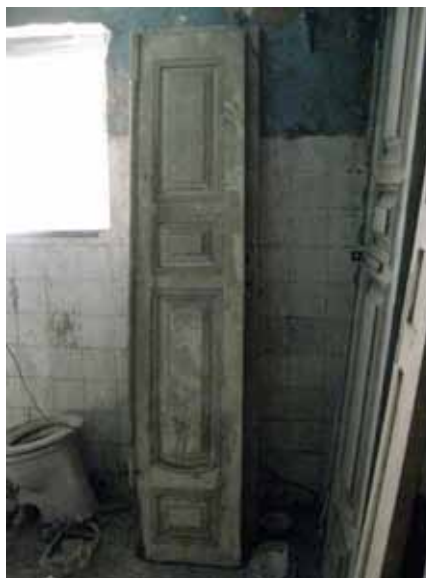
Number: #0033
Location: Attic
Image #: 217, 218

Item: door

Quantity: 1
Color: wood stain/wood stain
Hardware: hinges, slide lock
Other: broken glass, patterned

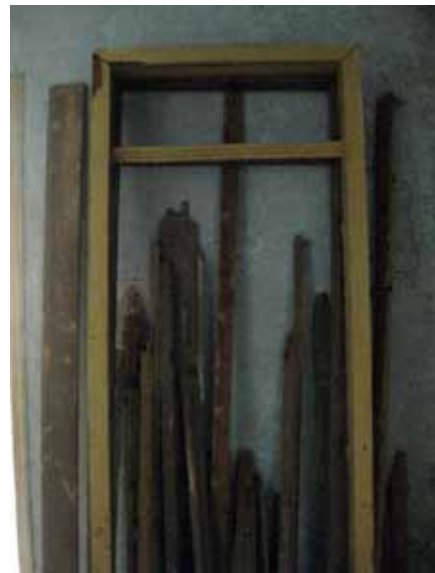
Number: #0036

Hardware: hardware intact

Other: missing bottom 2 glass panes

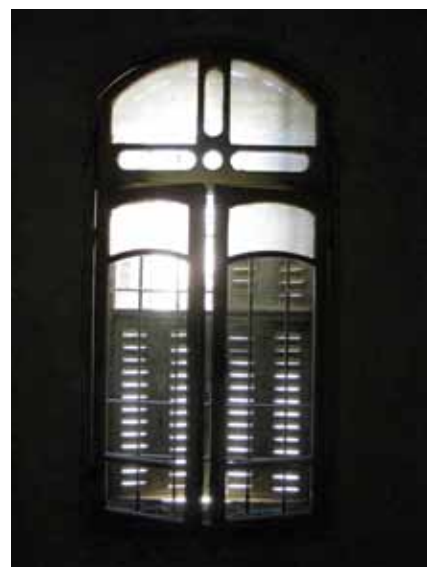
Number: #0037
Location: Existing Installed, master bed
Image #: 225

Item: window, double casement

Quantity: 1
Color: cream paint/cream paint
Hardware: hardware intact
Other: broken and missing glass

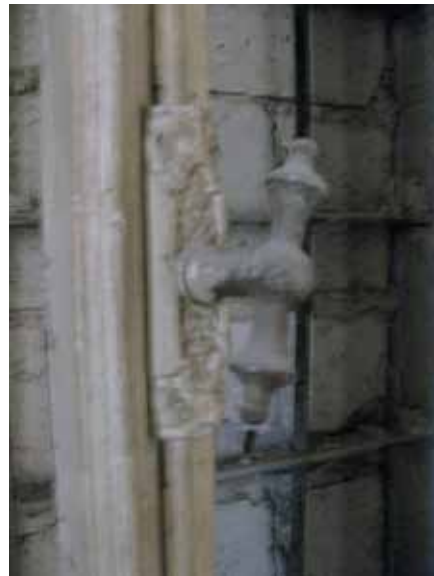
Number: #0039
Location: Existing Installed, master bed
Image #: 227

Item: door frame, with transom

Quantity: 1
Color: cream paint/cream paint
Hardware: hinges
Other: transom intact, missing door

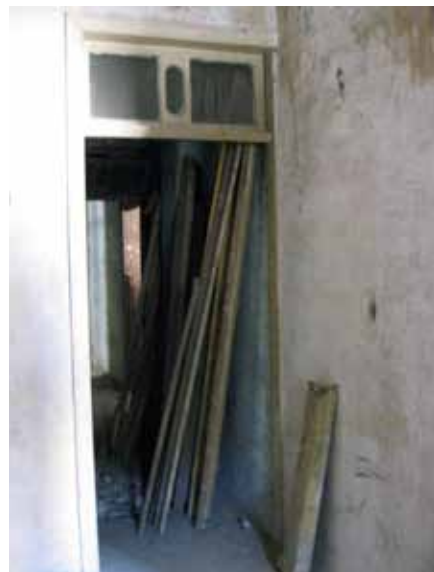
Number: #0040
Location: Existing Installed, master bed
Image #: 228

Item: door frame, with transom

Quantity: 1
Color: cream paint/cream paint
Hardware: hinges
Other: transom intact, missing door

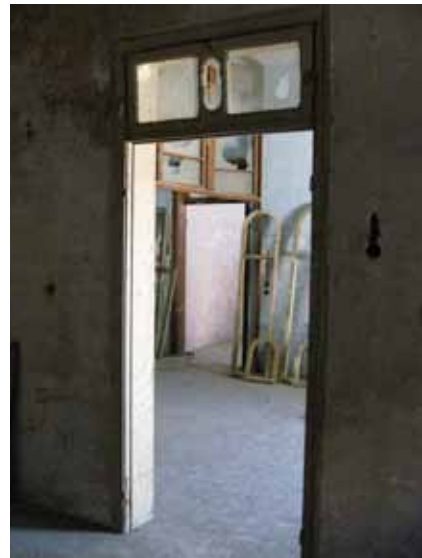
Number: #0041
Location: Existing Installed, master bed
Image #: 229

Item: door frame, with transom

Quantity: 1
Color: cream paint/cream paint
Hardware: hinges
Other: transom intact, missing door

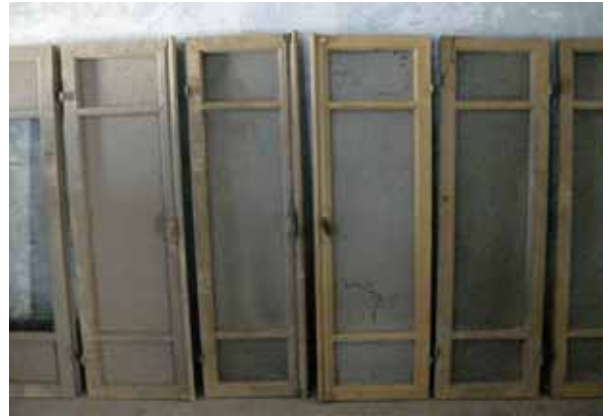
Number: #0011
Location: Attic
Image #: 189

Item: door, large pantry

Quantity: 1
Color: cream paint/cream paint
Hardware: missing handle
Other:

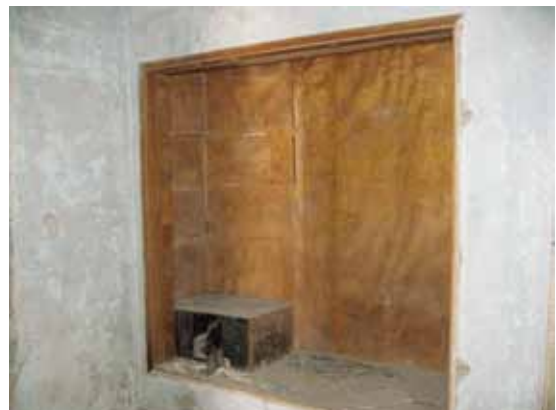
Number: #0045
Location: Existing Installed, hall
Image #: 235

Item: door frame, double doors

Quantity: 1
Color: yellow paint/cream paint
Hardware: lock plate gone, no hardware
Other:

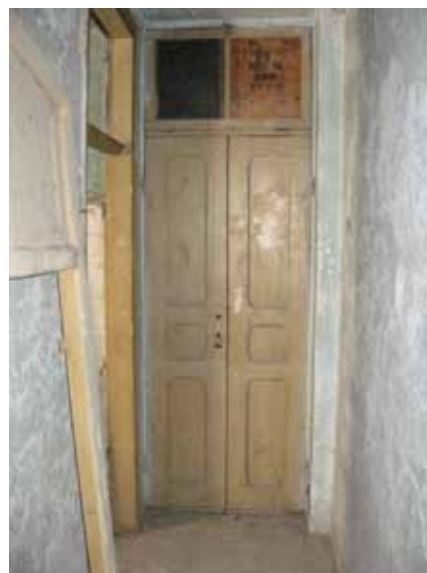
Number: #0046
Location: Existing Installed, bathroom
Image #: 236, 237

Item: door frame, with transom

Quantity: 1
Color: yellow paint/yellow paint
Hardware: broken lock, hinges on one side
Other: missing transom

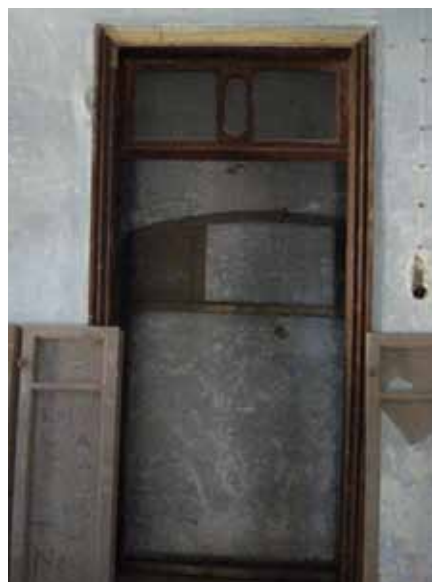
Number: #0047
Location: Existing Installed, liwan
Image #: 238

Item: door frame, with transom

Quantity: 1
Color:
Hardware: cream paint/wood stain
Other: hinges, misaligned

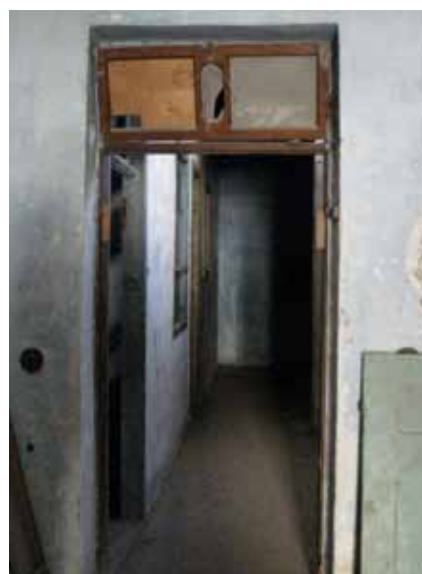
Number: #0048
Location: Existing Installed, liwan
Image #: 239

Item: door frame, with transom

Quantity: 1
Color: wood stain/wood stain
Hardware: hinges, both sides
Other: moulding on one side, higher threshold

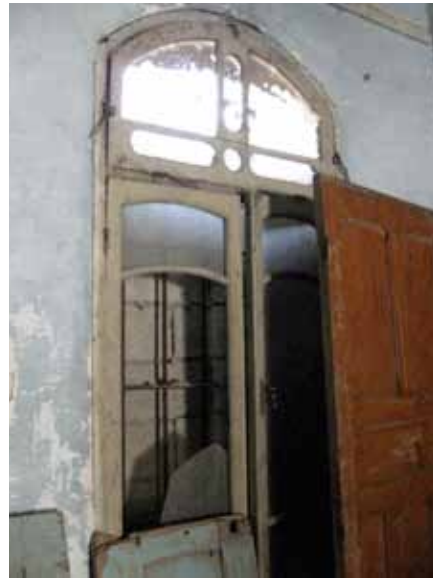
Number: #0049
Location:
Image #: Existing Installed, liwan
240
Item: window, double casement

Quantity: 1
Color: cream paint/cream paint
Hardware: hardware intact
Other: broken glass

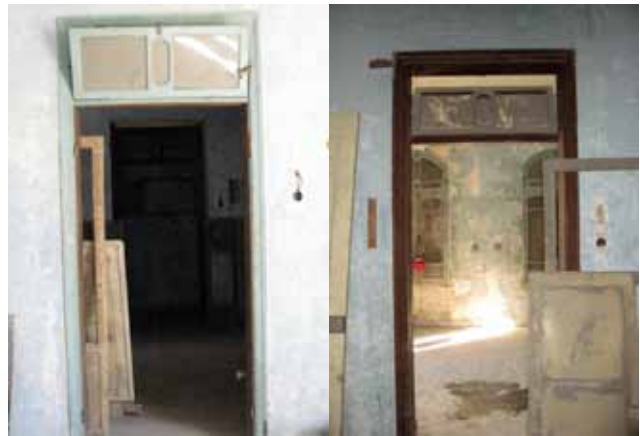
Number: #0050
Location: Existing Installed, liwan
Image #: 244, 245

Item: door frame, with transom

Quantity: 1
Color: green paint/wood stain
Hardware: hinges, both sides
Other:

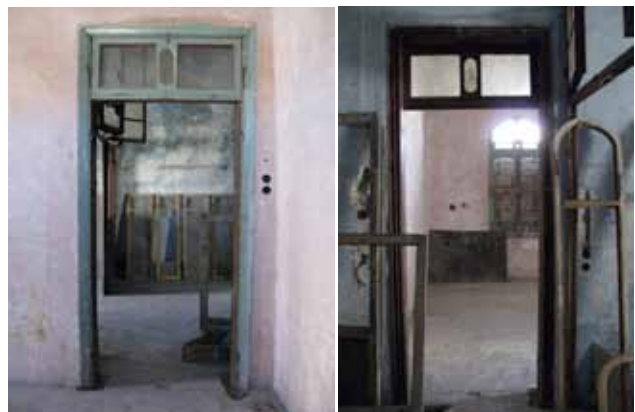
Number: #0051
Location: Existing Installed, liwan
Image #: 246, 247

Item: door frame, with transom

Quantity: 1
Color: green paint/wood stain
Hardware: hinges, both sides
Other:

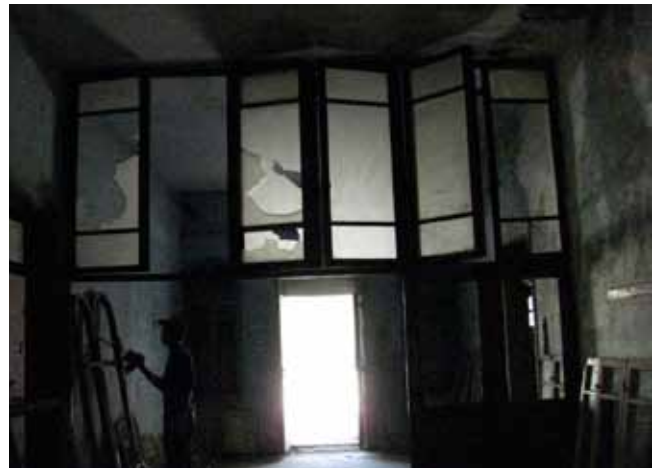
Number: #0052
Location: Existing Installed, liwan
Image #: 252

Item: door, accordion screen,
6 across
Quantity: 1
Color: wood stain/wood stain
Hardware: hardware intact
Other: variety of glass patterns broken,
water damage at right side

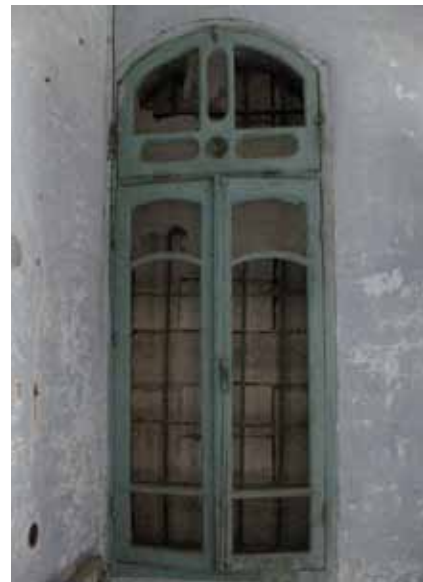
Number: #0053
Location: Existing Installed, liwan
Image #: 253

Item: window, double casement
Quantity: 1
Color: turquoise paint/turquoise paint
Hardware: hardware intact
Other: missing glass

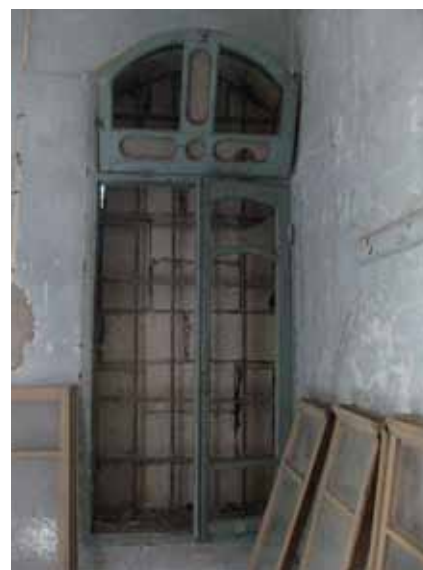
Number: #0054
Location: Existing Installed, liwan
Image #: 254

Item: window, double casement
Quantity: 1
Color: turquoise paint/turquoise paint
Hardware: hardware intact
Other:

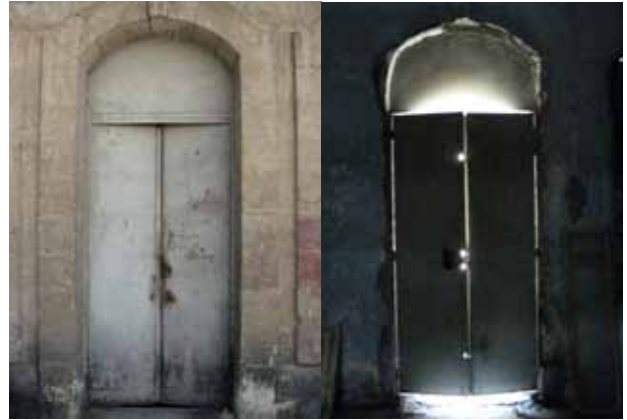
Number: #0055
Location: Existing Installed, liwan
Image #: 255,256

Item: door, exterior front with arched transom
Quantity: 1
Color: steel
Hardware: not original
Other:

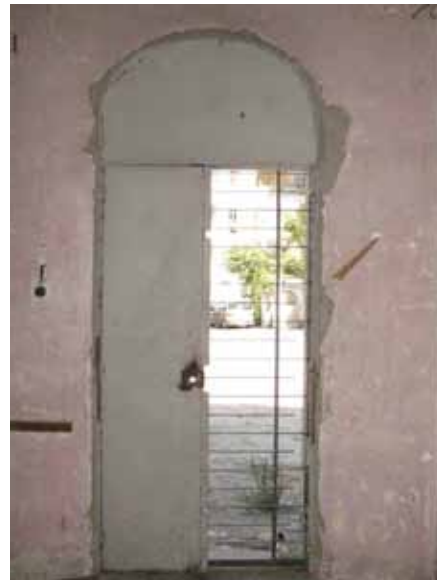
Number: #0056
Location: Existing Installed, study
Image #: 260

Item: Door, Exterior, double door, with arched transom
Quantity: 1
Color: steel
Hardware: not original
Other:

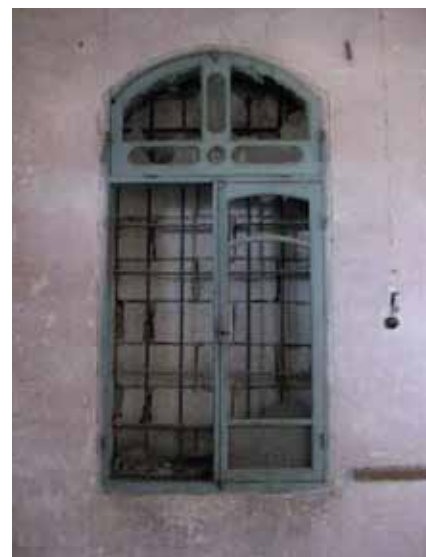
Number: #0057
Location: Existing Installed, study
Image #: 261

Item: window, double casement
Quantity: 1
Color: green paint/green paint
Hardware: hardware intact
Other: broken and missing glass

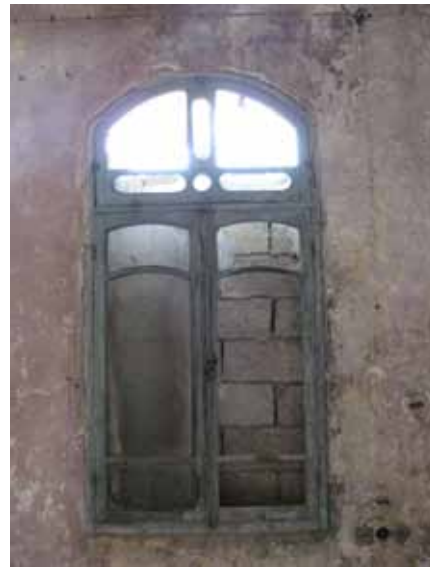
Number: #0058
Location: Existing Installed, study
Image #: 262

Item: window, double casement

Quantity: 1
Color: green paint/green paint
Hardware: hardware intact
Other: broken and missing glass

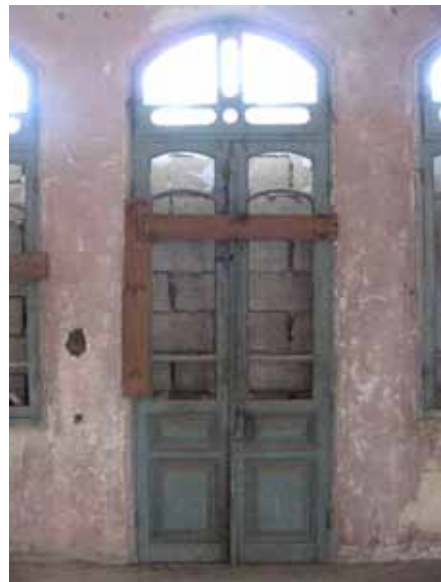
Number: #0059
Location: Existing Installed, study
Image #: 263

Item: door, exterior terrace with arched transom

Quantity: 1
Color: green paint/green paint
Hardware: key plate bent
Other: broken and missing glass

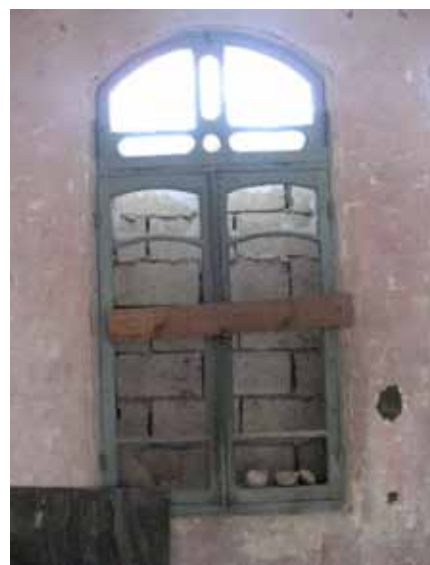
Number: #0060
Location: Existing Installed, study
Image #: 264

Item: window, double casement

Quantity: 1
Color: green paint/green paint
Hardware: hardware intact
Other: broken and missing glass

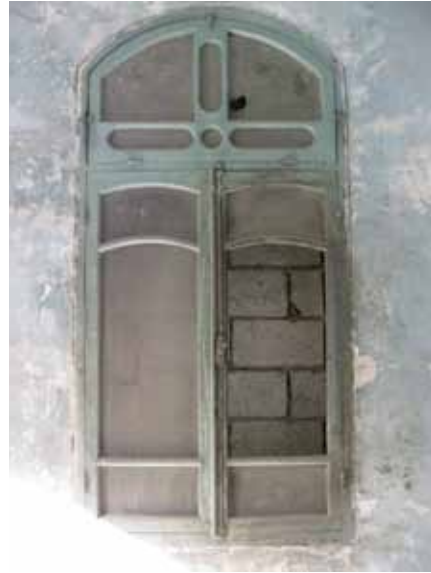
Number: #0061
Location: Existing Installed, girls bedroom
Image #: 268

Item: window, double casement

Quantity: 1
Color: green paint/green paint
Hardware: hardware intact
Other: broken and missing glass

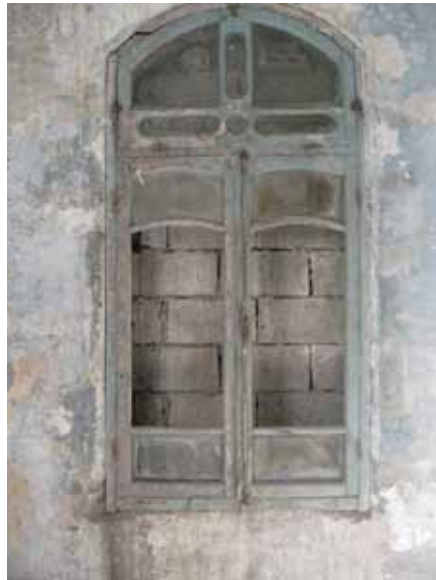
Number: #0062
Location: Existing Installed, girls bedroom
Image #: 269

Item: window, double casement

Quantity: 1
Color: green paint/green paint
Hardware: hardware intact
Other: broken and missing glass, water damage

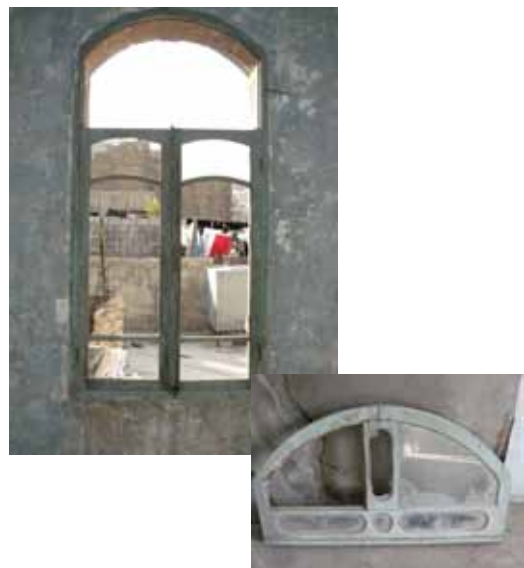
Number: #0063
Location: Existing Installed, girls bedroom
Image #: 270, 271

Item: window, to patio, double casement

Quantity: 1
Color: green paint/green paint
Hardware: hardware intact
Other: broken and missing glass

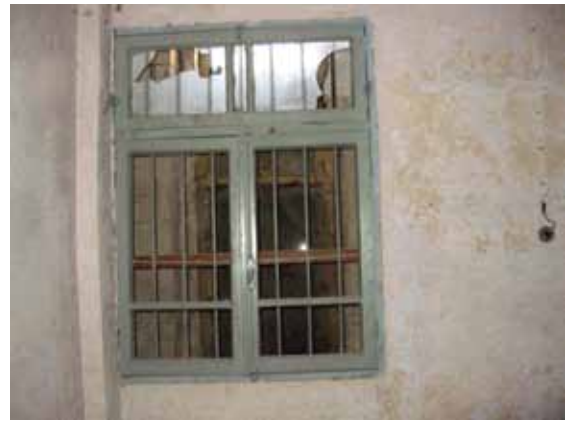
Number: #0064
Location: Existing Installed, boys bedroom
Image #: 274, 276

Item: window, double casement

Quantity: 1
Color: green paint/green paint
Hardware: hardware intact, exterior
Other: wondow bars
broken and missing glass

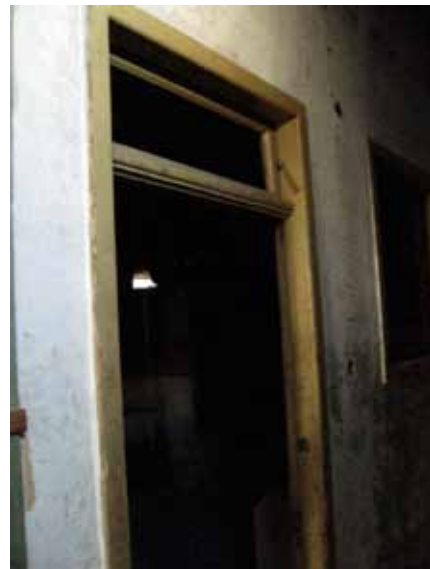
Number: #0087
Location: Existing Installed, boys bedroom
Image #: 277

Item: door frame, with transom

Quantity: 1
Color: yellow paint/yellow paint
Hardware:
Other:

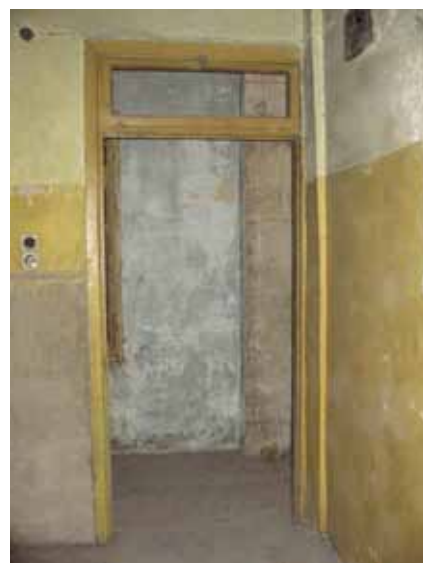
Number: #0065
Location: Existing Installed, kitchen
Image #: 278

Item: door frame, with transom

Quantity: 1
Color: yellow paint/yellow paint
Hardware:
Other: broken and missing glass

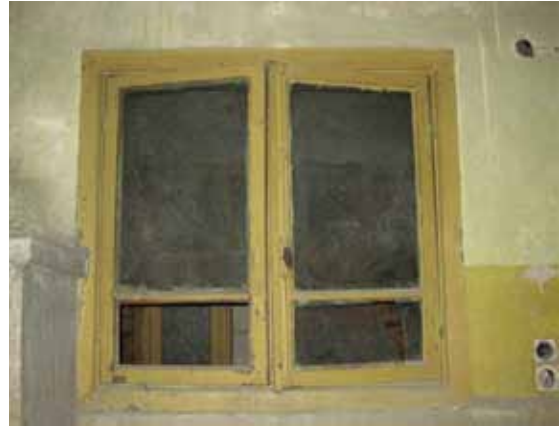
Number: #0066
Location: Existing Installed, hall
Image #: 279

Item: window, square, double casement
Quantity: 1
Color: yellow paint/yellow paint
Hardware:
Other: broken and missing glass

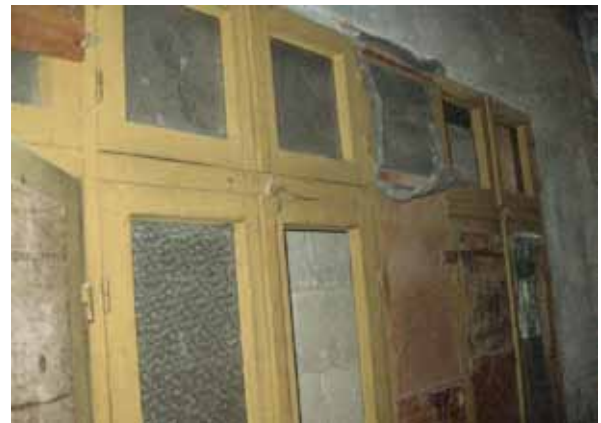
Number: #0067
Location: Existing Installed, hall
Image #: 280-282

Item: window door unit, 5 glass panes, 1 door
Quantity: 1
Color: yellow paint/yellow paint
Hardware: mortise lock missing
Other: broken and missing glass

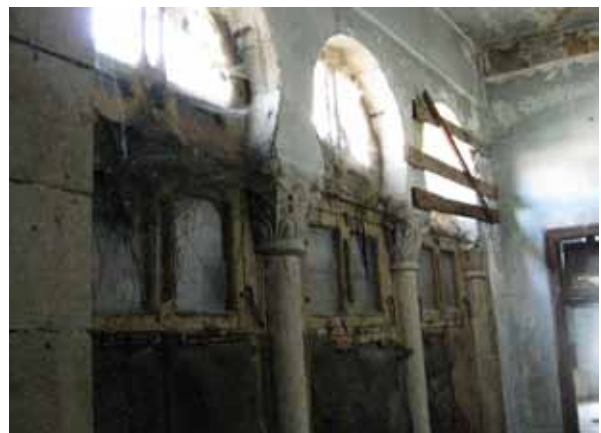
Number: #0068
Location: Existing Installed, hall
Image #: 290-292

Item: windows, columned arcade
Quantity: 1
Color: yellow paint/unknown
Hardware: hardware intact
Other: missing right upper transom

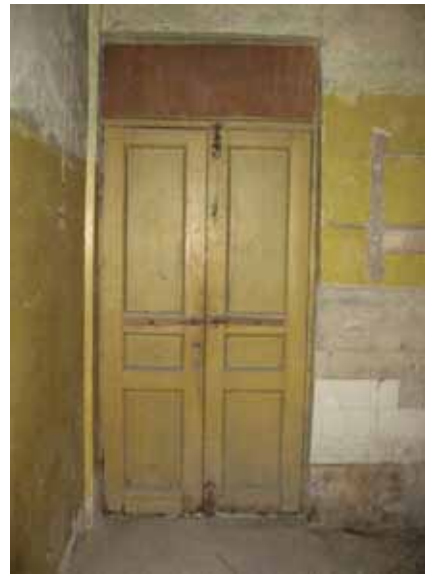
Number: #0069
Location: Existing Installed, kitchen
Image #: 293

Item: door, exterior, double doors with transom
Quantity: 1
Color: yellow paint/unkown
Hardware: lock intact
Other:

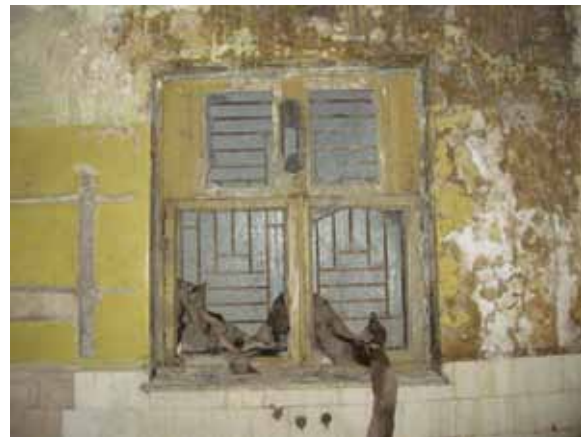
Number: #0070
Location: Existing Installed, kitchen
Image #: 294

Item: window, square with transom
Quantity: 1
Color: yellow paint/unkown
Hardware: no handle
Other: missing transom

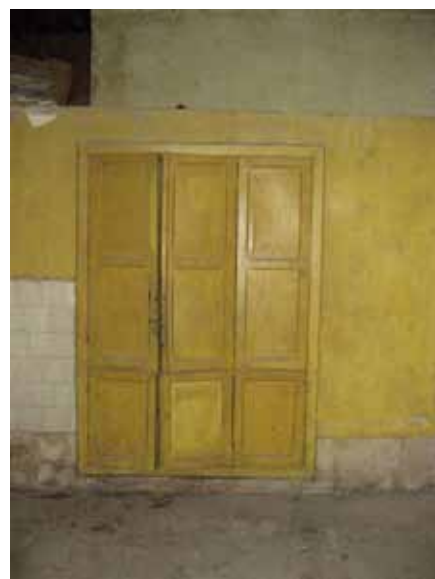
Number: #0071
Location: Existing Installed, kitchen
Image #: 295

Item: doors, cabinet
Quantity: 1
Color: yellow paint/unknown
Hardware: slide latches on interior
Other:

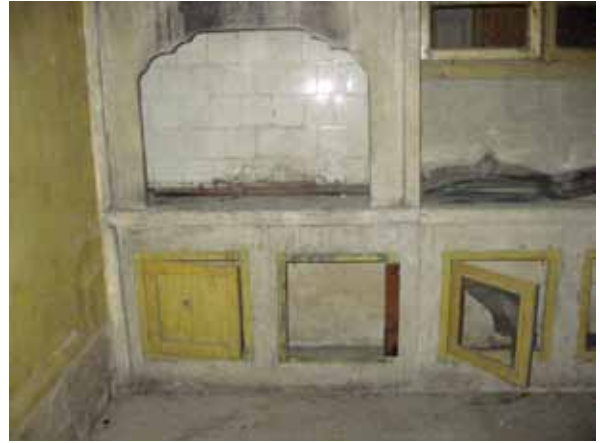
Number: #0072
Location: Existing Installed, kitchen
Image #: 296-298

Item: doors, cabinet

Quantity: 1
Color: yellow paint/cream paint
Hardware:
Other: cupboards at bottom,
missing 2 doors

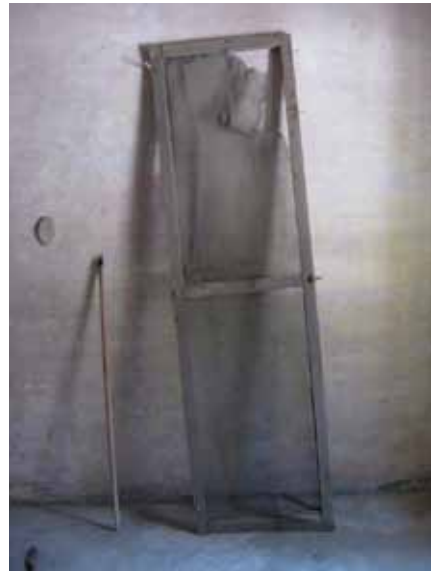
Number: #0073
Location: Attic
Image #: E1

Item: window screen, square

Quantity: 1
Color: wood stain/natural wood
Hardware: nails at perimeter
Other:

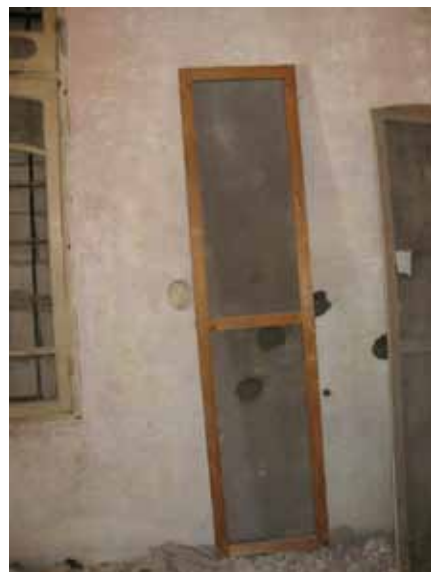
Number: #0074
Location: Attic
Image #: E2

Item: door screen, rectangle

Quantity: 1
Color: wood stain/natural wood
Hardware: nails at perimeter
Other:

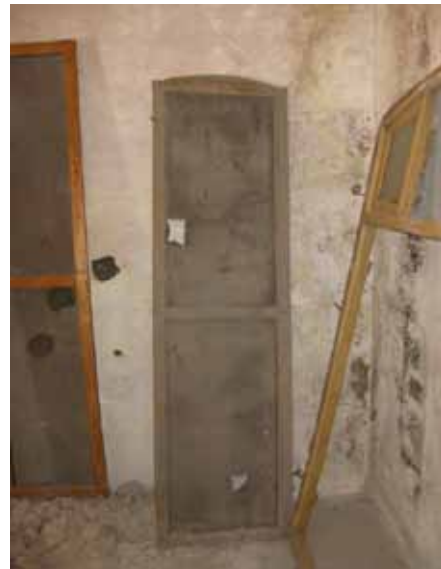
Number: #0075

Color: wood stain/natural wood

Hardware: nails at perimeter

Other: with added top arch

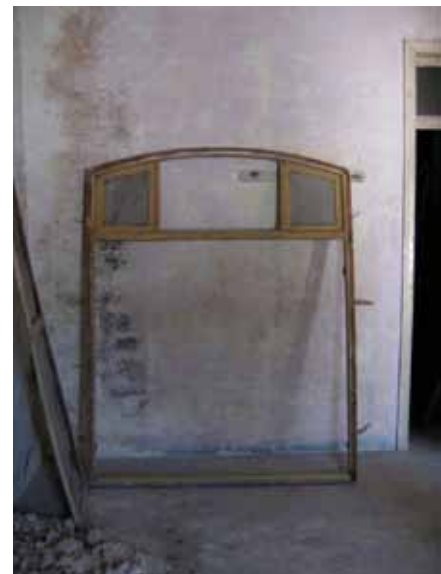
Number: #0076

Color: yellow paint/ wood stain

Hardware: hanging window straps

Other: missing panels

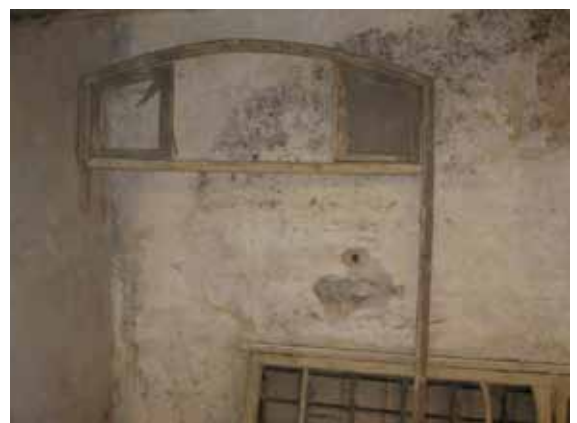
Number: #0077

Hardware: hanging window straps and hinges

Other: fragment

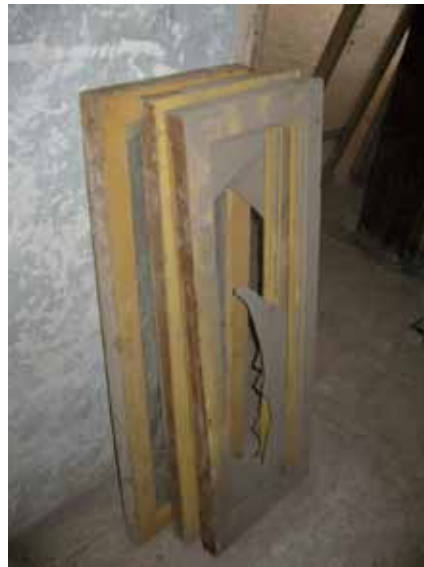
Number: #0078
Location: Attic
Image #: E7

Item: window, small rectangle

Quantity: 3
Color: yellow paint/yellow paint
Hardware:
Other: 2 missing glass

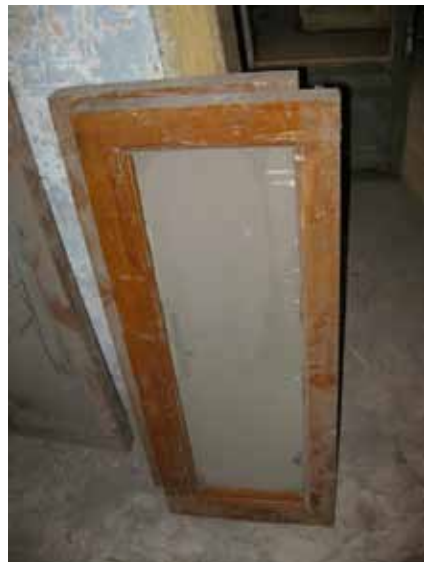
Number: #0079
Location: Attic
Image #: E8

Item: window, small rectangle

Quantity: 2
Color: yellow paint/ wood stain
Hardware:
Other:

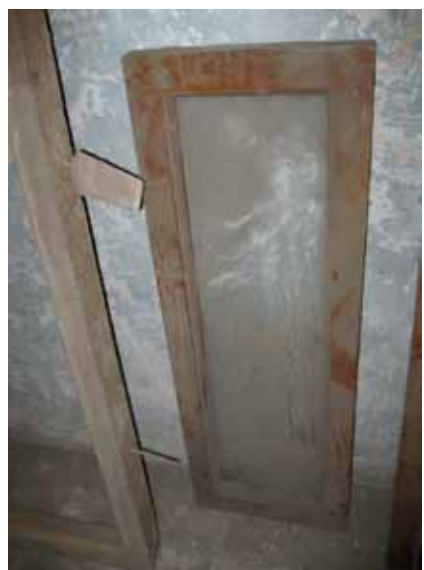
Number: #0080
Location: Attic
Image #: E9

Item: window, small rectangle (larger than Item #0079)

Quantity: 1
Color: wood stain/wood stain
Hardware:
Other:

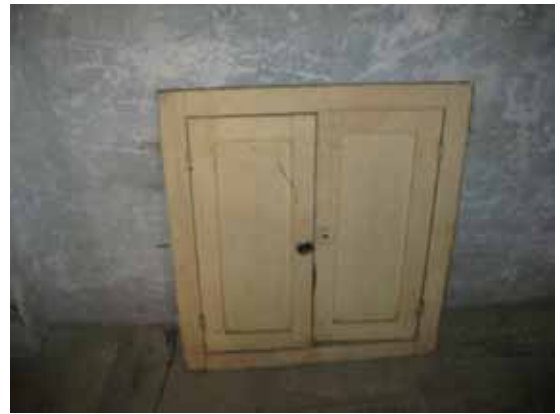
Number: #0081

Color: yellow paint/ wood stain

Hardware: both doors frame and knob

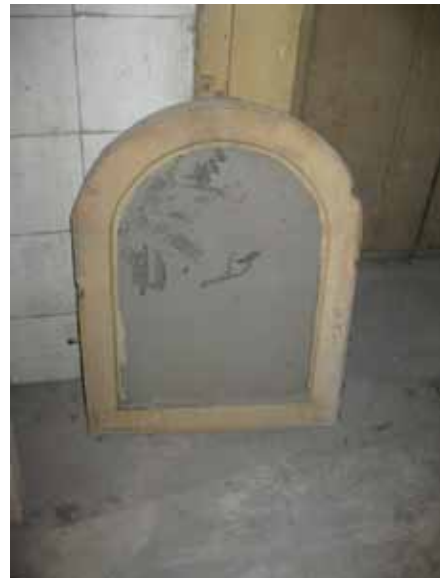
Number: #0082

Color: yellow paint/ wood stain

Hardware: hinges

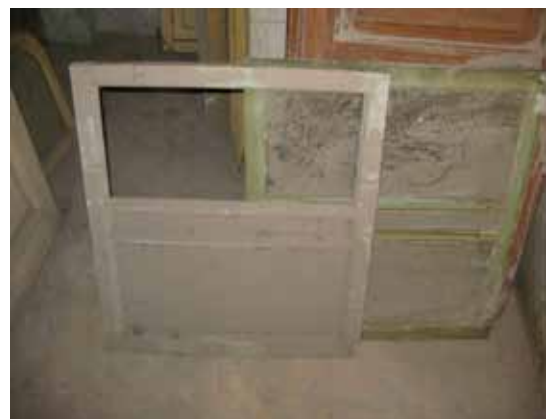
Number: #0083

Hardware: one glass pane missing

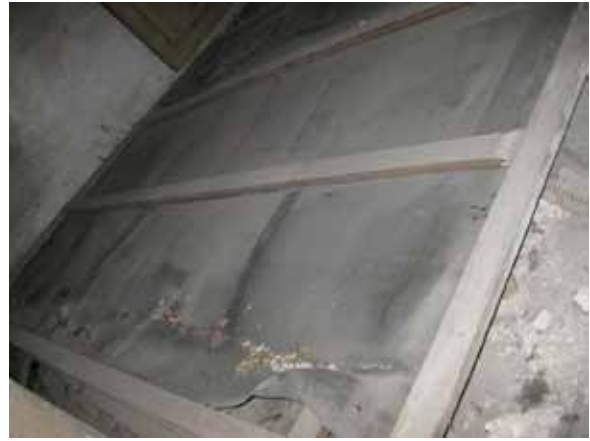
Number: #0084
Location: Attic
Image #: E13

Item: door screen, 3 panel

Quantity: 2
Color: natural wood/natural wood
Hardware: nails at perimeter
Other:

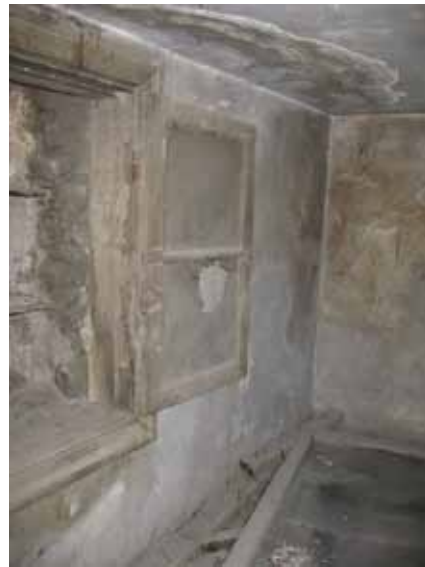
Number: #0085
Location: Existing Installed, Attic
Image #: E14

Item: window, small rectangle

Quantity: 1
Color: unknown
Hardware:
Other:

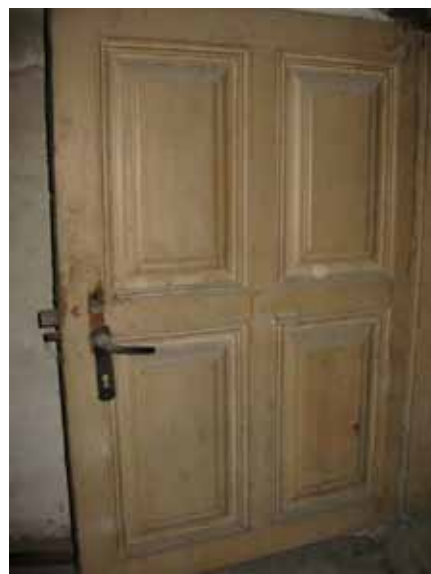
Number: #0086
Location: Existing Installed, Attic
Image #: E15

Item: door, half size, 4 panel

Quantity: 1
Color: yellow paint/yellow paint
Hardware: mortise lock (male)with handle
Other:
