## Miramar Coastal Trail on the edge of an eroding shoreline

#### Mirada Rd Coastal Trail Bridge

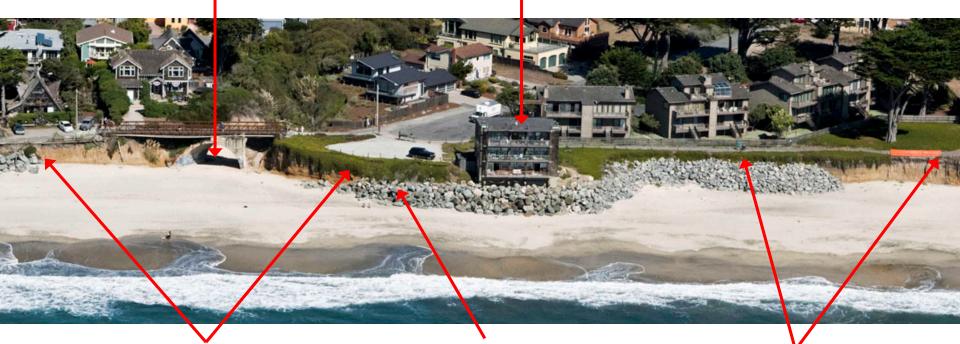
County proposes aluminum replacement bridge and armoring to wrap both sides of the mouth of the arroyo, connecting to existing shoreline riprap.

Coastal Commission has open enforcement action on unpermitted riprap along the private parking lot.

Coastal Commission won't allow armoring to protect the Coastal Trail – must reroute inland.

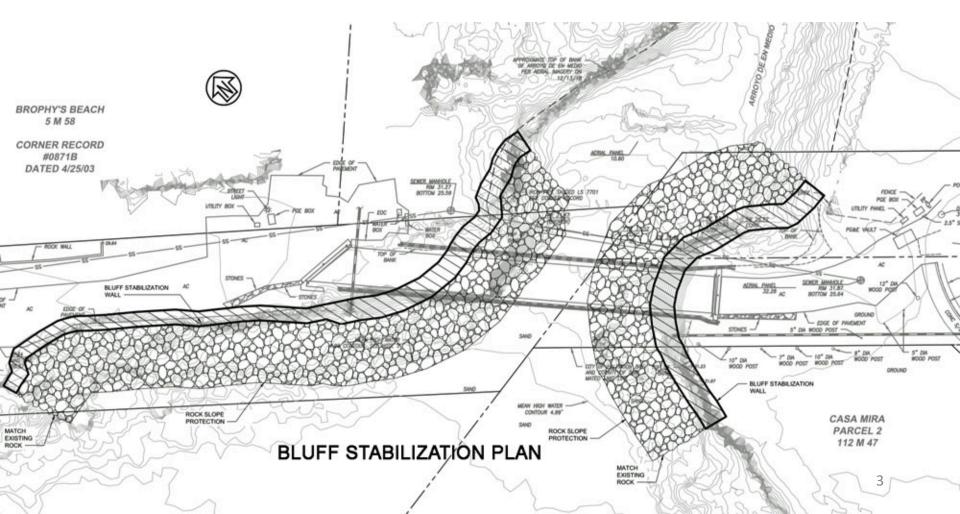
### 6/3/20 CDP application by County Dept of Public Works to Coastal Commission:

- 120-ft long single-span aluminum bridge with hybrid armoring consisting of
- · shotcrete seawalls with tieback anchors, and
- rock slope protection along both banks of Arroyo de en Medio.

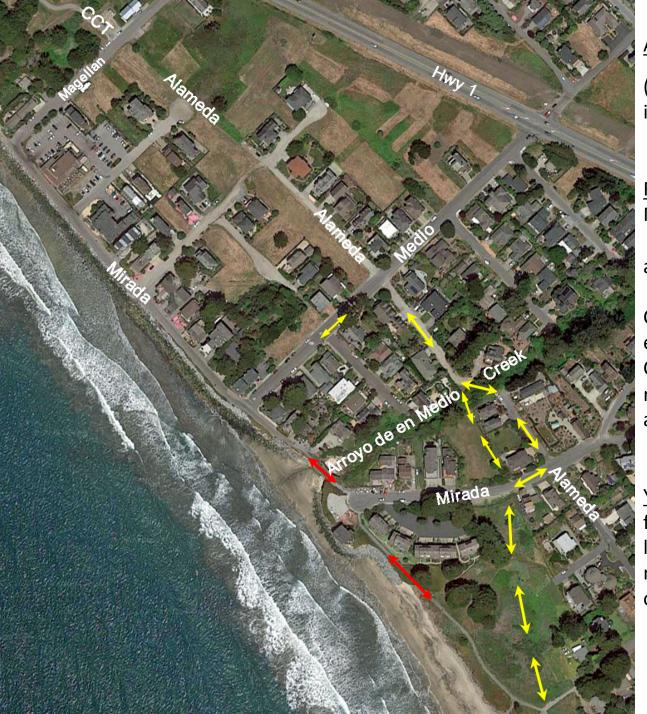
#### **Alignment Alternatives**

(South of Mirada Rd jurisdiction is City of Half Moon Bay)

#### Red arrows:

Mirada Rd Coastal Trail Bridge closed at Arroyo de en Medio Creek

Coastal Trail threatened by erosion at Casa Mira condos – Coastal Commission prefers re-routing the trail to armoring the shoreline.

Yellow arrows: Alternate routes for Coastal Trail via State Parks land, and Alameda Ave, with new inland bike/ped bridge over Medio Creek.

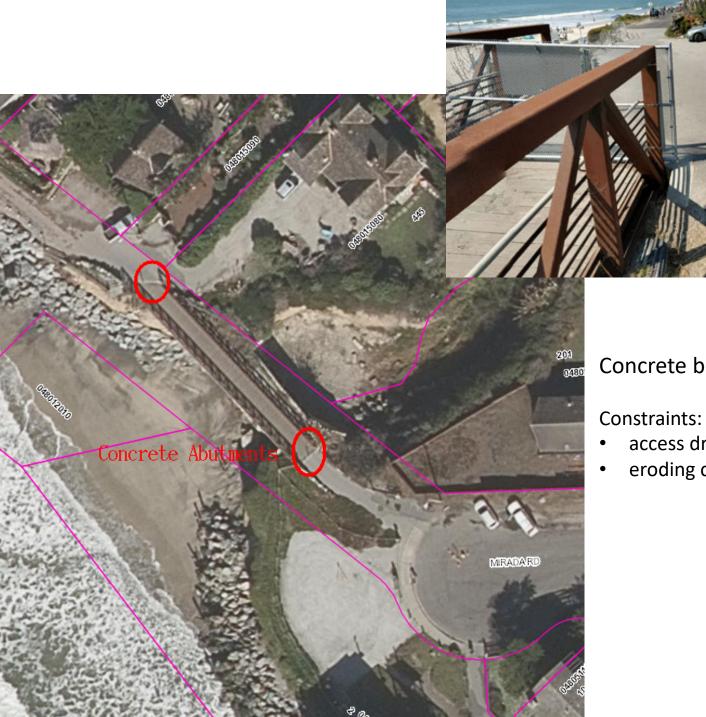
# Concrete bridge abutments

- access driveways
- eroding coastal bluffs
