Fitzgerald Marine Reserve Sunshine Valley to Beach Access Ramp

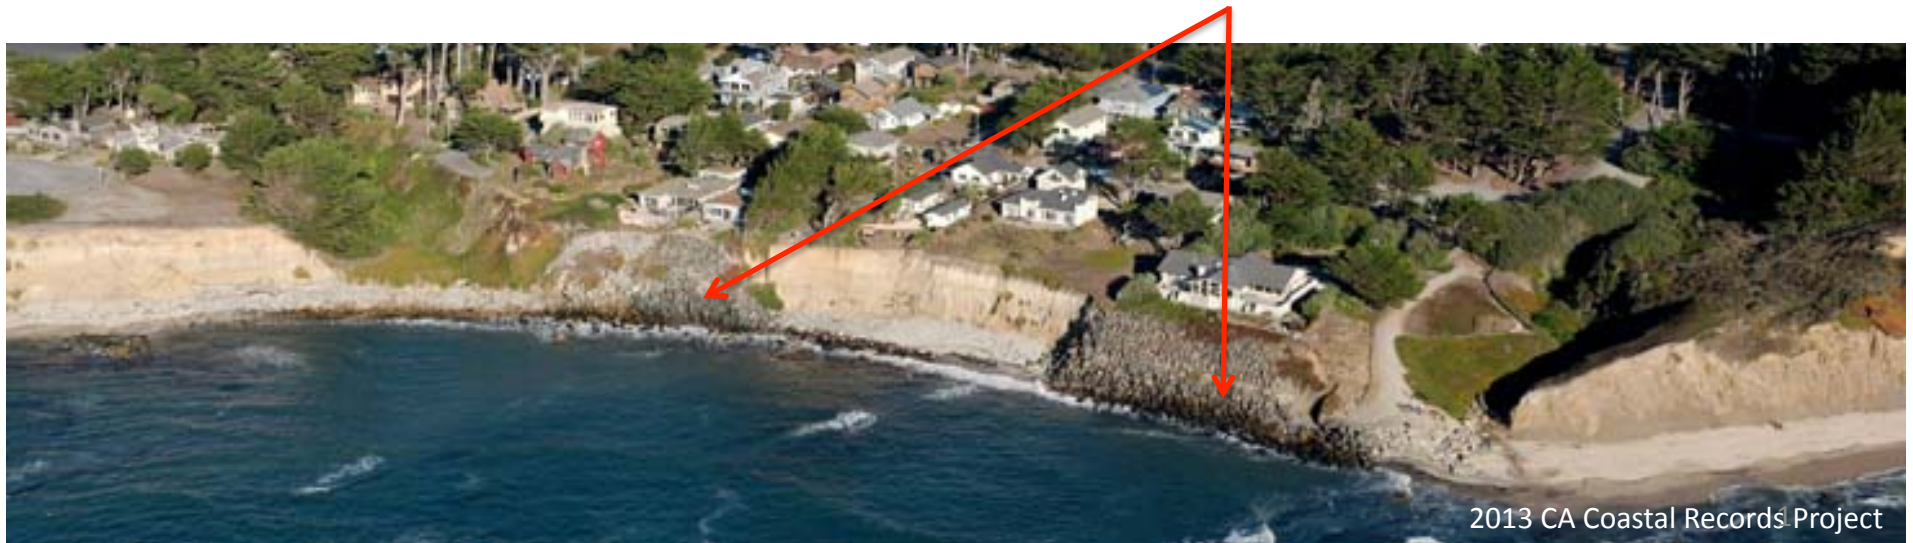
Historic house at 101 Beach St --

Threatened by bluff erosion in 2002,
instead of armoring the cliff,
the house was moved inland onto
a neighboring parcel.

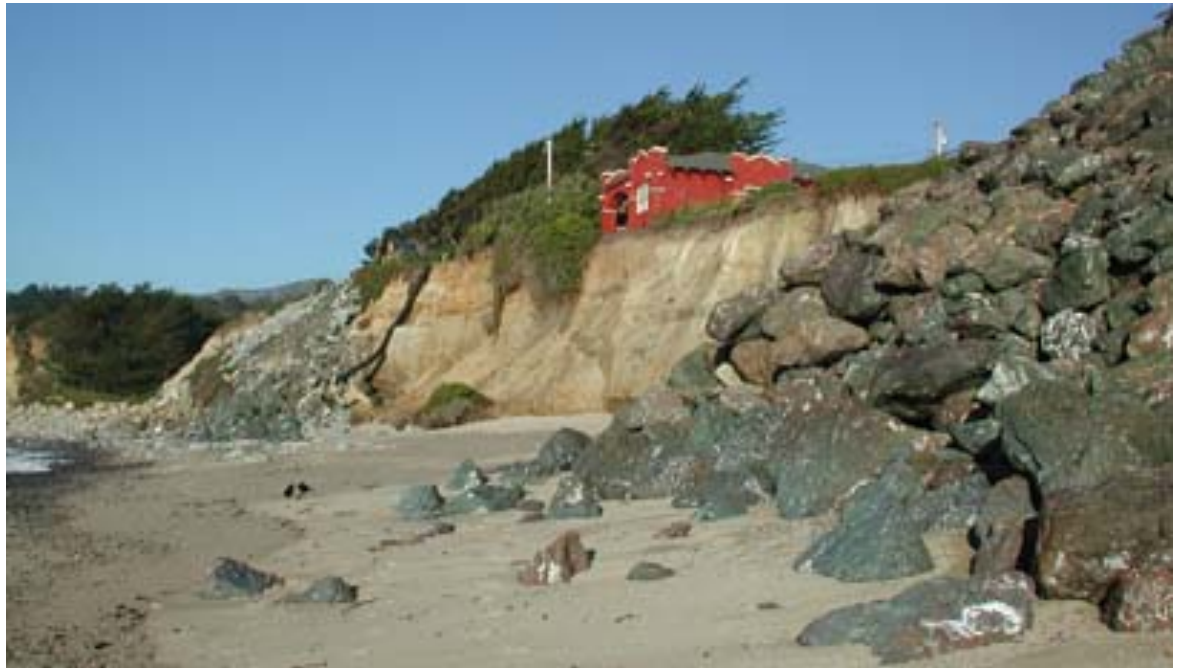
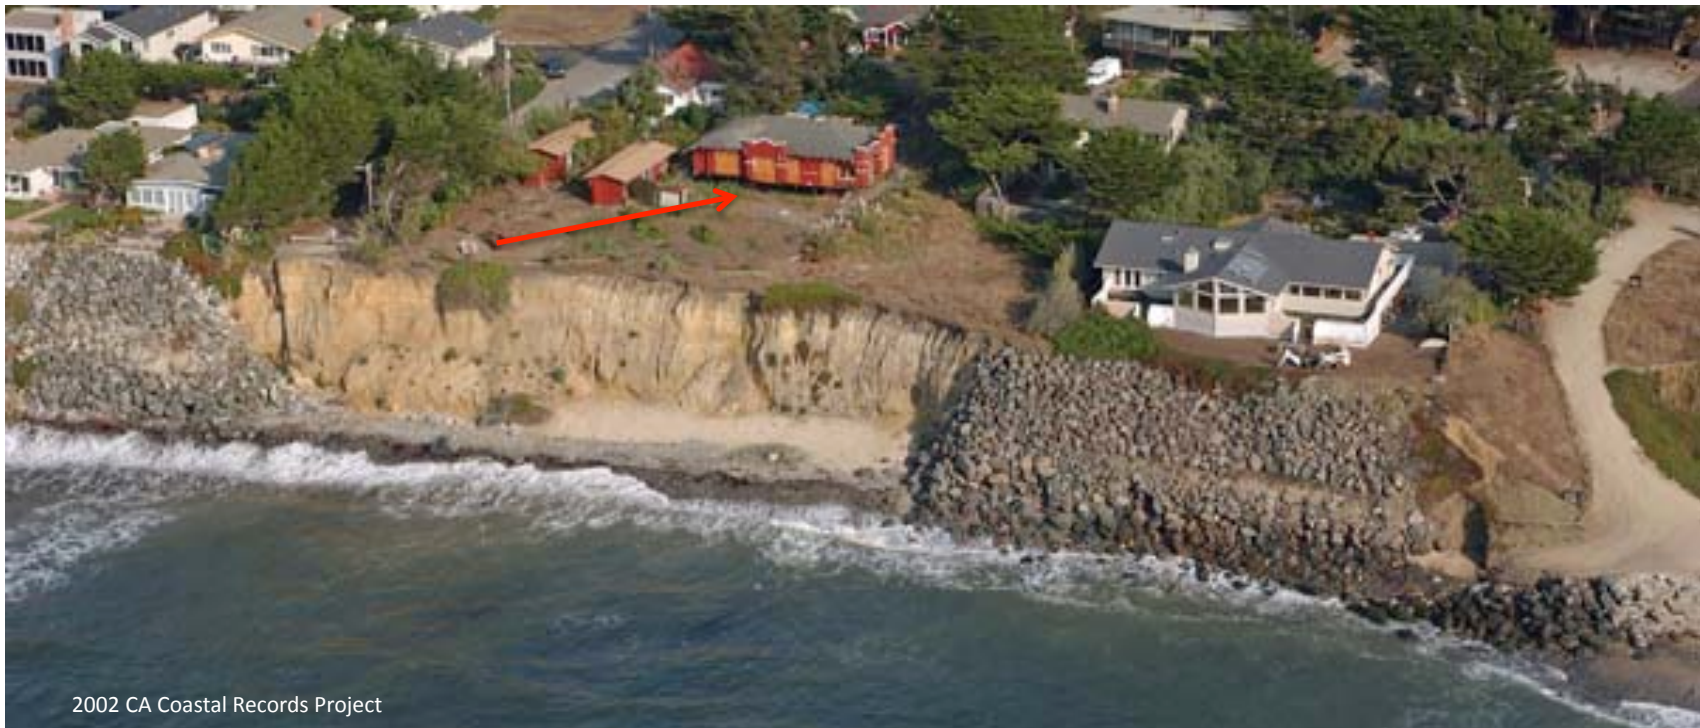
View north from FMR beach access point, 2012

At high tide, public beach access to the north is completely blocked and the view is marred by coastal armoring.

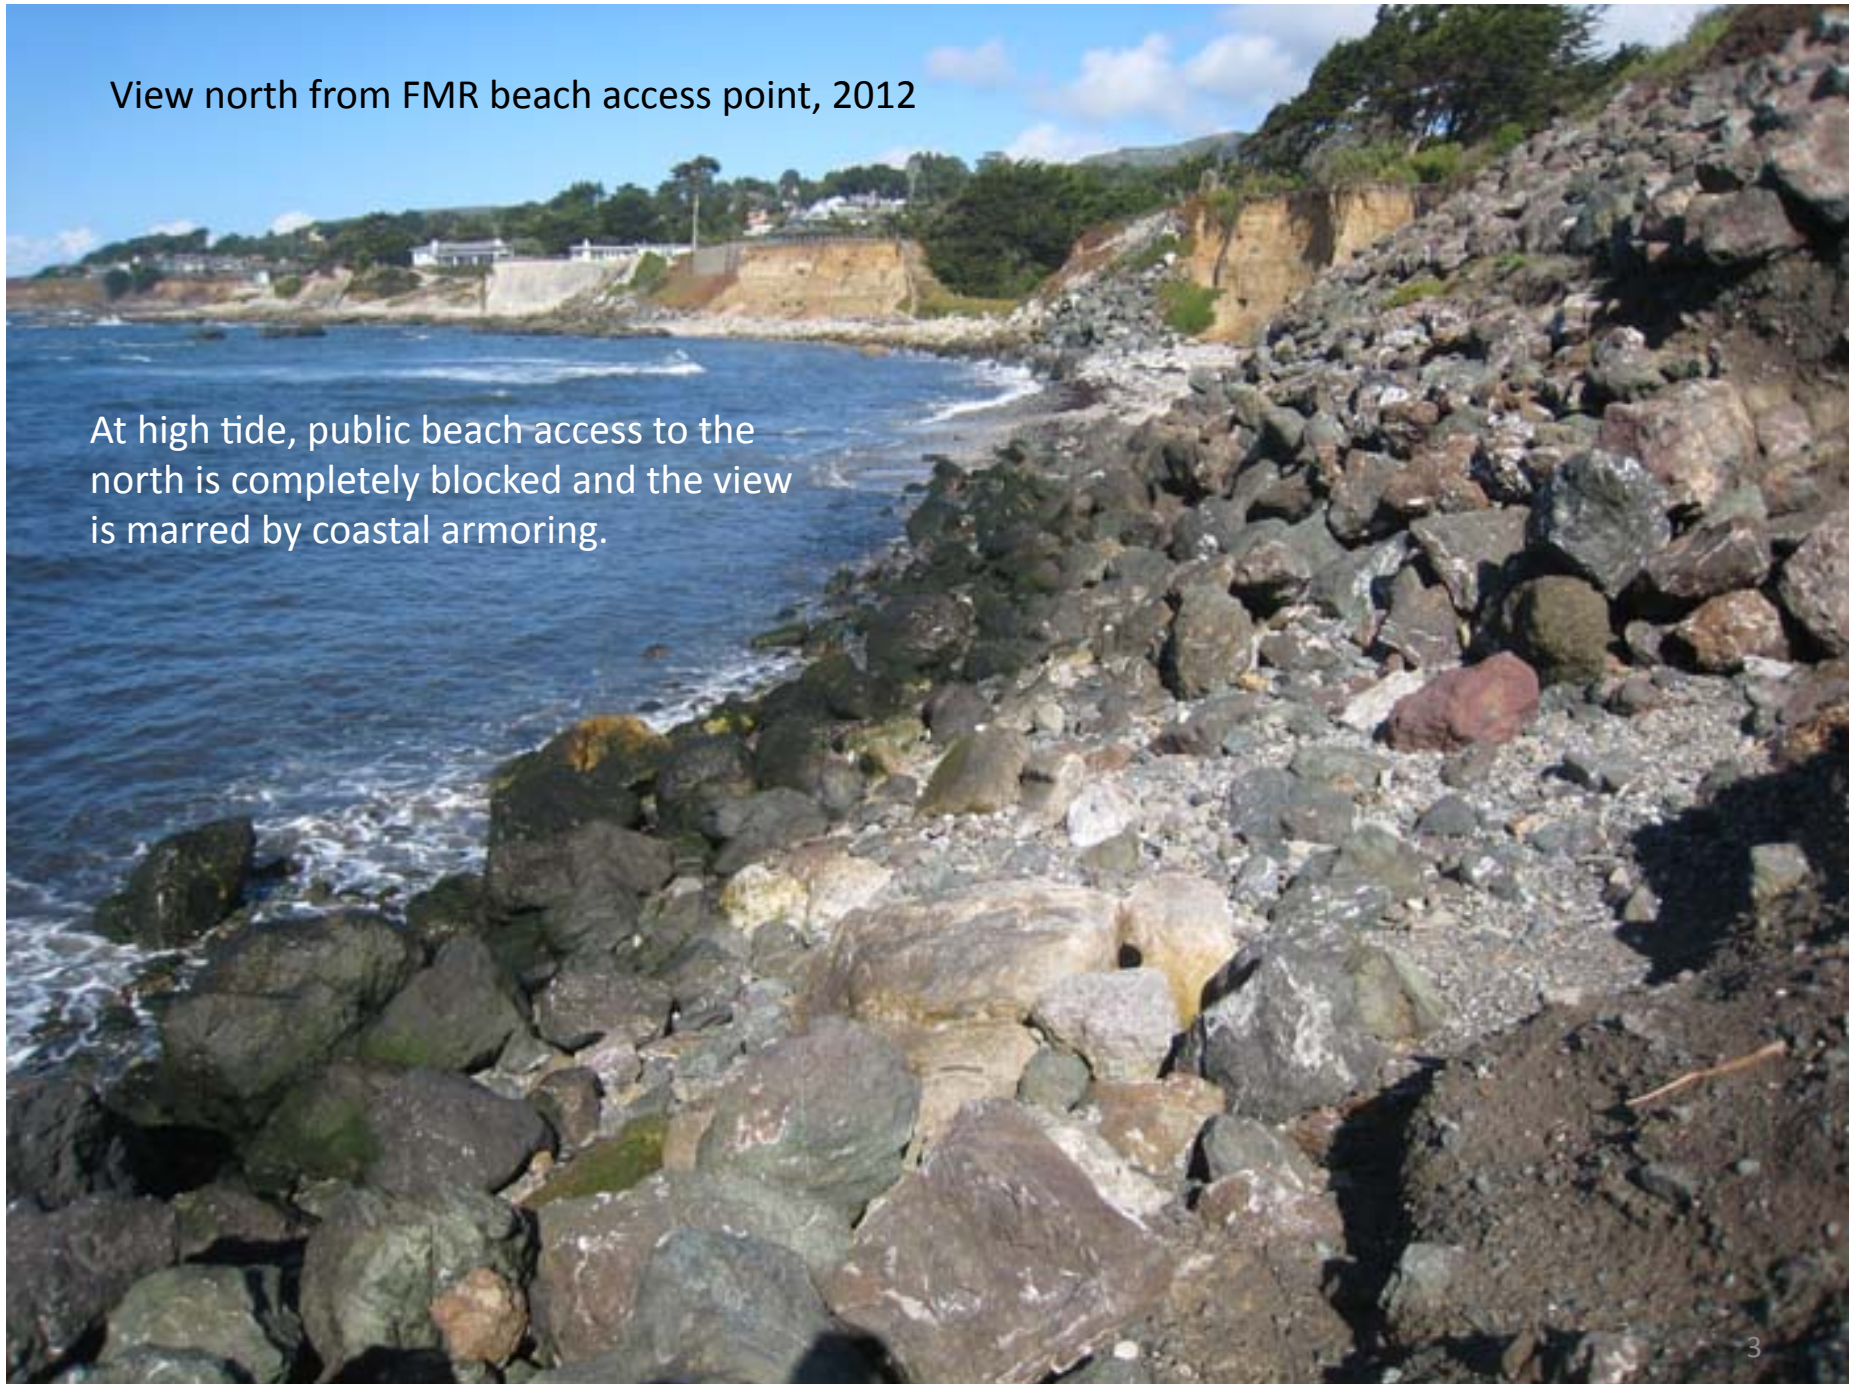
FITZGERALD MARINE RESERVE, JANUARY 1, 2013, ~NOON

Other large boulders
and blocks in rip rap

Precariously perched
boulders of rip rap
(diam~1-2 m)

Rip rap strewn on
beach due to wave
erosion

ROCK FALL HAZARD!!

Bedrock and terrace
gravel exposed by erosion
of rip rap

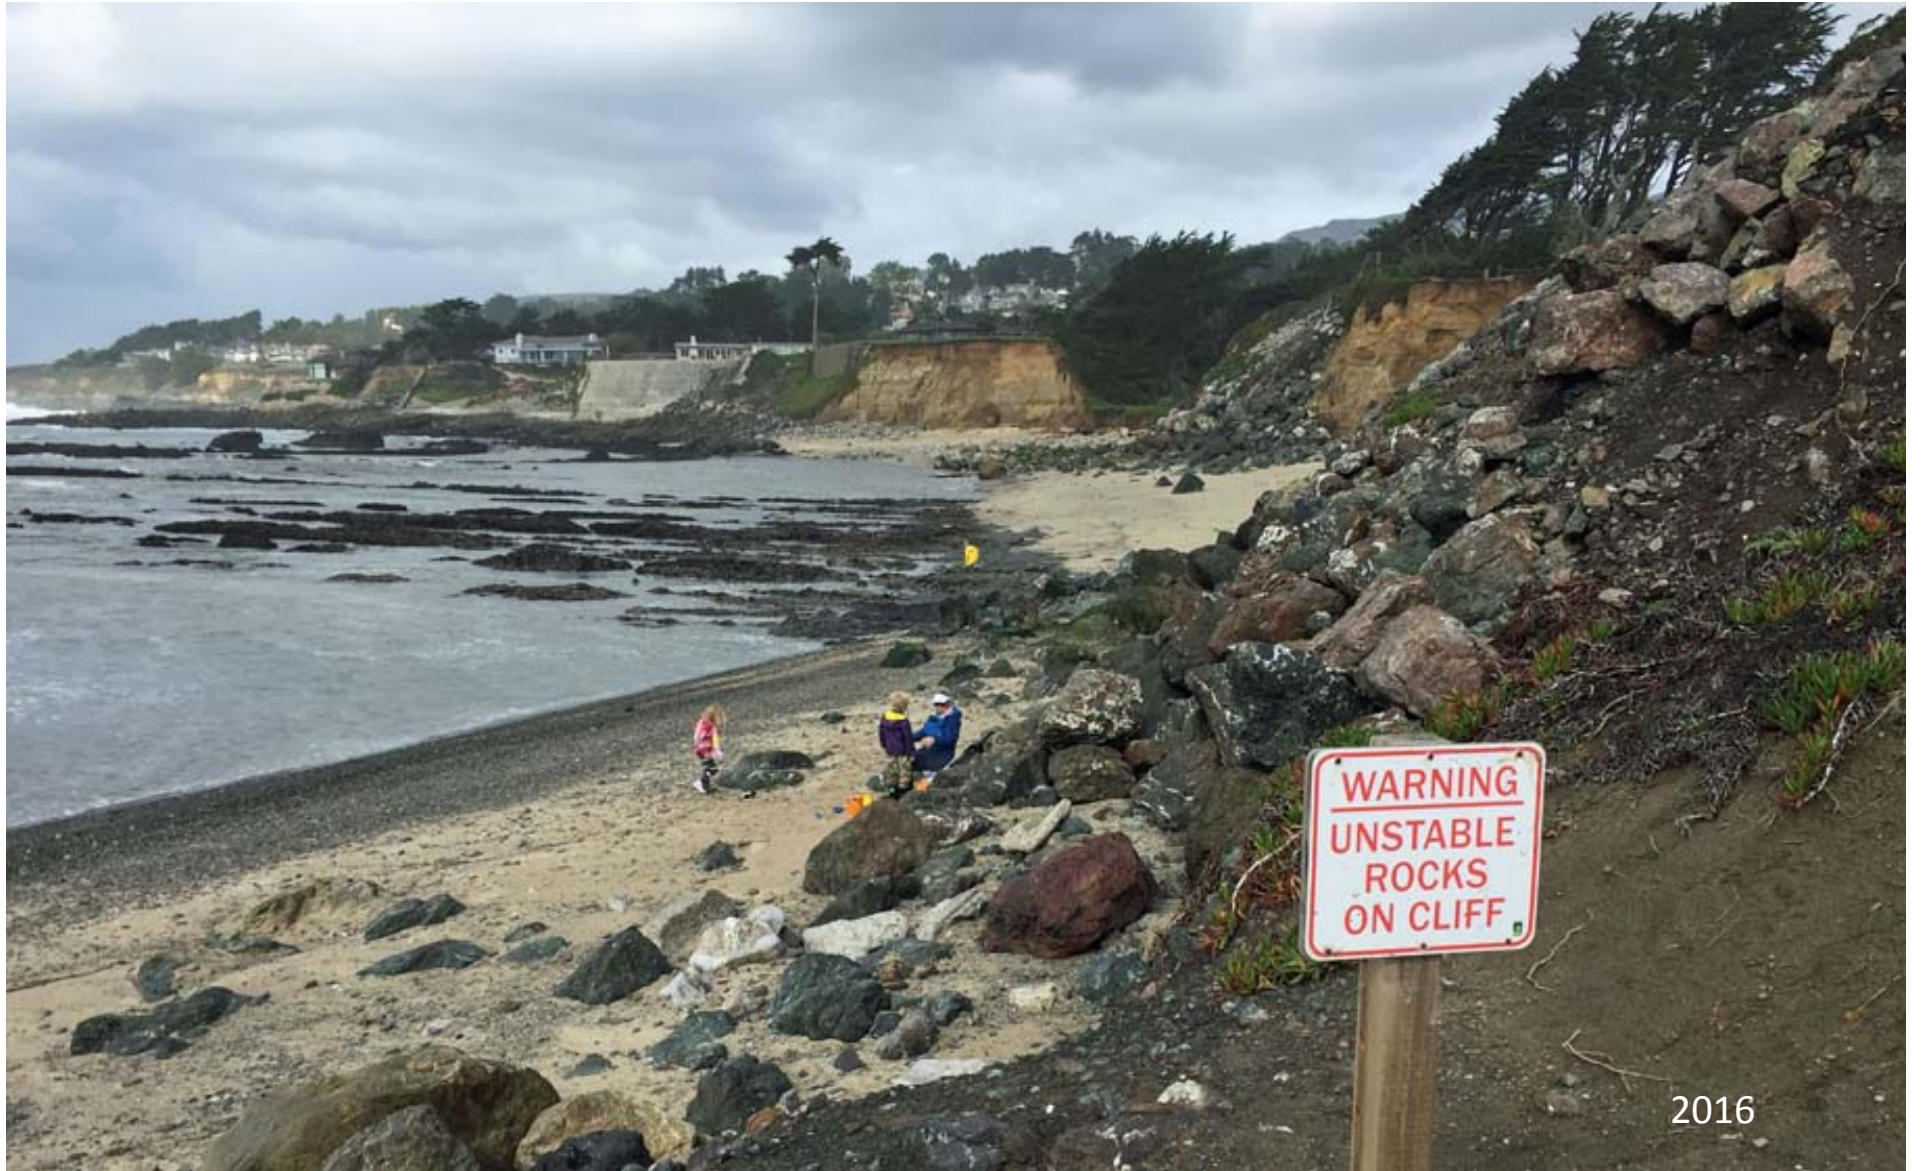
2016

Peninsulas of rock expand across the beach at FMR as riprap deteriorates and surrounding cliffs erode naturally.
March 2017
