**Drainage Improvement Study for the 2nd Street,
Kanoff Street and East Avenue Areas
of Unincorporated Montara
County of San Mateo, California**

County of San Mateo, California

Creegan + D'Angelo Infrastructure Engineers

February 7, 2011

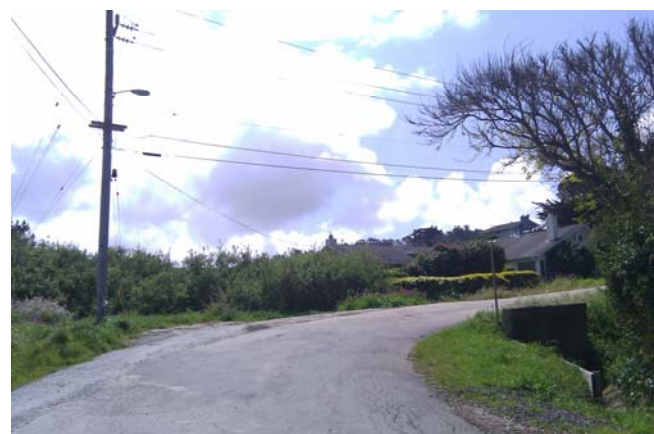
Photo 6. Looking at the northeast corner where Kanoff Street turns to Farallone Avenue to photo right. Note the large willow thicket in the photo background.

The western end of the study area at Kanoff Street is the lowest point in elevation of the entire study area (see Photo 5). Just west of the residence at Kanoff Street is another wetland area, dominated by native willows, nonnative blackberries and German ivy (see Photo 5). This wetland area connects to the blue line creek shown on the USGS Montara Mountain quadrangle, and also connects to the newly created wetland mitigation pond created by Caltrans. It is also hydrologically connected to the large willow thicket in the natural area just east of the corner where Kanoff Street turns to Farallone Avenue (see Photo 6).

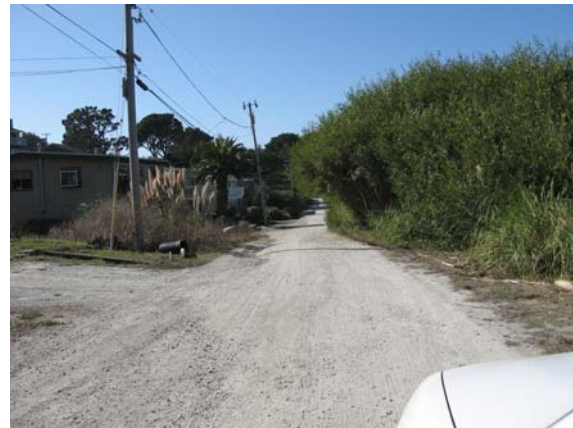
From Catchment Point 1 (CP1) to CP2, a 3 feet deep earthen ditch conveys runoff into a “flat area with no distinguishable toe or bank” adjacent to Second Street. This area is heavily overgrown with vegetation as shown in the photograph (to the right of the road), so a Manning’s channel roughness coefficient (n) of .08 is assumed; representing conditions of brush and trees in a floodplain. Higher ground to the north of the swale forces the natural release of floodwaters onto Second Street and adjacent low lying properties to the south. The driveway elevation at 360 Second Street is nearly one foot lower than the swale containment elevation.

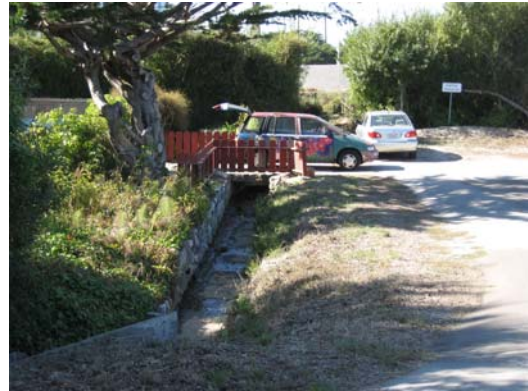
Drainage from CP2 to CP3 is routed downstream in a 4 feet wide concrete box channel. The driveway crossing tends to choke flow since the headroom is only about 1.4 feet and inlet control governs. Excess flow would tend to flow to lower ground to the south and west. This channel continues into dense brush to the north and eventually discharges into the Caltrans wetland mitigation site. The safe release elevation for this storage area (39 feet at Highway 1) is more than ten feet lower than driveway elevations along First Street.

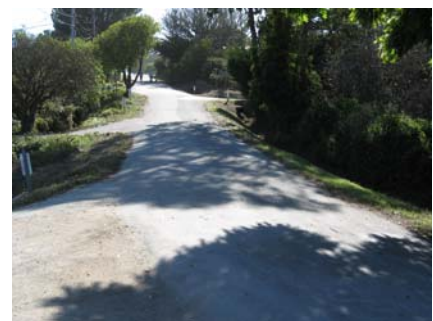
Farallone to CP2: As evidenced by Table 5, the ditches running parallel to Farallone Avenue from Second Street to Kanoff Street have sufficient capacity; it is the undersized CMP crossings that choke the flow and cause storm runoff to spill onto private property. Kanoff Street is steep in this location (with a slope of 12 percent), so culvert hydraulics are inlet control; that is, the culvert capacity is controlled by the pipe diameter and inlet condition (headwall, projecting pipe, etc.).
