Caltrans Hwy 1 vegetation management in Montara

Midcoast Community Council
March 18, 2018

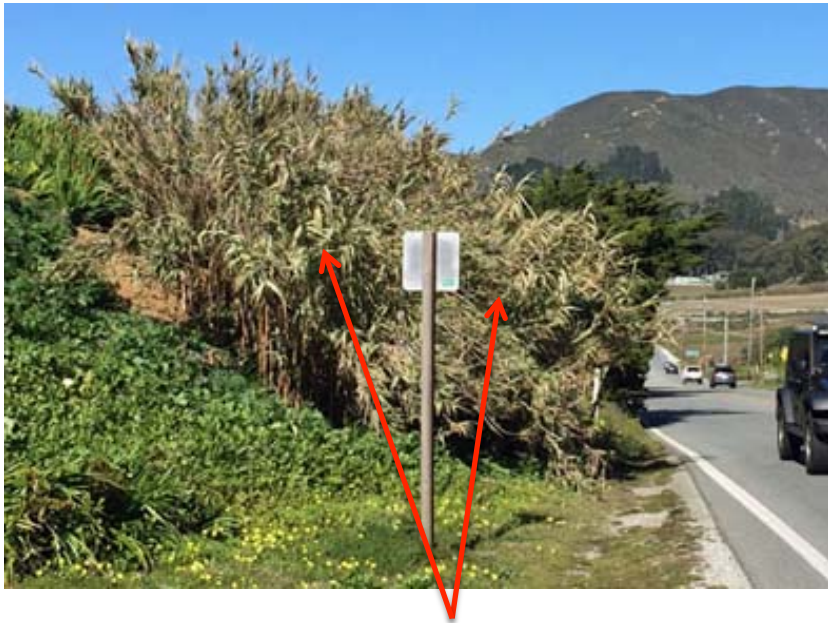
4th to Montara State Beach lot

At 4th St, remove *Arundo donax* (giant reed) – spreading, invasive weed

Prune lower cypress branches off at trunk.

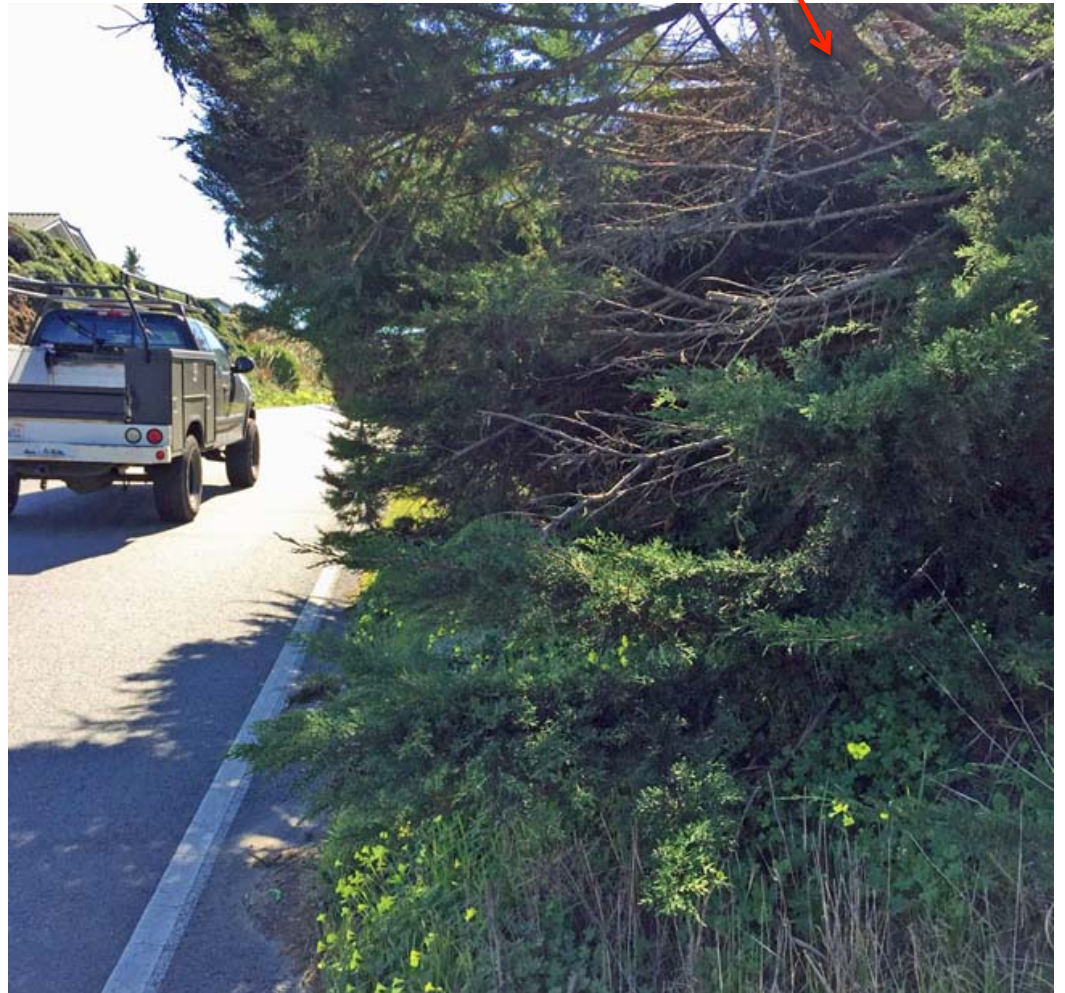
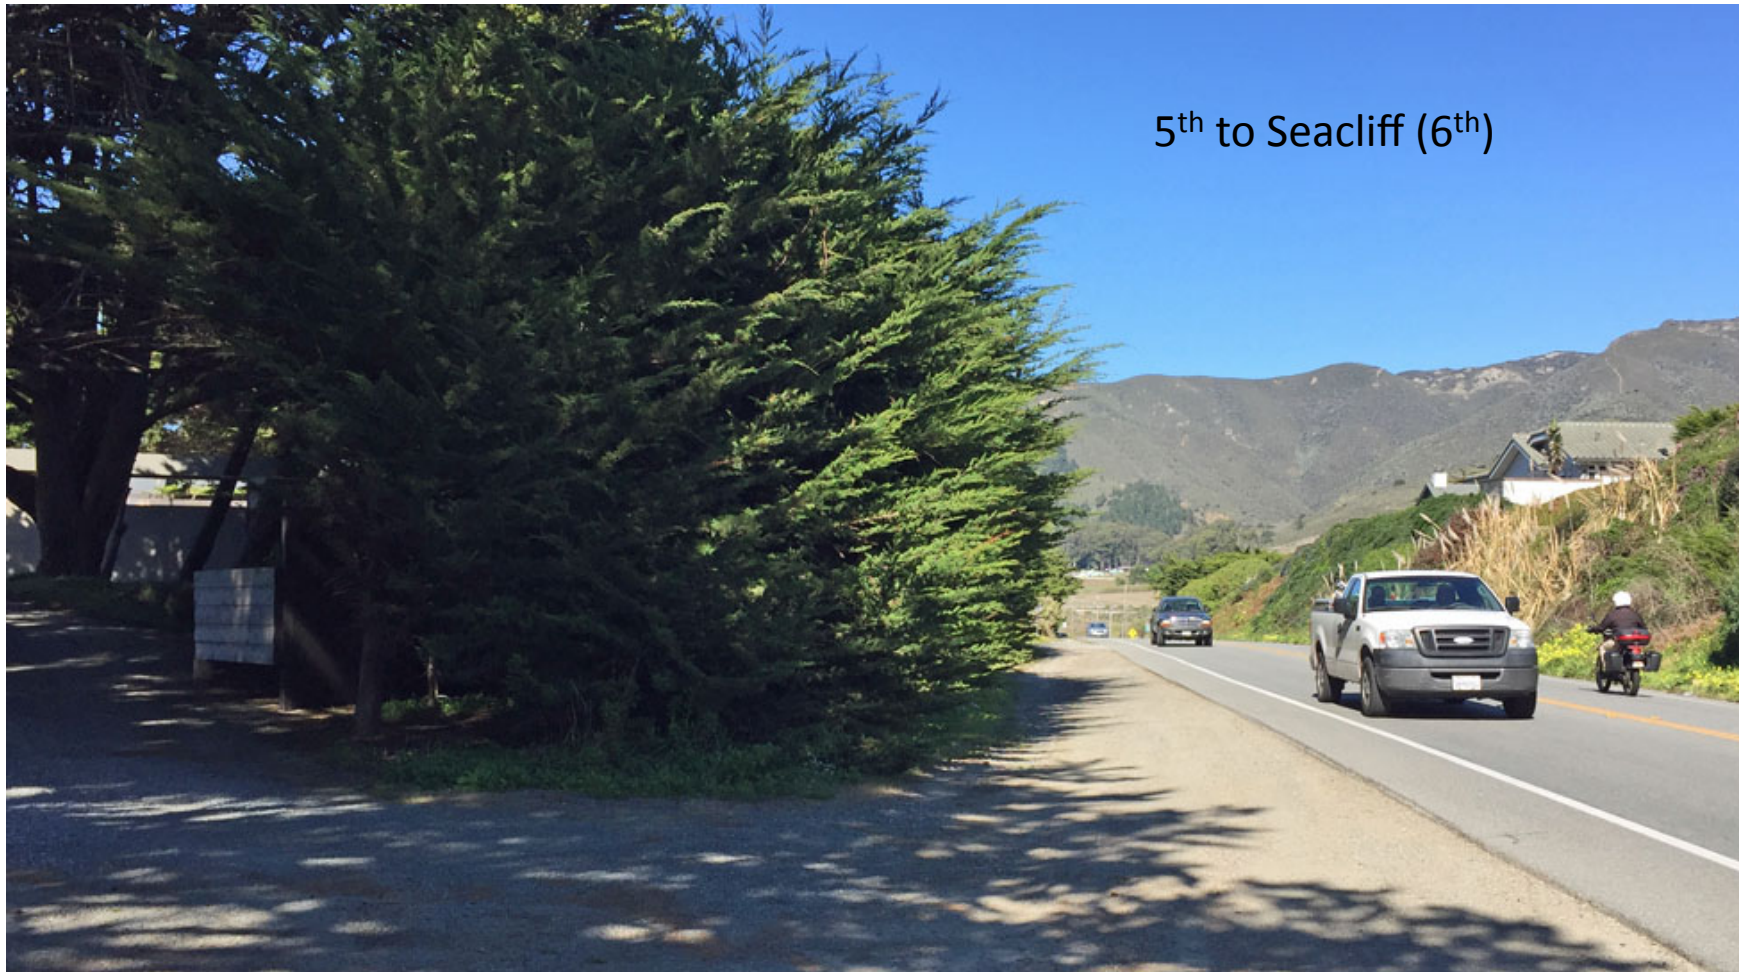
Block-long dense cypress tree planting in front of tall masonry wall is encroaching into the Caltrans gravel shoulder.

Prune off lower branches at trunks for long-term solution to maintain the wide shoulder clear for pedestrians.

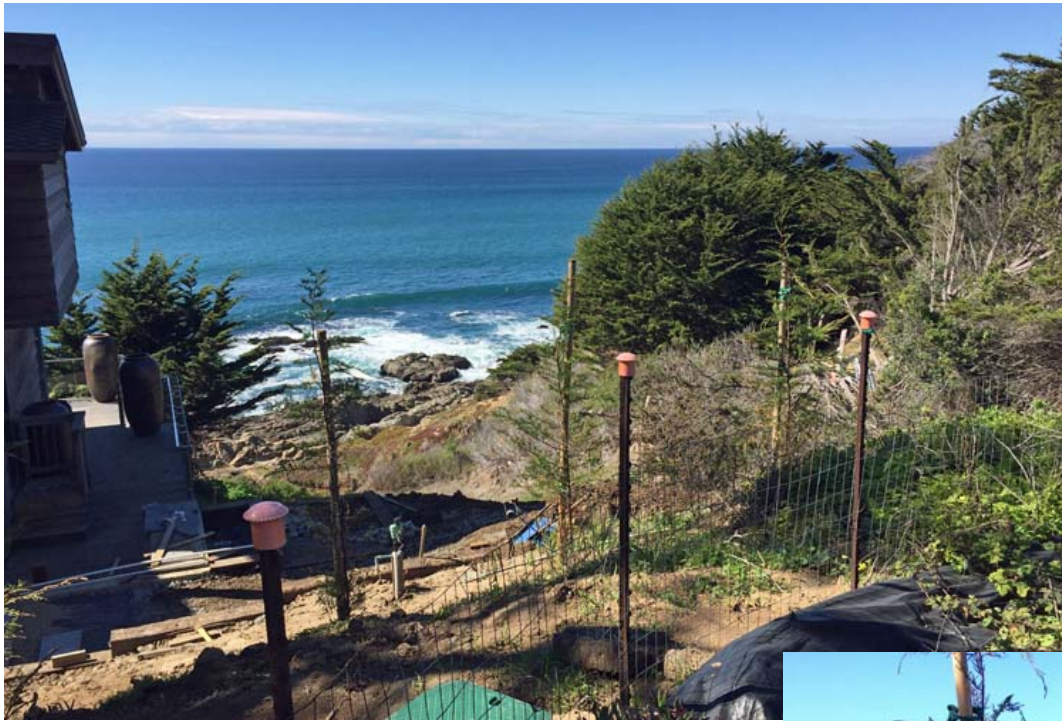
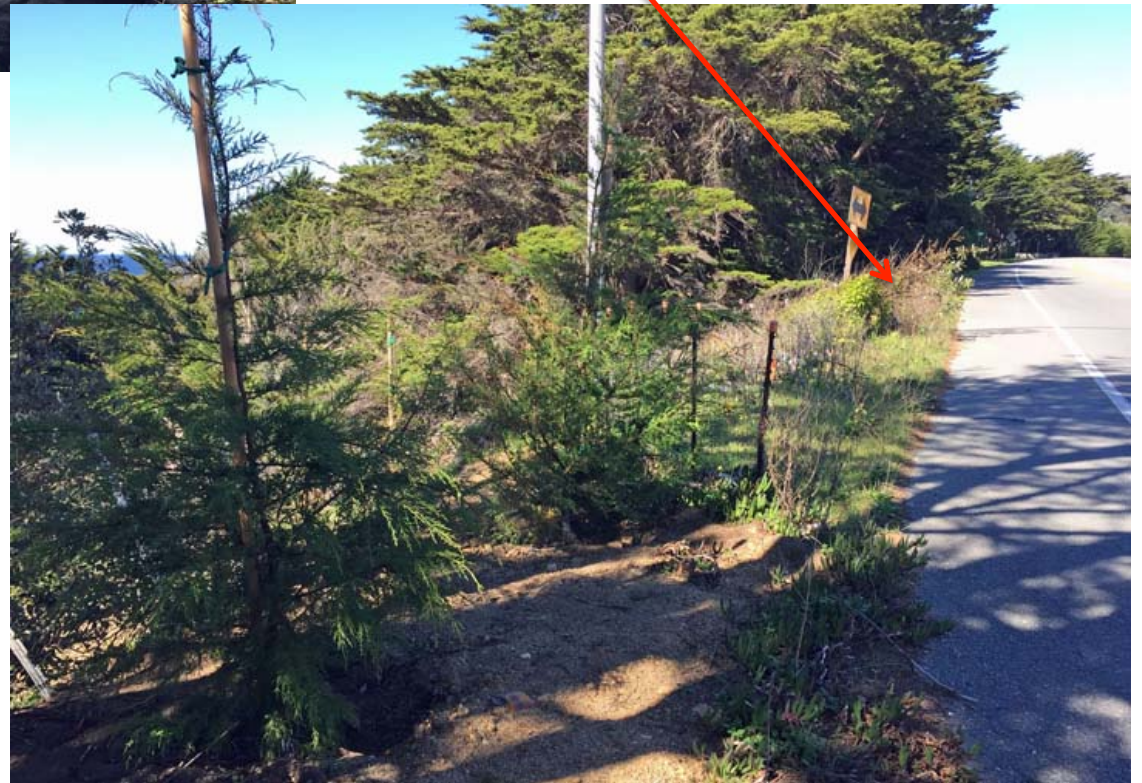
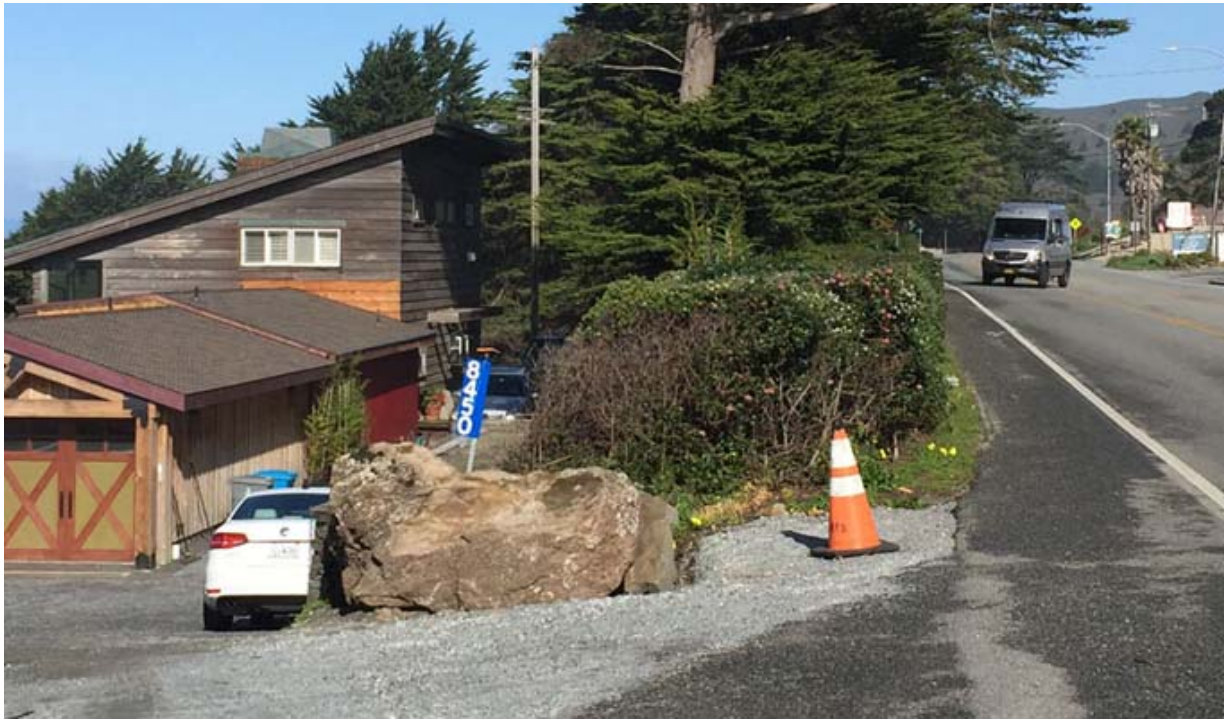
Remove recently planted cypress trees in 8th St view corridor.
Landscaping is development – these trees require a CDP.

Remove young willow at 8th St arrow sign – fast-growing shrub/tree will block ocean view & require frequent pruning to keep shoulder clear.

Remove wire fencing from Caltrans ROW, both 2015 construction fencing at 8th, and new chicken wire along the road bank above the house.

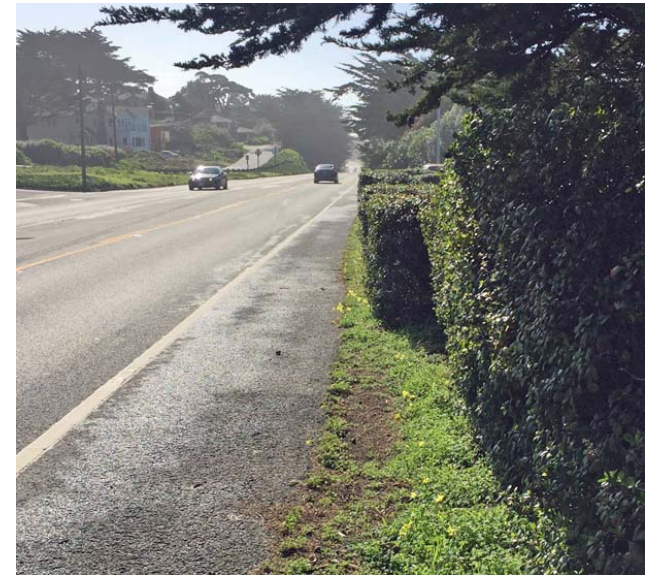
between 8th & 9th

- Recently planted row of cypress trees (within the existing roadside canopy but only 10 ft from fog line) will require removal of all lower branches on the highway side.
- More suitable long-term screening would be achieved with shade-tolerant shrubs near the house where they were removed in 2015 for access to 8th St landslide repairs.
- Caltrans ROW extends down the road bank to within ~3 feet of the house.
- Pedestrian comfort and safety are higher priority than landscaping encroachments such as this hedge taking up space in the 8-10 ft level highway shoulder area.
- Cut back hedge width off level ground.
- Lower hedge height in view corridor above driveway to 3 ft maximum to open the ocean view to travelers on the designated scenic highway.

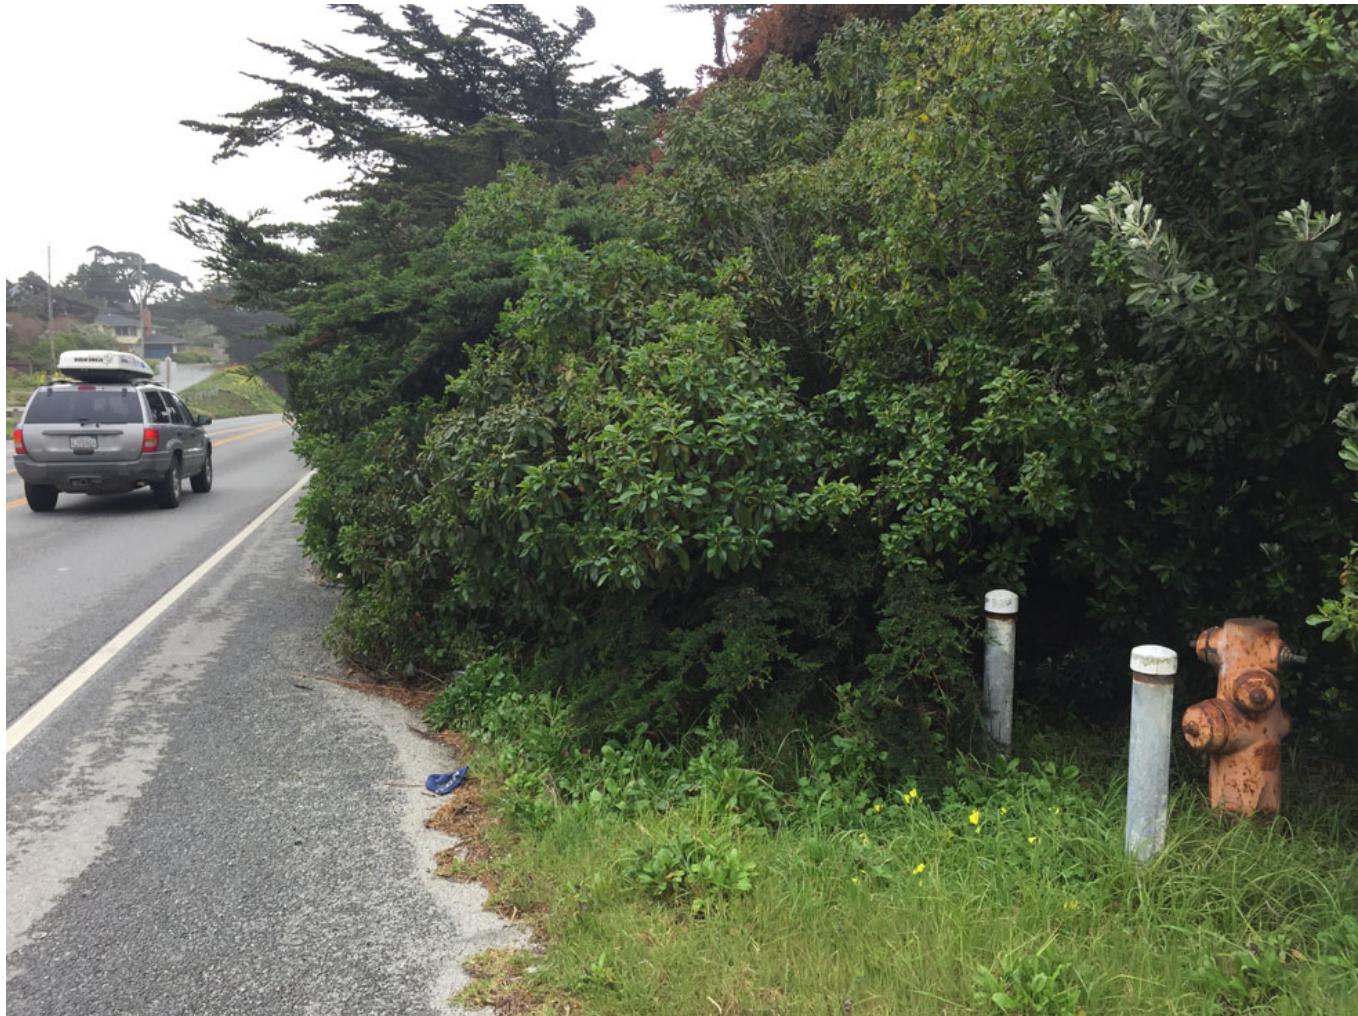
Just south of 9th

- Prune cypress branches back to trunks.
- Prune back & maintain shrubs even with fire hydrant -- makes level unpaved shoulder area available for pedestrians, fire truck, and driveway sight distance.
- See next slide for maintenance history at this location.

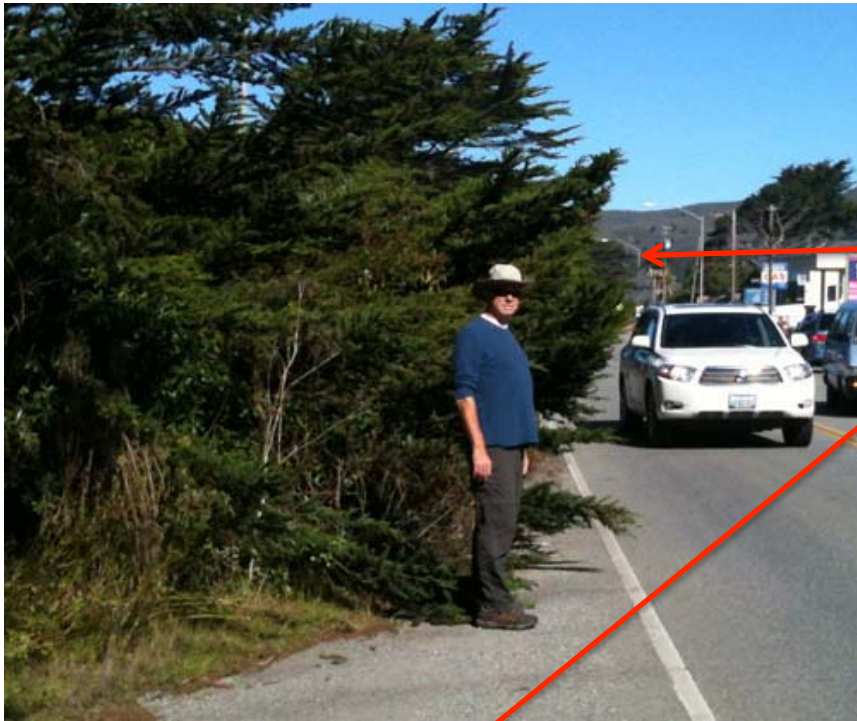
Maintenance requests just south of 9th St:

Nov 2012: hazardous condition reported

Jan 2013: maintenance pruning cut back to minimum width for shoulder trail

Jan 2018: hazardous condition reported

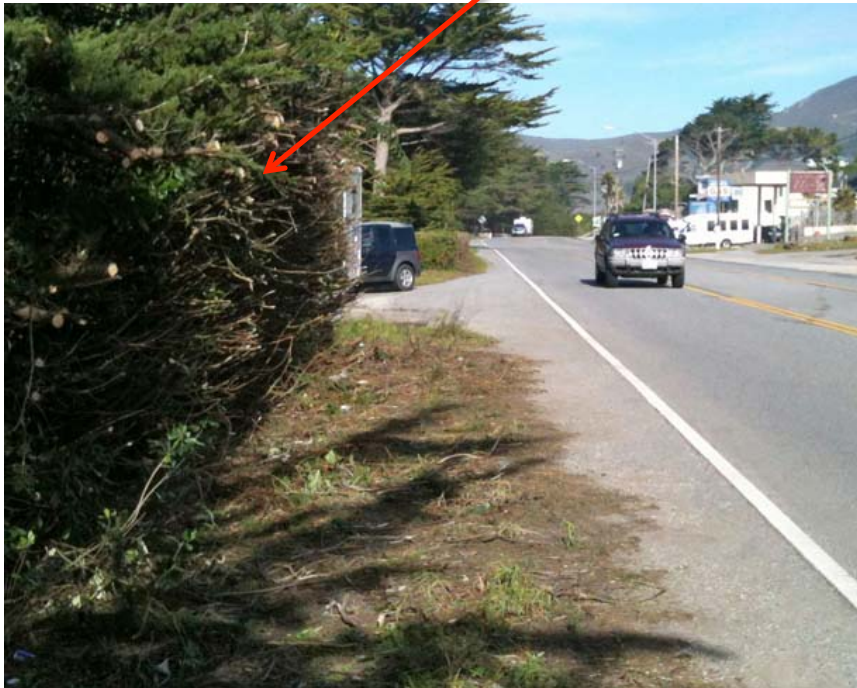
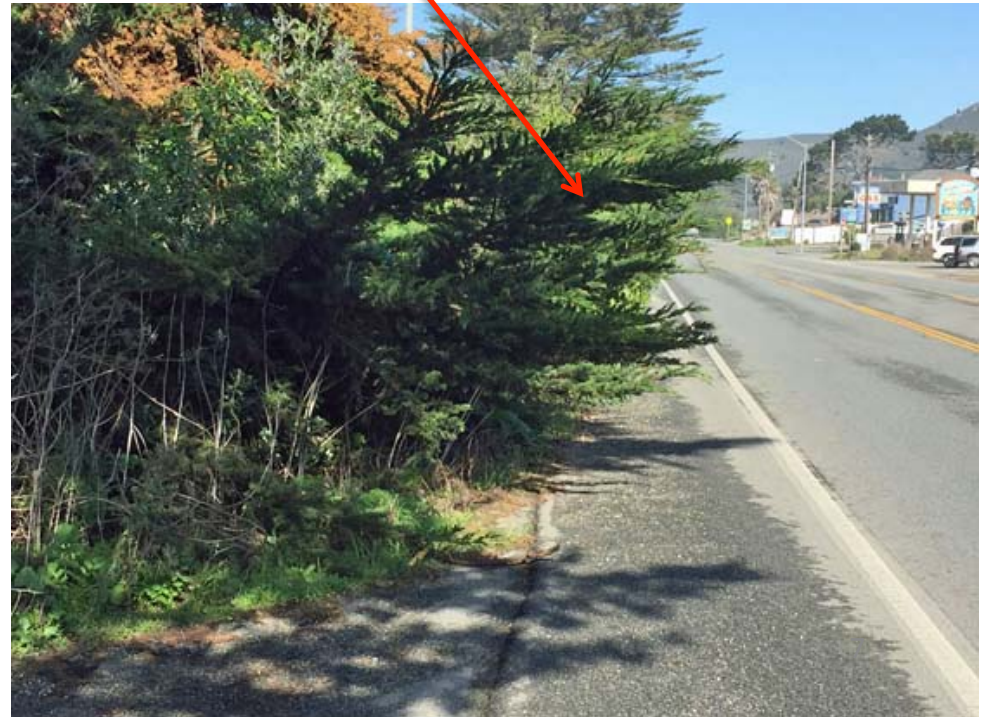
10th St.

Remove 3 small dead staked cypress trees from view corridor.

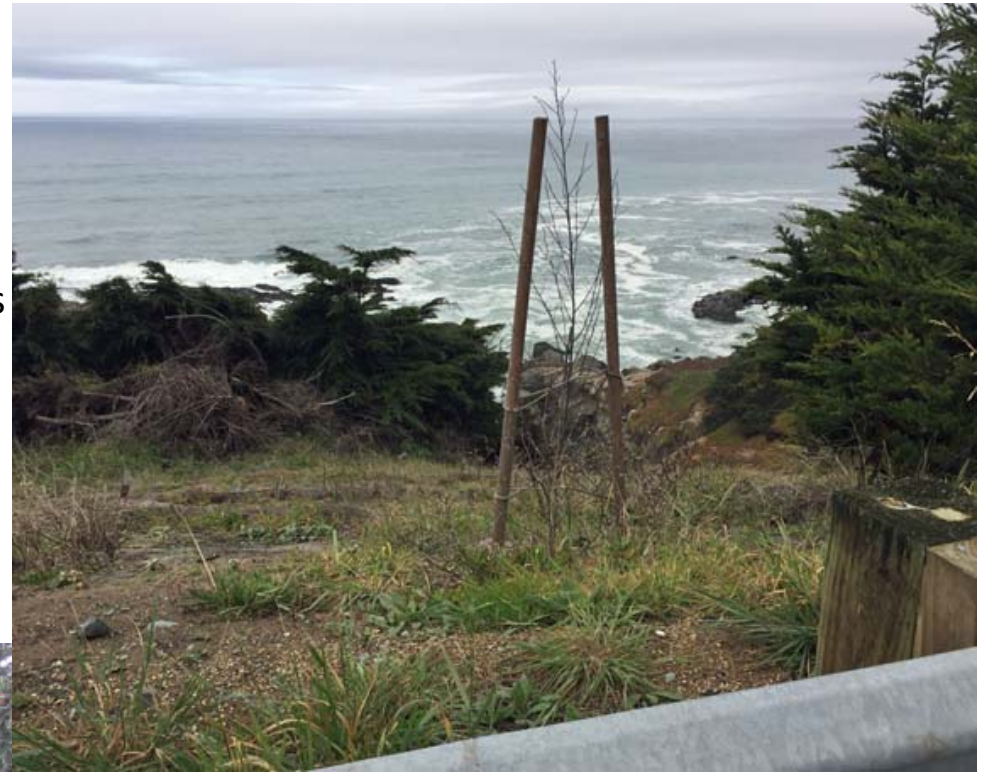
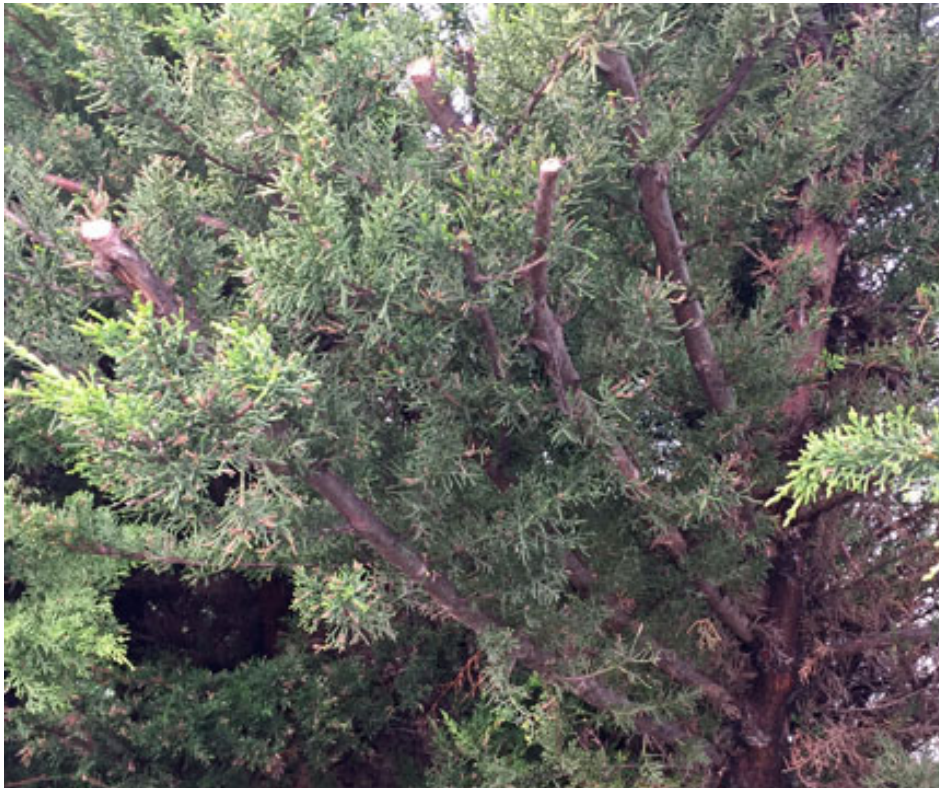
Prune encroaching lower cypress branches off at the trunk, instead of stub cuts, which quickly regrow, or die and look unsightly.

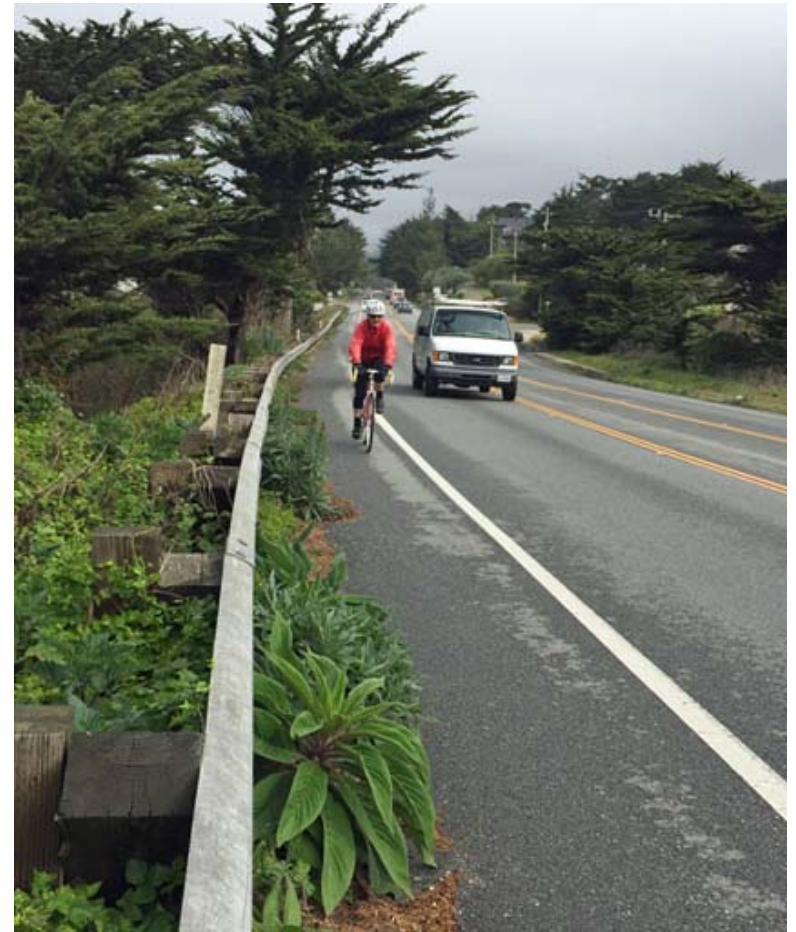
14th – 16th

Who is responsible for landscape pruning for hostel sign visibility?

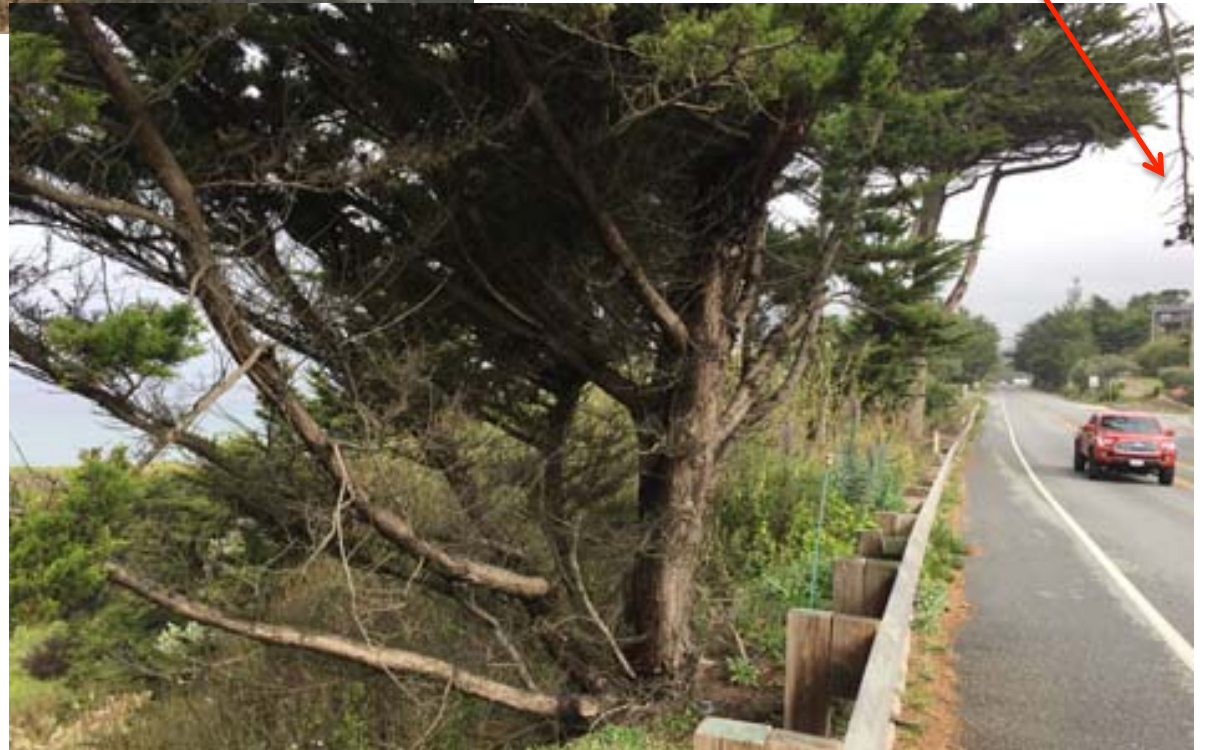
14th to 16th

Remove dead cypress branch stubs sticking out into paved shoulder area at about eye level.

Remove overhead broken branches before they fall.

Here's a good example of lower roadside branches pruned off at trunk, avoiding ongoing maintenance, opening the coastal view, and providing greater clearance and sight distance.

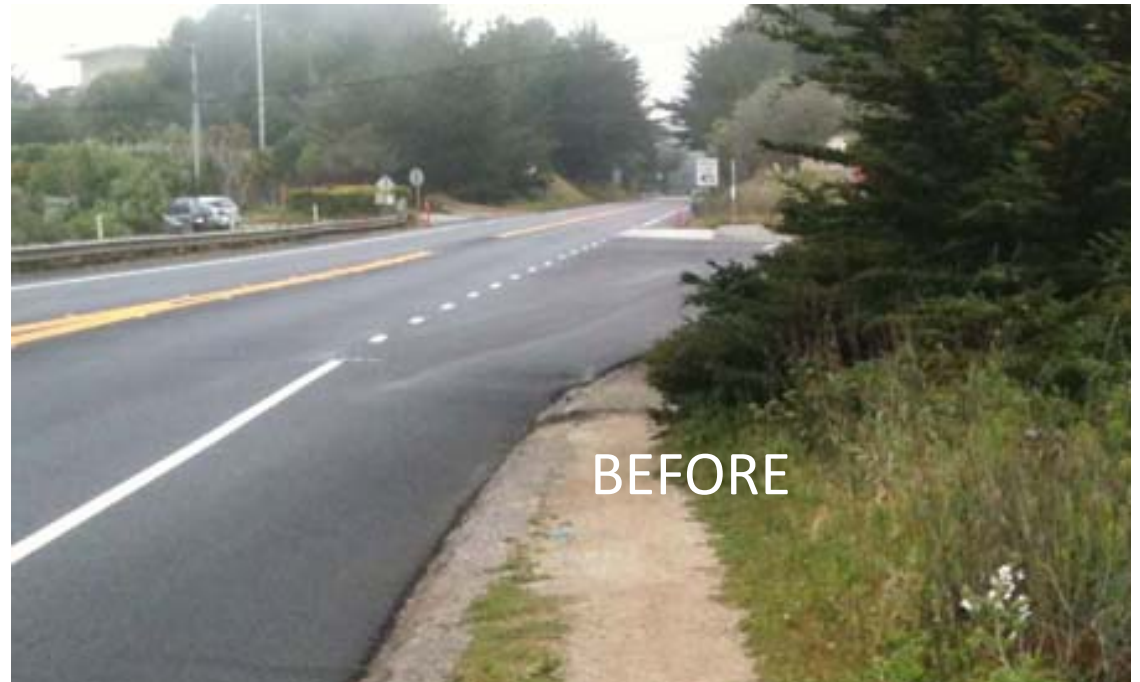
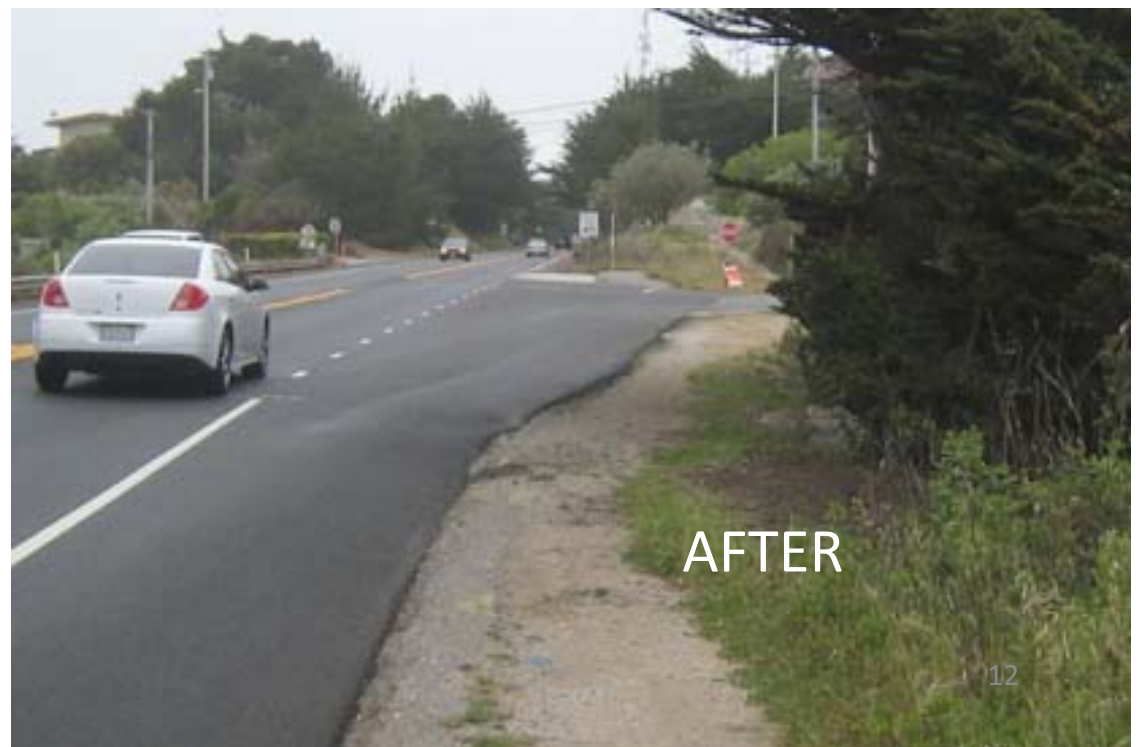
14-16th east side

East side unpaved shoulder across Montara Creek ravine, is critical trail connection between Montara and Moss Beach.

After 2012 highway widening for center turn lane, a citizen tree pruning effort regained lost trail space.

Rather than continuing the vigilante approach, would Caltrans step in and remove all lower branches that encroach on level ground for the trail?
