# Vegetation Management in Caltrans Highway 1 right-of-way in Montara

Midcoast Community Council

March 14, 2018

## Caltrans Hwy 1 vegetation maintenance in Montara

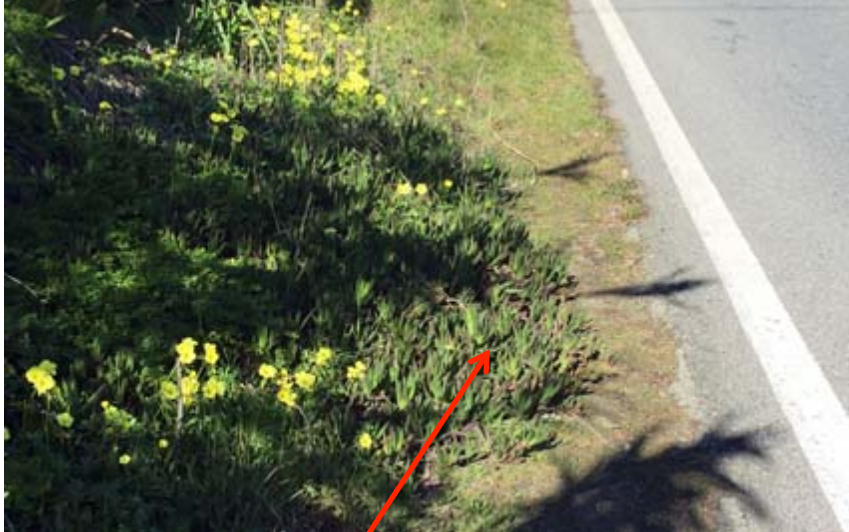
4<sup>th</sup> to Montara State Beach lot

Prune lower cypress branches off at trunk.

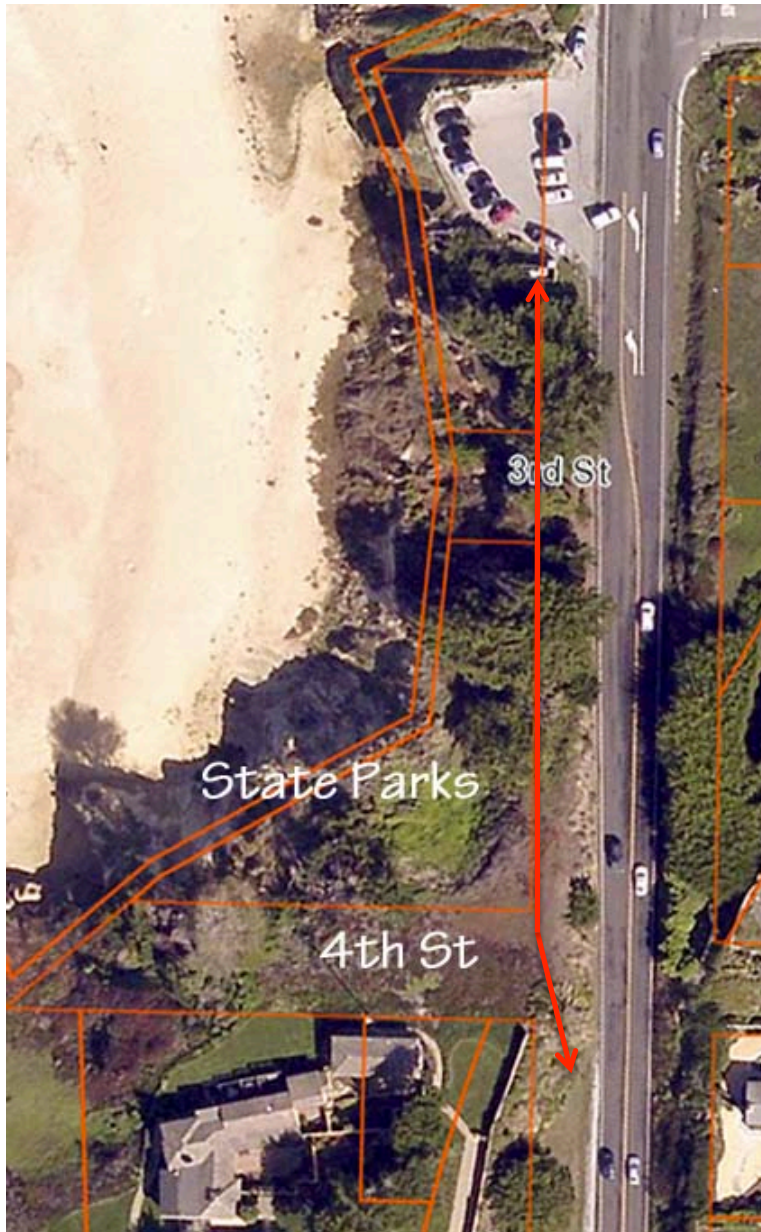
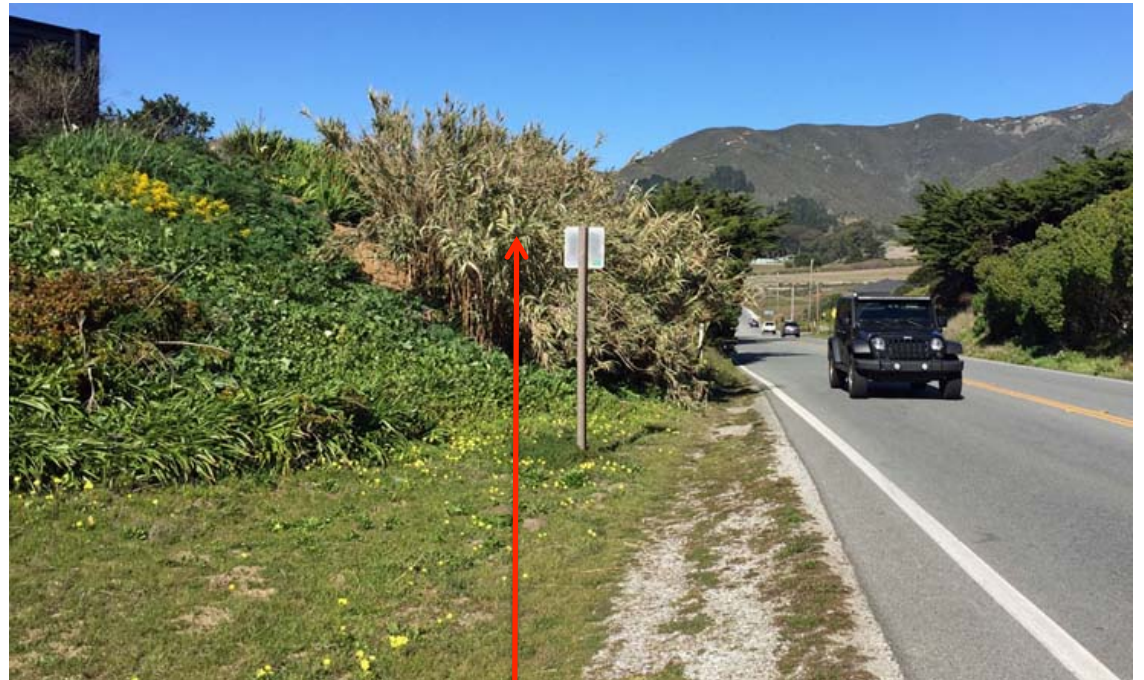
## 4<sup>th</sup> to Montara State Beach lot

At 4<sup>th</sup> St, remove *Arundo donax* (giant reed) -- spreading, invasive weed

**Longer term consideration:** Avoid this narrow shoulder segment and bring hikers up to the ocean view, by grading pedestrian trail access at 4<sup>th</sup>, and pruning lower cypress branches along top of road cut, to connect trail to Montara Beach parking lot. Would involve State Parks and DPW in addition to Caltrans.

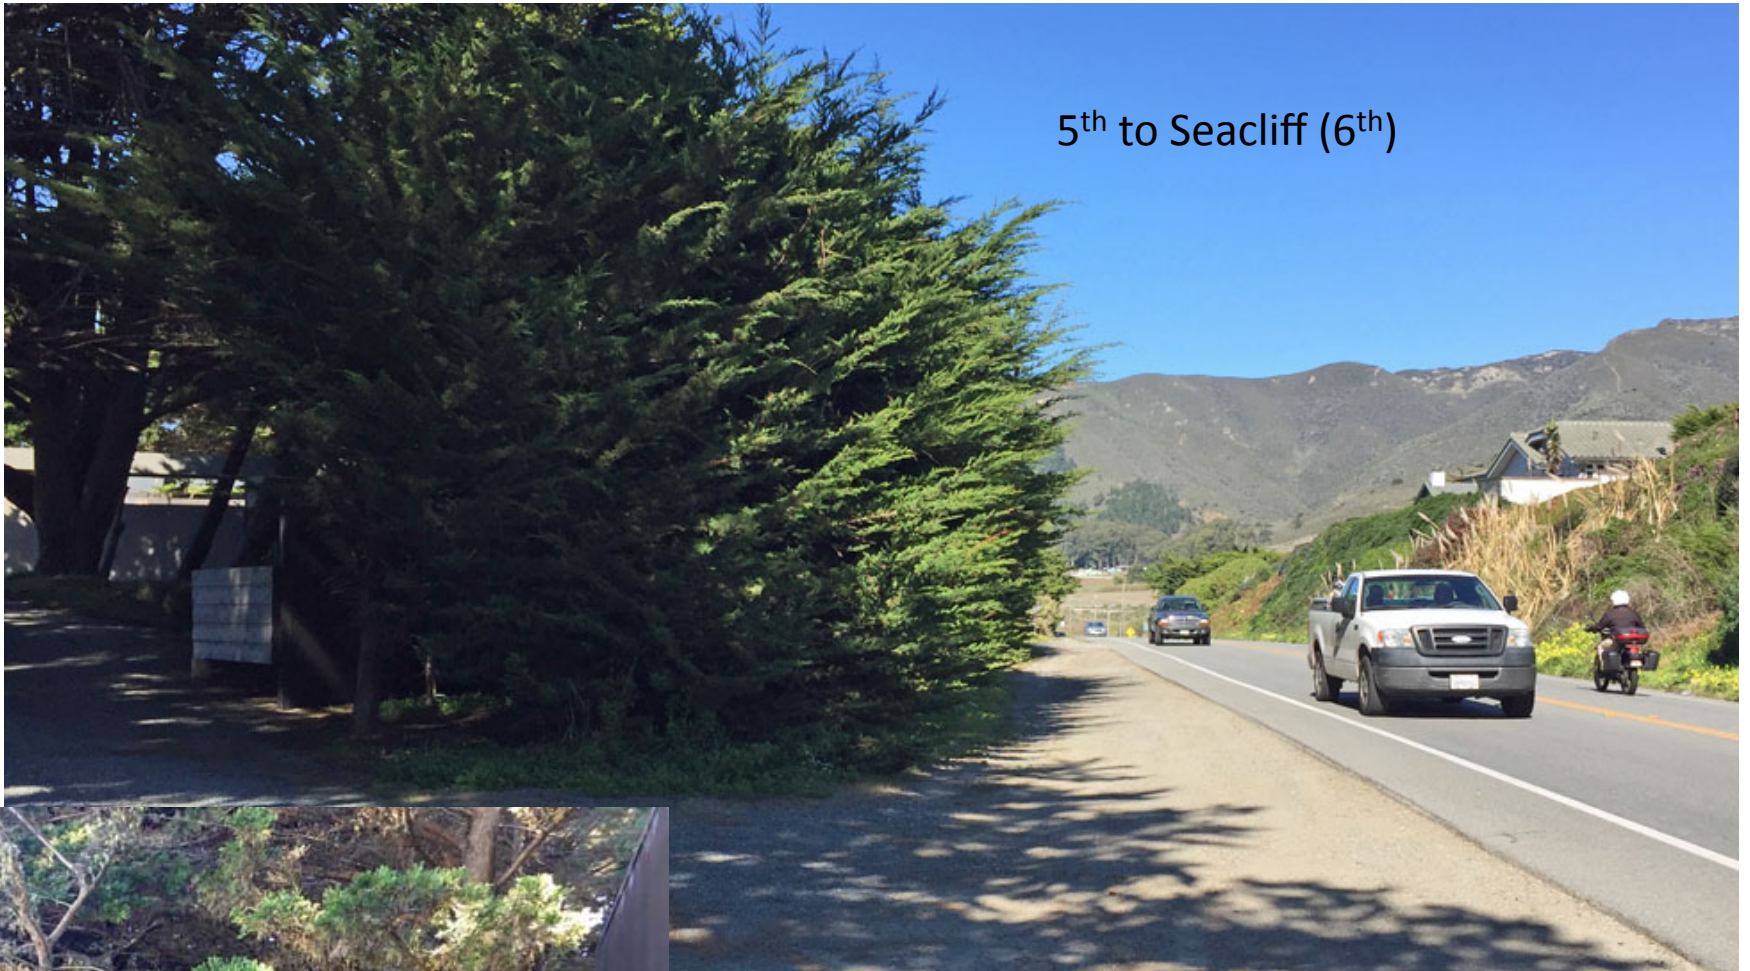
5<sup>th</sup> to Seacliff (6<sup>th</sup>)

Dense cypress tree planting in front of tall masonry wall is encroaching into the Caltrans gravel shoulder.

Prune off lower branches at trunks for long-term solution to keeping the wide shoulder clear for pedestrians.

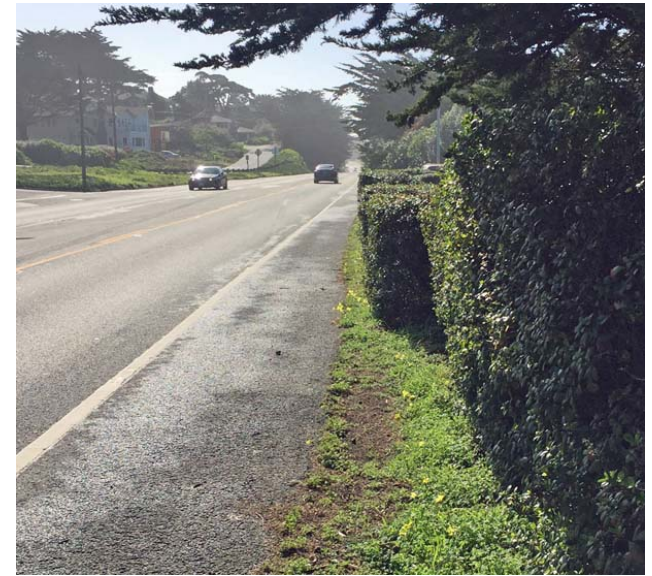
between 8<sup>th</sup> & 9<sup>th</sup>

- Recently planted row of cypress trees (within the existing roadside canopy but only 10 ft from fog line) will require removal of all lower branches on the highway side.
- More suitable long-term screening would be achieved with shade-tolerant shrubs near the house where they were removed in 2015 for access to 8<sup>th</sup> St landslide repairs.
- Caltrans ROW extends down the road bank to within ~3 feet of the house.
- Pedestrian comfort and safety are higher priority than landscaping encroachments such as this hedge taking up space in the 8-10 ft level hwy shoulder area.
- Cut back hedge width off level ground.
- Lower hedge height in view corridor above driveway to 3 ft maximum to open the ocean view to travelers on the scenic highway.

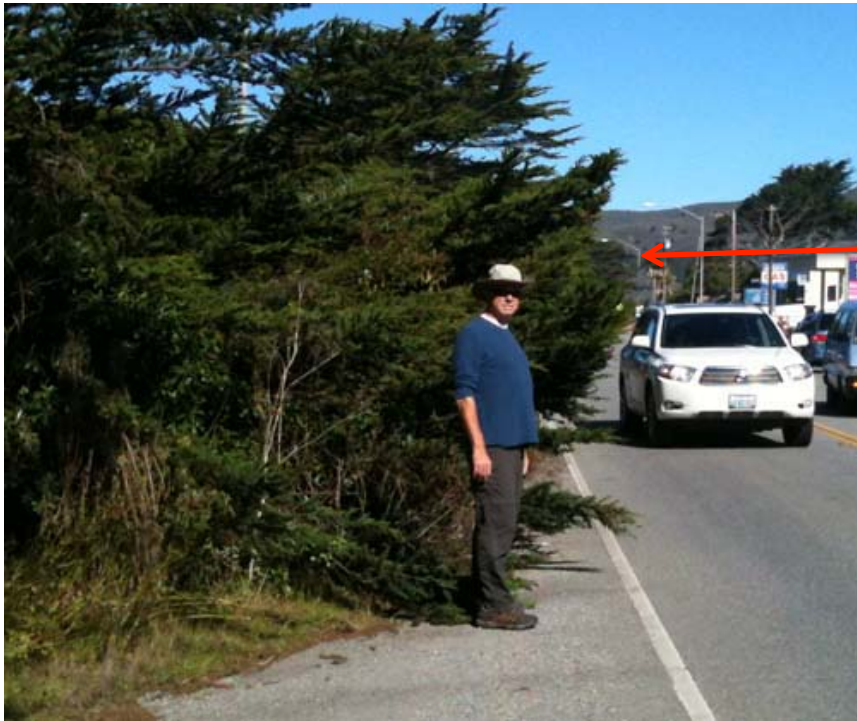
Maintenance requests just south of 9<sup>th</sup> St:

Nov 2012: hazardous condition reported

Jan 2013: maintenance pruning cut back to minimum width for shoulder trail

Jan 2018: hazardous condition reported

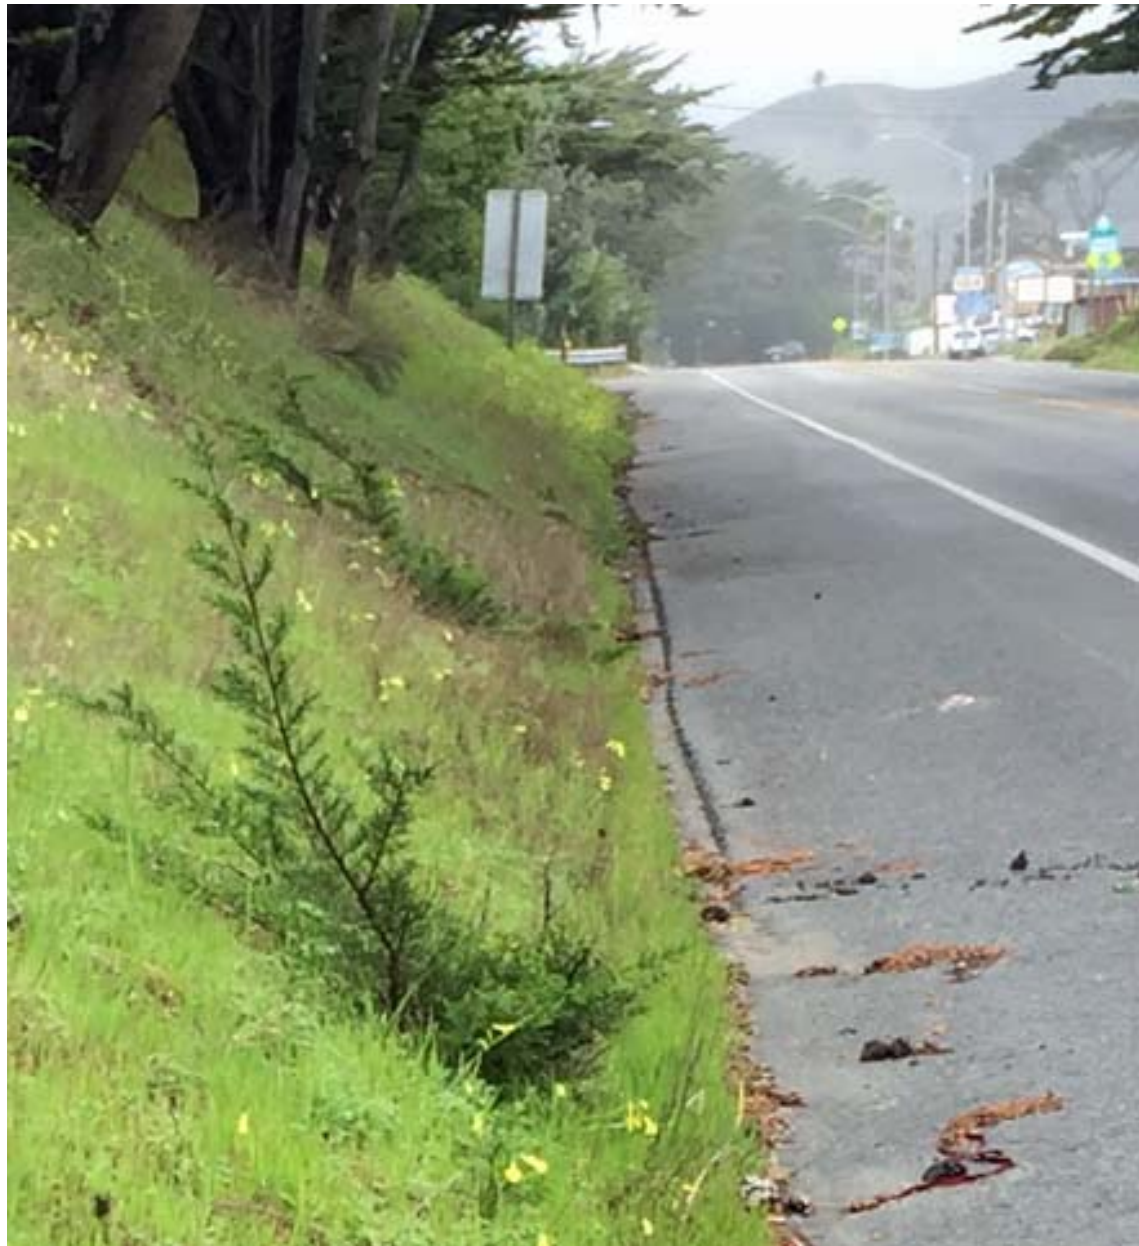
11<sup>th</sup> to 12<sup>th</sup>

Remove cypress tree seedlings at road edge to avoid long-term maintenance issue.

Consider that cypress trees naturally grow to 40 ft high & wide.

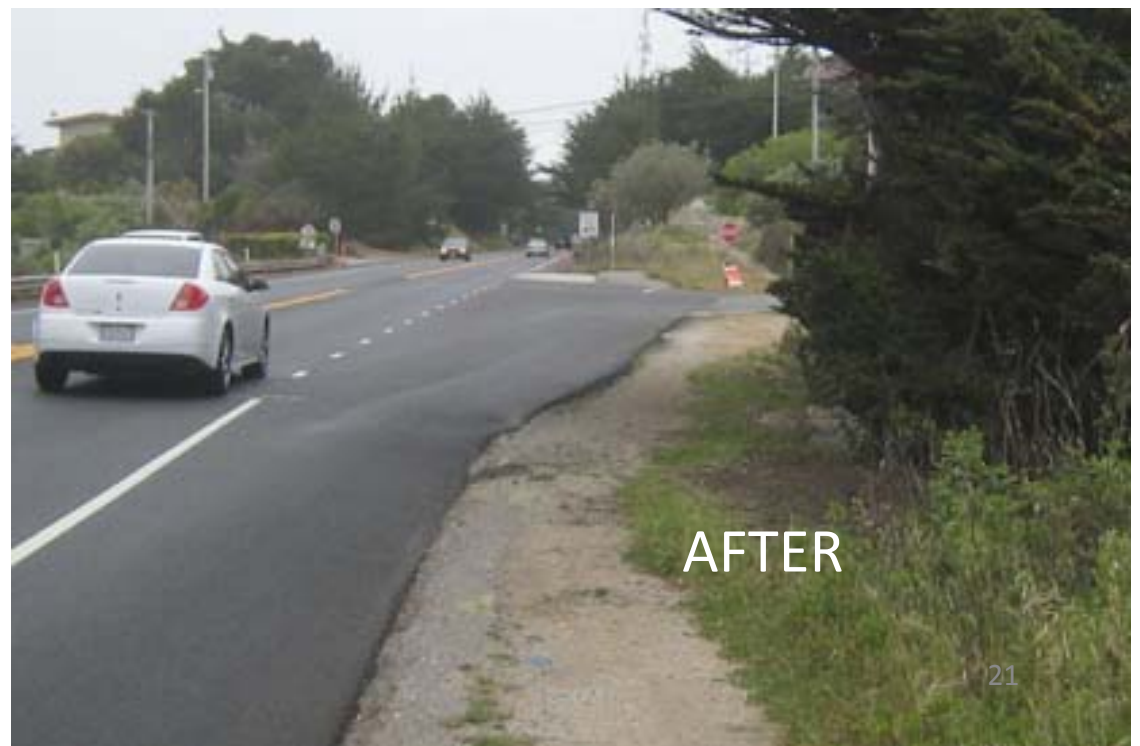
## 14-16<sup>th</sup> east side

East side unpaved shoulder across Montara Creek ravine, is critical trail connection between Montara and Moss Beach.

After 2012 highway widening for center turn lane, a citizen tree pruning effort regained lost trail space.

Rather than continuing the vigilante approach, would Caltrans step in and remove all lower branches that encroach on level ground for the trail?
