# Shoreline armoring to protect development in Montara, Moss Beach, & Princeton

Midcoast Community Council  
December 9, 2015  
(L. Ketcham)

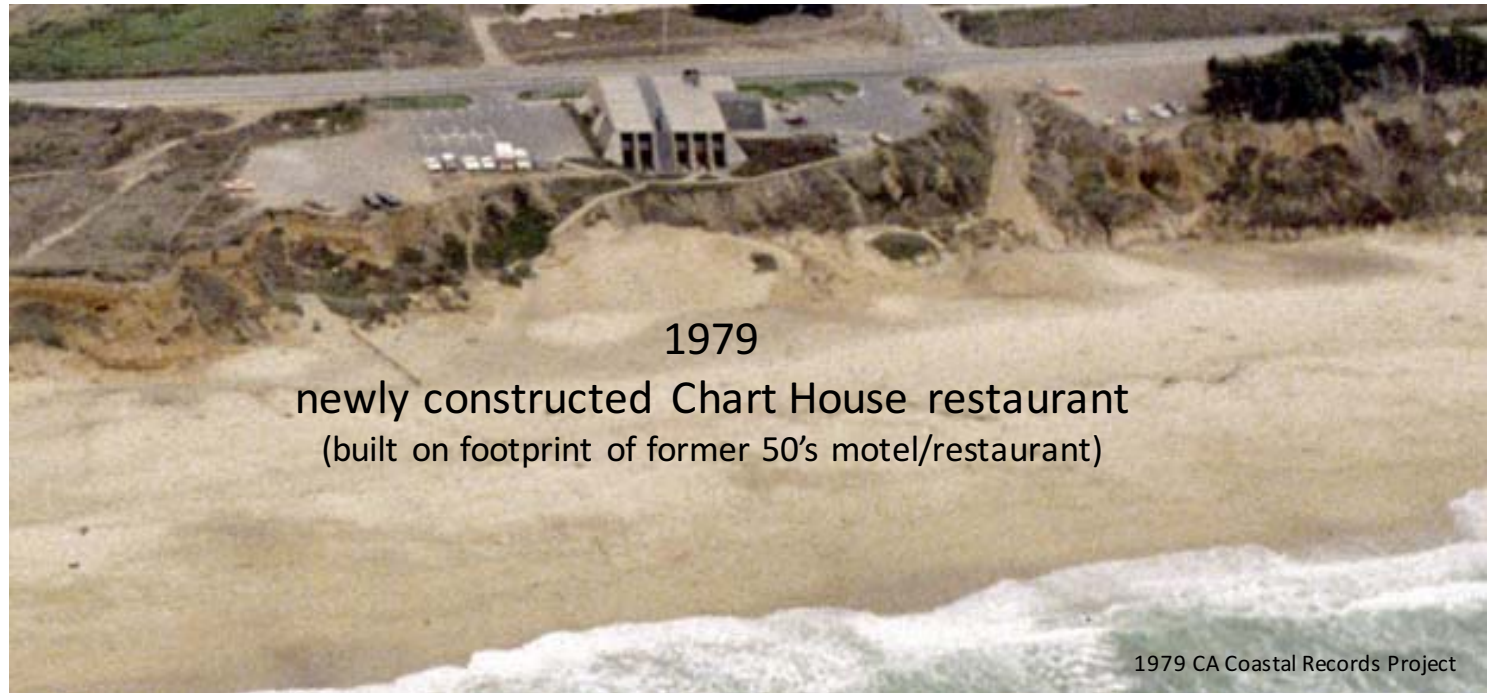
1979  
newly constructed Chart House restaurant  
(built on footprint of former 50's motel/restaurant)

Only 4 years after construction, in 1983 --  
\$750,000 heap of rocks, 460 feet long, installed on the public beach

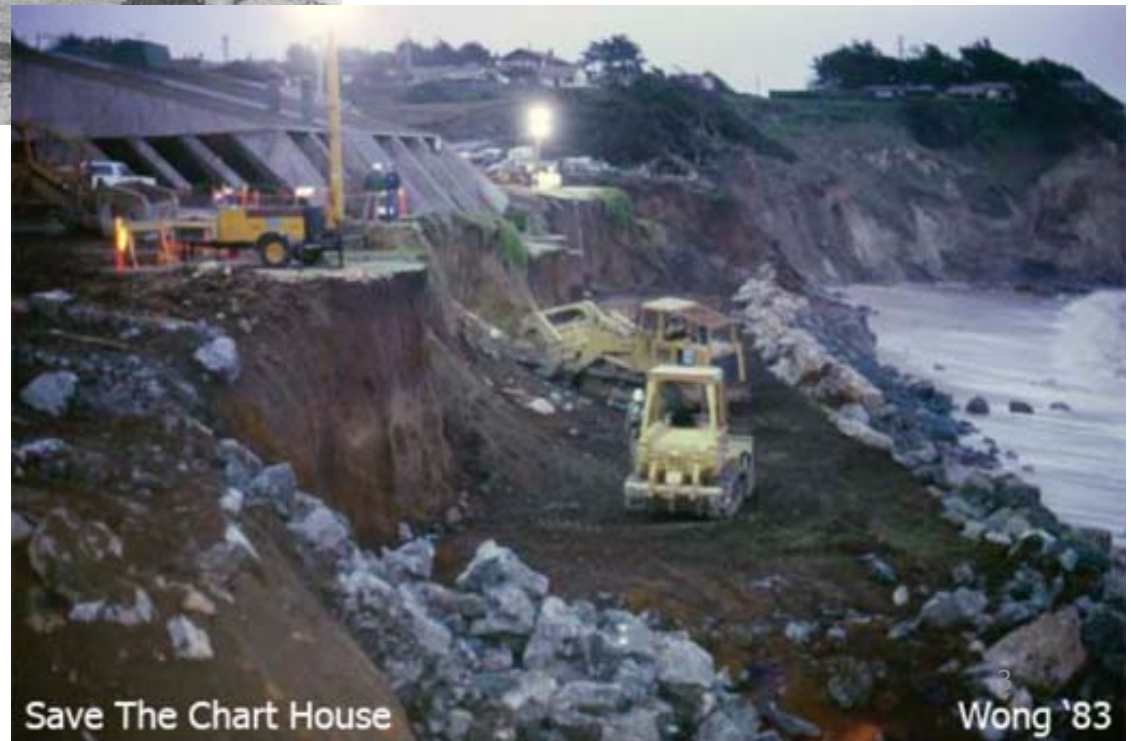
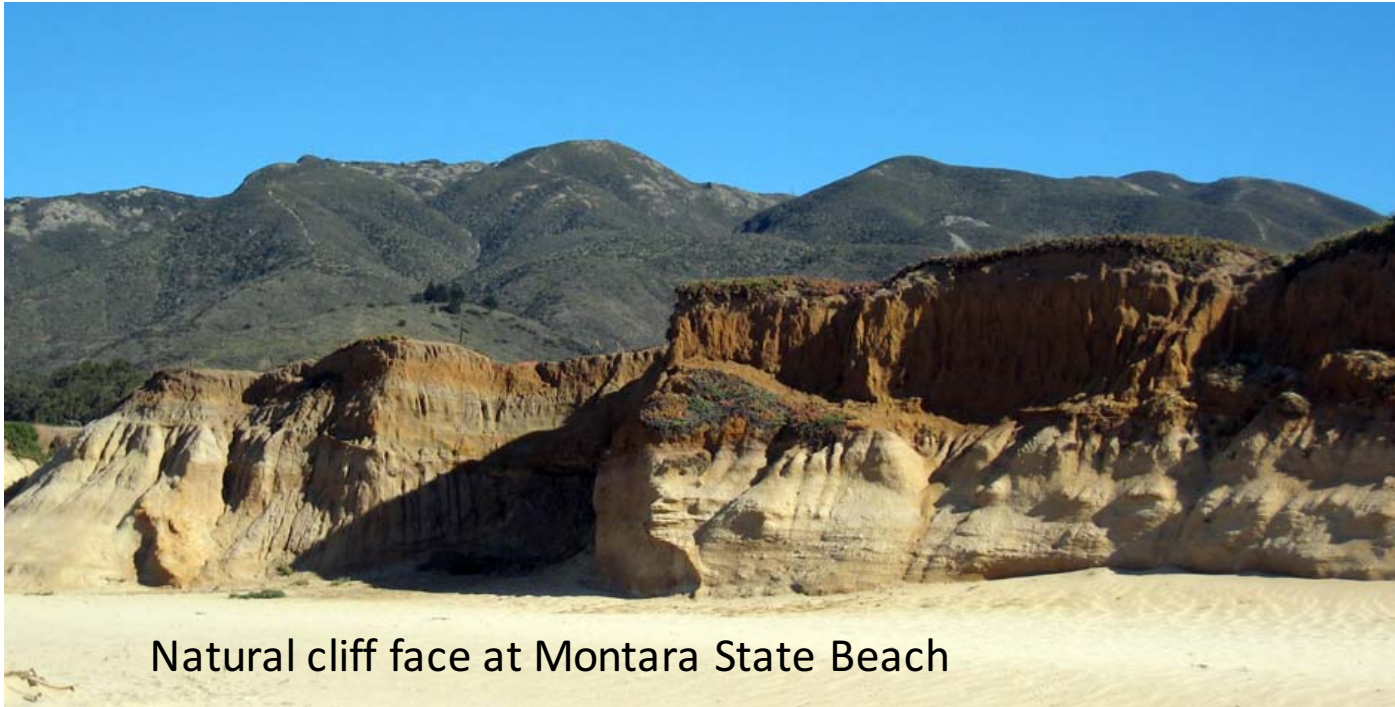
1983 El Niño storms –  
emergency armoring for  
the Chart House restaurant

Historical erosion annual averages  
can be misleading.

Coastal bluff erosion often occurs  
in dramatic seemingly unexpected  
events during winter storms.

The reaction has been piecemeal  
emergency armoring to protect  
development without regard to  
aesthetics, coastal access, or long-term  
area shoreline dynamics.

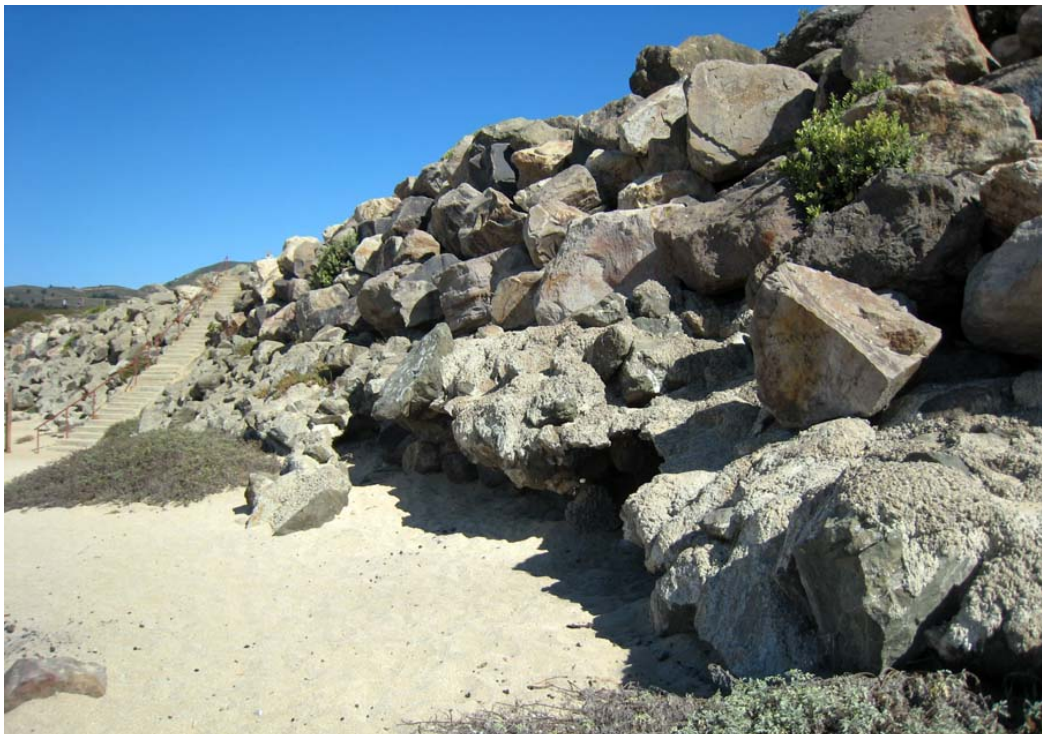
Aesthetics: Alien boulders and concrete slurry contrast harshly with the surrounding natural landscape and scar the view.

Maintenance & useful life: Over 30 years old, the steep wall of boulders protecting the restaurant is undermined and hazardous.

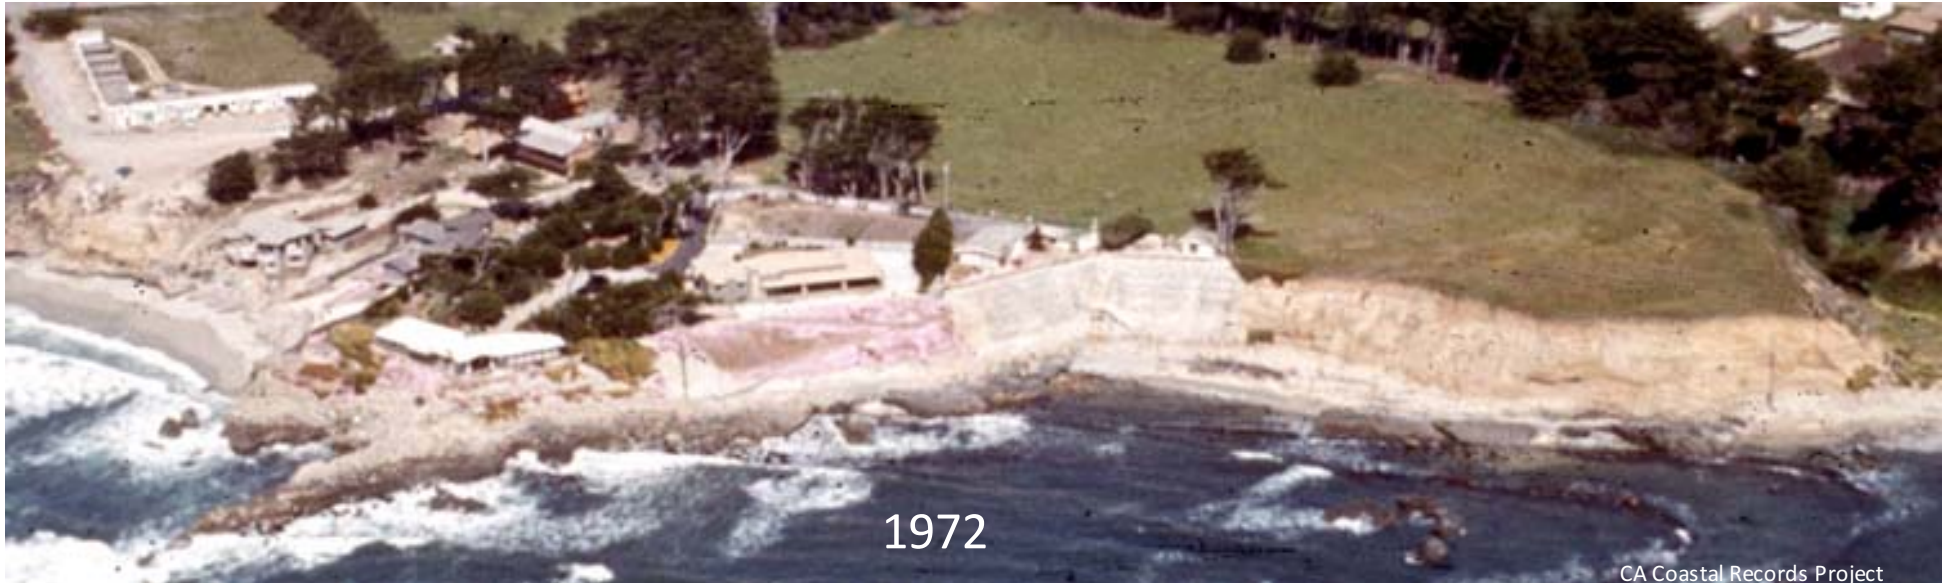
Reef Point Rd development and complete coastal armoring occurred prior to 1972. Extensive repairs have been necessary over the years.

Arbor Lane was subdivided in 1972 and developed, leaving a scenic easement on the shoreline, although half of that was armored in the 1980's to protect the nearest house.

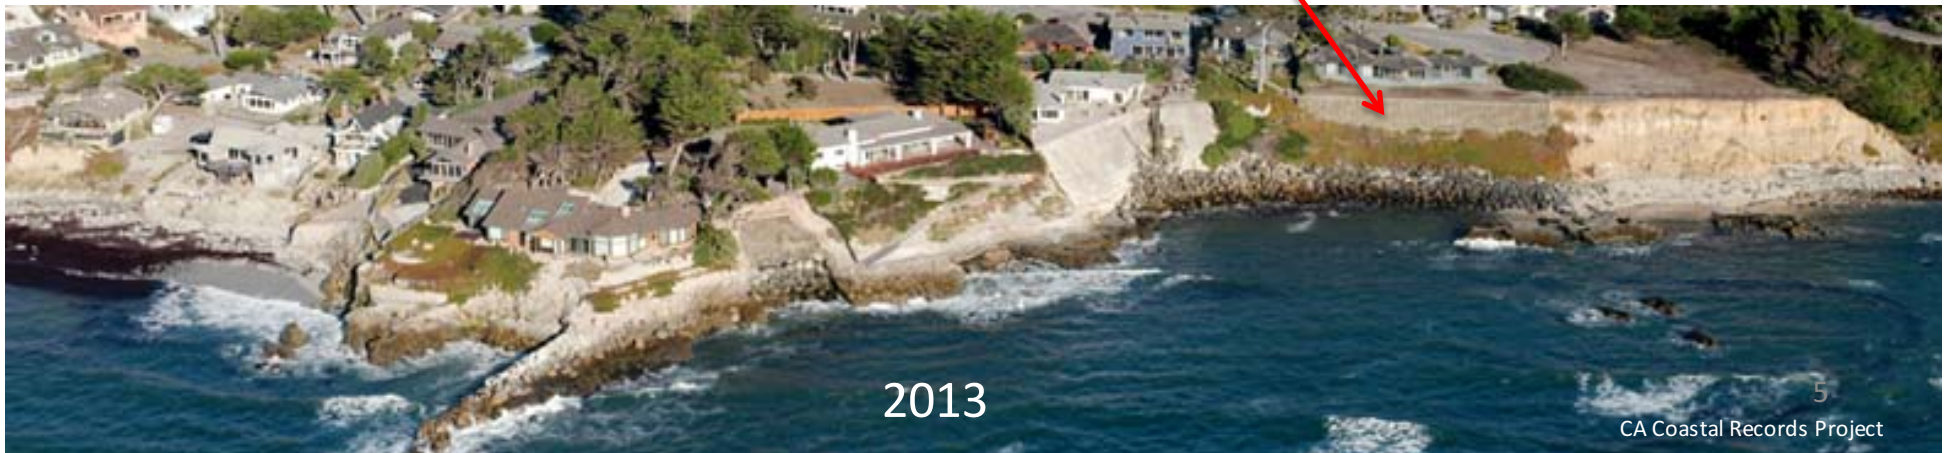
Reef Point Rd 60's-era coastal armoring  
viewed from Fitzgerald Marine Reserve beach access point 2002

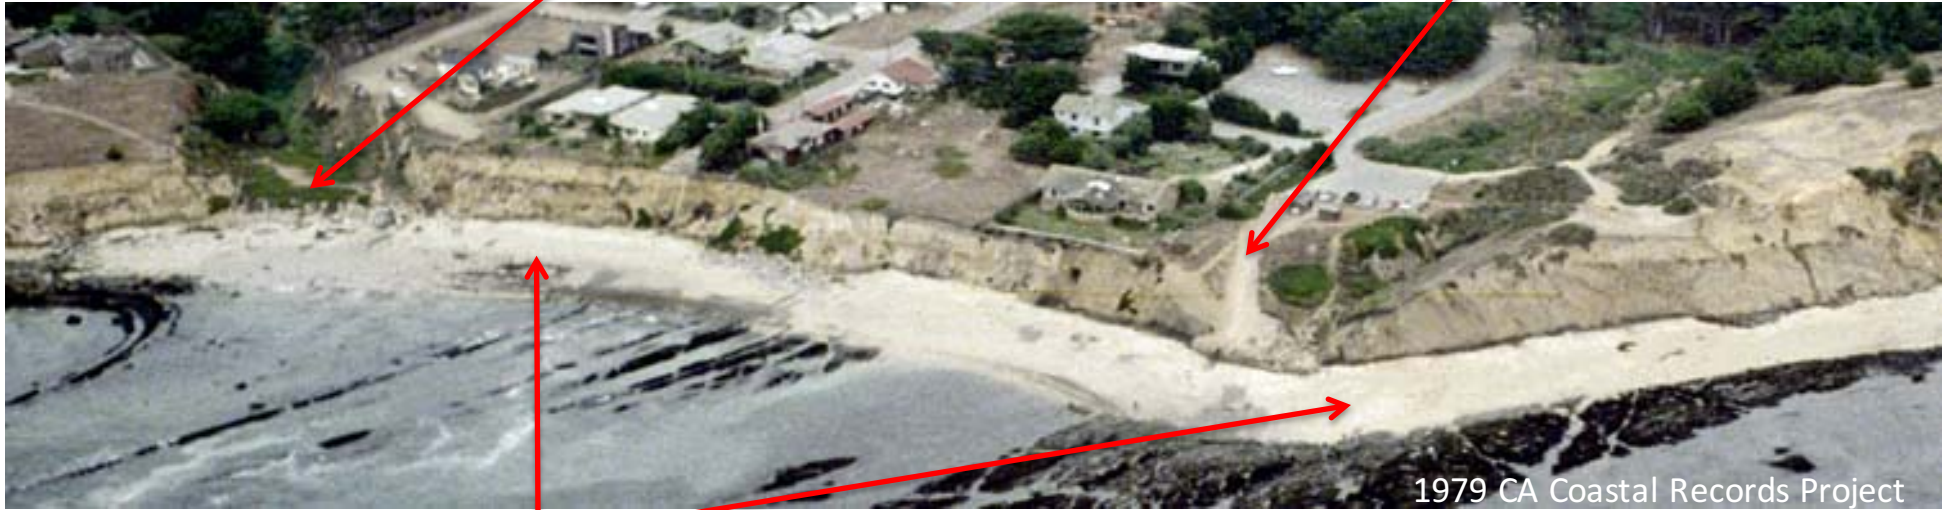
Prior to 1983 public beach access existed both north and south of the FMR ramp.

1980's armoring rocks placed on the public beach to protect 3 homes – County approvals noted the wide beach and that lateral access would not be blocked.

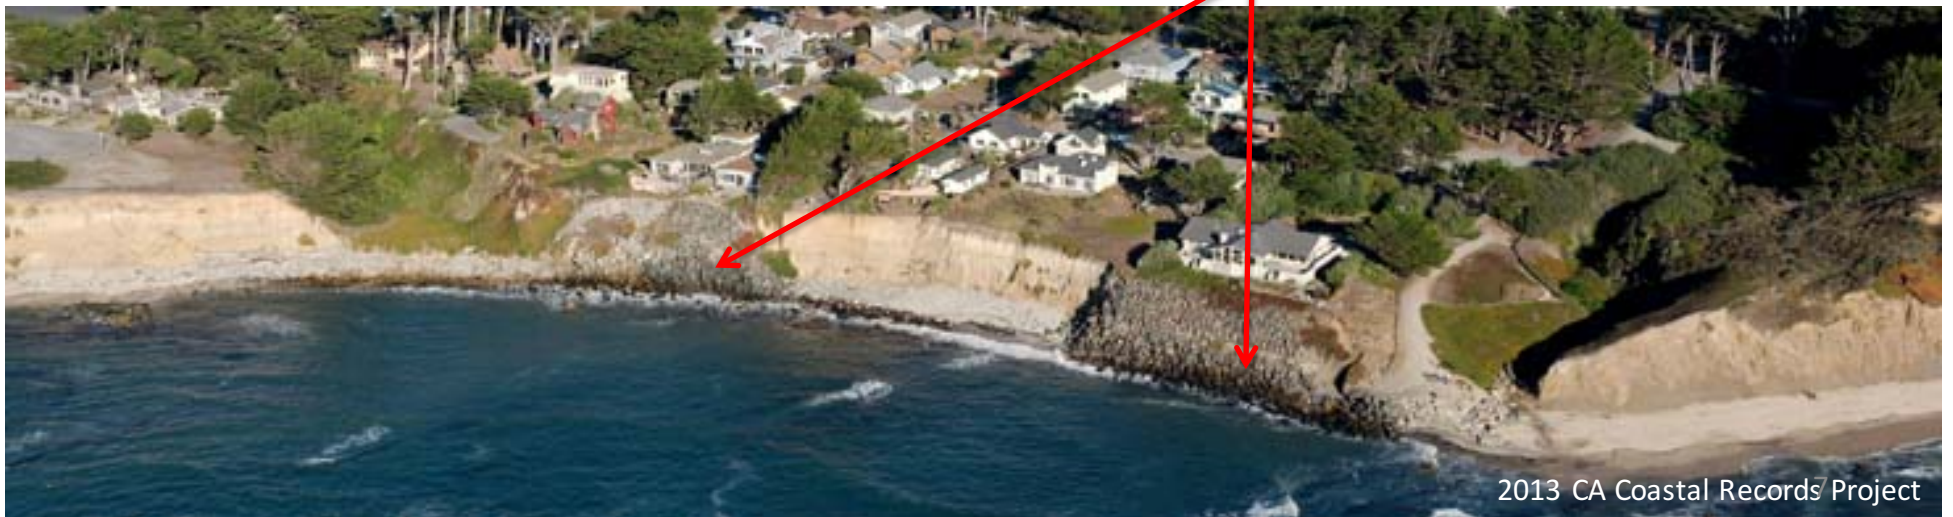
View north from FMR beach access point, 2012

At high tide, public beach access to the north is completely blocked and the view is marred by coastal armoring.

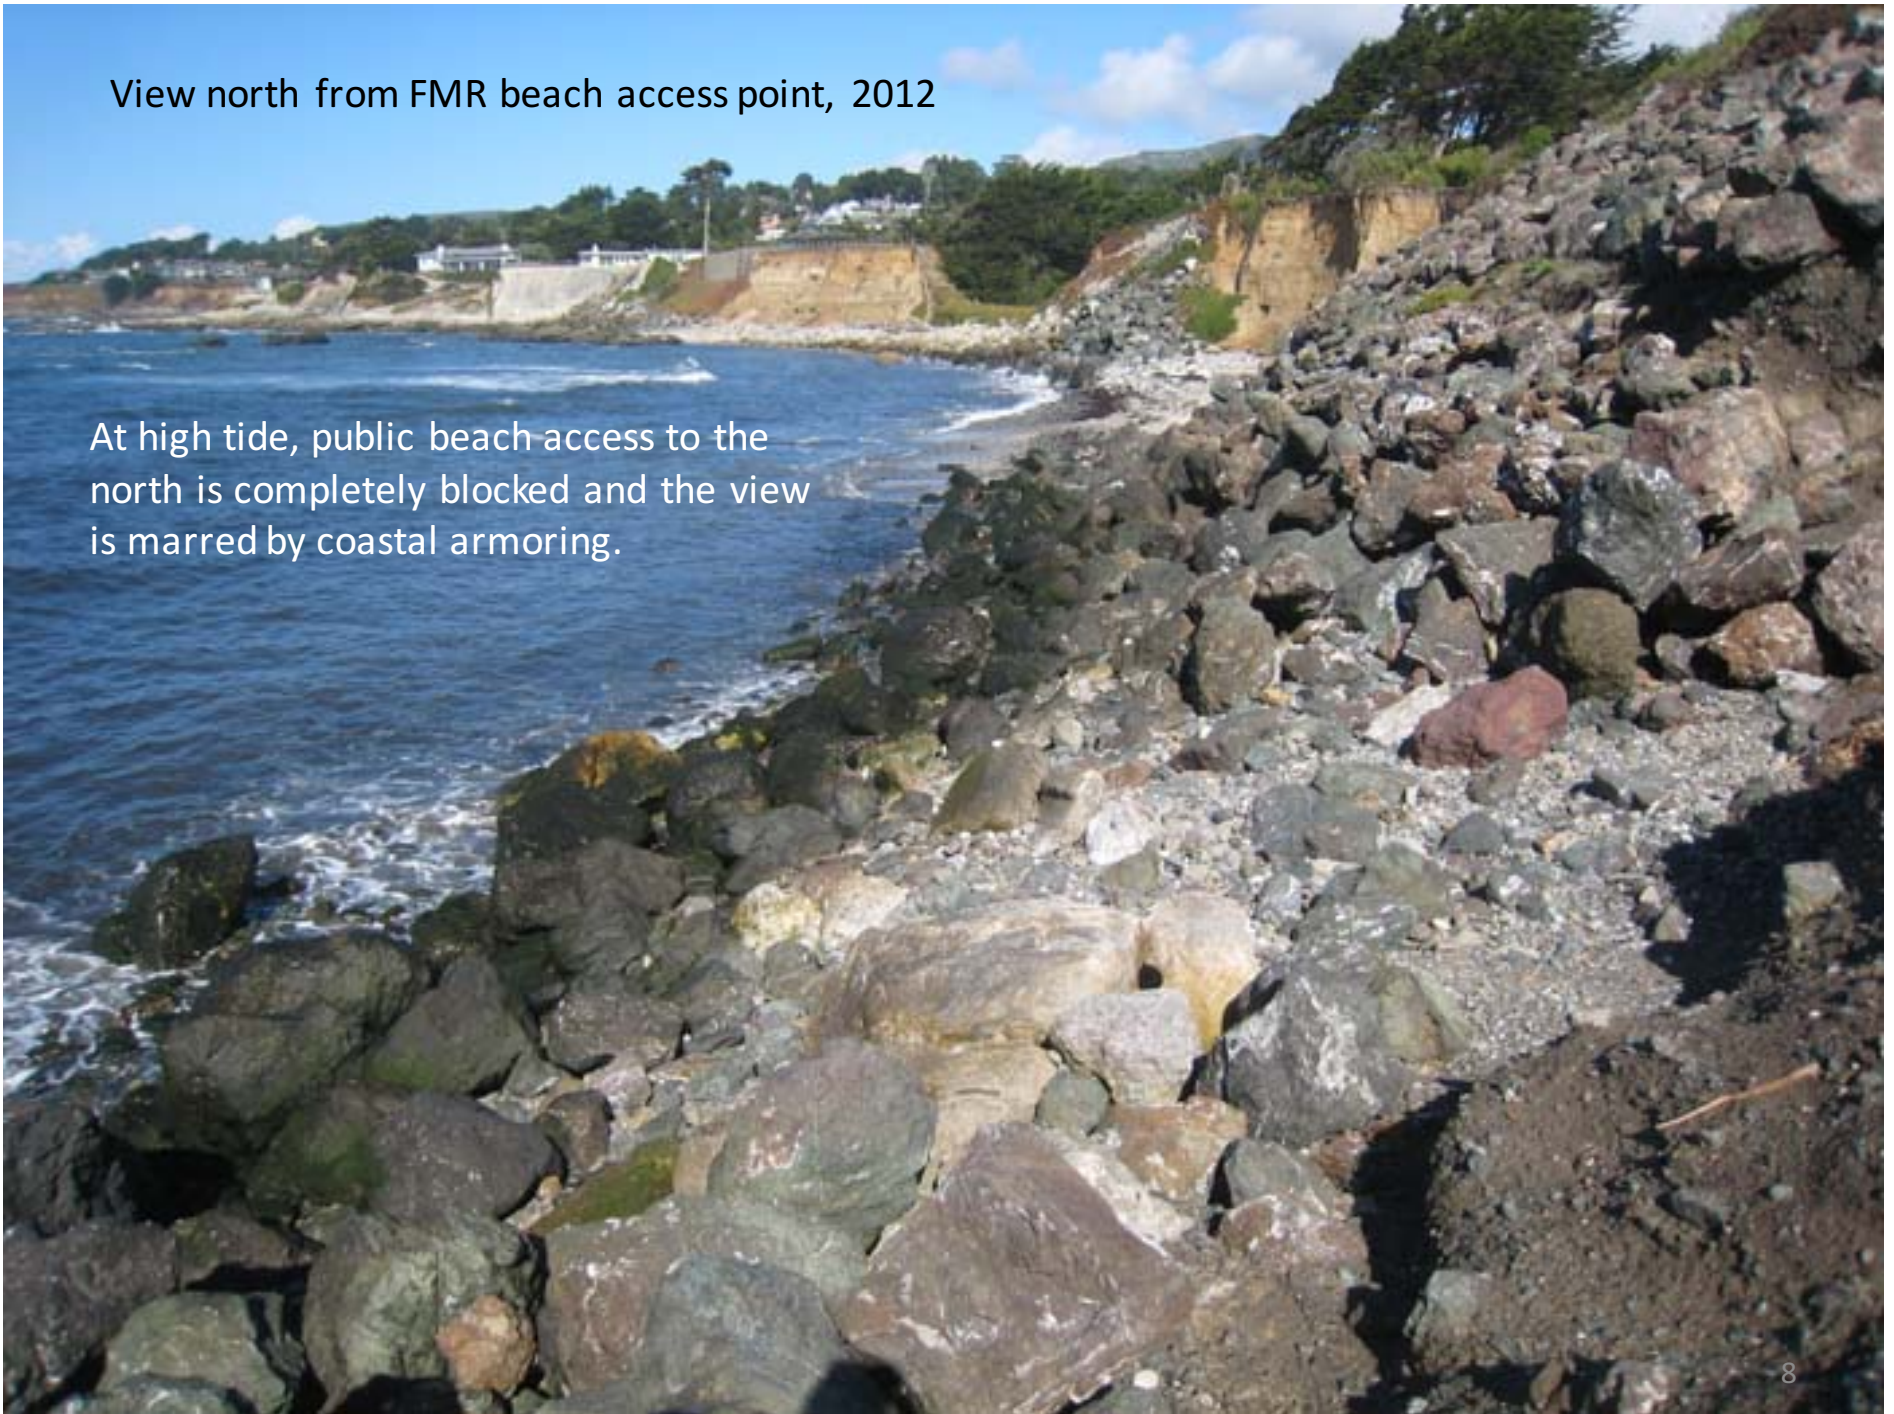
## FMR to Sunshine Valley -- 2015

Even at low tide, public access along the shoreline is difficult and hazardous due to deteriorating riprap with precariously perched boulders overhead and strewn all over the beach.

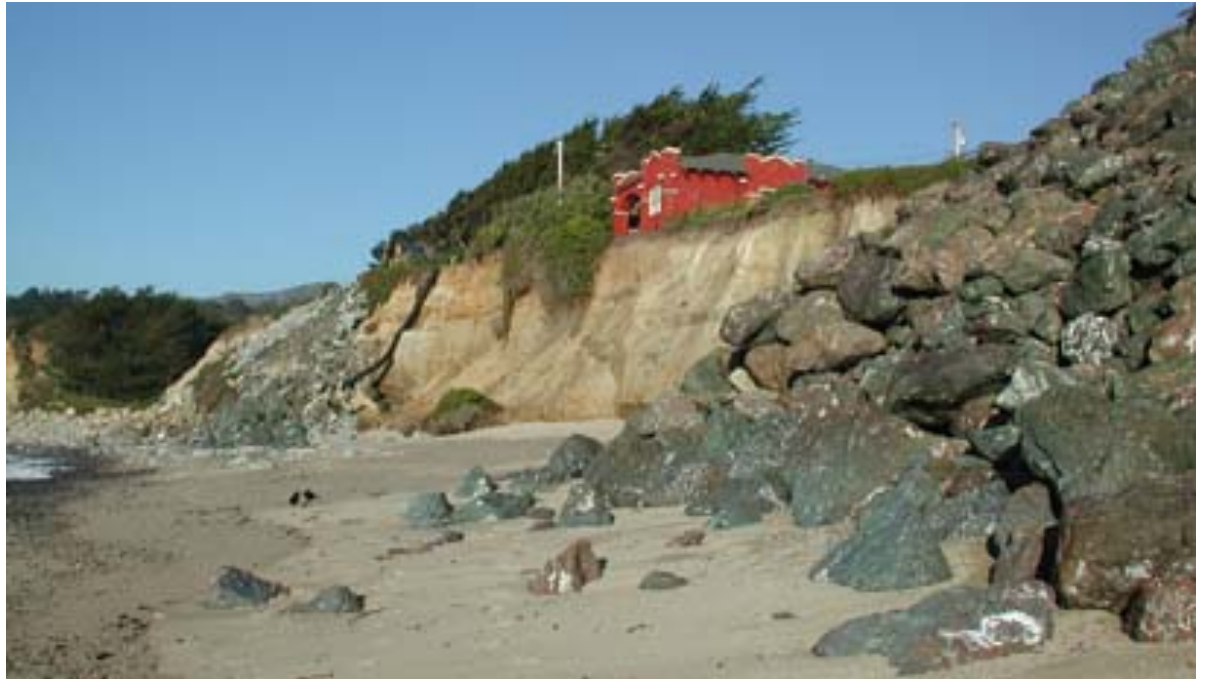
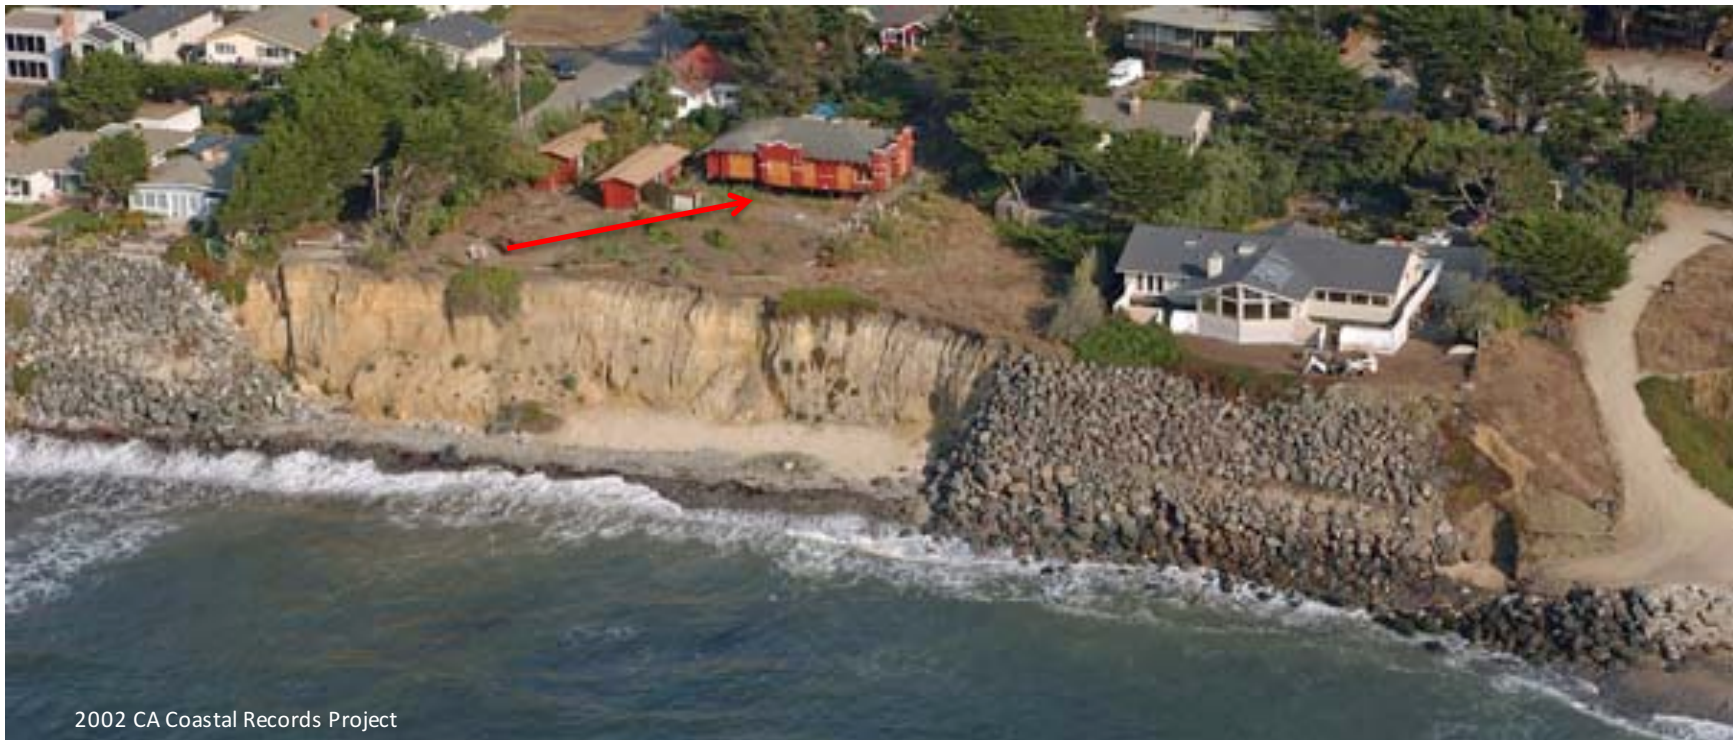
Historic house at 101 Beach St --

Threatened by bluff erosion in 2002, instead of armoring the cliff, the house was moved inland onto a neighboring parcel.

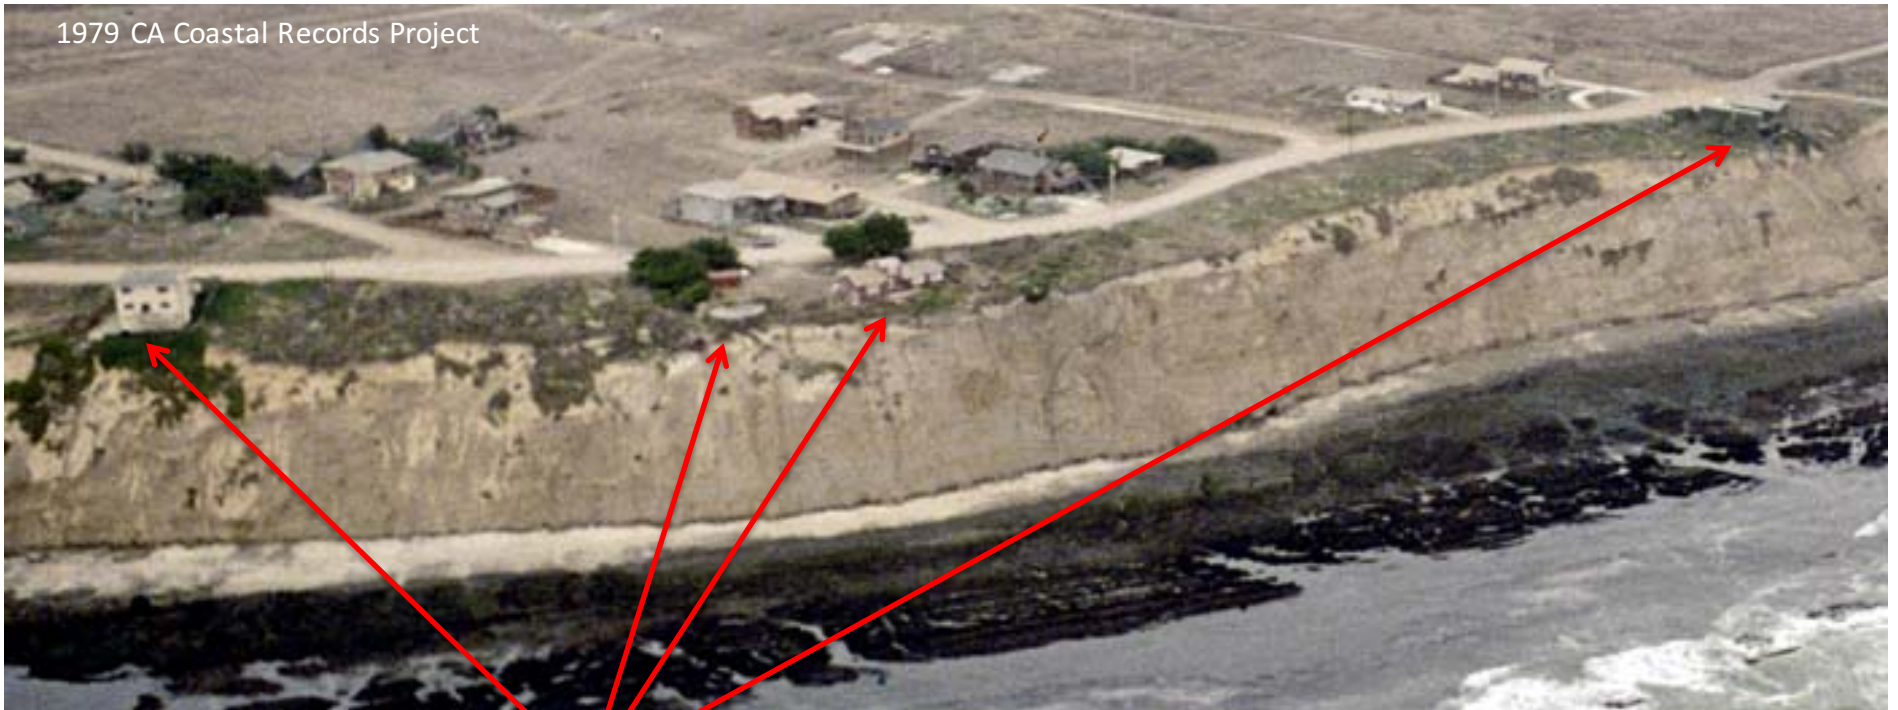
All 4 houses seen in 1979 along the cliff edge  
have been demolished and removed.

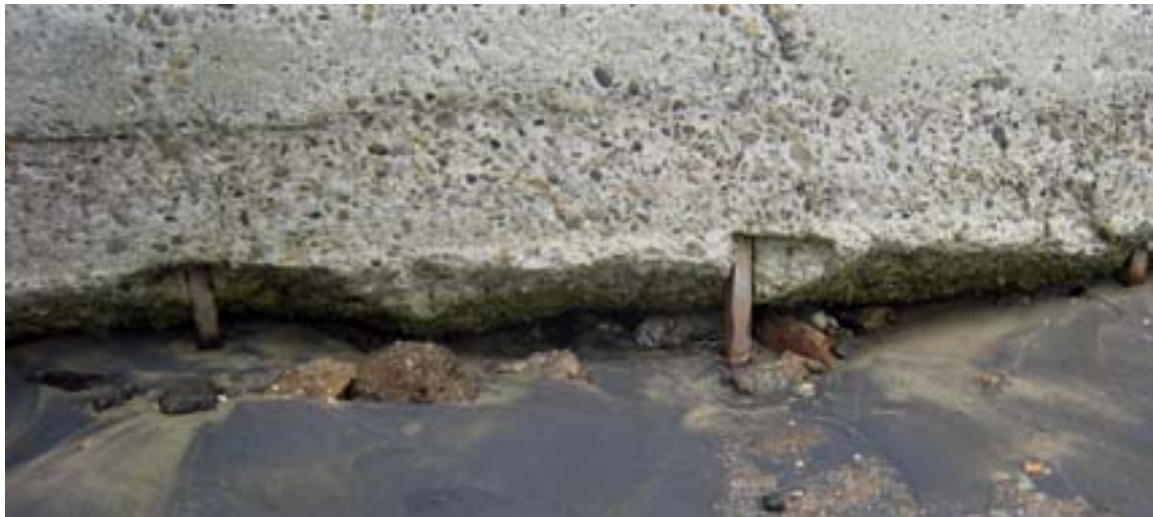
Lateral beach access blocked by illegally-placed riprap.

Unpermitted armoring and lack of enforcement by County or State

Unpermitted 1970's seawall undermined by loss of beach. Wave energy reflecting off shoreline armoring structures undercuts the beach and hastens erosion in front of the structure and neighboring properties.

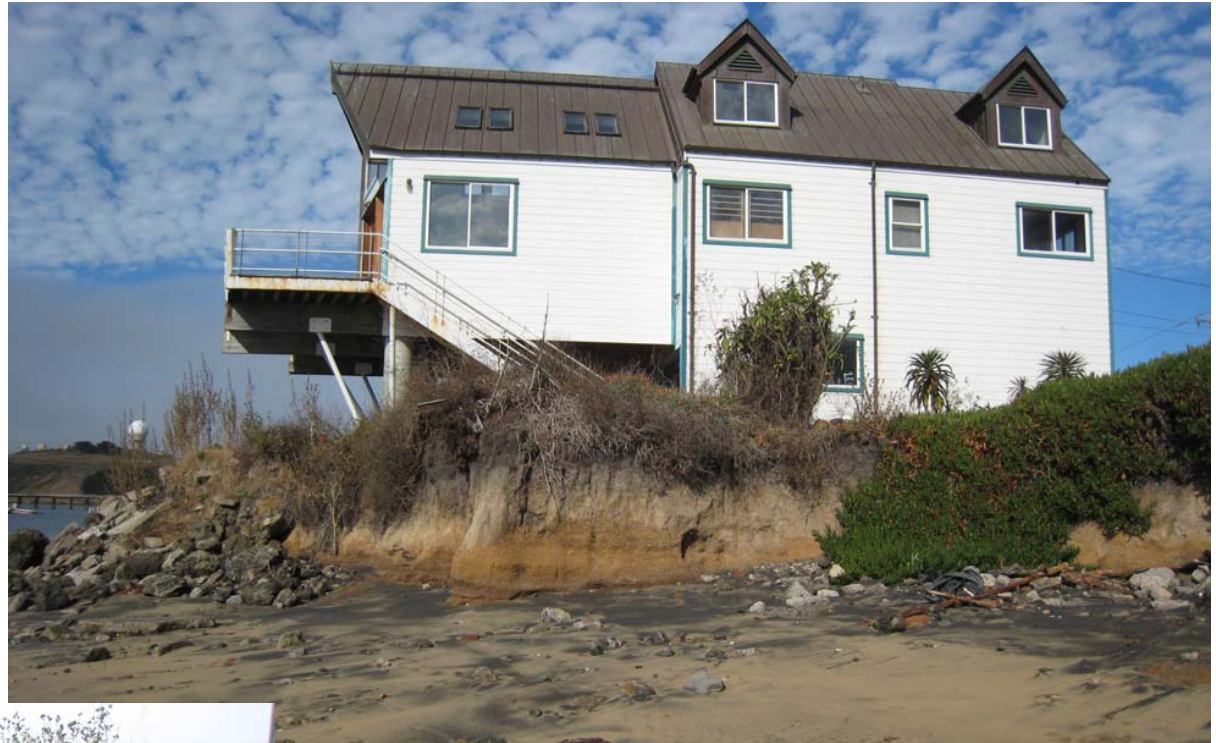
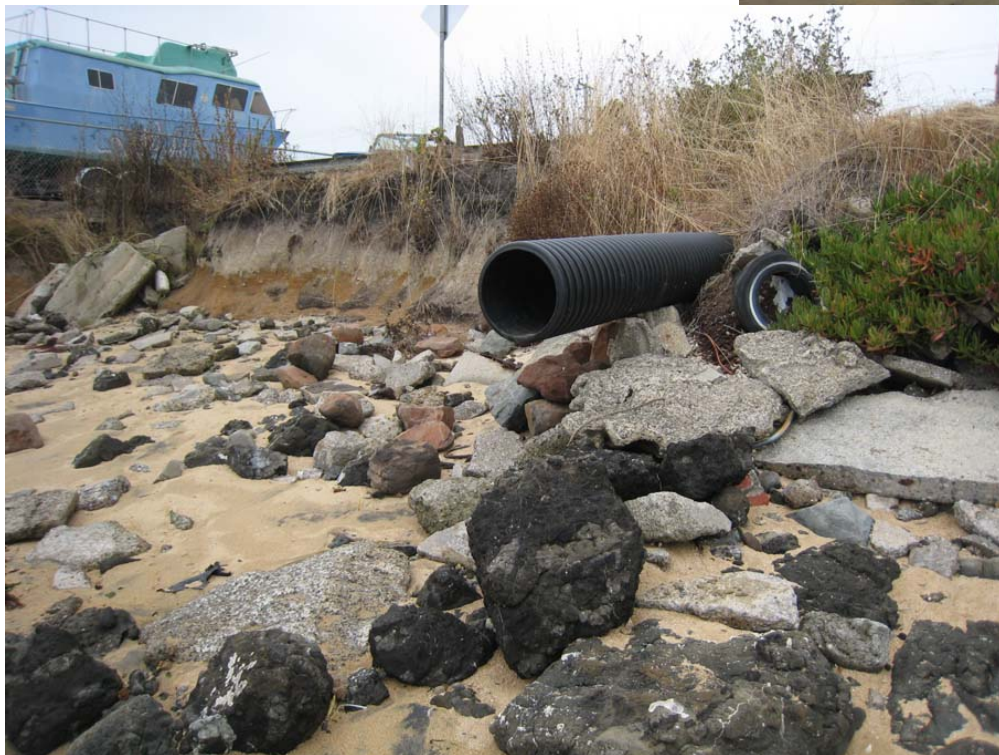
Rubble-strewn sandy beach  
at foot of Columbia –  
inevitable result  
of unmaintained armoring

Piecemeal armoring leaves  
protected development on a  
peninsula due to accelerated  
erosion of adjacent bluff.

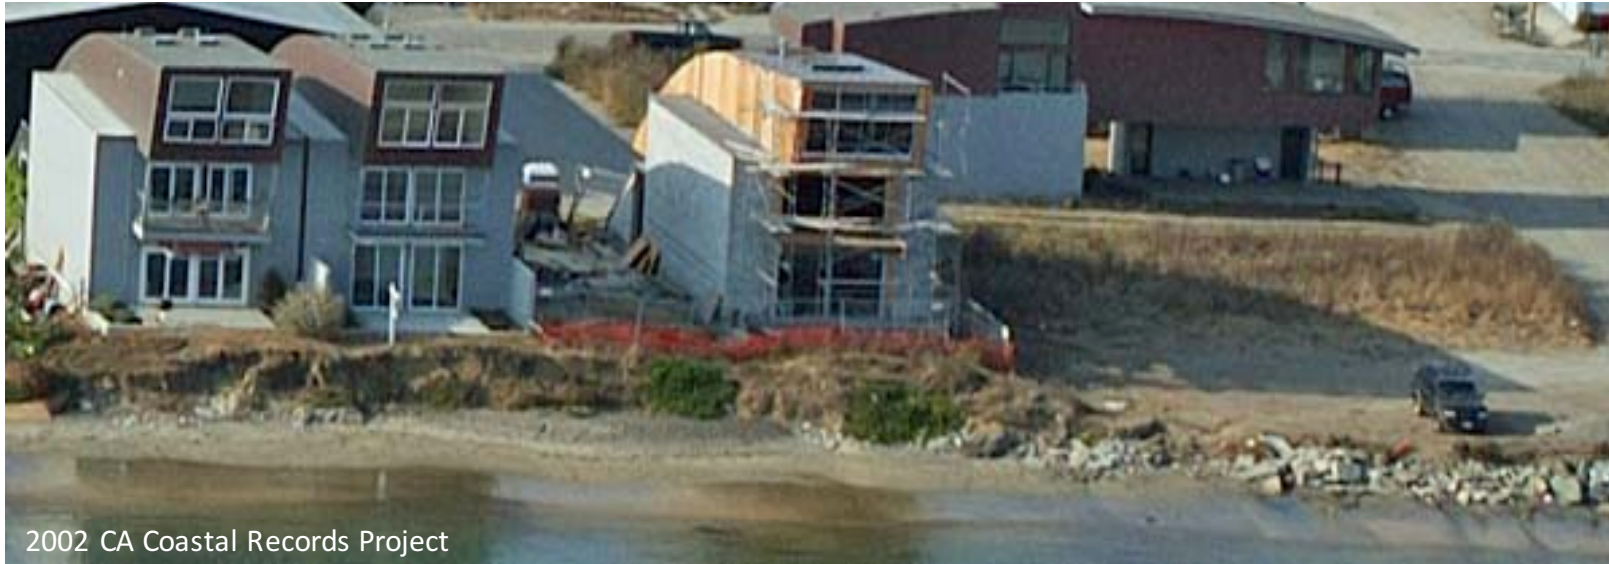
2002 CA Coastal Records Project

County approved shoreline development in late '90's. Emergency armoring added before construction even complete.

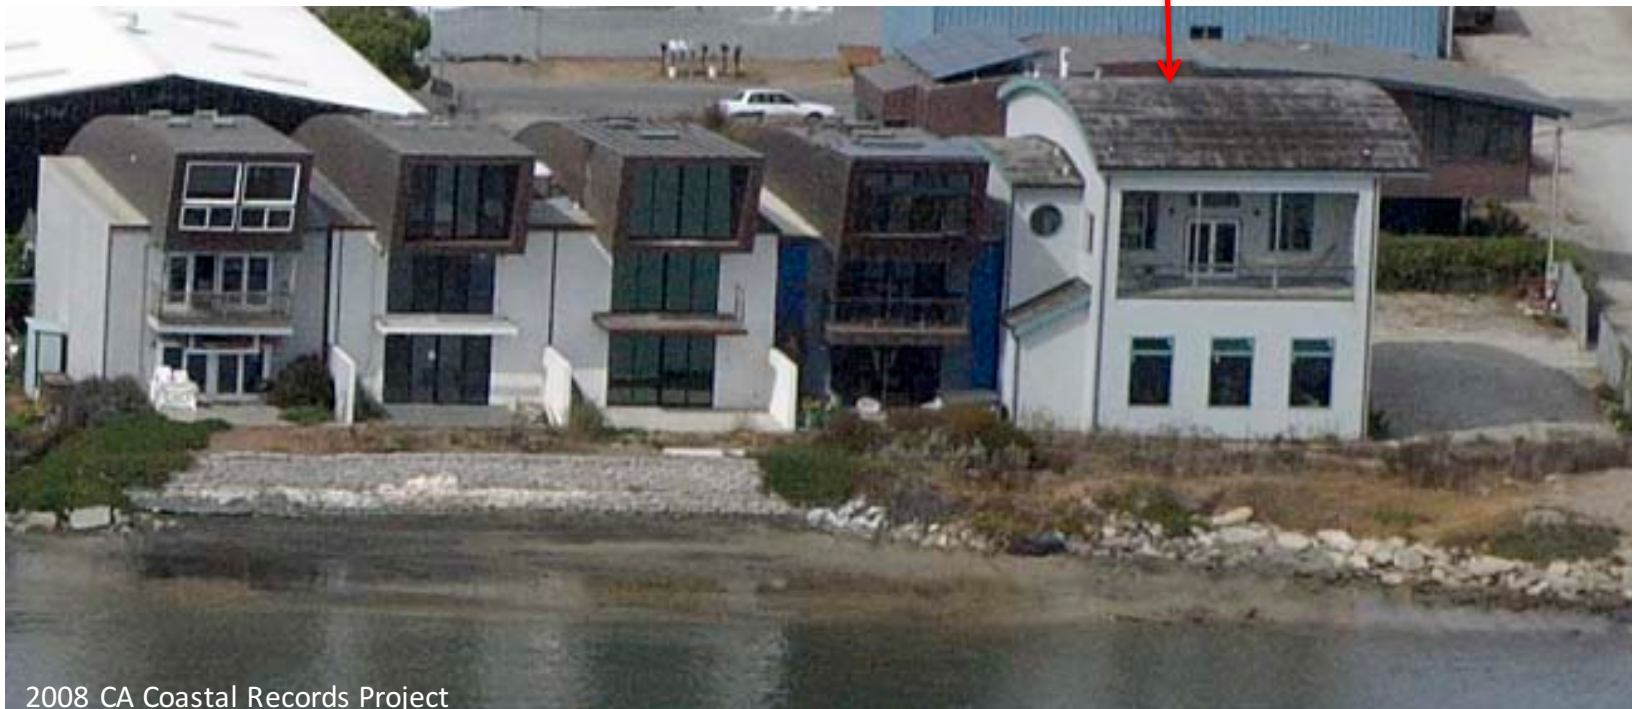
2008 CA Coastal Records Project

101 Vassar development permit appealed to CCC in 1999 -- condition added:

Deed restricted prohibition - no shoreline protective device now or in future.

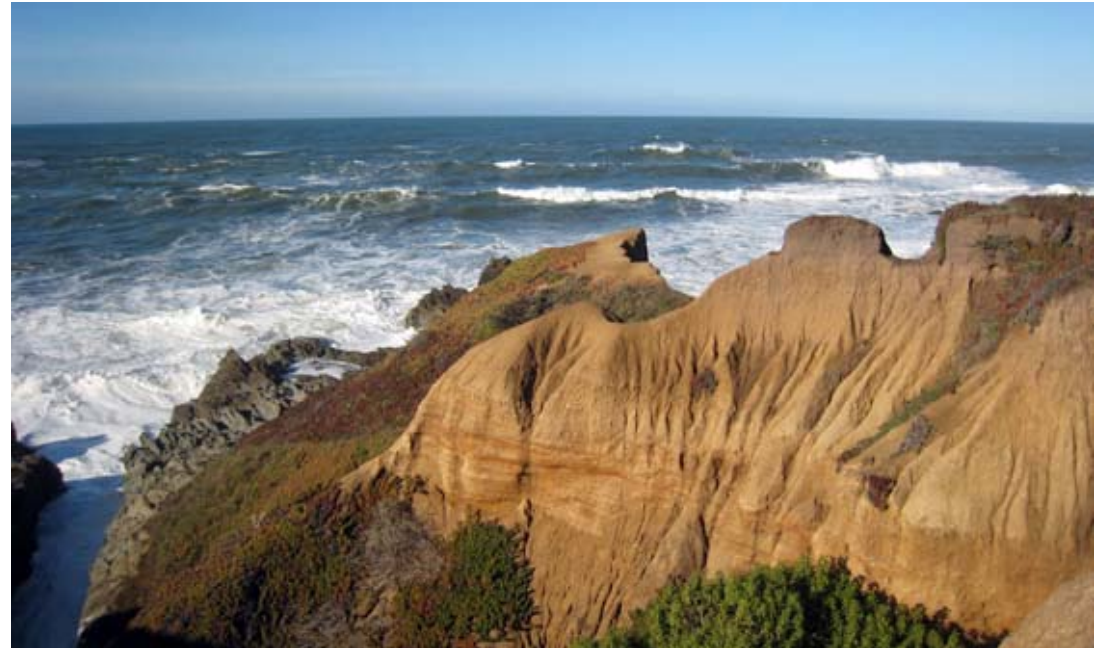
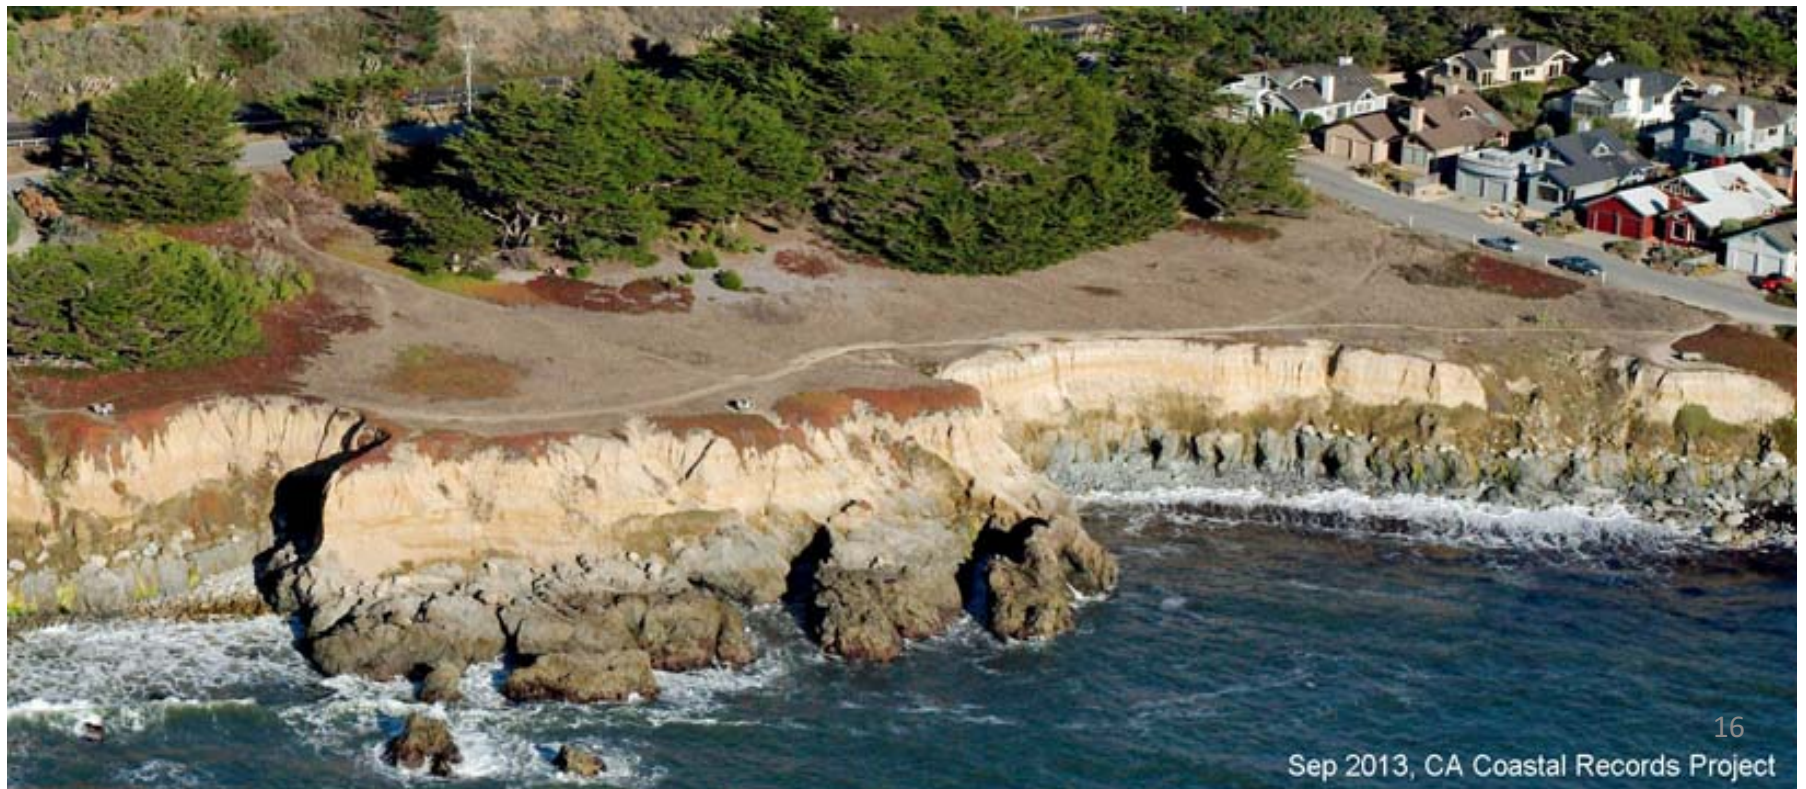
- unarmored
- proposed for development

The only way to save this beautiful shoreline is to give it plenty of space and allow it to retreat naturally.
