School Streets and Traffic Displacement

Technical Report

Document details	
Reference ID:	SUSR1996
Version:	5.0
Client:	The Road Safety Trust
Circulation Status:	External – client and key stakeholders (The Road Safety Trust and Birmingham CC)
Issue Date:	28/06/2022
Author(s):	Tom Belcourt-Weir, Chris Cannell, Matt Pearce
Reviewed by:	Matt Pearce
Signed off by:	Anjali Badloe

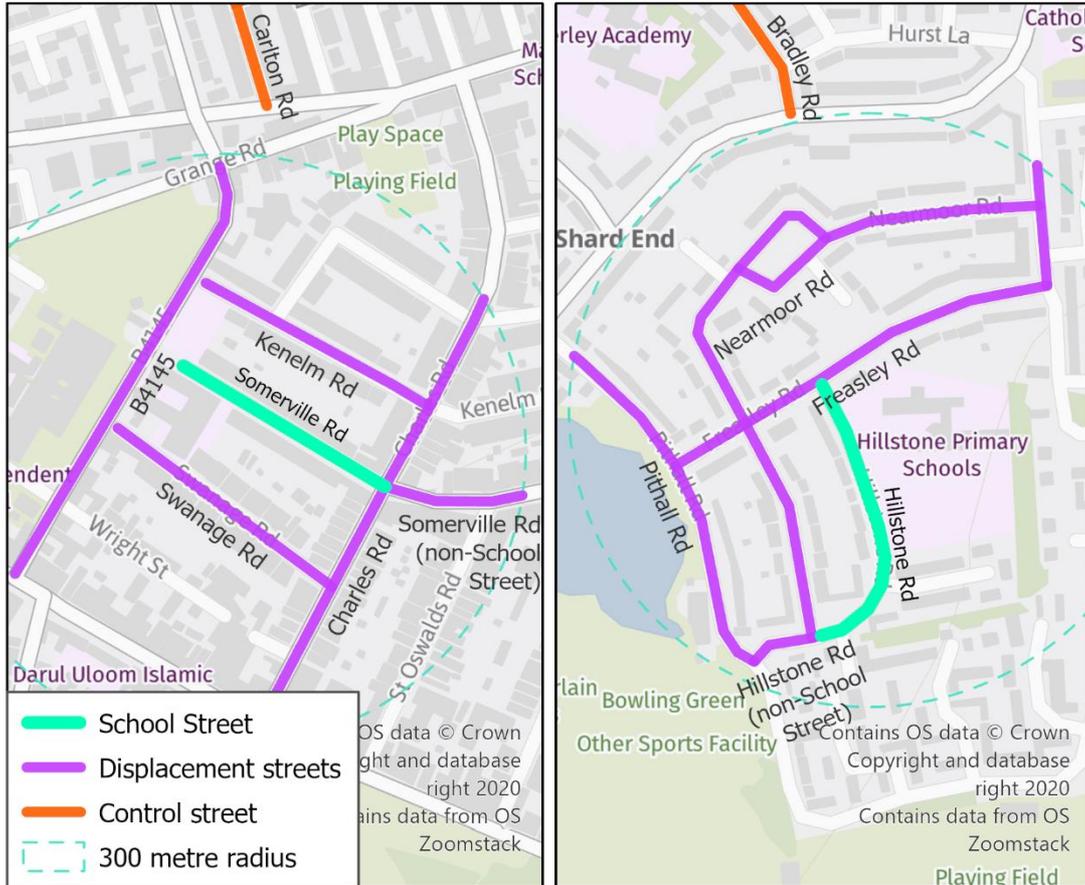
Figure 1: Maps of streets monitored at Somerville Primary School (left) and Hillstone Primary School (right): the School Street, surrounding streets with potential for displacement, and a control street

We identified the key findings of the existing body of evidence on the impact of Schools Streets by conducting a literature review. We followed this up with a field exercise to collect fresh evidence on two Schools Streets primary schools in Birmingham. We chose the schools in question to see if road layouts would make a difference, one school being on a cul-de-sac and the other being on a road with junctions at both ends. Figure 1 show maps of the School Streets and surrounding streets.

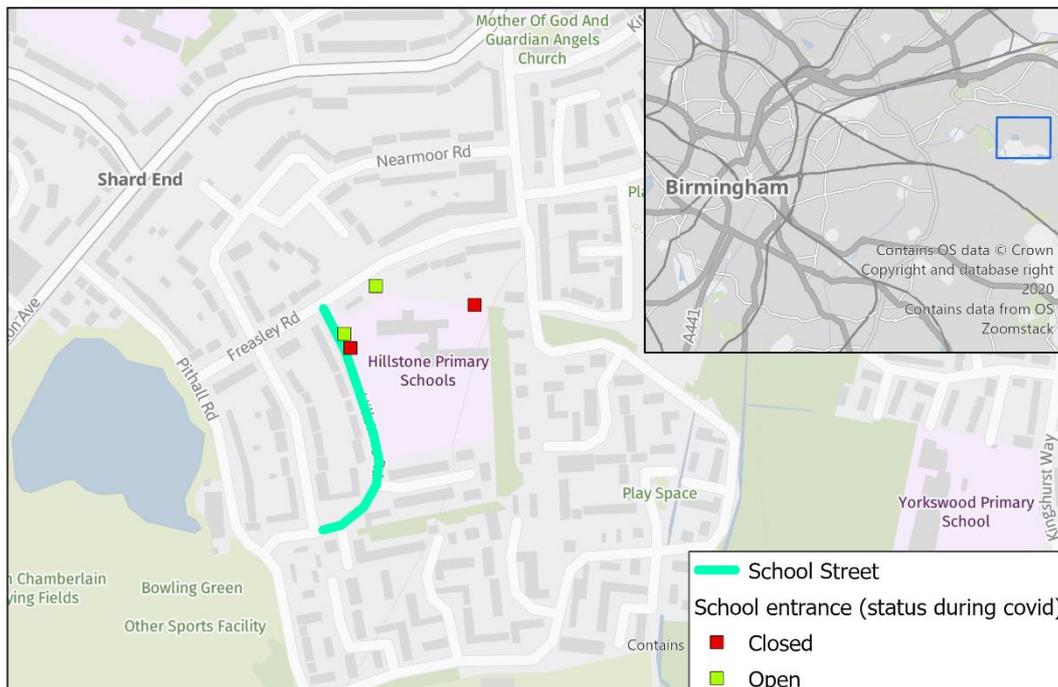
Figure 3: Map of Hillstone Primary School with School Street and entrances

Figure 3 and Figure 4 show maps of each school location. When planning our monitoring, we took into account the entrances being used for pupil access, including any special Covid-19 measures.

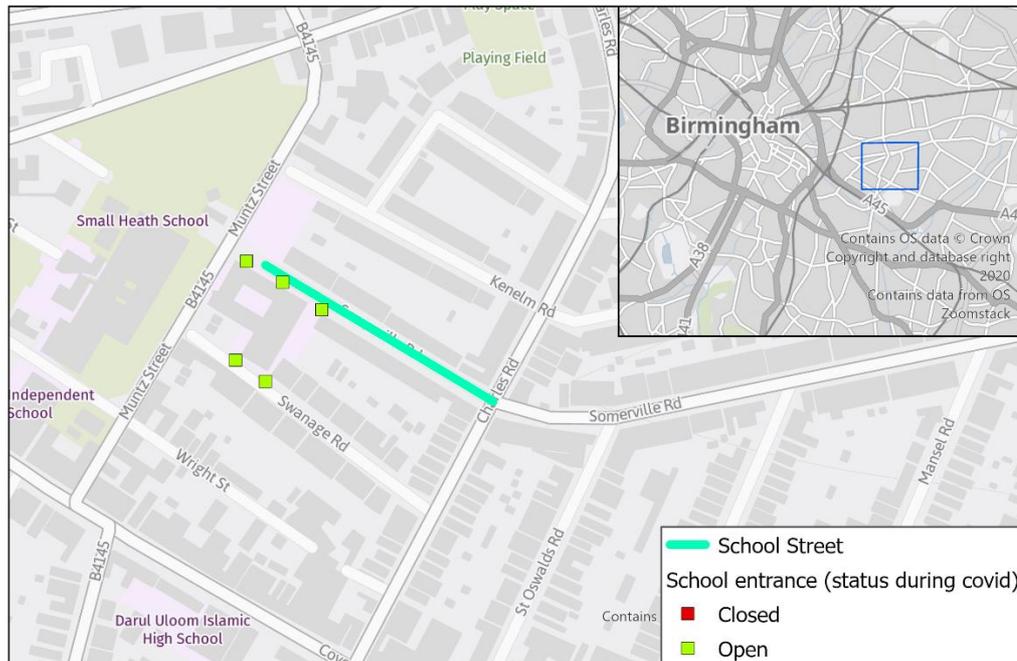
Figure 4: Map of Somerville Primary School with School Street and entrances

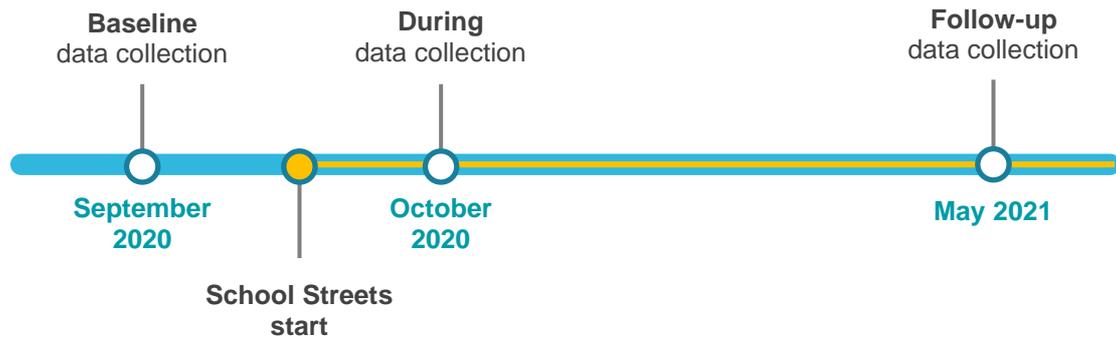
Figure 5: Timeline of data collection phases before and during School Streets

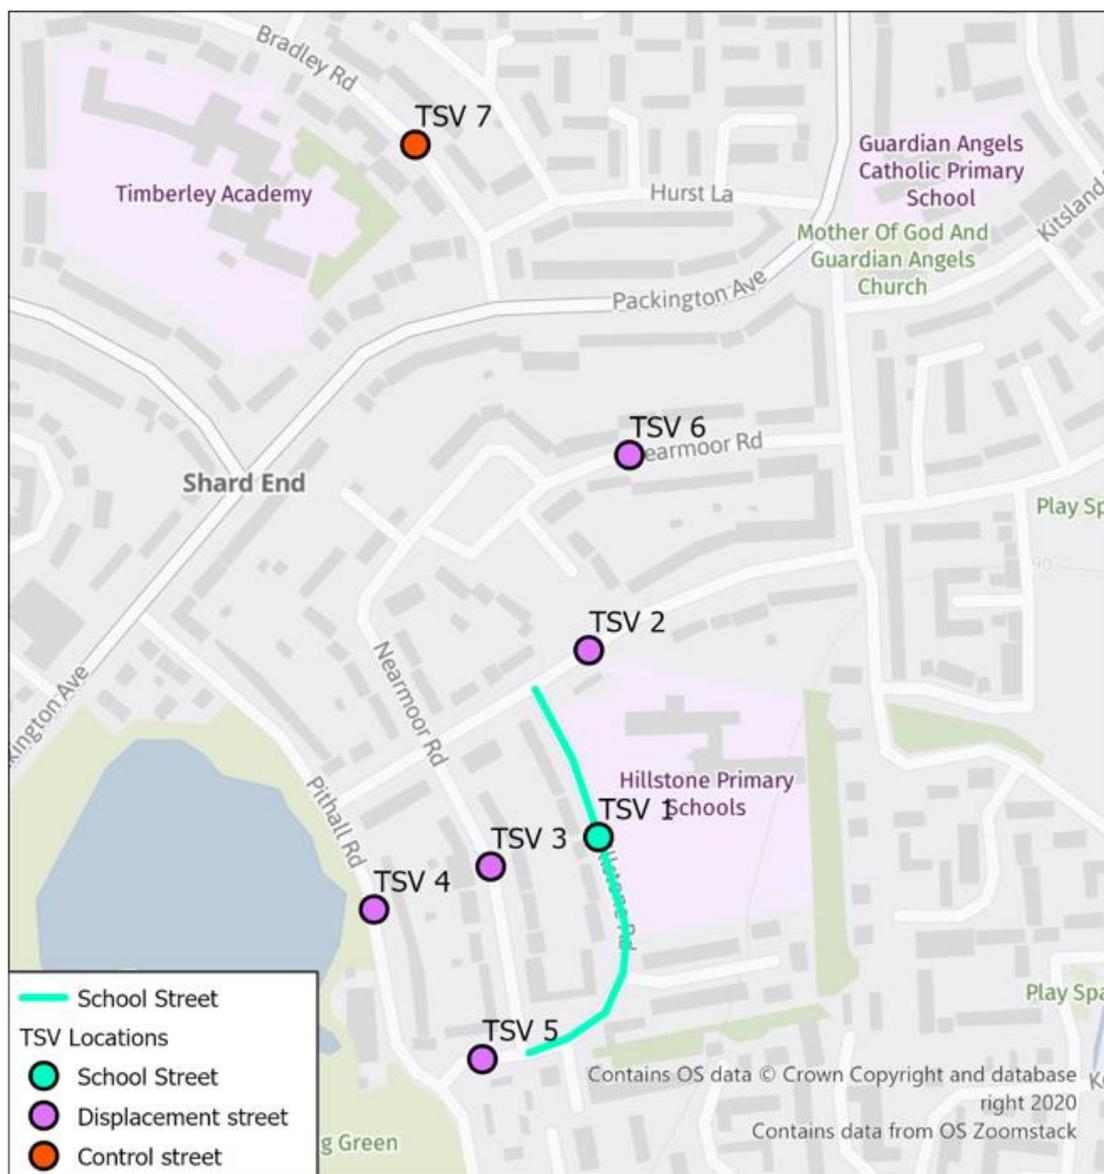
Figure 6: Traffic Speed & Volume (TSV) locations for Hillstone Primary School

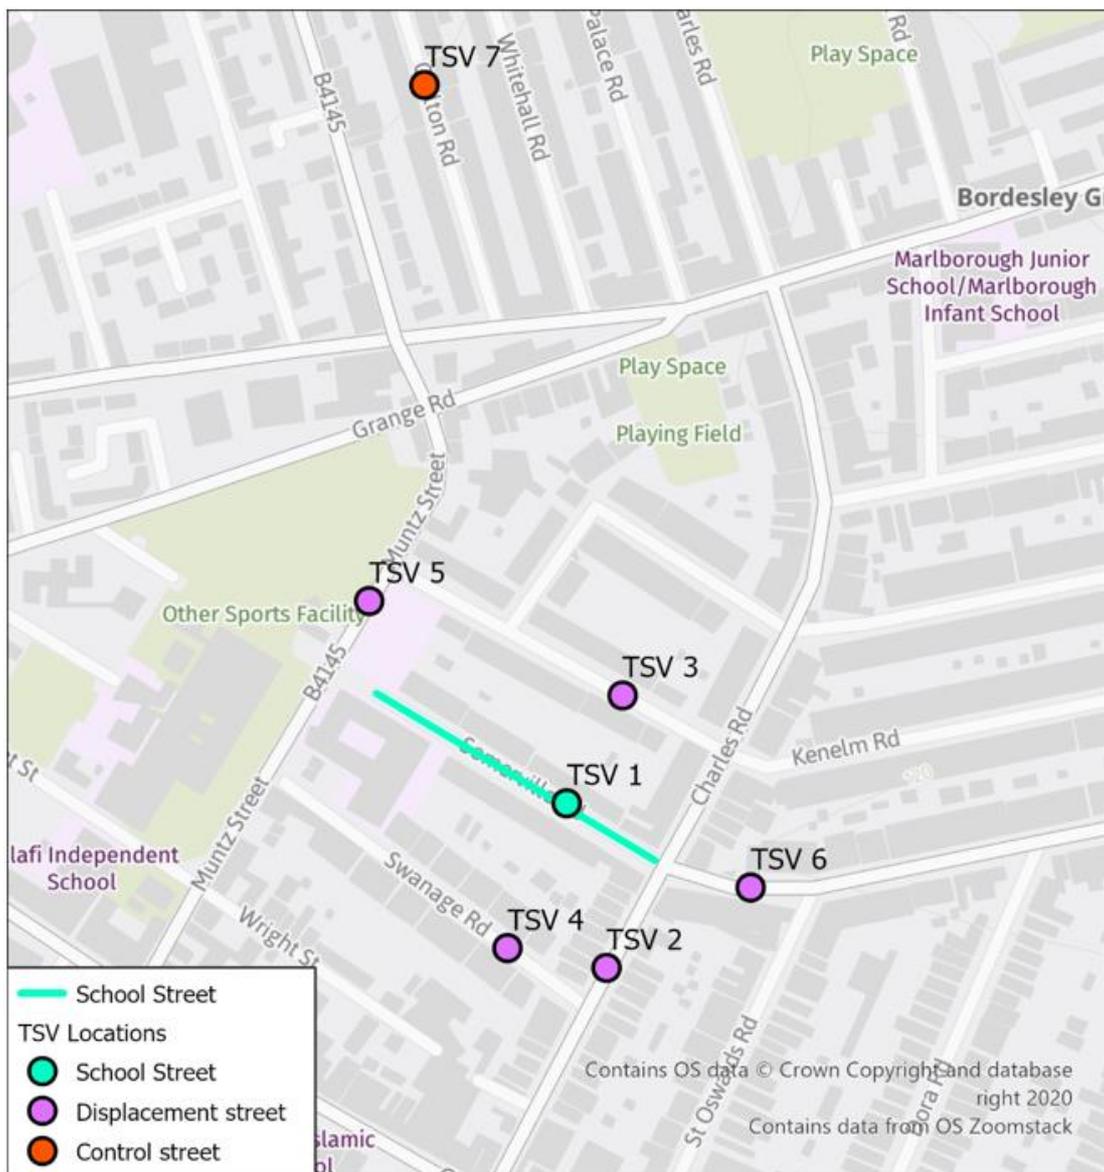
As shown in Figure 7, one TSV location was on the School Street itself, Somerville Road (TSV 1). Five were then located on potential displacement routes. Two of these were on Charles Road (TSV 2) and Somerville Road, near to the school street entrance (TSV 6). Two more were located on parallel roads Kenelm Road (TSV 3) and Swanage Road (TSV 4). One was also located on the B4145 (TSV 5) to capture traffic potentially using the B145 instead of Somerville Road to drop-off/pick-up. Finally, the control location was on Carlton Road (TSV 7).

Figure 7: Traffic Speed & Volume locations for Somerville Primary School

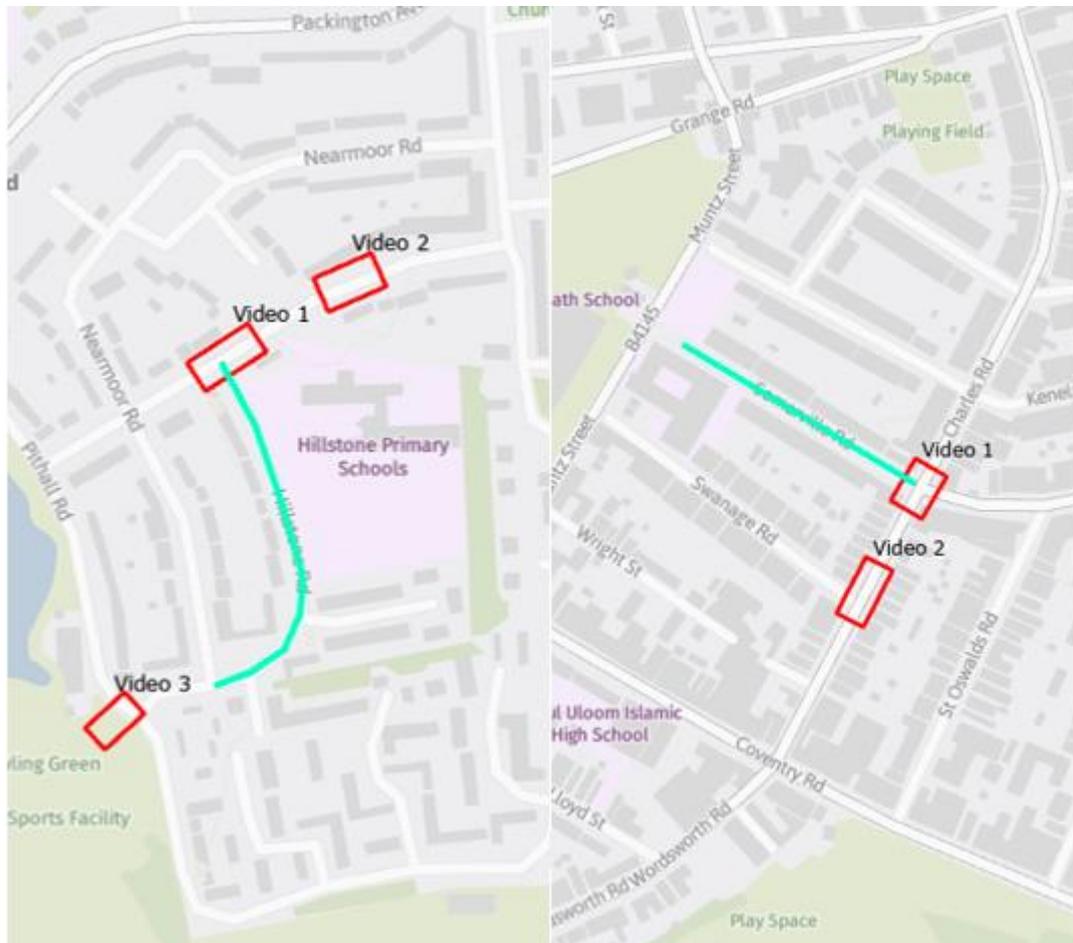
Figure 8: Video locations for Hillstone Primary School (left) and Somerville Primary School (right), with School Streets indicated by turquoise line

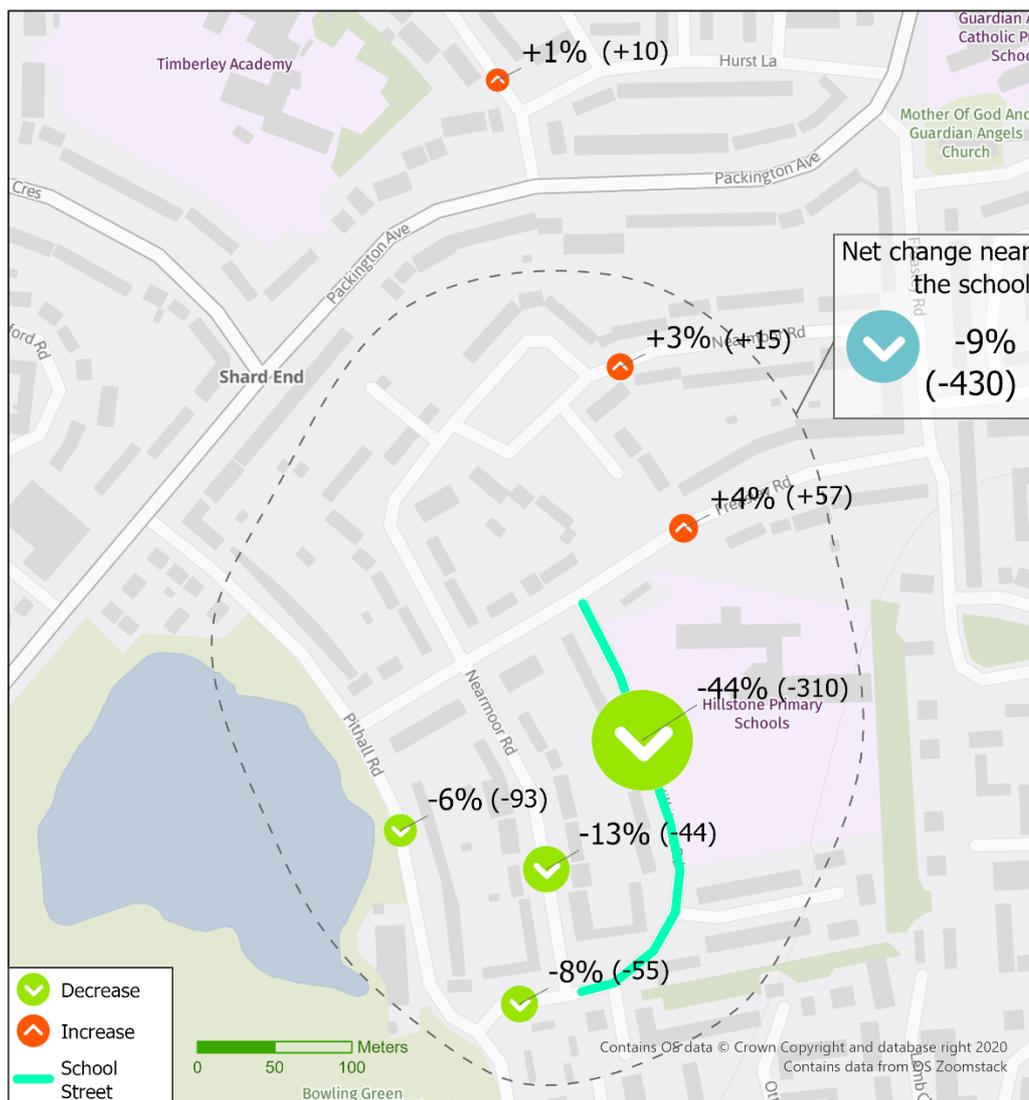
Figure 9: % change in traffic volumes (change in number of vehicles) around Hillstone Primary School between baseline and during intervention

As expected, the Hillstone Road (School Street) location saw a large fall in traffic volume at both phases. The fall from baseline was perhaps not as large as expected though, at -44% (from 698 to 388 vehicles) during the School Street and then -36% (from 698 to 450 vehicles) at follow-up, considering the intervention prevented access to all through traffic. As the ATC data does not allow for differentiation between non-compliant drivers and exempt drivers on the School Street, it is not possible to comment on whether a degree of the traffic observed was attributable to non-compliant drivers or any lapse in enforcement.

The volume of traffic also fell on the non-School Street section of Hillstone Rd (-8% during intervention, from 659 to 604 vehicles), and on the two roads parallel to the School Street: Pithall Road (-6% during intervention, from 1,542 to 1,449 vehicles) and Nearn Moor Rd south (-

Two locations did see a rise in traffic though. Freasley Road is the main perpendicular access road to the School Street, with a T-junction at the top of Hillstone Road. As such we expected that it might be a key road onto which traffic would be displaced. We observed a 5% rise in the traffic at this location at follow-up (from 1,310 to 1,381 vehicles), as well as a 3% rise on Nearmoor Road (north) at the during intervention phase, from 465 to 480 vehicles.

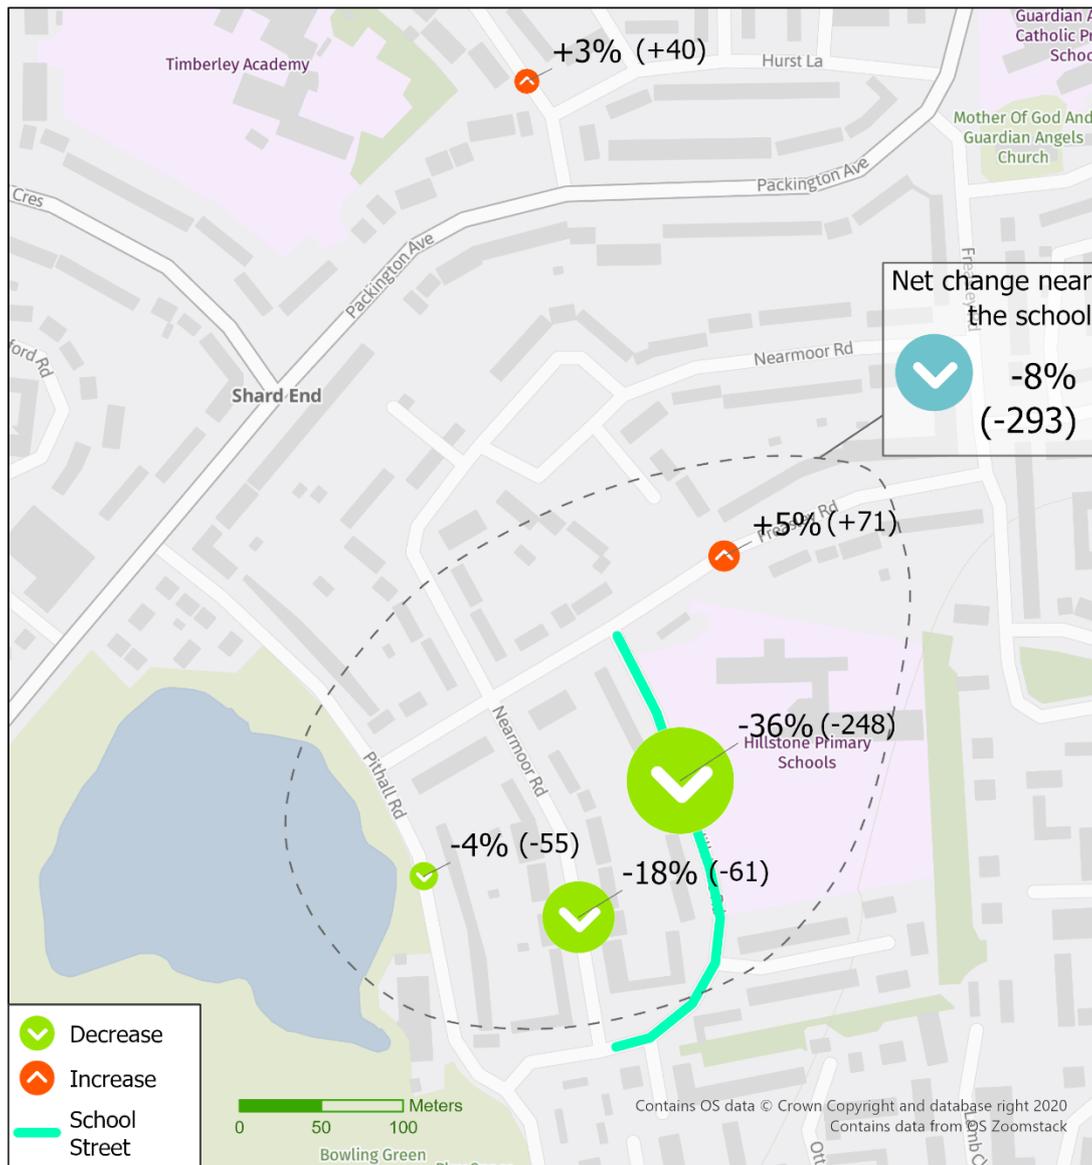
Figure 10: % change in traffic volumes (change in number of vehicles) around Hillstone Primary School between baseline and follow-up

At the follow-up phase there was a 3% rise in traffic at the control location on Bradley Road (from 1,481 to 1,521 vehicles). This indicates that some rise may have been expected, even if the School Street was not in place, but the observed rise at Bradley Road of 3% may also represent random fluctuation.

During the School Streets hours, total traffic levels across the area surrounding the school as a whole fell by 8% (from 3,880 to 3,587 vehicles, see Figure 10) from the baseline to follow-up phase. Conversely, outside of the School Streets hours, total traffic rose by 5% (from 14,792 to 15,517 vehicles) across the same area (monitoring locations 1 – 4, see Table 7). This shows that the change in traffic volumes on streets surrounding the School Street moved in opposite directions during and outside of the School Streets hours. The fact that no fall in traffic flow was observed outside the School Street hours suggests that the School Street was associated with a fall in traffic flow.

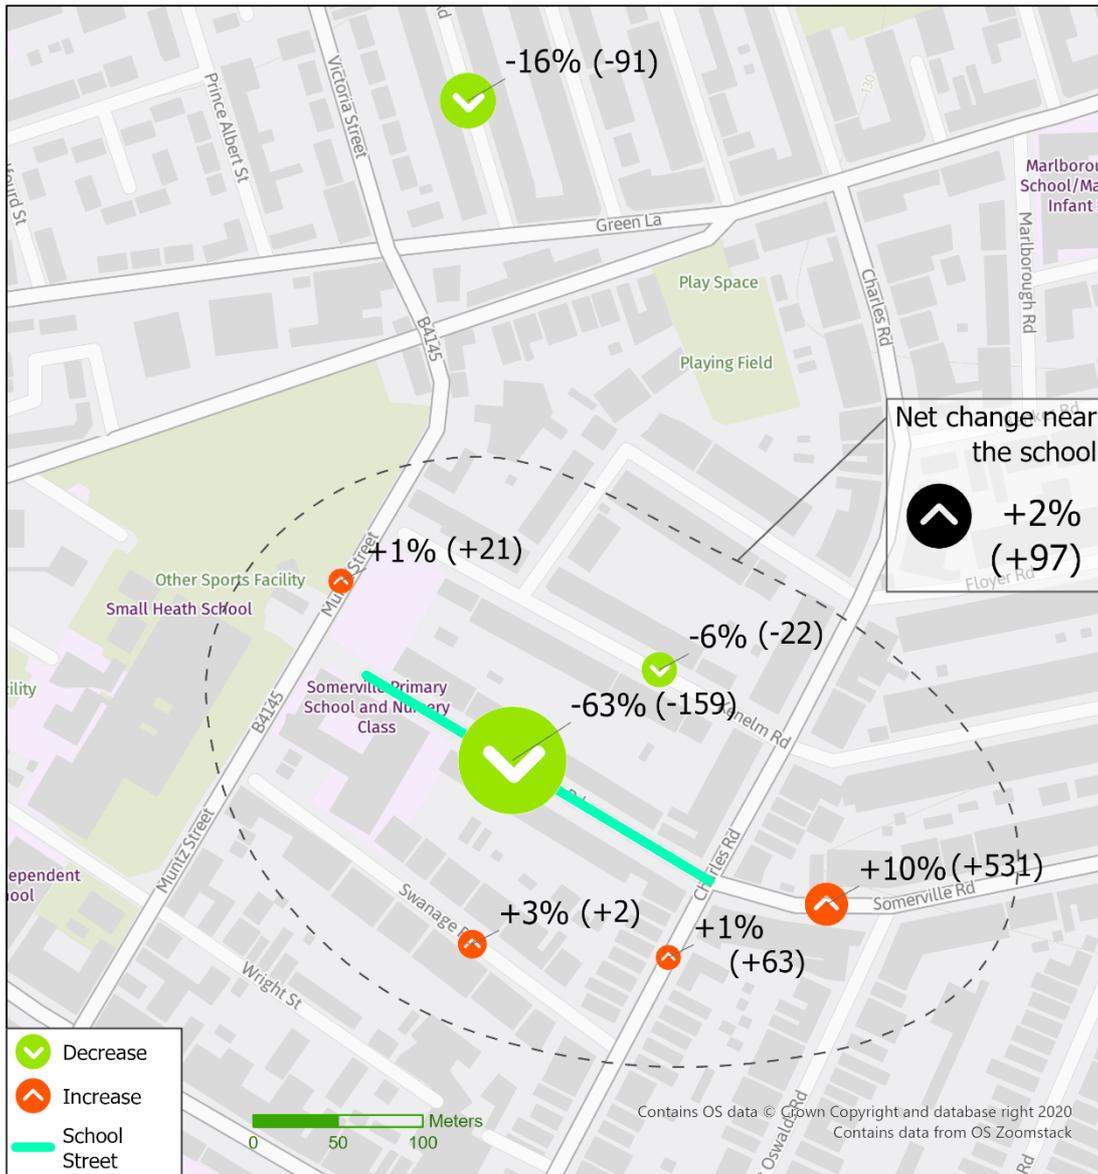
Figure 11: % change in traffic volumes (change in number of vehicles) around Somerville Primary School between baseline and during intervention

As expected, traffic volumes fell on Somerville Road due to the School Street. Traffic volumes fell by 63% (from 254 to 95 vehicles) from baseline to during the School Street, but only fell by 20% (from 254 to 204 vehicles) at the follow-up phase.

There is evidence that some of this traffic may have displaced onto Charles Road (7% rise at follow-up, from 4,725 to 5,058 vehicles) and Somerville Road (10% rise during intervention, from 5,198 to 5,729 vehicles) which both approach the entrance to the School Street, and onto parallel Swanage Road (18% rise at follow-up, from 71 to 84 vehicles) which also has school entrances.

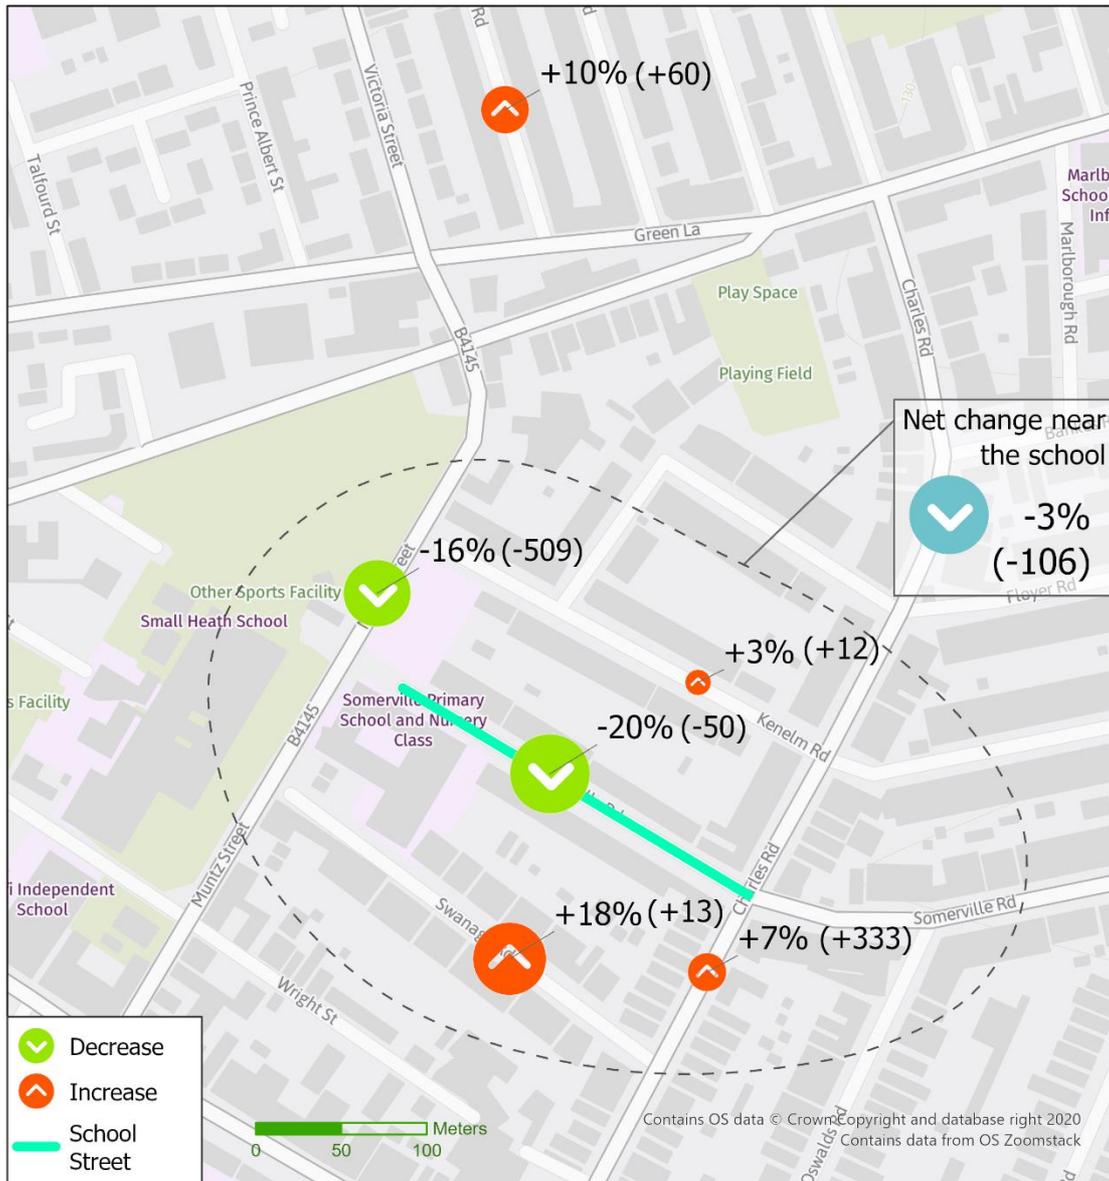
Figure 12: % change in traffic volumes (change in number of vehicles) around Somerville Primary School between baseline and follow-up

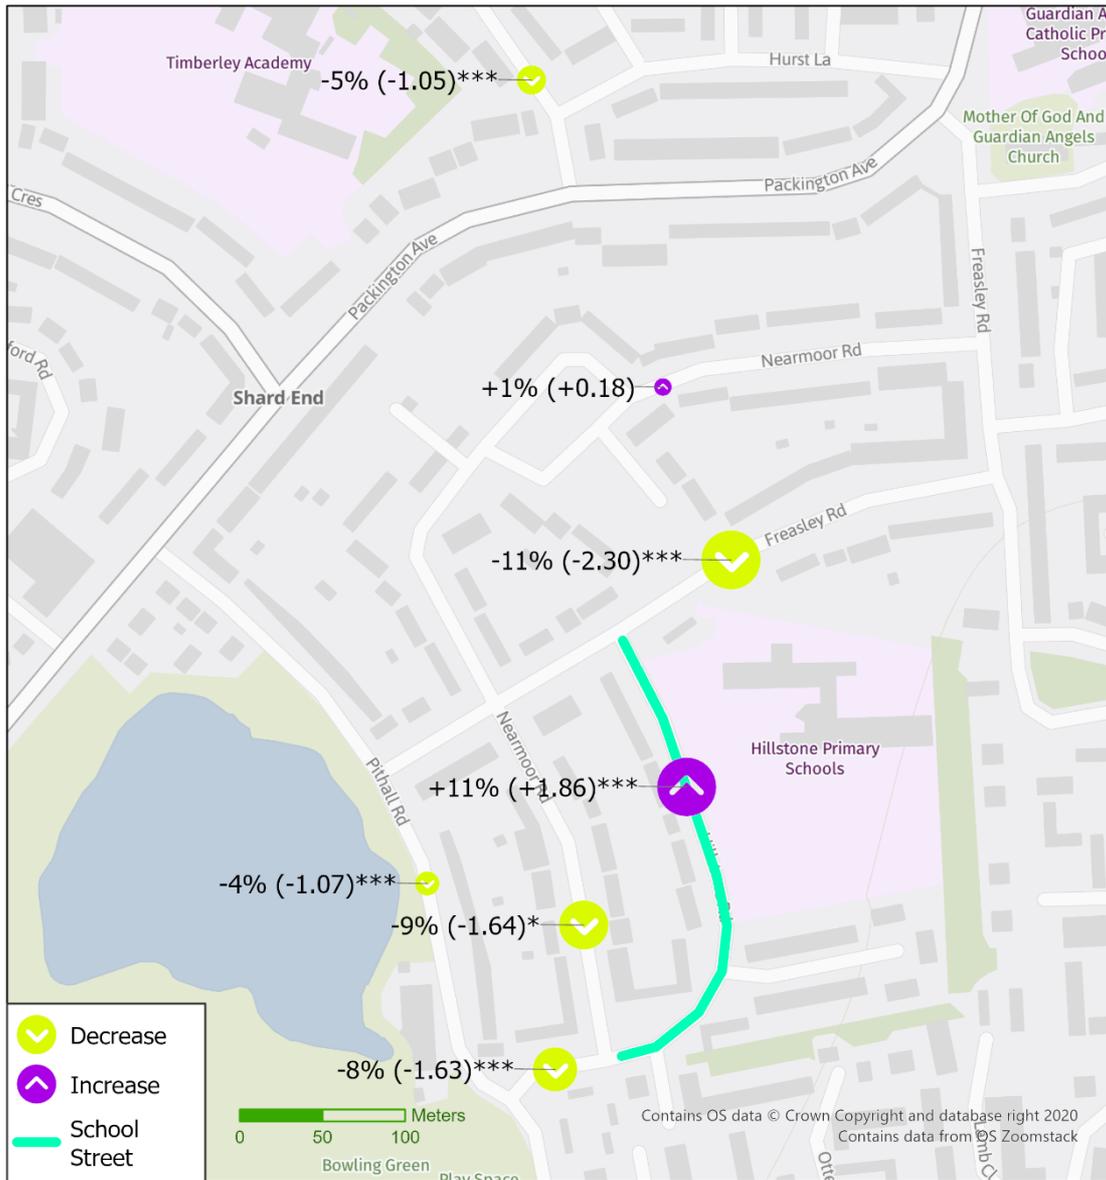
Figure 13: % (and numerical) change in average morning traffic speeds (08:00-09:00) between baseline and during intervention

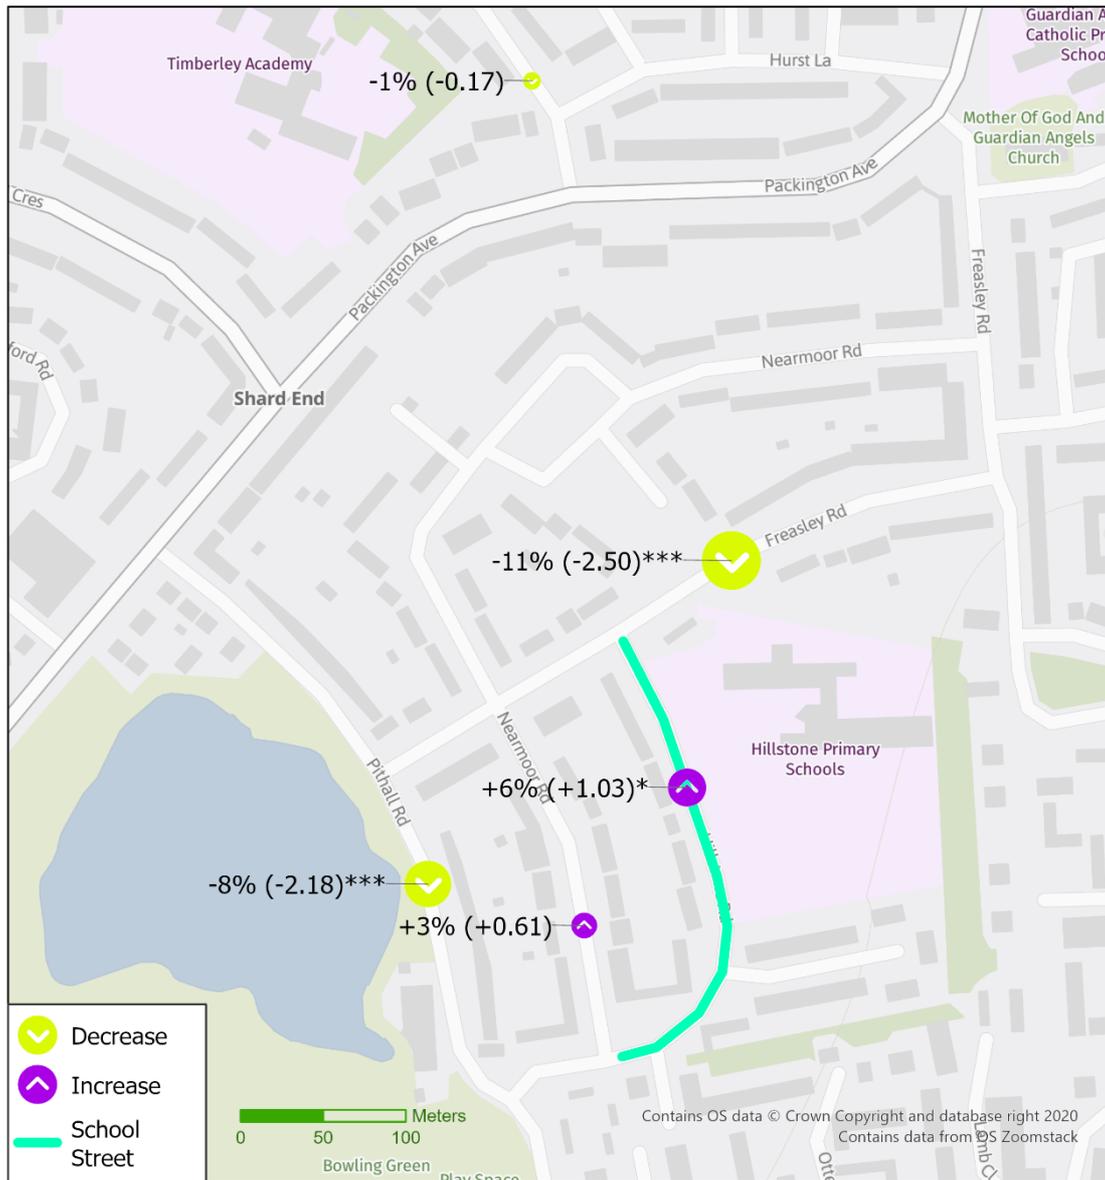
Figure 14: % (and numerical) change in average morning traffic speeds (08:00-09:00) between baseline and follow-up

One issue to examine is whether patterns were the same in the morning and afternoon. When looking at the baseline to follow-up change (Figure 14 and Figure 16), all but one of the locations saw the same direction of change in average speeds in the morning and afternoon. This suggests that on a given street, any observed change in traffic speeds is likely to be the same during the morning and afternoon. The only exception was Nearmoor Road (parallel to School Street) which, at follow-up, saw morning speeds rise (from 19.2 mph to 19.8 mph) but afternoon speeds fall (from 17.4 mph to 16.5 mph); however, neither change was statistically significant. Generally the speeds were higher in the afternoon than in the morning.

On Freasley Road (with the junction connecting to the school road), average speeds fell from 21.7 mph to 19.2 mph in the morning, and 19.2 mph to 18.6 mph in the afternoon, from baseline

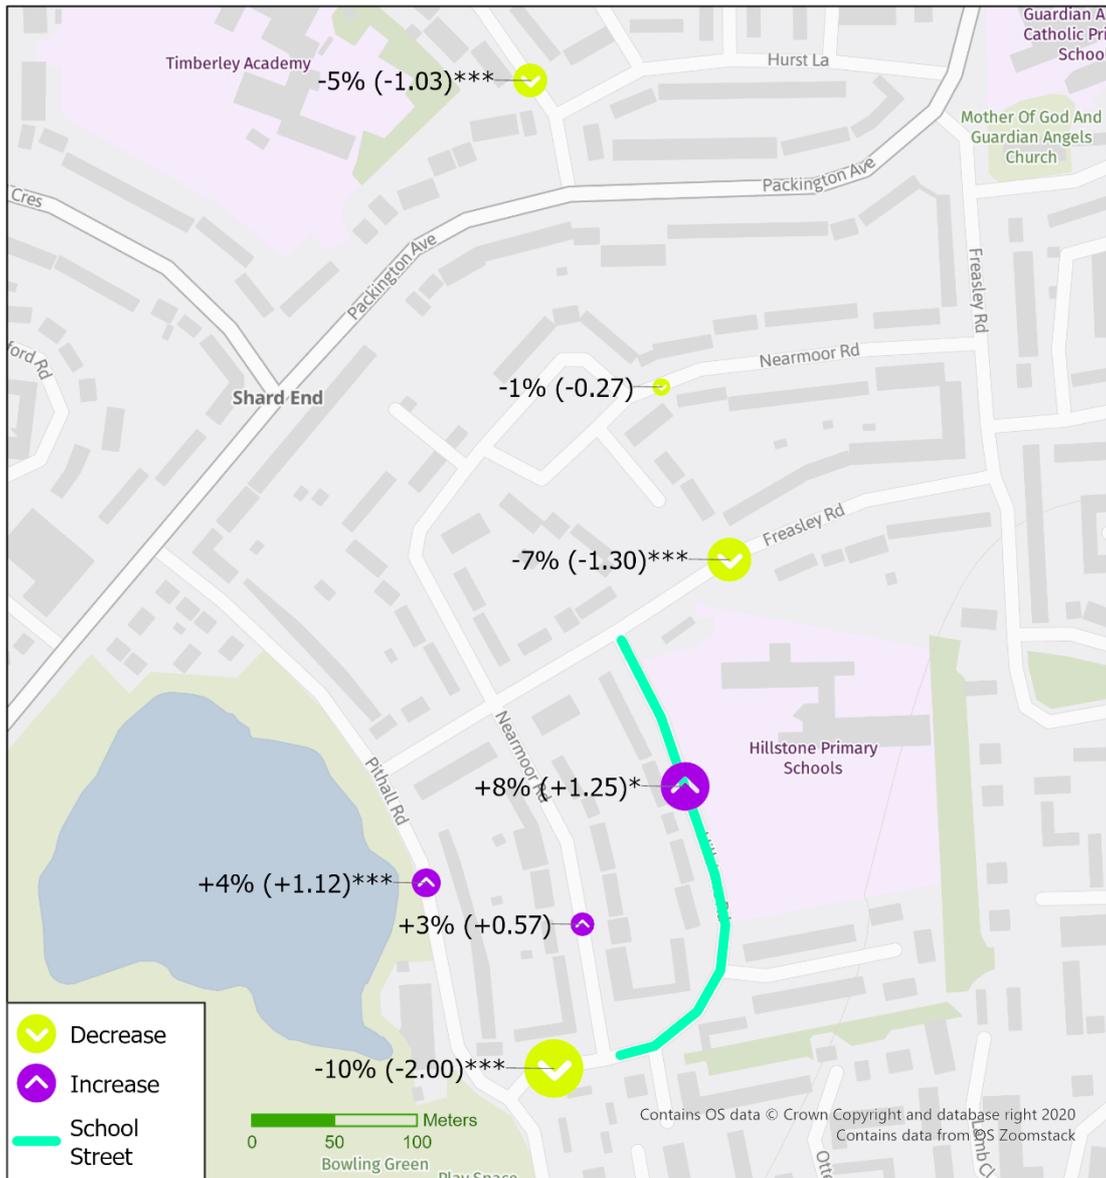
Figure 15: % (and numerical) change in average afternoon traffic speeds (14:45-15:45) between baseline and during intervention

The change in average traffic speeds at the locations around Hillstone Primary School during the afternoon School Street hours are shown in Figure 15 (baseline to during intervention) and Figure 16 (baseline to follow-up).

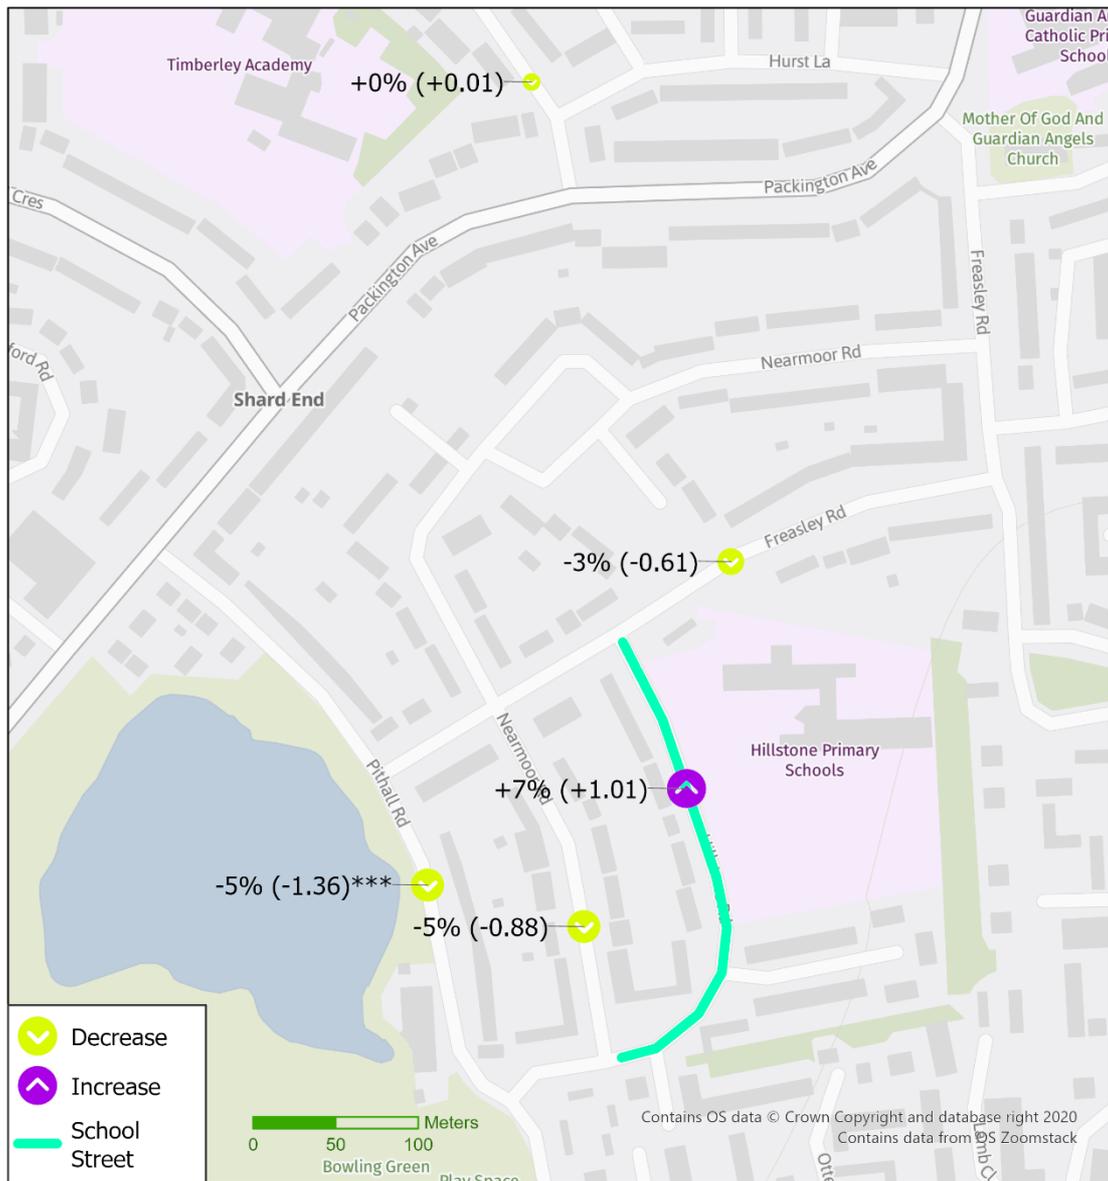
Figure 16: % (and numerical) change in average afternoon traffic speeds (14:45-15:45) between baseline and follow-up

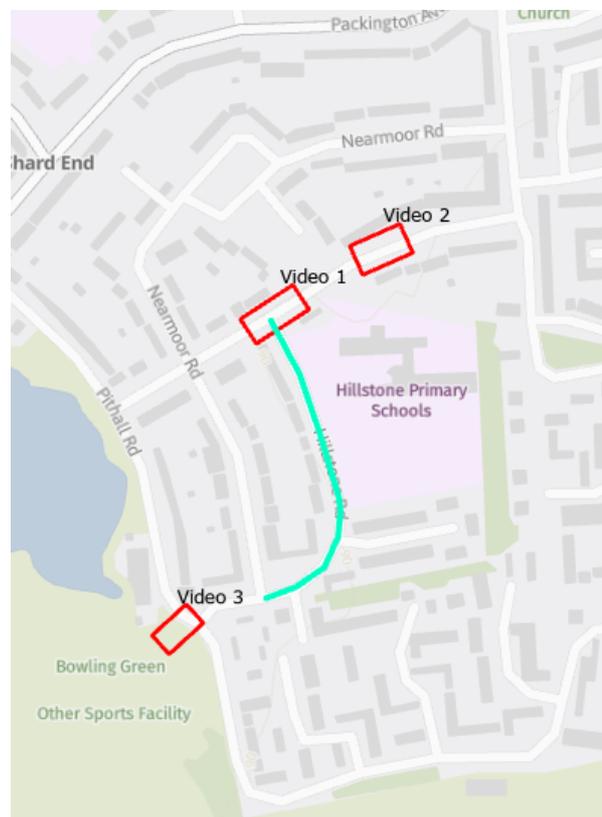
Figure 17: Map of video monitoring locations 1, 2 and 3 at Hillstone Primary School

We monitored four behaviours at the junction of Freasley Road and Hillstone Road (Video location 1 in Figure 17) to do with driver parking and driver-pedestrian interaction. An overview of the indicators is shown in Figure 18.

As well as noting any unsafe or illegal resident parking behaviour for case studies, we monitored two behaviours at Freasley Road (Video location 2 in Figure 17). The images in Figure 19 give a visual representation of the indicators analysed.

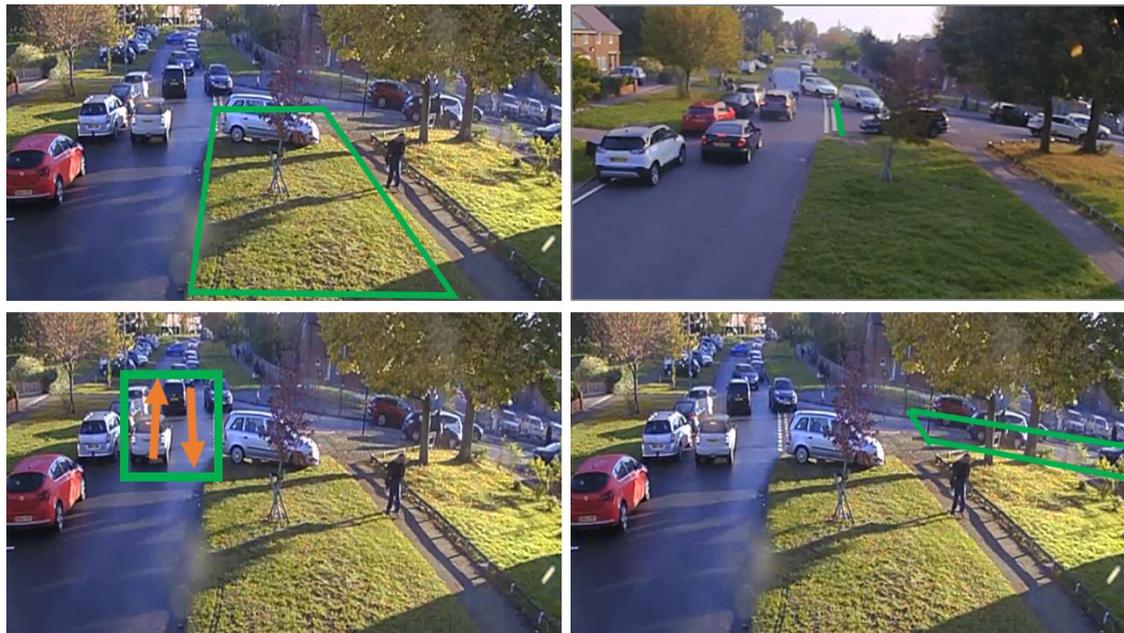
Figure 18: Markings for behaviours at Hillstone Video Location 1. Parking on grass verge (top left), interactions between drivers within junction area (bottom left), drivers manoeuvring over give way lines (top right), and parking in School Street (bottom right).

The number of interactions between drivers meeting at the junction of Hillstone Road and Freasley Road rose by 20 from baseline to during, but returned back to similar levels at follow-up (see Table 10). The number of level 1 interactions increased from the baseline (18) to the during intervention phase (19), but dropped below baseline levels at the follow-up phase (15). The number of level 2 interactions were markedly higher at the during intervention phase (58), compared to the baseline (39). At the follow-up phase the number of level 2 interactions were higher than at baseline, but much lower than at the during intervention phase. The number of level 3 interactions observed was consistent across the phases.

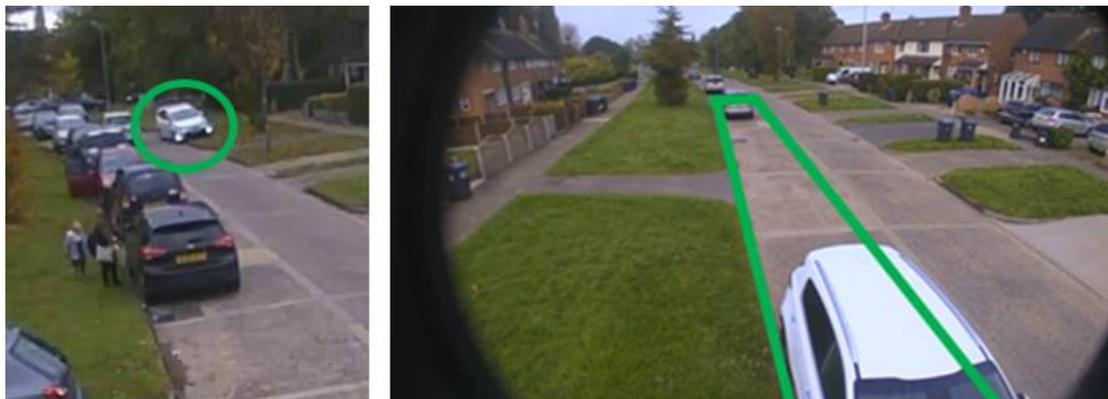
Figure 19: Markings for behaviours at Hillstone Video Location 2. Instances of drivers mounting the kerb/verge due to not being able to pass oncoming traffic (left), and instances of drivers parking (right)

The analysis revealed that there were no instances of drivers driving on the grass verge due to a lack of space on the road at baseline, but there were four at the during intervention phase and three at the follow-up phase. This unsafe driver response to the School Street causes obstructions and makes the road more dangerous for other road users. Despite this, the number of parked vehicles on the stretch of road saw a 42% reduction, from 12 at baseline to seven at follow-up (see Table 11), and the proportion of cases in which children were in the vehicle fell even further, suggesting that there had not been a displacement of school drop off/pick up parking.

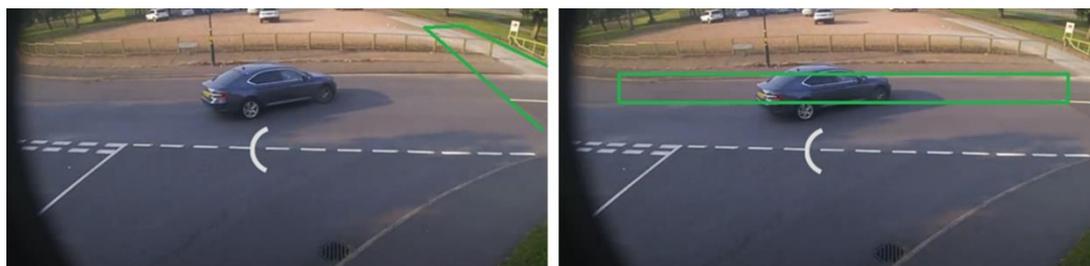
Figure 20: Markings for behaviours at Hillstone Video Location 3. Instances of drivers entering the car park (left), and dropping someone off (right)

There were no instances of drivers parking on the road outside the car park at baseline, during intervention or follow-up phases. As shown in Table 12, the number of drivers entering the car park only fell between the baseline and during intervention and follow-up phases. This is surprising as it was expected that some of the school drop off parking would be displaced to the car park. The number of interactions remained low between baseline and follow-up, with only two interactions at both baseline and follow-up and zero interactions at the during intervention phase. We anticipated that there might be a rise in use of the car park following the introduction of the School Streets, which would increase the likelihood of drivers interacting with one another around the car park entrance, but this did not occur.

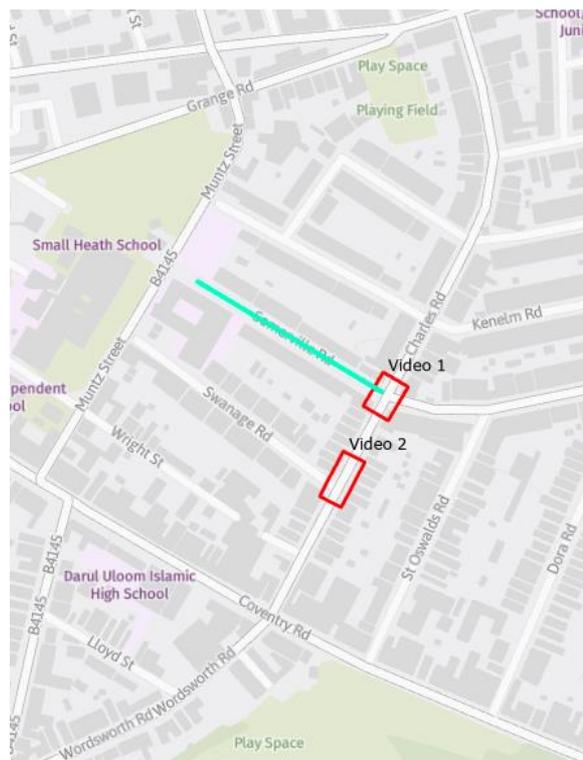
Figure 21: Map of video monitoring locations 1 and 2 at Somerville Primary School

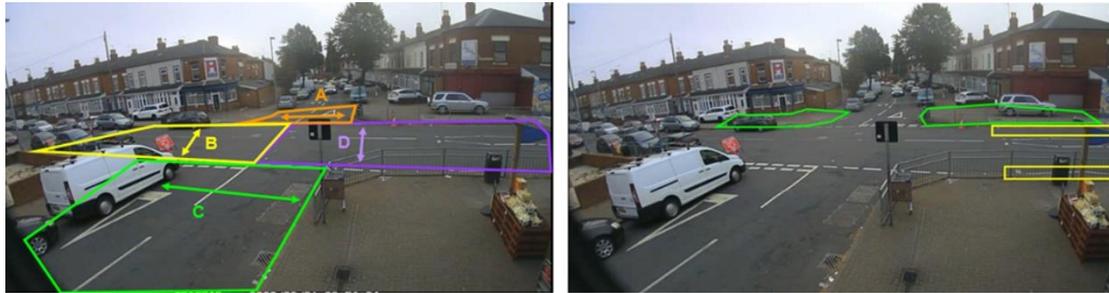
Figure 22: Markings for relevant behaviours at Somerville Video Location 1. Crossing points for pedestrians (left), and instances of drivers parking (right)

At crossing point C (the School Streets entrance) the number of pedestrians crossing rose by a large amount from baseline to during intervention, with another small rise at the follow-up phase. There were also rises in the number of pedestrians crossing at points A and B, while at crossing point D there was a slight rise initially followed by a fall at follow-up. Overall, the number of pedestrians crossing the road rose by 32% when looking at all four crossings as a whole. This indicates that the roads became busier with pedestrians during the School Street.

There was a fall in the proportion of pedestrians who waited before crossing at points B, C and D, which would suggest that these crossing points were easier to cross following the introduction of the School Streets. However, at crossing point A (junction between Charles Road and non-School Street section of Somerville Road) there was a large rise in the proportion of pedestrians waiting between baseline and follow-up. This coincided with a rise in traffic volumes at this location, which could cause pedestrians to have to wait before crossing. Overall, there was a 4 percentage point rise in the proportion of pedestrians waiting to cross when looking at all four crossings as a whole.
