School Streets and Traffic Displacement

Technical Report

Document details	
Reference ID:	SUSR1996
Version:	5.0
Client:	The Road Safety Trust
Circulation Status:	External – client and key stakeholders (The Road Safety Trust and Birmingham CC)
Issue Date:	28/06/2022
Author(s):	Tom Belcourt-Weir, Chris Cannell, Matt Pearce
Reviewed by:	Matt Pearce
Signed off by:	Anjali Badloe

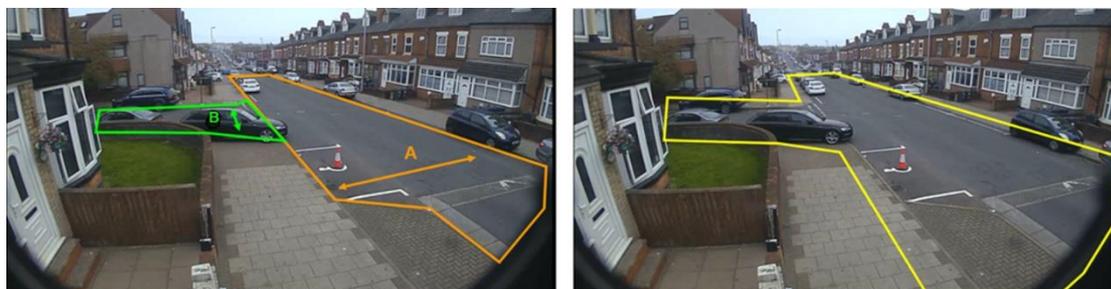
Figure 23: Markings for behaviours at Somerville Video Location 2. Crossing points for pedestrians (left), and instances of drivers stopping (right)

As shown in Table 16, at both crossing points A and B, the total number of pedestrians crossing initially fell between baseline and during intervention phases but then rose to above baseline levels at follow-up. The proportion of pedestrians waiting at crossing point A stayed relatively stable whereas the proportion waiting at crossing point B near doubled from 7% at baseline to 15% at follow-up. In addition, the proportion of child pedestrians needing to wait at crossing point B rose dramatically, from 6% at baseline to 32% at follow-up. This indicates that crossing point B was more difficult at the follow-up phase than at baseline. As there was an 18% rise in motorised traffic observed on Swanage Road, the junction of which is crossing point B, it is likely that displaced traffic has contributed to the rise in the proportion of pedestrians needing to wait to cross.

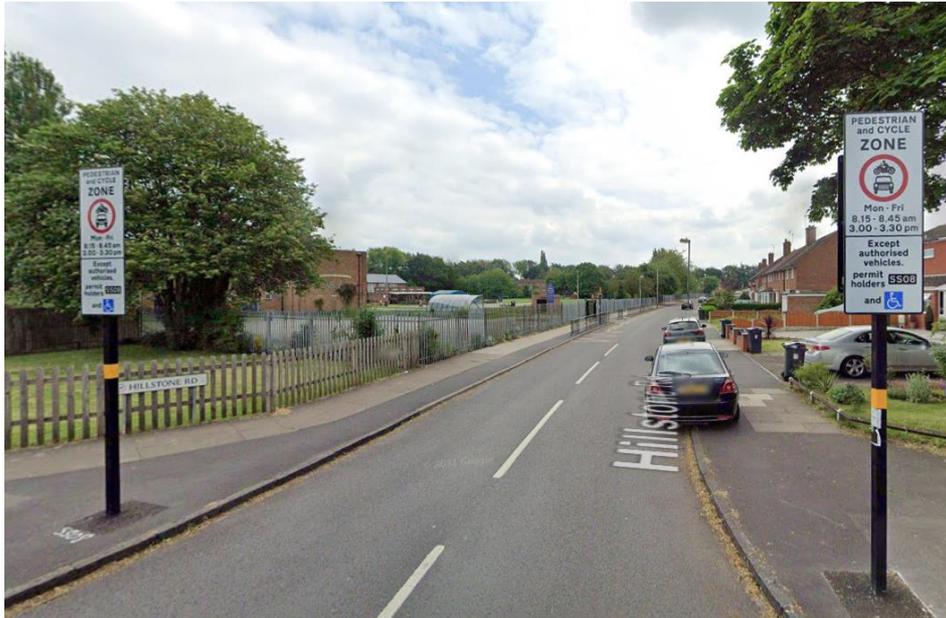
Figure 24: Example of School Streets signage on Hillstone Road

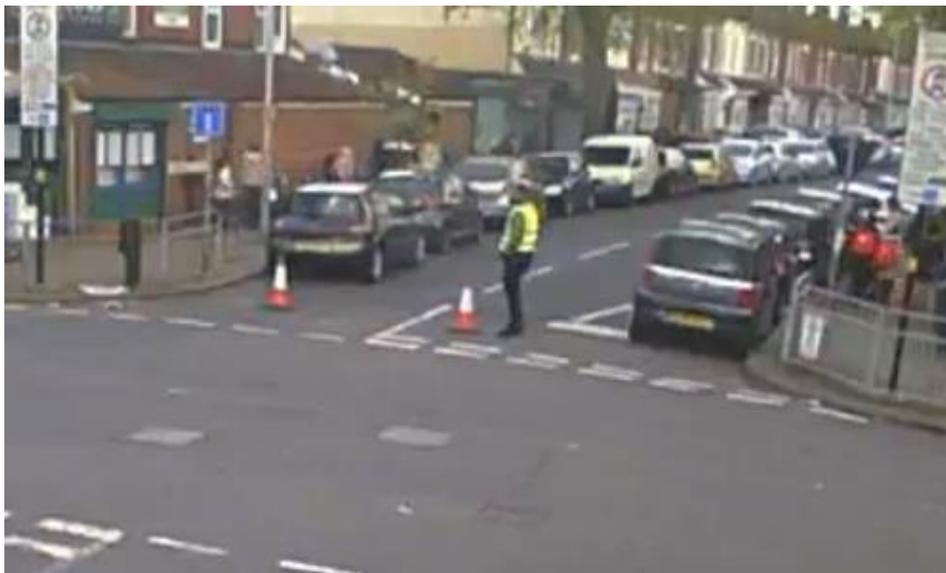
Figure 25: Example of School Streets stewarding on Somerville Road

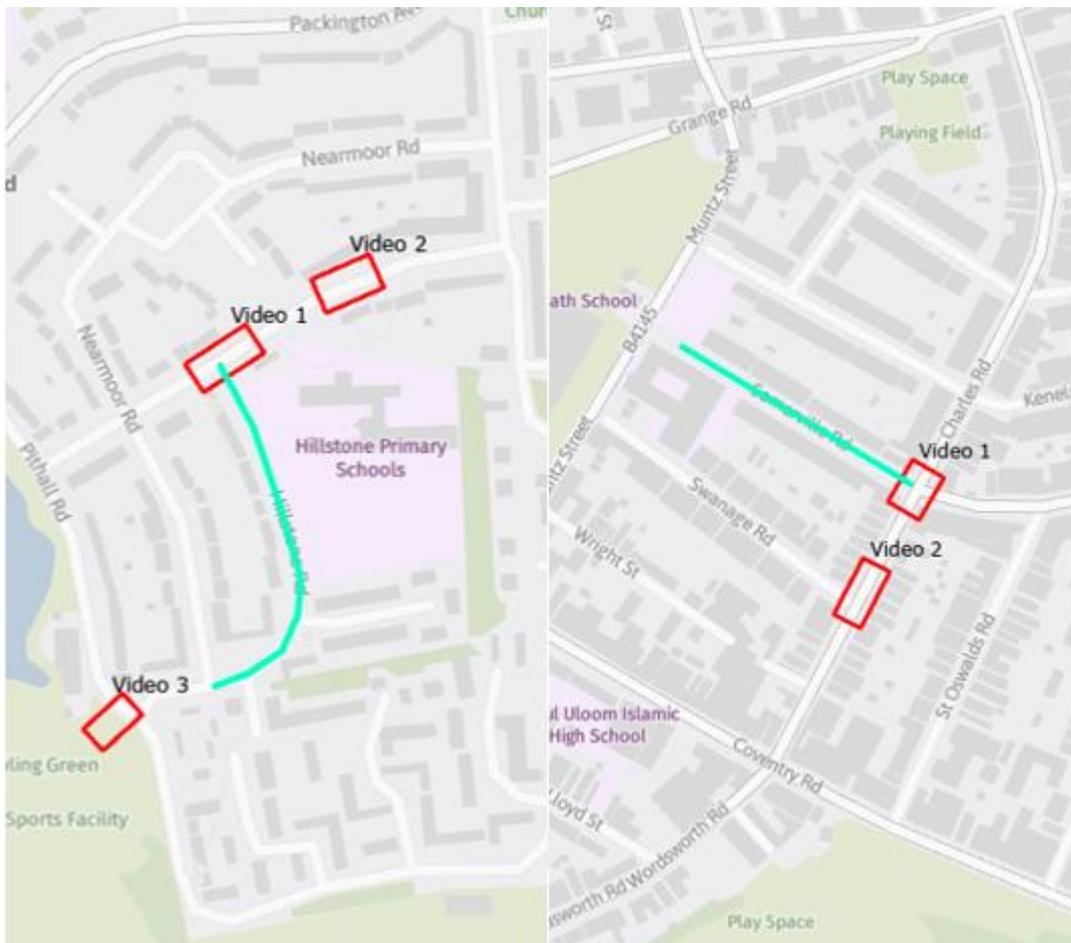
Figure 26: Video locations for Hillstone Primary School (left) and Somerville Primary School (right), with School Streets indicated by turquoise line

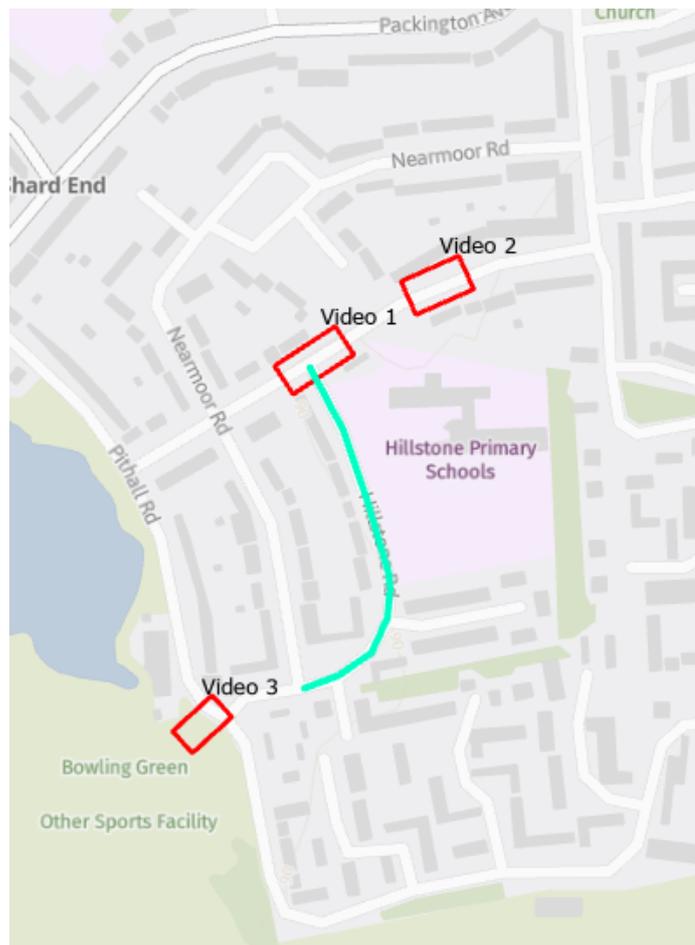
Figure 27: Map of video monitoring locations 1, 2 and 3 at Hillstone Primary School

We monitored four behaviours at the junction of Freasley Road and Hillstone Road (Video location 1 in Figure 27):

Two behaviours were recorded at the car park opposite the junction at Hillstone Road and Pithall Road (Video location 3 in Figure 27).

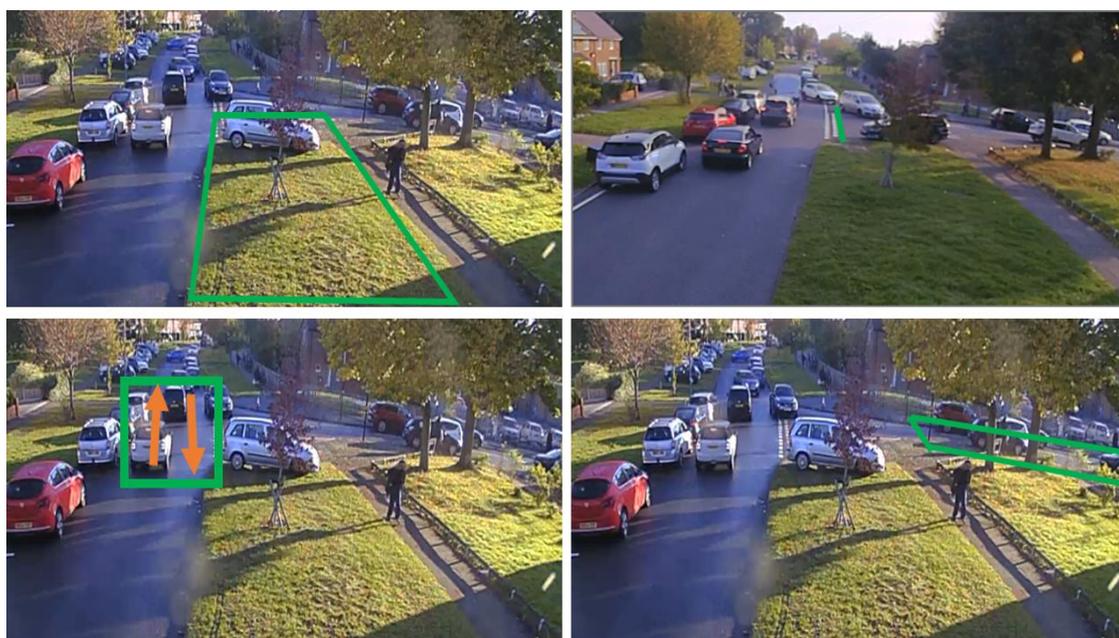
Figure 28: Markings for behaviours at Hillstone Video Location 1. Parking on grass verge (top left), interactions between drivers within junction area (bottom left), drivers manoeuvring over give way lines (top right), and parking in the School Street (bottom right).

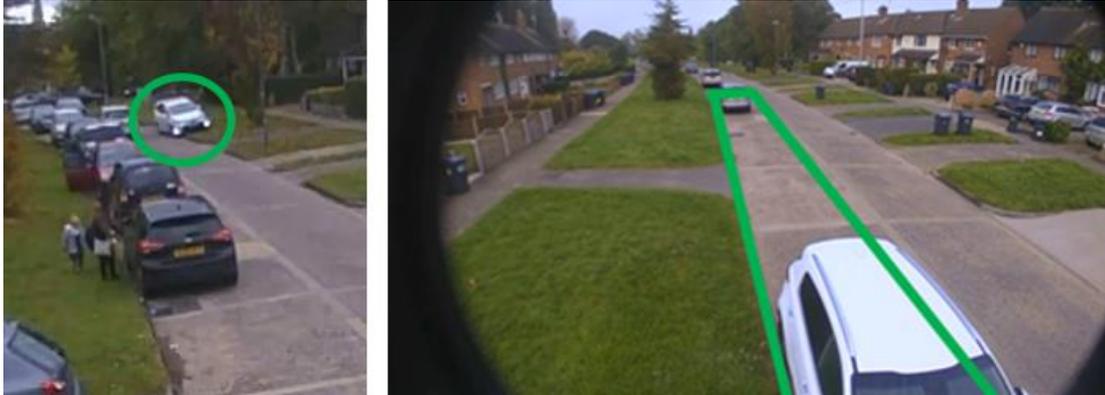
Figure 29: Markings for behaviours at Hillstone Video Location 2. Instances of drivers mounting the kerb/verge due to not being able to pass oncoming traffic (left), and instances of drivers parking (right)

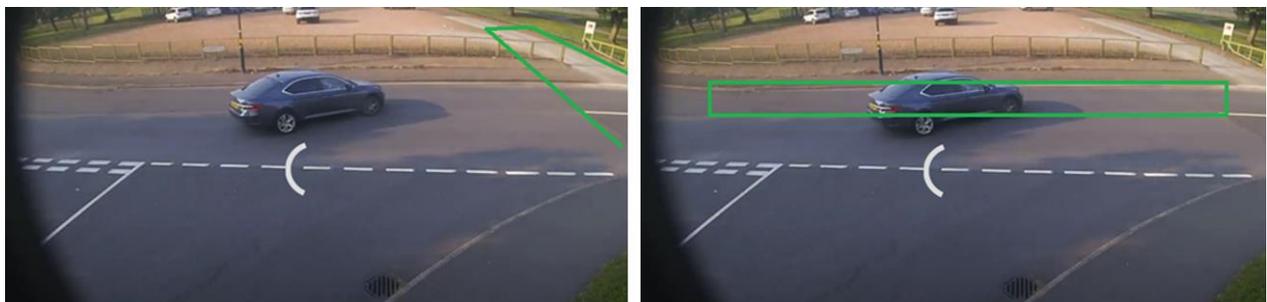
Figure 30: Markings for behaviours at Hillstone Video Location 3. Instances of drivers entering the car park (left), and dropping someone off (right)

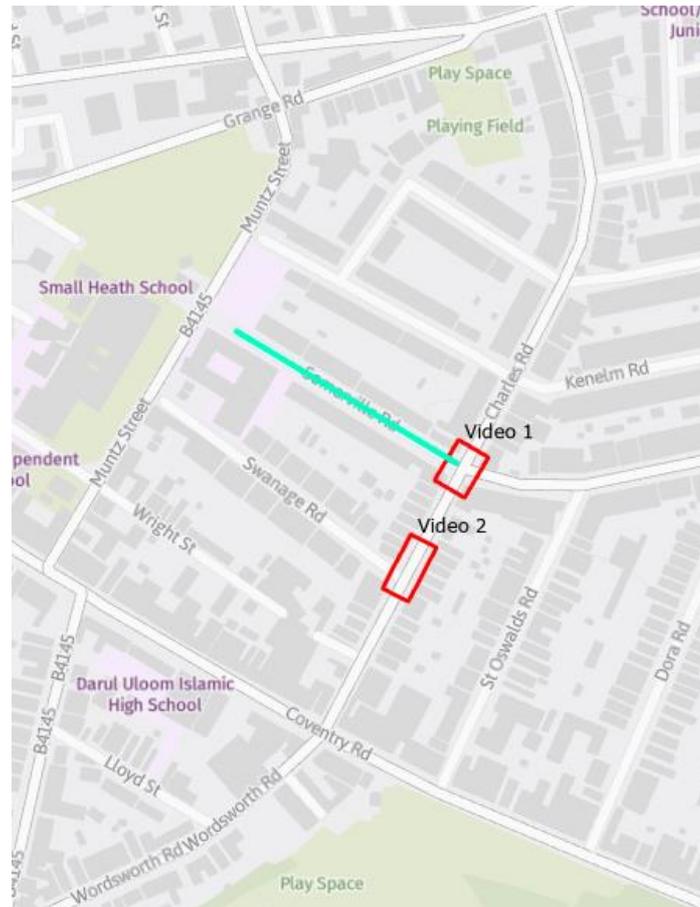
Figure 31: Map of video monitoring locations 1 and 2 at Somerville Primary School

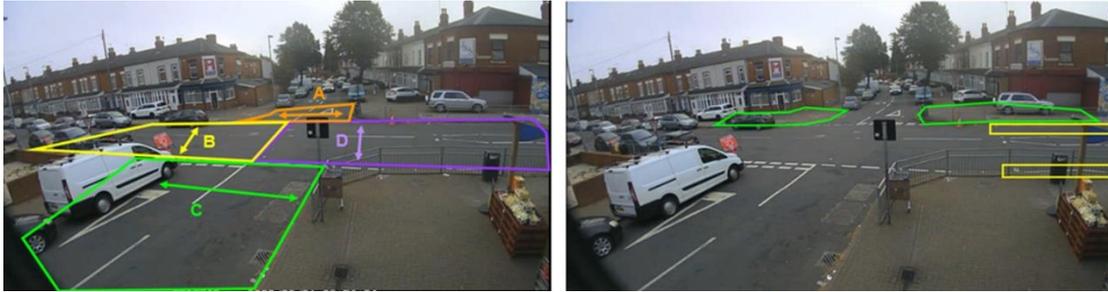
Figure 32: Markings for relevant behaviours at Somerville Video Location 1. Crossing points for pedestrians (left), and instances of drivers parking (right)

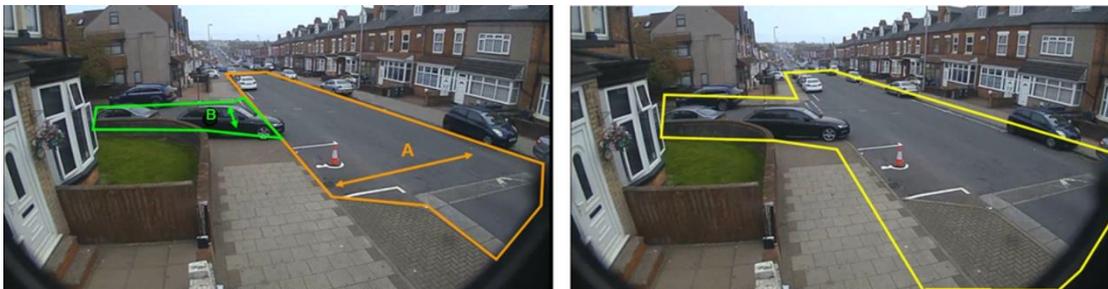
Figure 33: Markings for behaviours at Somerville Video Location 2. Crossing points for pedestrians (left), and instances of drivers stopping (right)

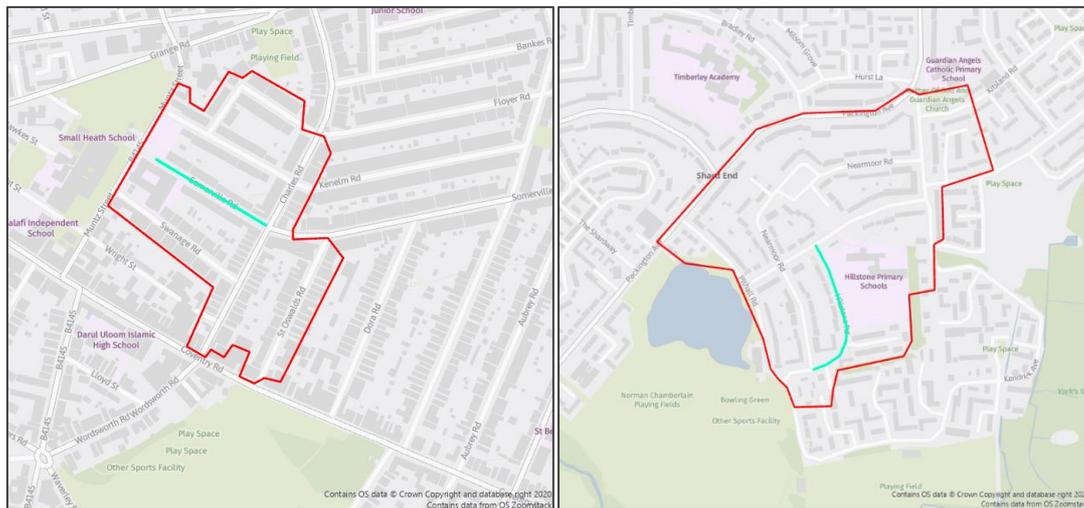
Figure 34: Postal survey distribution area around Somerville Primary School (left) and Hillstone Primary School (right)
