# **HISTORIC U.S. 66 BRIDGE DATABASE 1926-1985**

COMPILED BY JIM ROSS IN PREPARATION FOR THE BOOK: ROUTE 66 CROSSINGS: Historic Bridges of the Mother Road, published by THE UNIVERSITY OF OKLAHOMA PRESS. Periodic updates will denote bridges lost since its creation in 2015 with a red \* asterisk.

## OKLAHOMA

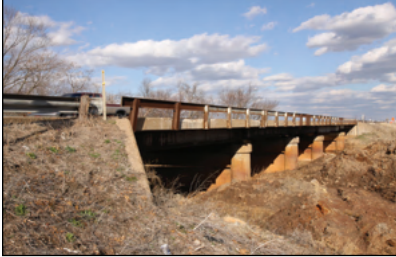
2013

### 1. Lost Steel Stringer on Tar Creek east of Commerce.

Date Built: 1933

Type: Steel Stringer

Status: GONE. Replaced by a Precast Concrete Girder in 2013.

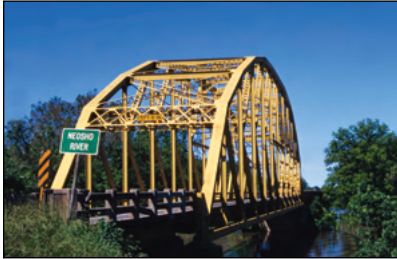
1992

4. Lost Neosho River Bridge on Steve Owens Blvd. / US 69 in Miami (1937 alignment).

Date Built: 1937

Type: Through K-Truss with Steel Stringer approaches.

Status: GONE. Replaced in 1996 by a Steel Girder bridge.

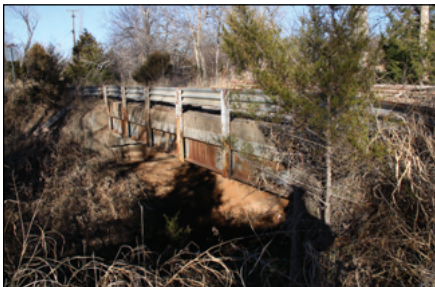
53. Stone culvert on the 1926 route east of Bristow (about 1 mi. south of the Jct. with SH66 / SH48).

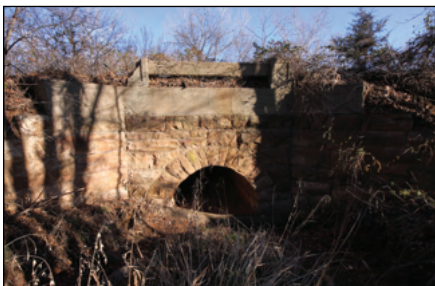
54. Lost Sand Creek Bridge on the upgrade route (SH 66) at the north edge of Bristow.  
Date Built: 1965; replacing a pony truss bridge on the parallel 1926 alignment.  
Type: Steel Stringer  
Status: GONE. Replaced in 2014 with a large Concrete Culvert.  
Coordinates: 35.85724,-96.387961

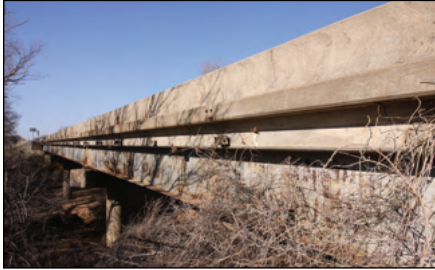
55. \*Lost Sand Creek Bridge on the 1926 route on the north edge of Bristow.  
Date Built: 1935 (replaced an earlier bridge). Bypassed in 1965 with the bridge listed above.  
Type: Warren Pony Truss with Verticals.  
Status: GONE. Destroyed in 2017.  
Coordinates: 35.857705,-96.387285

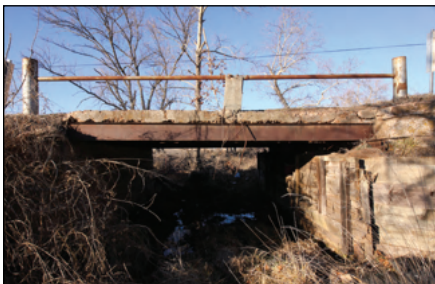
60. Little Deep Fork Creek Bridge (1926 route) on 241st St. S. (Jaycee Ave.) west of Bristow.  
Date Built: 1914 by the Kansas City Bridge Co.  
Type: One-lane Bedstead Warren Pony Truss with a timber deck.  
Status: Closed to all traffic; on private property.  
Coordinates: 35.813685,-96.435329

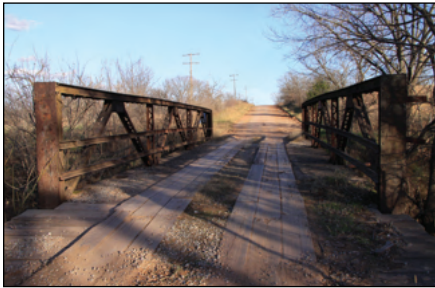
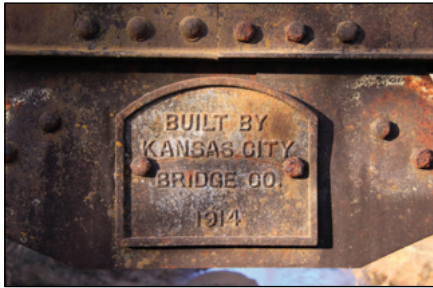
61. Two short bridges on the abandoned segment of the 1926-1928 route west of Bristow.  
Date Built: circa early-1920s.  
Type: East: Steel Beam with stone abutments, concrete and pipe guardrails; West = Concrete Culvert with guardrails.  
Status: Abandoned; on private property.  
Coordinates: E = 35.813632,-96.452065; W = 35.81472,-96.456639

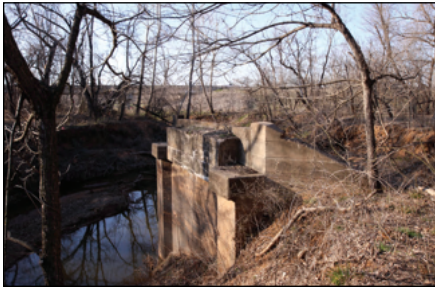
Status: GONE. This bridge was moved to an offset alignment in 1928 on an improved curve. In 1973, the curve was altered again and a Precast Concrete Girder (next entry) replaced the truss bridge.

Original site of truss bridge (2008 photo)

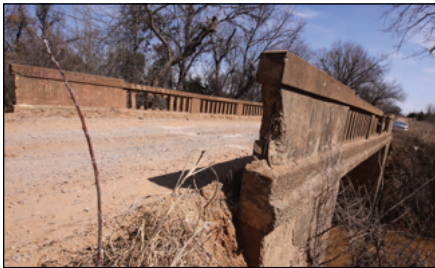
2013

70. Lilly Creek Bridge on the 1926-1930 route just west of Graham Rd. and north of I-44 at Stroud.

Status: Open to traffic. In poor condition; highly endangered.

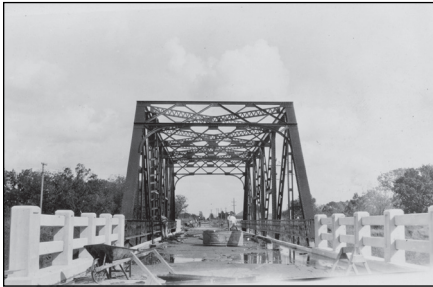
Date Built: 1928; would have replaced an existing bridge of unknown type and date, possibly timber.

ODOT photo of 1928 bridge

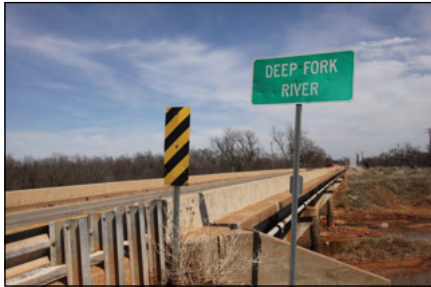
Status: GONE. Replaced in 1952 with a Steel Stringer, and again in 2014 with a Precast Concrete Girder.

2013 photo of the 1952 bridge

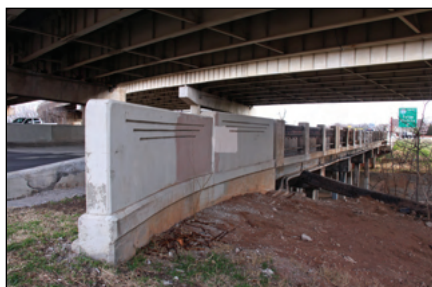
2013 - Side view of westbound bridge

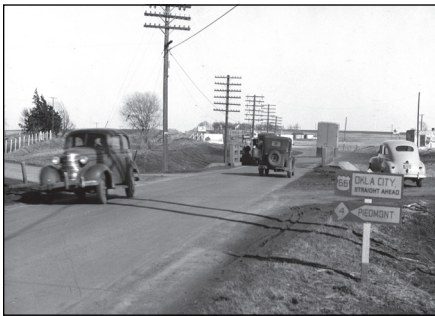
Status: GONE. Replaced in 1949 and later widened for current intersection.

ODOT photo circa 1949 prior to replacement

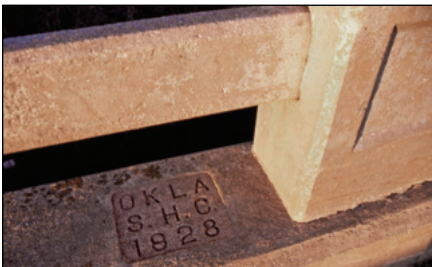
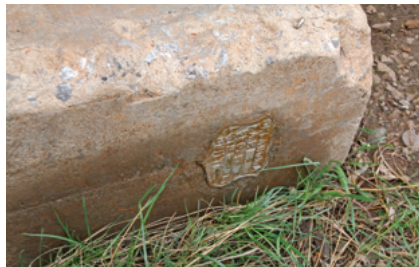
116. Dated Concrete Culvert with an FAP marker 2.6 mi. west of the Fort Reno turnoff.

Date Built: 1928 with 4-post concrete guardrails, which were replaced circa 2012 with scrap steel guardrails. The concrete posts (including the FAP Marker) were left in the creek bed.

2013 - Endpost with FAP shield in creekbed

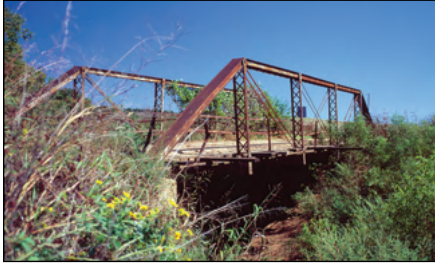
1992

120. Lost bridge on Lumpmouth Creek (unpaved 1926 route) south of Geary.  
 Date Built: 1920 (ODOT); bridge number & location: 06E1000N2610009; 71 feet in length.  
 Type: One-lane, Single-span Pratt Pony truss with a timber deck.  
 Status: GONE. Replaced in 1995 with a Steel Beam bridge.  
 Coordinates: 35.564593,-98.332445

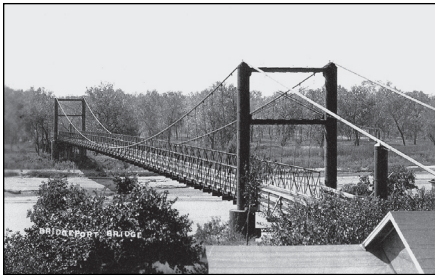
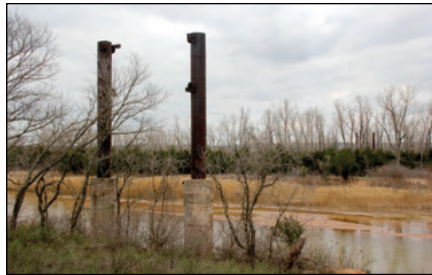
121. Lost Suspension bridge on the South Canadian River north of Bridgeport.  
 Date Built: 1921 by businessman George Key as a toll bridge. Known as the Key Bridge.  
 Type: One-lane Steel Suspension bridge with a timber deck (1000 feet in suspension).  
 Status: GONE. Bypassed with a new bridge downstream in 1934; demolished in 1952 following a fire.  
 Coordinates: 35.567124,-98.374688

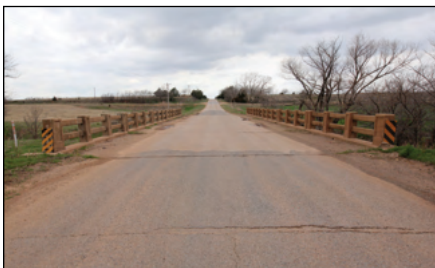
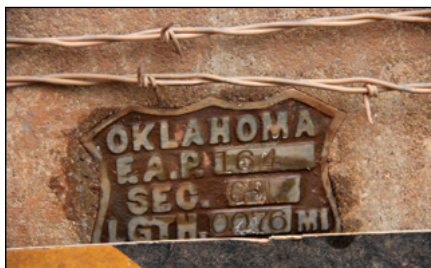
122. Concrete bridge on Powder Face Creek 2.2 mi. east of the Jct. with US 281 Spur.  
 Date Built: 1932 (FAP 164-G).  
 Type: Concrete Slab with a brass FAP marker embedded in each end.  
 Status: Open to traffic.  
 Coordinates: 35.536609,-98.200645

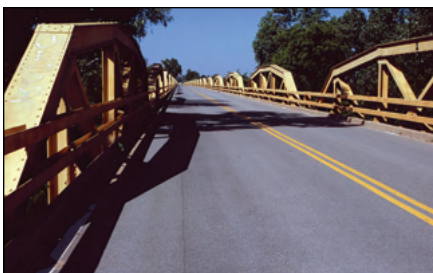
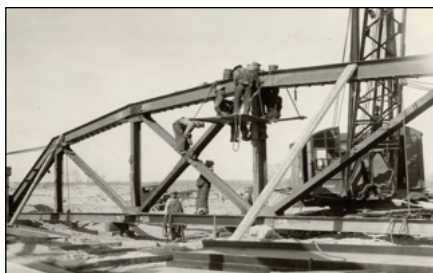
125. William H. Murray "Pony" bridge over the South Canadian River on the 1932 route.

Status: Open to traffic. Cicra 2022 this bridge will undergo superstructure replacement and be widened 4 feet, with the original trusses retained.

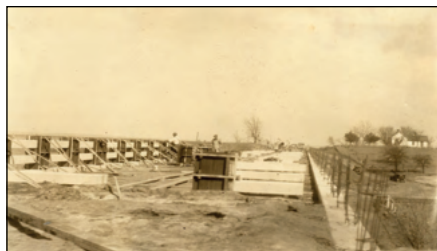
ODOT photo during 1933 construction

126. Stringer over a creek and RR on the 1934 route west of the "Pony" bridge listed above.

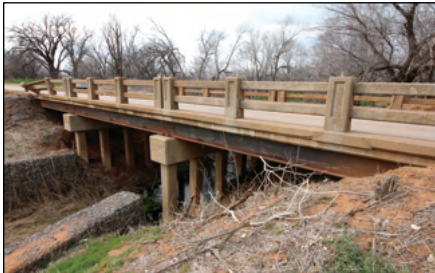
2013

133. Steel Stringer on an unnamed creek 1.3 mi. east of Hydro.

Type: Steel Stringer with concrete guardrails (damaged).

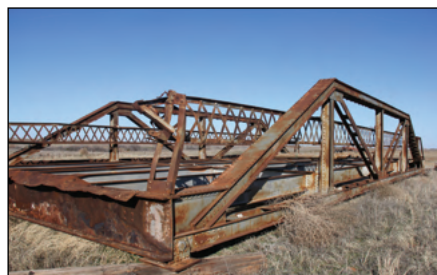
2013 (after removal)

134. Lost Steel Truss bridge 1.4 mi. W. of Hydro.

Status: GONE. Replaced by large Concrete Culvert circa 2006.

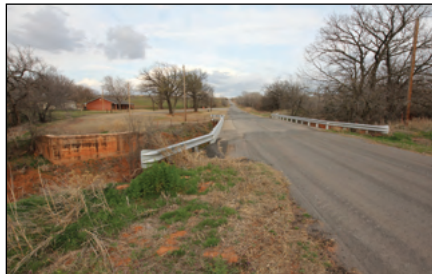
2013 (truss bridge abutments on left)

140. Lost Turtle Creek Bridge (1926 route) at Clinton (north of the 4-lane bridges).

Status: GONE. Replaced by new bridges for the 4-lane alignment in 1959. Abutments remain.

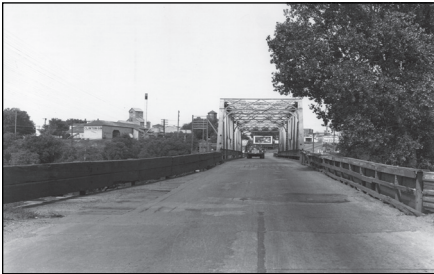
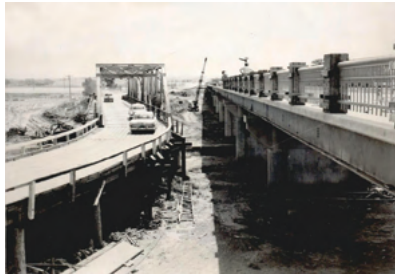
ODOT photo (1940s)

142. Lost steel truss bridge on the Washita River at Clinton.

Status: GONE. Replaced in 1953 by the Louis Tittle Bridge (see next entry).

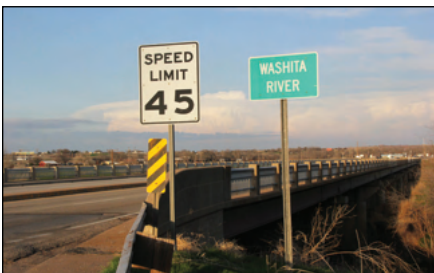
2013

143. \*Lost Louis Tittle Bridge on the Washita River at Clinton.

Status: GONE. Replaced in 2021.

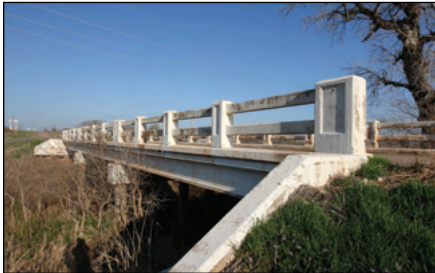
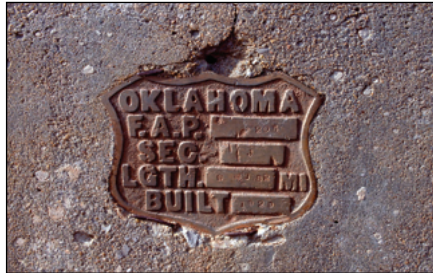
2013

144. Steel Stringer .25 mi. east of I-40 Exit 62 (west of Clinton).

Date Built: 1929 (FAP 205-J); likely replaced an earlier bridge, possibly timber).

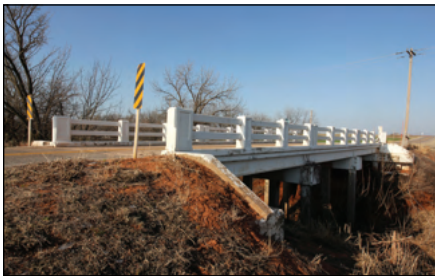
2013

145. Steel Stringer on Dry Creek at I-40 Exit 61 west of Clinton.

Date Built: 1929; likely replaced an earlier bridge.

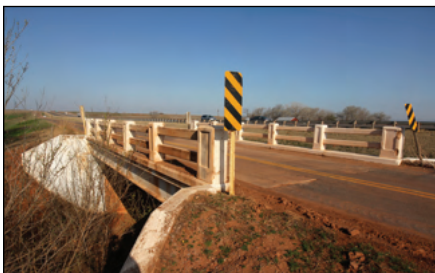
2013

146. Steel Beam bridge on an unnamed creek 1 mi. west of I-40 Exit 61.

Date Built: 1929; likely replaced an earlier bridge.

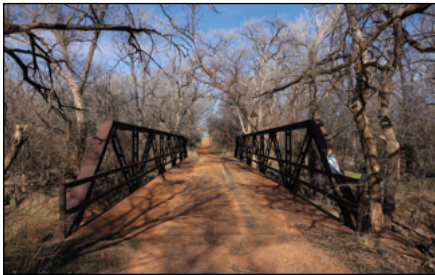
2014

157.        West Elk Creek Bridge on Randall Ave. south of Elk City.

Type: 80', Single-span Warren Pony Truss with a 16' timber deck (later replaced with steel plates).

Status: Closed to Traffic. Limited access.

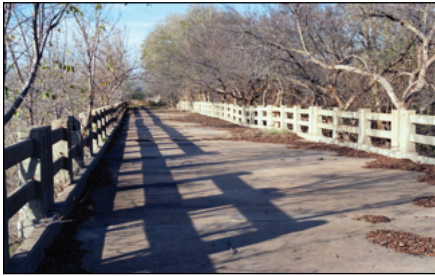
2013

163. Timber, Steel, & Concrete bridge on the North Fork Red River (1926-1957 route) on the west side of Sayre.

Status: In ruins. Replaced in 1958 when US 66 moved eastward to the Carmichael Bridge.

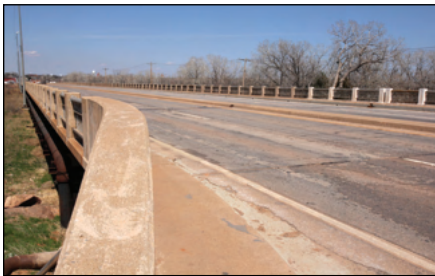
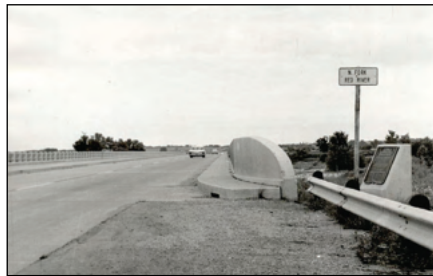
ODOT photo, circa 1959

Date Built: 1958 to replace the 1924 bridge listed above.

Status: GONE. Replaced in 2021.

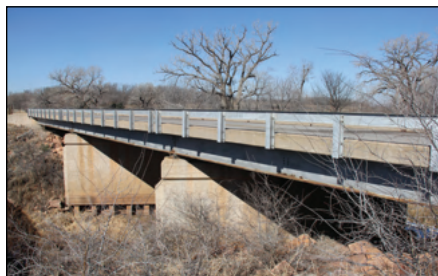
2013

Type: Steel Stringer; would have replaced an earlier span of unknown type and date.

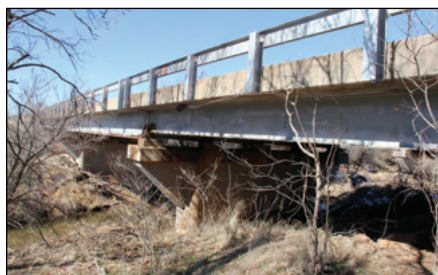
2013

167. Turkey Creek twin bridges on 4-lane US 66 3.4 mi. west of the bridge above.

Date Built: 1956 with 4-lane expansion. The westbound bridge would have replaced an earlier bridge on the original 2-lane alignment.

Status: The westbound bridge is closed; the eastbound bridge is open to traffic.

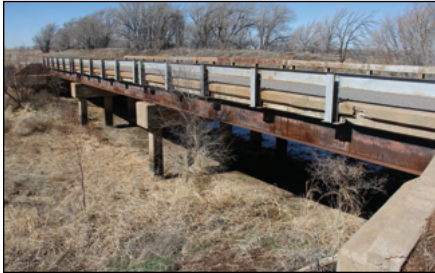
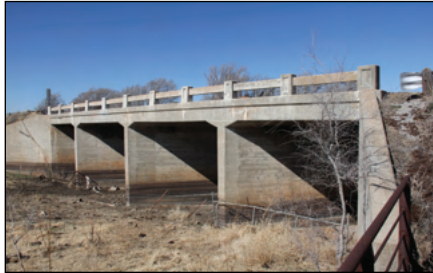
168.       \*Lost side by side bridges on Little Turkey Creek (4-lane route west of Erick).

Status: GONE. Replaced in 2021 with a large culvert.

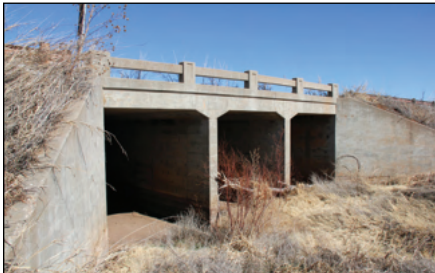
2013

169.       Large Culvert underneath the 4-lane route west of the entry above.

Type: Concrete Culvert across entire 4-lane; would have replaced a bridge on the original WB 2-lane.

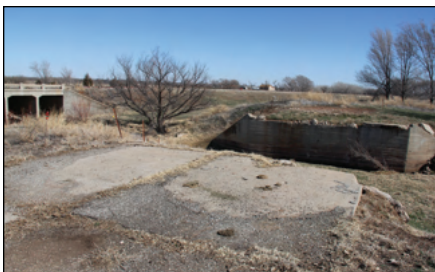
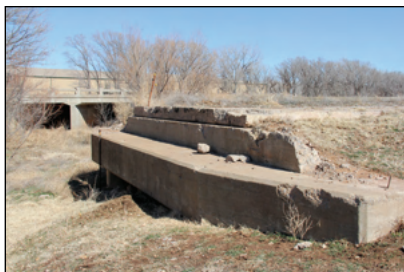
170.       Abutments for two lost bridges on a curve that was corrected when the 1928 2-lane east of Texola was expanded to 4 lanes in 1955-1956.

Status: Ruins. Note: These are opposite the culvert listed above (east) and the culvert listed next (west).

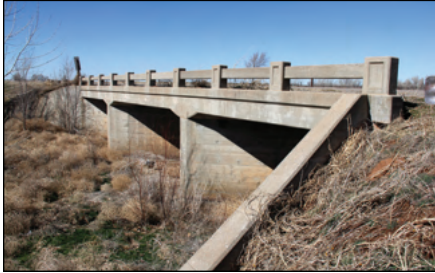
2013

171. Culvert beneath the 4-lane next to the western bridge abutment listed above.

Type: Concrete Culvert; would have replaced an existing westbound bridge on the original 2-lane.
