# Southern Oregon Wildlife Crossing Project

## Conceptual Design Report

### **Southern Oregon Wildlife Crossing Coalition**

### **River Design Group, Inc.**

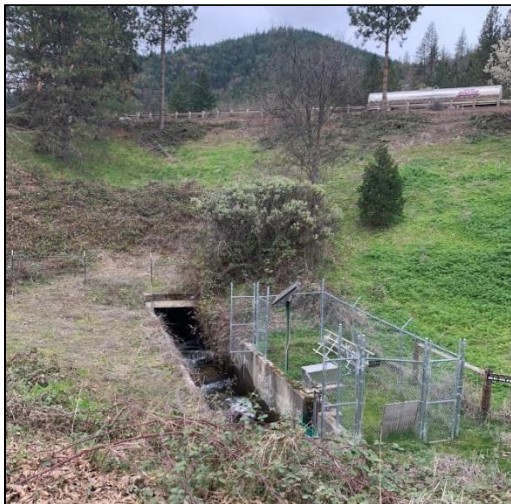
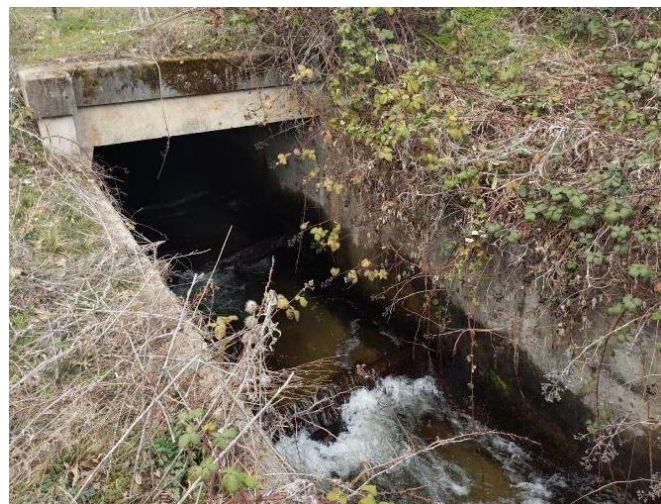
The existing culvert over Neil Creek under I-5 (ODOT bridge ID 02196 at MP 10.43) is an 8-foot span by 8-foot rise by 435-foot-long concrete box culvert. It has 44 feet of cover at the inlet and 42 feet of cover at the outlet (**Figure 3-1**). It was constructed in 1936 and was most recently inspected in June 2018 with a fair bridge condition, meaning it warrants preservation measures, a culvert rating of 5 (moderate damage) and a sufficiency rating of 24 (FHWA, 2022). It is considered scour-critical which is defined as a bridge with a foundation element that has been determined to be unstable for the observed or evaluated scour condition. Wetted marks and erosion on the culvert sides indicate that the culvert regularly flows more than half-full. The structure continues under Neil Creek Road with an open-air section at the outlet of I-5. Access to the outlet is via Neil Creek Road and a vegetated access road. Access to the inlet was not observed. ODOT installed concrete baffles to improve fish passage in 2018 (ODFW and ODOT, 2021). The culvert bottom is mostly bare concrete in the observed area though some sand and gravel are depositing upstream of the baffles.

The Neil Creek culvert crossing is only available for fully aquatic species. Aquatic species that are not strong swimmers or are unable to withstand swift currents, amphibians in particular or possibly juvenile fish, are unable to use this crossing. Additionally, Neil Creek is not available to semi-aquatic species or terrestrial species. Current species activity is unclear, and it is unknown if fish surveys have been conducted since the 2018 retrofit.

**Figure 3-1.** Outlet of Neil Creek Culvert (left) with I-5 at the top of the image; detail of fish passage retrofit baffles (right).

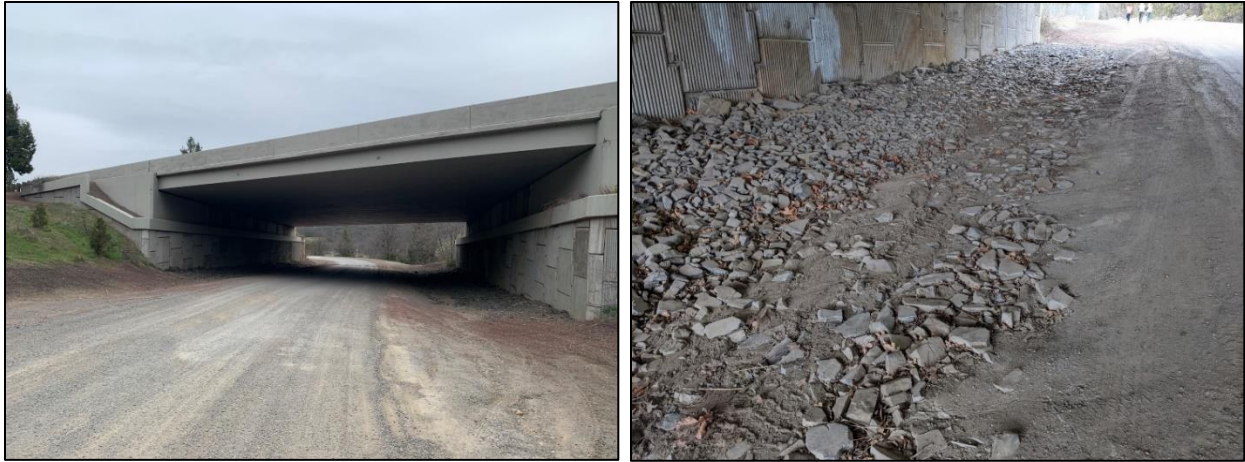
The existing bridge over Neil Creek Road (ODOT bridge ID 20673 at MP 10.34) is a 75-foot long (along I-5) by 101-foot wide (along Neil Creek Road) prestressed concrete bridge with approximately 16 feet of clearance between Neil Creek Road and the low chord (**Figure 3-2**). It was constructed in 2008 and most recently inspected in June 2020 with a fair condition and sufficiency rating of 87.9. The bridge is not over water and thus scour was not assessed; however, a roadside ditch runs along the south side of Neil Creek

Road and is armored with quarry spalls. Some erosion is evident along the flow line of the ditch. Access to the bridge is very good via Neil Creek Road.

**Figure 3-2.** Neil Creek Road bridge (left) with I-5 at the top of the image; detail of existing road shoulder materials (right).

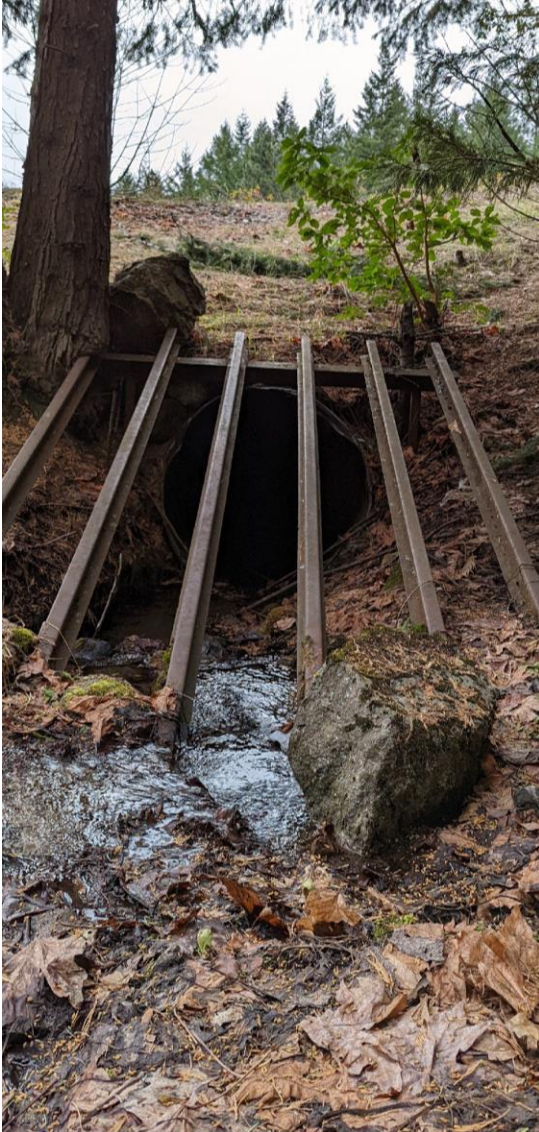
The existing culvert over the south fork of Wall Creek at I-5 (ODOT drainage facility ID D039606 at MP 7.07) is a 3-foot diameter by 308-foot-long circular concrete pipe culvert (Figure 3-5). It has 14 feet of cover at the inlet and 32 feet of cover at the outlet. It was constructed in 1966 and most recently inspected in July 2013 with a condition rating of fair.

**Figure 3-5.** Wall Creek culvert inlet with I-5 at the top of the image.

Potential for species use at the Wall Creek culvert is limited to semi-aquatic species of medium to small animals. This culvert is currently not safely passing any species as it does not have a straight path under the highway, rather it connects to a complex underground culvert system. If a pathway was constructed for wildlife, there would be additional challenges as cold conditions in small culverts can prohibit use by some ectothermic species.

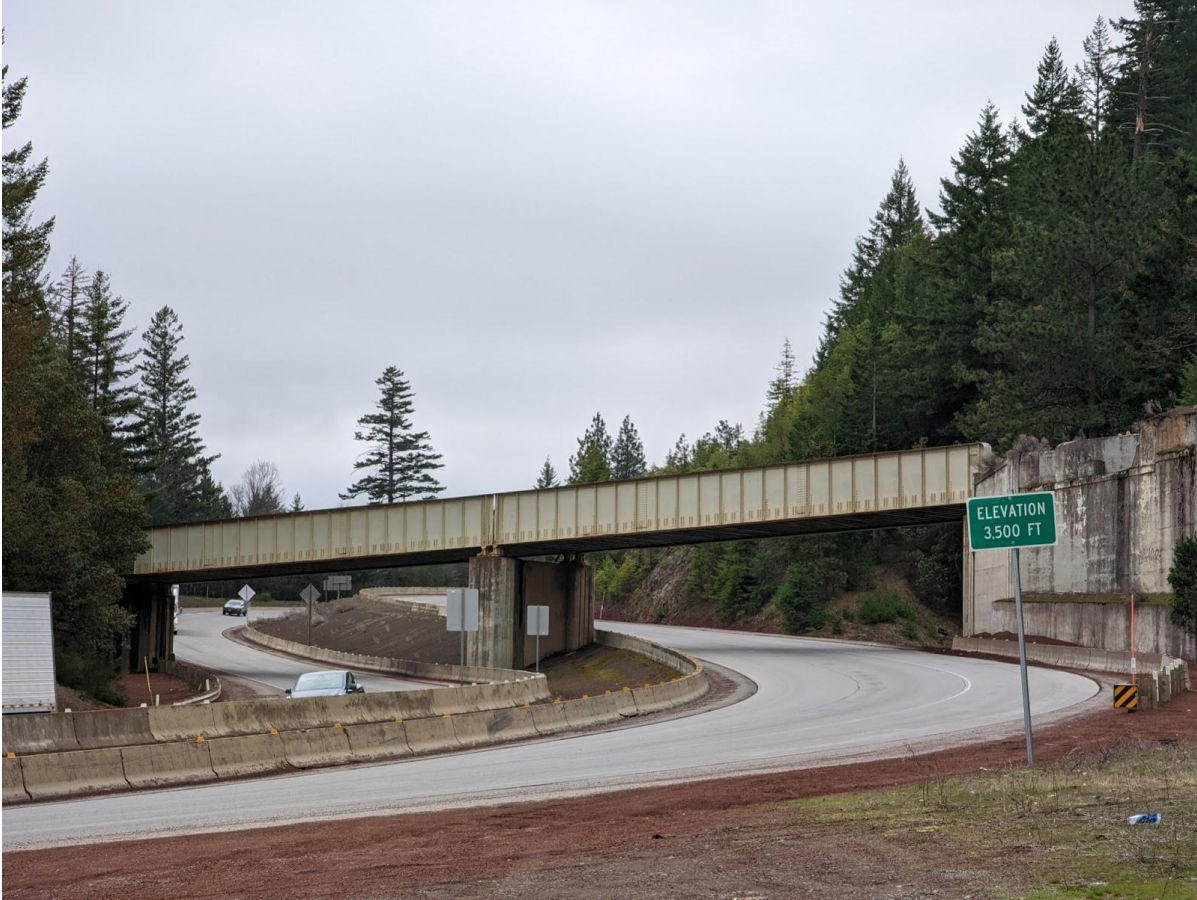
The Wall Creek railroad bridge crossing over I-5 (ODOT Bridge ID 02011A at MP 7.08) is a 48-foot long (along railroad) steel girder bridge (**Figure 3-6**). It was constructed in 1937, replaced in 1966, and most recently inspected in June 2020 with a fair condition and sufficiency rating of -2. Access to the railroad bridge is limited due to the steep embankments. Drainage from the bridge is reported by ODOT maintenance staff to cause icy, unsafe conditions on the roadway under the bridge. The railroad is situated on a bench cut into the hillside on the west and a trough cut through the hillside to the west with retaining walls supporting the existing bridge abutments. A small berm of remnant hillside separates the railroad from the highway on the east side from approximately MP 7.0 to MP 6.9.

**Figure 3-6.** Wall Creek Railroad Bridge (looking south).

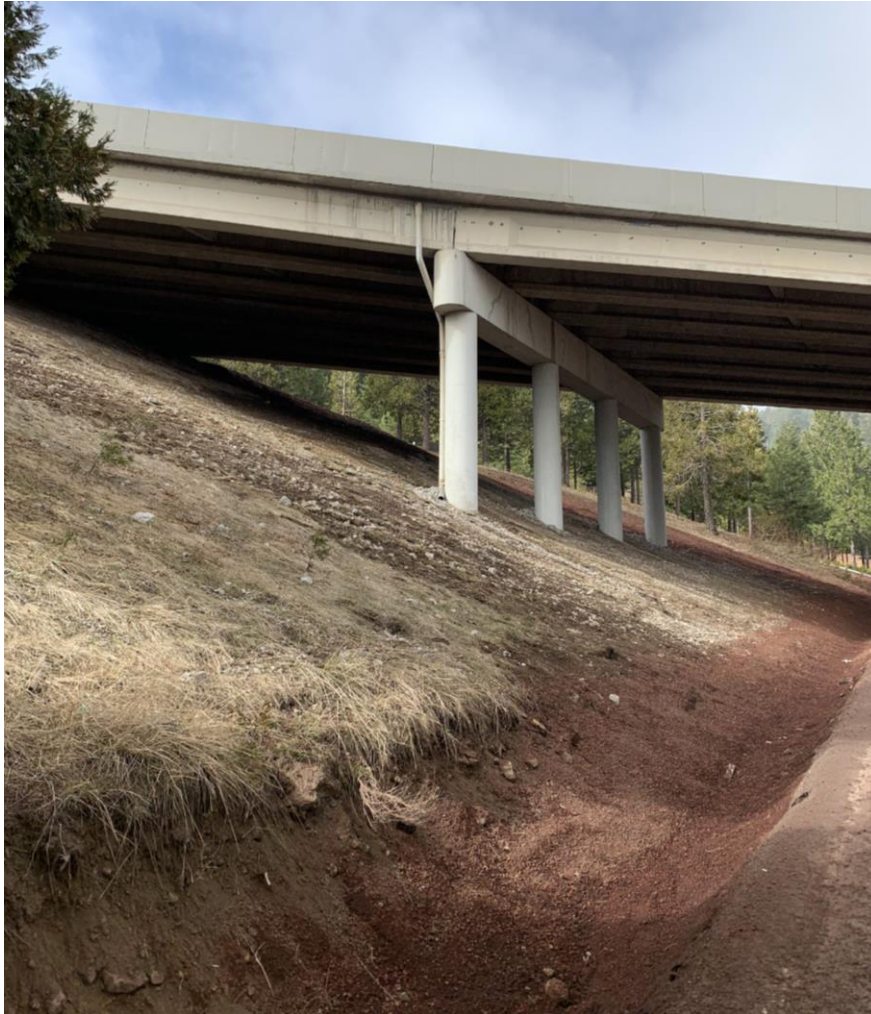
The existing bridge over Highway 273 (ODOT bridge ID 09259 at MP 5.32) is a 234-foot long (along I-5) by 58-foot wide (along Highway 273) prestressed concrete girder bridge (**Figure 3-8**). It was constructed in 1965 and most recently inspected in June 2020 with a fair condition and sufficiency rating of 92 (southbound) and 88.2 (northbound). The bridge is not over water and thus scour was not assessed; however, a roadside ditch runs both sides of Highway 273. The ditches are partially routed through culverts which are mostly embedded with sediment from the road shoulder and ditch. Some erosion is evident along the flow line of the ditch. Access to the bridge is very good via Highway 273.

**Figure 3-8.** Mt. Ashland Exit bridge (southbound) (looking west).

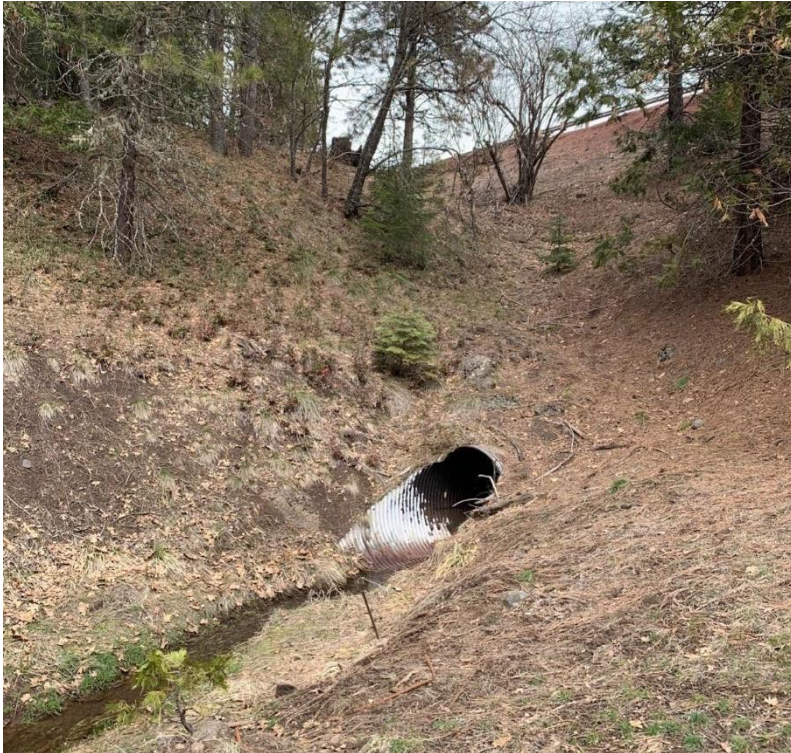
The existing crossing structure observed is a 4-foot diameter corrugated metal pipe culvert with approximately 40 feet of cover at the inlet (**Figure 3-10**). It was constructed in 1966 and most recently inspected in July 2013 with a condition rating of fair. The channel upstream of the culvert had an approximate 8-foot bottom width, fine organic material in the bed with low benches (<6 inches above the channel bottom) and tall, nearly vertical banks approximately 3 feet tall. The culvert showed evidence of invert degradation and some small roots appeared to be entering through culvert walls. The inlet is accessible via a maintenance road to the south.

**Figure 3-10.** Siskiyou Summit culvert inlet with I-5 at the top of the image.

There is potential for species use by both terrestrial and semi-aquatic species. There is likely infrequent use by small animals like ground squirrels and/or occasional amphibians. This culvert is unavailable to fully aquatic species. Additionally, smaller terrestrial species that prefer cover are less likely to use this crossing. Larger species, particularly ungulates are unable to use this crossing as is. Camera monitoring documented gray fox and a fawn entering the culvert, however adult deer are not likely to use this culvert. A person was observed entering the culvert (presumably a hiker from the nearby Pacific Crest Trail). They did not re-emerge from the culvert and are assumed to have traveled through.

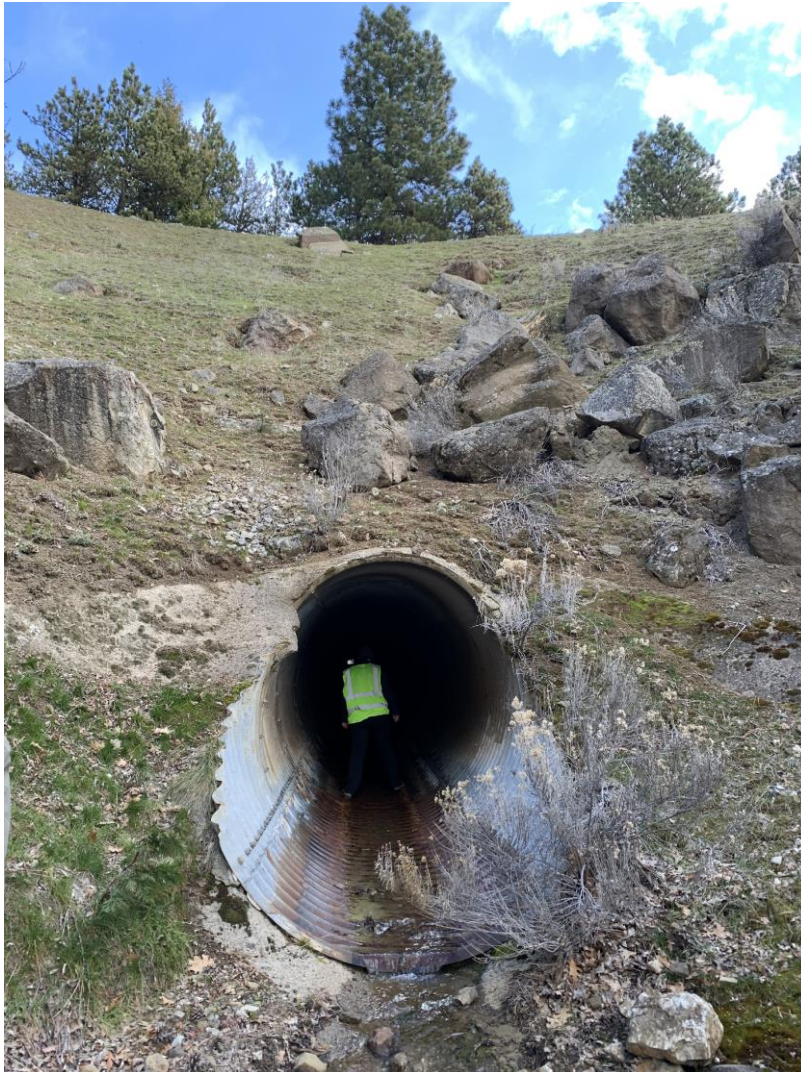
The existing culvert at Bear Gulch under I-5 (ODOT bridge ID 0P215 at MP 2.55) is a 7-foot diameter by 699-foot-long circular corrugated metal pipe (**Figure 3-11**). The culvert is listed in the national bridge inventory. It has 131 feet of cover at the inlet and 94 feet of cover at the outlet. The construction date is 1965 and it was most recently inspected in November 2020 with a fair bridge condition, a culvert rating of 6 (deterioration) and sufficiency rating of 24. The culvert is considered scour critical. Wetted marks in the culvert indicate that it does not regularly flow more than half-full. The channel downstream of the culvert is paved with concrete and some of the reinforcing bars are exposed. The channel upstream of the culvert is composed of gravels, cobbles, and some angular rock. Sediment has been transported and deposited approximately halfway through the culvert.

**Figure 3-11.** Bear Gulch culvert outlet with access road bench at top of the image. I-5 is not visible from the culvert outlet.

There is potential for species use by terrestrial and semi aquatic species. There is likely infrequent use by small mammals like ground squirrels. The crossing is not on a fish bearing stream, and it is unlikely to pass amphibians or reptiles due to a combination of the length of the culvert and cold internal conditions.

Additionally, the culvert is unavailable to small and medium mammals that avoid wading through water. Smaller terrestrial species that prefer cover are also less likely to use this culvert. Larger species that prefer long sight distance may avoid using this culvert. Camera monitoring has documented deer, bear tracks have been observed at the culvert outlet (west), and fox tracks have been observed at the culvert inlet (east).

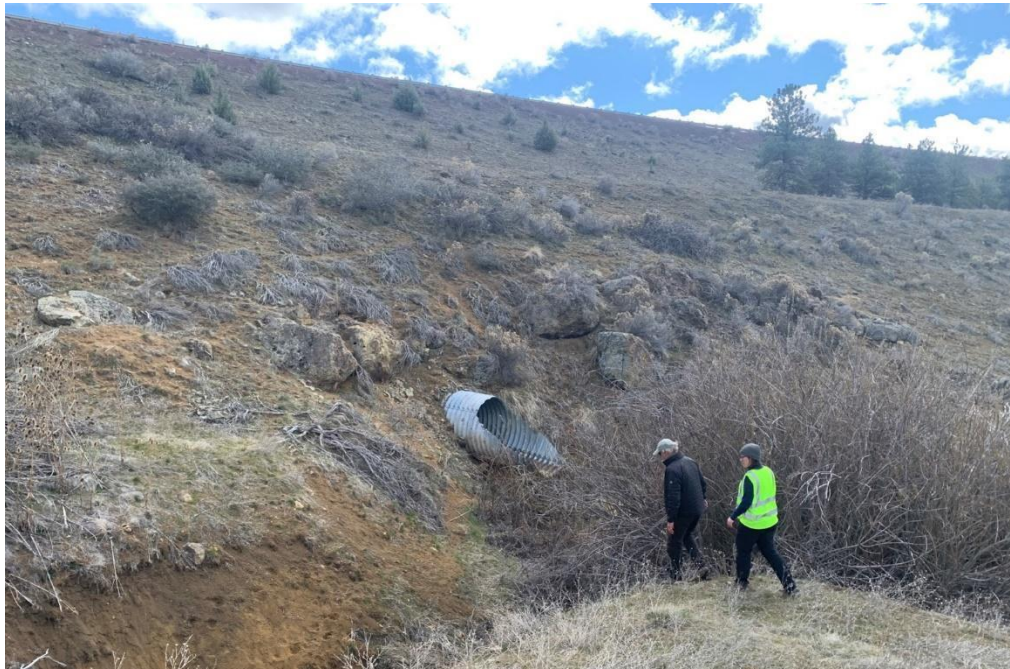
The existing culvert over Indian Creek at Mariposa Preserve (ODOT drainage facility ID D039512 at MP 1.35) is a 5-foot diameter by 614-foot-long circular corrugated metal pipe metal pipe culvert (**Figure 3-13**). The culvert has 81 feet of cover at the inlet and 67 feet of cover at the outlet. It was constructed in 1965 and most recently inspected in June 2013 with a condition rating of fair. The culvert is not listed in the national bridge inventory. The culvert outlet is perched approximately 5 feet above the creek bed. Access to the outlet is via the highway shoulder and an access road with occasional rutting. The ditch running along the access road was deeply incised (over 10 feet) at the confluence with the creek at the outlet (**Figure 3-13**).

**Figure 3-13.** Mariposa Preserve culvert outlet with access road bench near the top of the image and I-5 at the top of the image.

There is potential for species use by medium sized terrestrial and semi-aquatic species. There is likely infrequent use by small mammals like ground squirrels. It is unavailable to aquatic species and Indian Creek at the crossing location is not considered a fish bearing stream. The culvert is unlikely to pass amphibians or reptiles due to a combination of the length of the culvert, cold internal conditions, and the fact that it is a perched culvert. Additionally, the culvert is not available to small and medium mammals that avoid wading through water. Smaller terrestrial species that prefer cover are less likely to use this culvert. Large species do not have enough room to use this crossing. Camera monitoring has documented wildlife activity adjacent to the culvert including bobcat and several bird species. It is unclear what level of use and what species actually use the culvert.

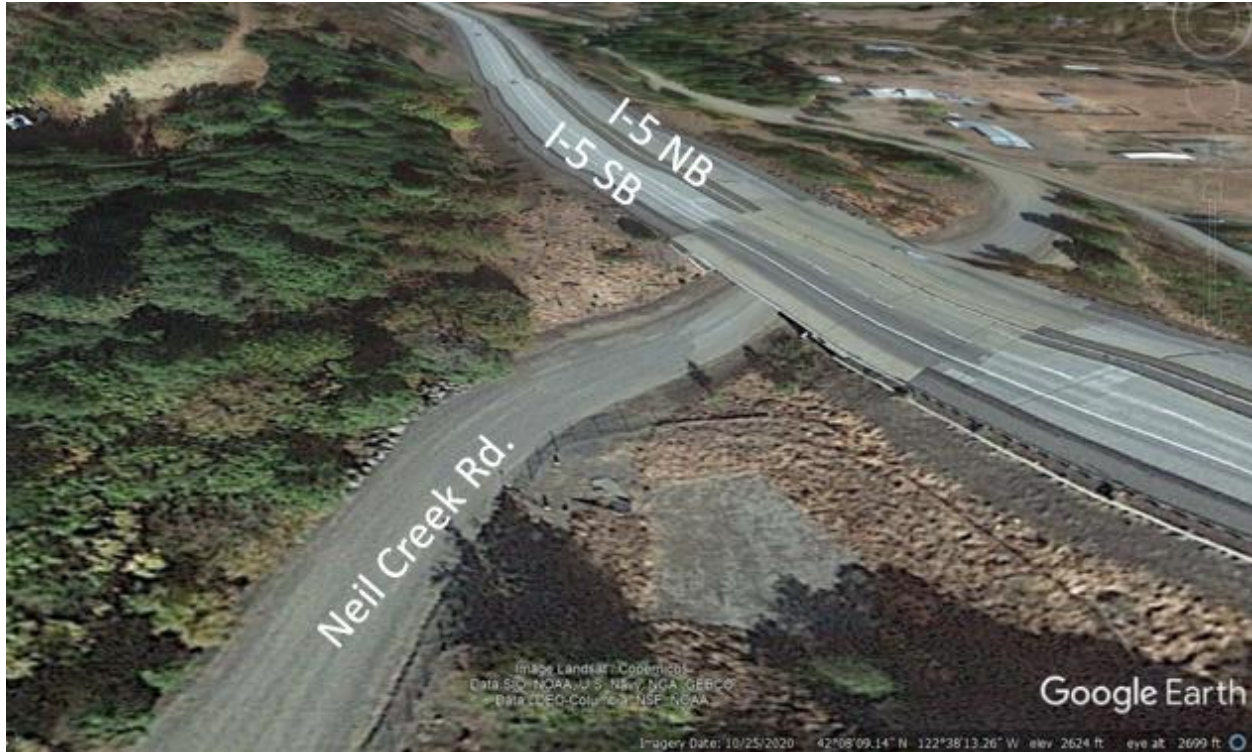
Table 6-1. Design recommendations for Neil Creek Road retrofit.	
Design Element	Recommended Dimensions
Soft shoulder	8 feet min. wide and separated from the road traffic with rock piles. Composed of select general backfill without angular rock fragments.
Rock piles	6 - 8 inches diameter, piles up to 4 foot diameter by 2.5 feet high. Rocks shall be subangular to subrounded. Place rock piles to maximize solar exposure. Do not compact rock piles (leave voids open). Include at least three boulders in each rock pile.

**Figure 6-1.** Perspective view of Neil Creek Road undercrossing (looking west to east along Neil Creek Road).

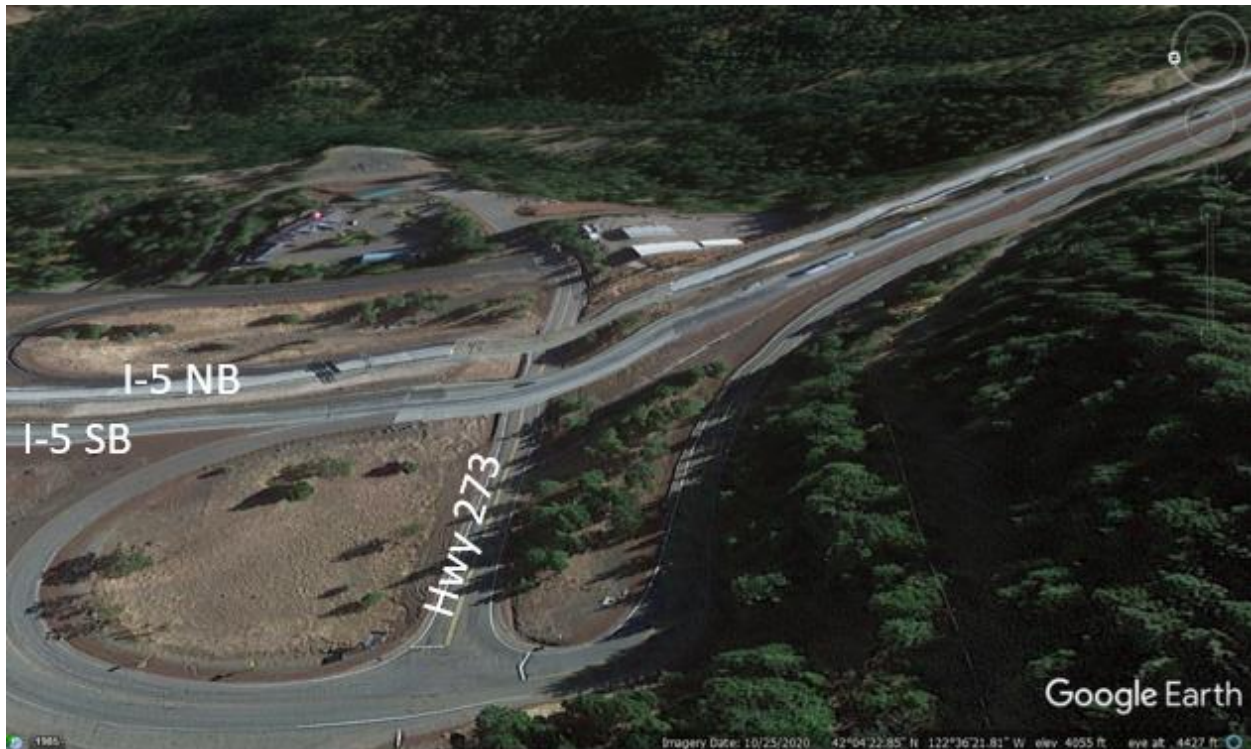
Table 6-4. Design recommendations for Mt. Ashland Exit retrofit.	
Design Element	Design Recommendation
	maximize solar exposure. Do not compact rock piles (leave voids open). Include at least three boulders in each rock pile.
Boulders	10 - 16 inches diameter, resting on growing medium surface (not embedded). Boulders shall be subrounded to rounded.

Figure 6-4. Perspective view of Mt. Ashland Exit (looking west to east along Highway 273).

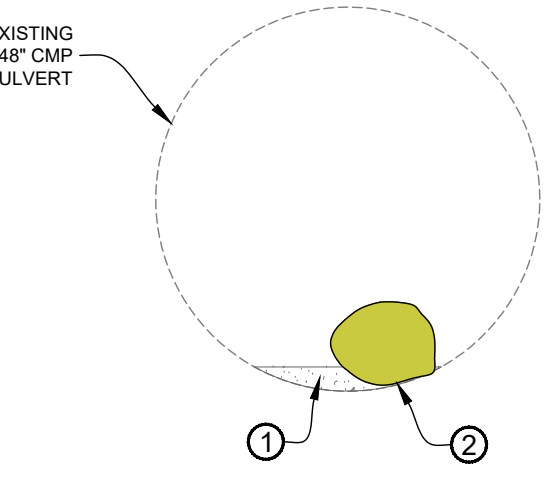
**2 TYPICAL RETROFIT SECTION**  
 HORIZ 1" = 2'  
 VERT 1" = 2'

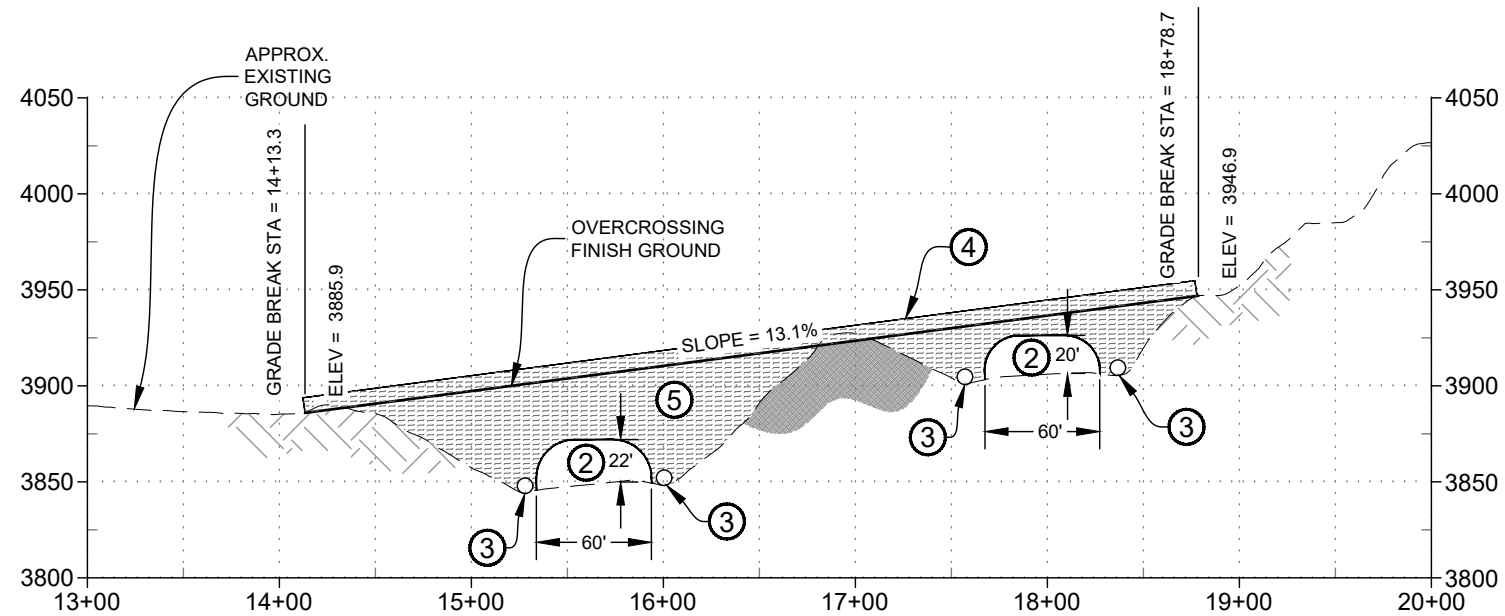
**2 OVERCROSSING PROFILE**
