» DELIVERABLE D3.3

EVALUATION OF MATERIALS CHARACTERIZATIONS

Project information	GA No. 101069600 "Novel Concepts for SAfer, Lighter, Circular and Smarter Vehicle Structure Design for Enhanced Crashworthiness and Higher Compatibility"
Project acronym	SALIENT
Funding scheme	RIA
Starting date	01 Sept 2022
End date	31 Aug 2025
Duration	36 months
Coordinator	CTAG (Spain)
Project website	www.salient-project.eu

Deliverable n°	D3.3
Deliverable title	Evaluation of materials characterizations
WP No. & title	WP3 - Innovations in Materials Development and Manufacturing Processes
WP Leader	tPE
Contributors	CID
	ASAS
	CTAG
	tPE
	FRA
	CRF
	UNN
	IDI
	VIF

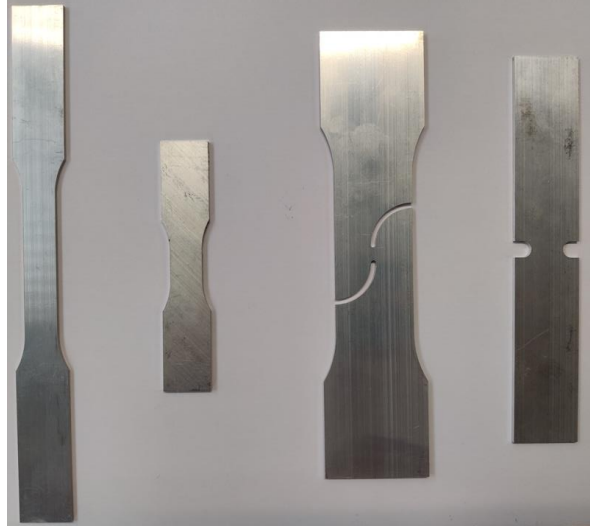
Figure 1: Examples of Al6063 coupons for testing. From left to right: QS tensile, dynamic tensile, shear and biaxial (small notch) coupons.

Aluminium coupons were machined by a 5-axis CNC Milling Machine owing to CAM technology. In order to shorten operation time and energy consumption, the CAD data for CAM programming was designed to maximize the amount of specimens. Sample designs were taken from the standards. Feed rate, rotational speed, and cutting depth were assigned regarding the opted optimum stock material and cutting tool. Examples of the coupons machined for testing purposes are presented in Figure 1 below.

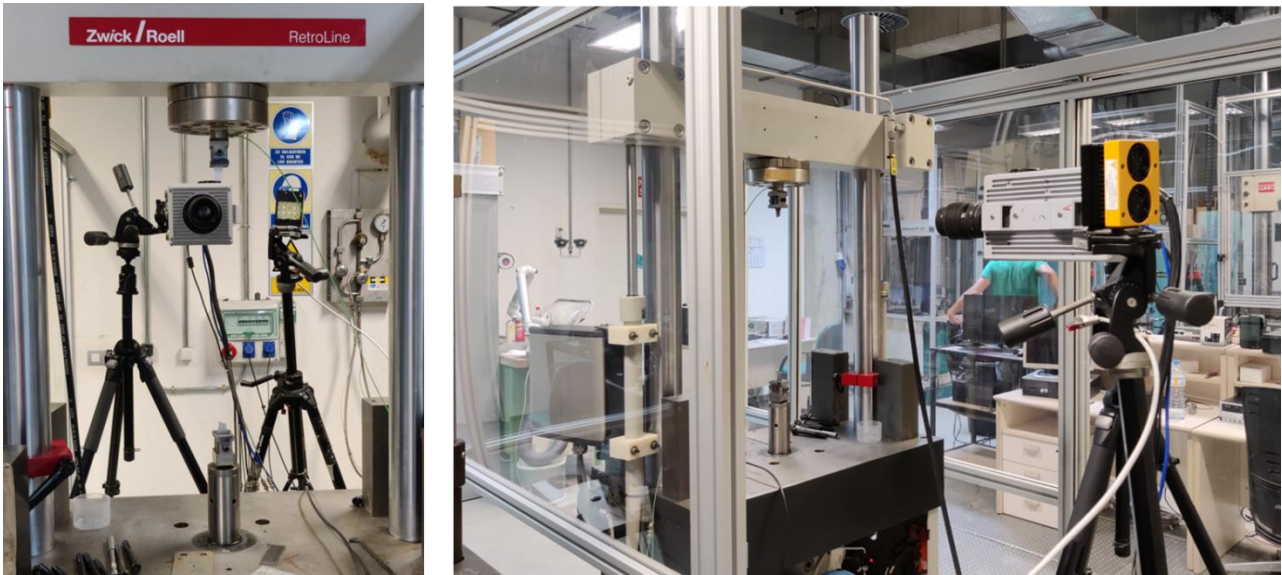
Figure 12: Front (left) and side (right) view of the testing equipment used for the dynamic tensile tests.

For these tests, a different testing machine was needed, as it has to be able to introduce the loads needed to execute the test at much higher speeds (compared with the QS scenario), while at the same time ensure a reliable measurement of the test variables. The test equipment and setup employed for the dynamic tensile tests is shown in Figure 12.

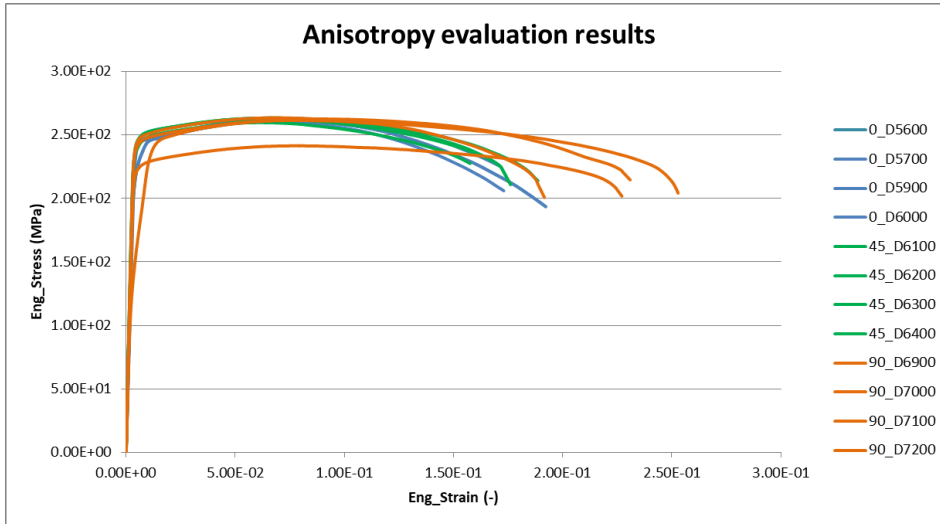
Figure 19: Anisotropy evaluation results for the Al6063

In Figure 19 the results (stress-strain graphs) for the three orientations are presented in an aggregate manner to ease their interpretations, while in Figure 20 the aspect of the coupons after failure is shown, also for all orientations.

The measured values of stress and strain for all tested coupons (4 valid results per each material orientation) show that there are no strong signs of anisotropic behaviour in this material, even though it has been subjected to an extrusion process. If there is any anisotropy, it cannot be clearly distinguished from the inherent scattering of the coupons tested, in terms of Young modulus, yield strength and ultimate strength. This is aligned with the observations made at microstructural scale, reported in section 3.2.1, in which it was seen that the same grain structure appears after failure regardless of the orientation of the material. Apparently there are some differences in the strain registered in the 90° coupons (in three out of four coupons), that reach higher ultimate strains than the other coupons from 0° and 45° orientations, and also the stress drop prior to failure appears at higher strains. This might be related to the failure mode appearing in the coupons (Figure 20).

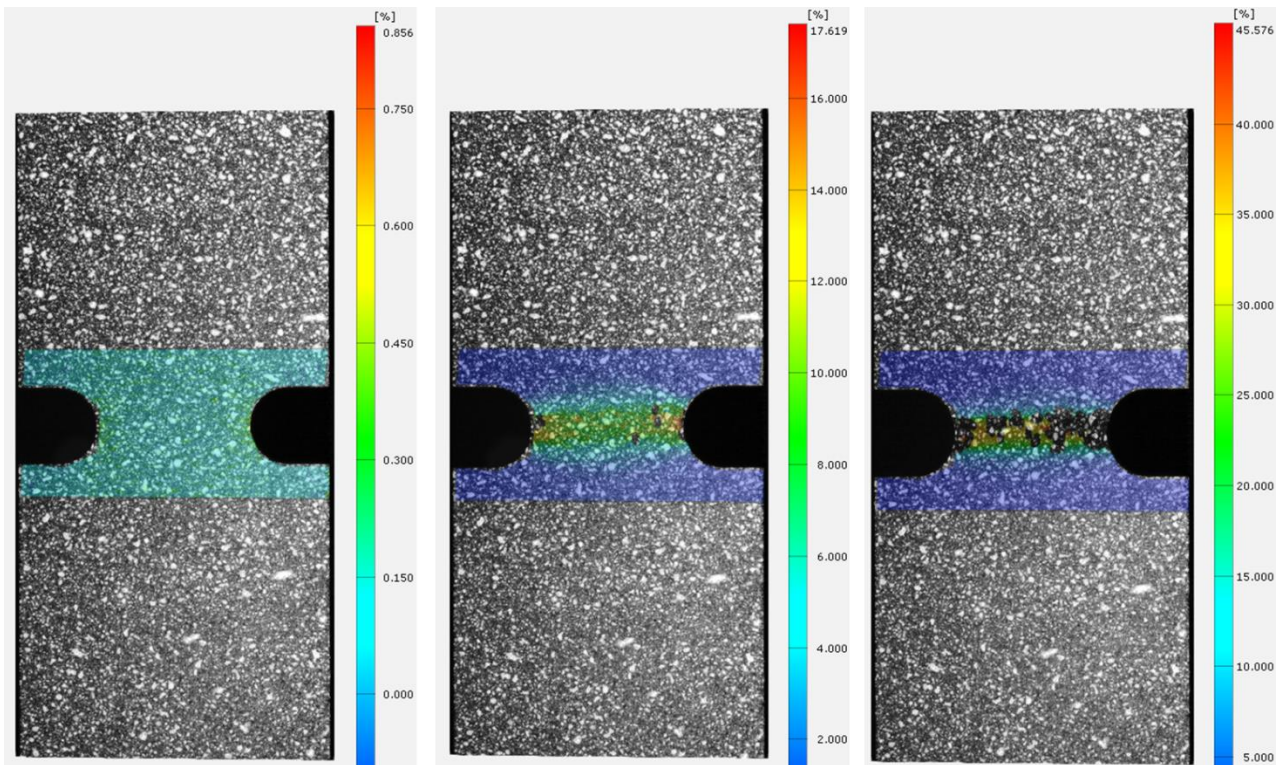
Figure 25: Strain fields measured during QS biaxial test. Left: early stage; Centre: intermediate stage; Right: stage close to failure.

DIC was also used in this test configuration. In Figure 25 it can be seen that deformation during the test is mostly concentrated in the coupon area between the notches, while the rest of the coupon is essentially unaltered, what proves additionally the validity of the design. At late stages of the tests, the central area of the coupons becomes so deformed that is difficult for the system to track deformations with sub-pixel accuracy (Figure 25, right).

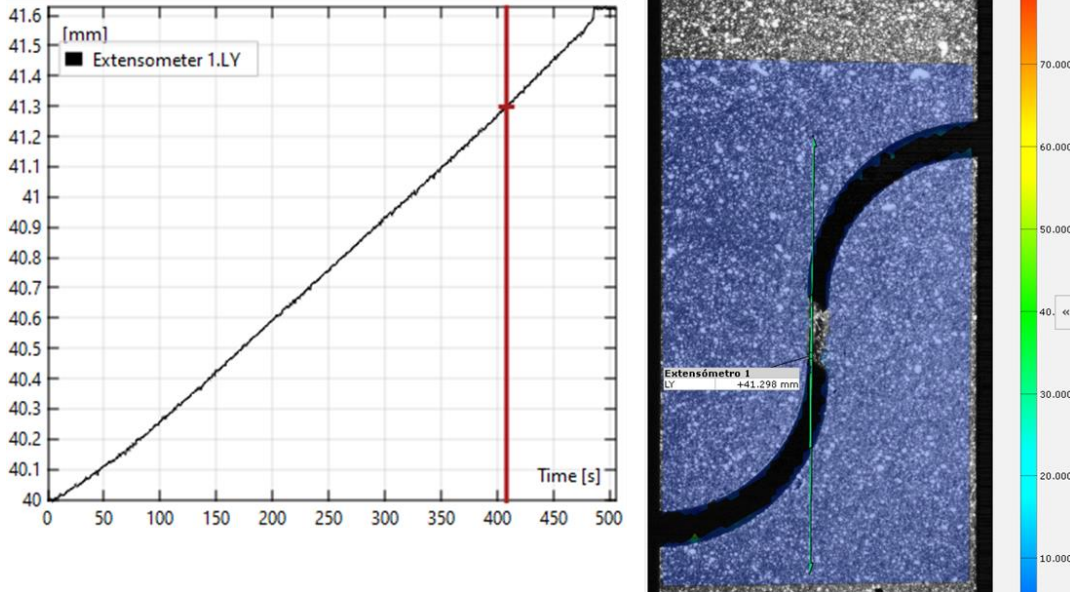
Figure 32: Tracking of global deformation on shear specimens after full-field signal is lost.

DIC was also used to track full-field deformations during the tests (Figure 31). At advanced stages of the test, the most deformed areas of the coupon were lost; nevertheless global deformations can be successfully tracked throughout the whole duration of the tests as demonstrated in Figure 32.

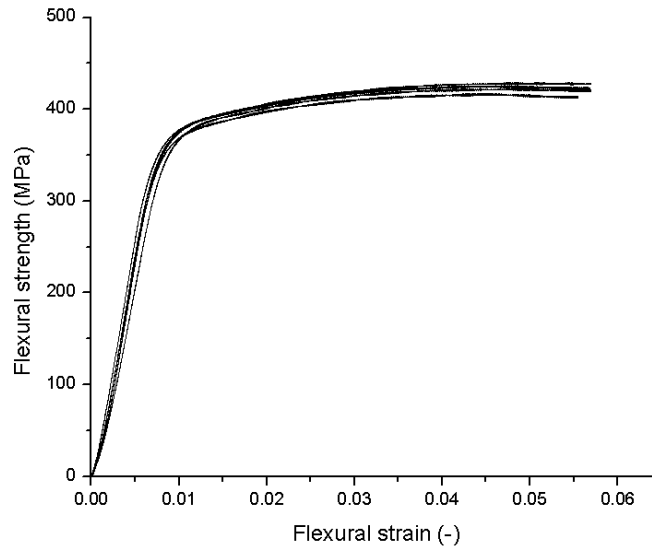
Figure 34: Stress-strain curves of the three point bending samples.

The stress-strain results of the three point bending tests are presented in Figure 34. The aspect of the samples after the test is shown in Figure 35. Great repetitiveness was found between the samples during the tests. No failure was reached. Due to the test setup employed (see 3.7.1), the maximum displacement allowed by the testing equipment is reached before failure occurs.

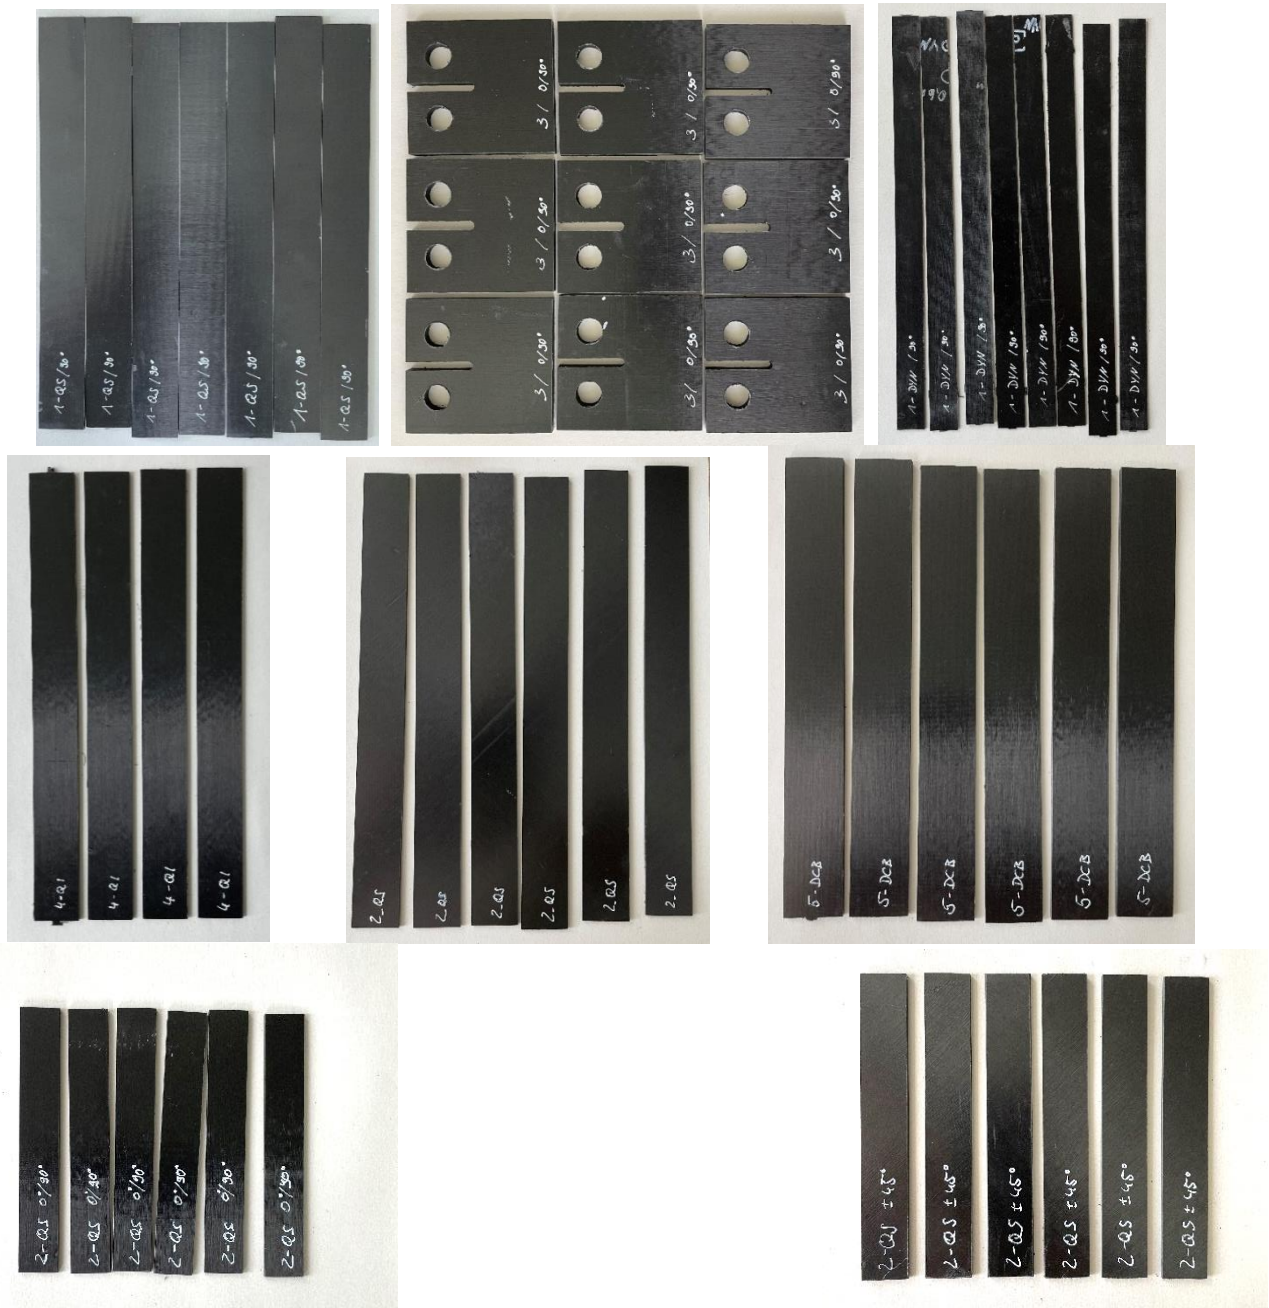
Figure 38: Test specimens for a variety of relevant tests

Once completed, the samples were appropriately labelled (see Figure 38) and sent to the project partners for characterization. Further details about the design and manufacturing of the TP/CFRP can be found in D3.1, here only a brief description is provided focusing on the close relationship existing between material manufacturing (T3.1) and material characterization (T3.2).

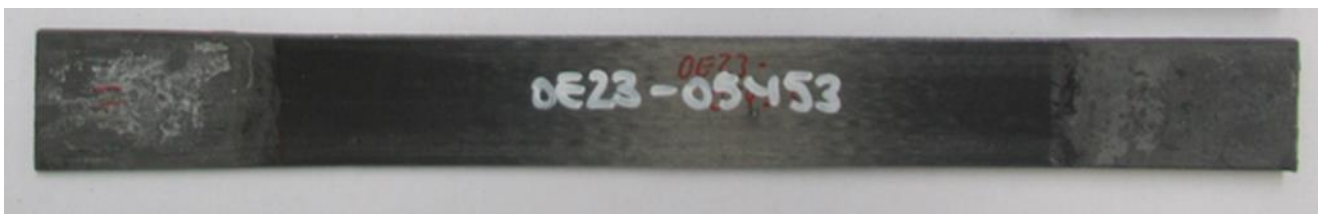
Figure 43: Coupon tested without tabs after test finished.

To determine the optimal setup of the tests, a trial and error procedure was followed employing the thick coupons, because their bigger dimensions mean that they are able to withstand higher forces during the tests and therefore potential issues become more evident. Initially, a coupon without tabs was tested; no failure appeared because of slippage issues (Figure 43).

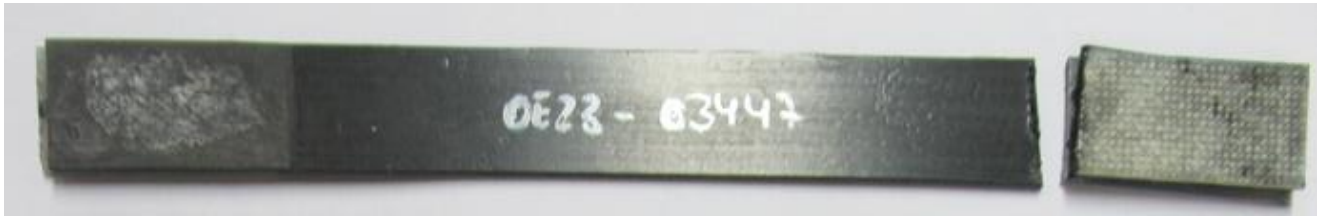
Figure 44: Coupon tested with sharp tabs after failure.

After that, it was decided to glue tabs in the standard way to smooth transfer loads from the machine to the coupon, that is to say, with both ends at 90°. In this case, an undesired failure mode was obtained because failure appeared at the tab ends (Figure 44), which is the weakest part of the coupon in thin configuration because of the stress concentrations that are induced. Besides, it is necessary to take into account that this laminate is much weaker in the transversal direction, so any load that is transferred in a non-longitudinal direction may potentially cause premature failure of the coupon.

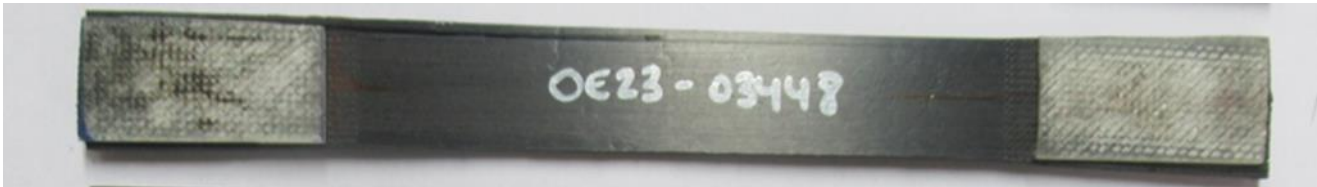
Figure 45: Coupon tested with milled tab ends after failure.

Finally, a configuration using tabs milled at 45° in one end to smooth load transfer even more proved to be effective, leading to acceptable force values and more appropriate failure modes as shown in Figure 45.

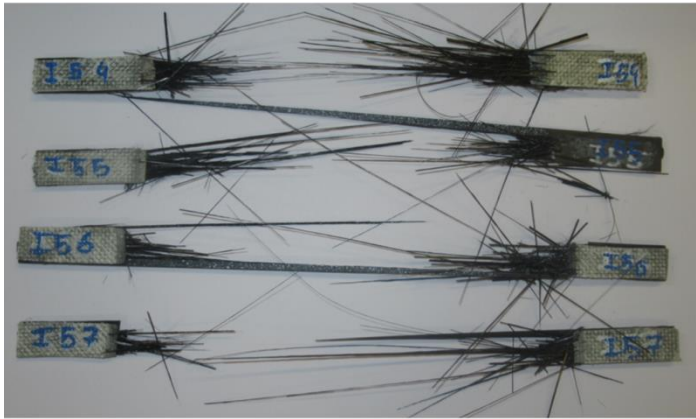
Figure 47: Aspect of the coupons (left) and force-displacement values from QS tests at 0° (right), for the thin coupons.

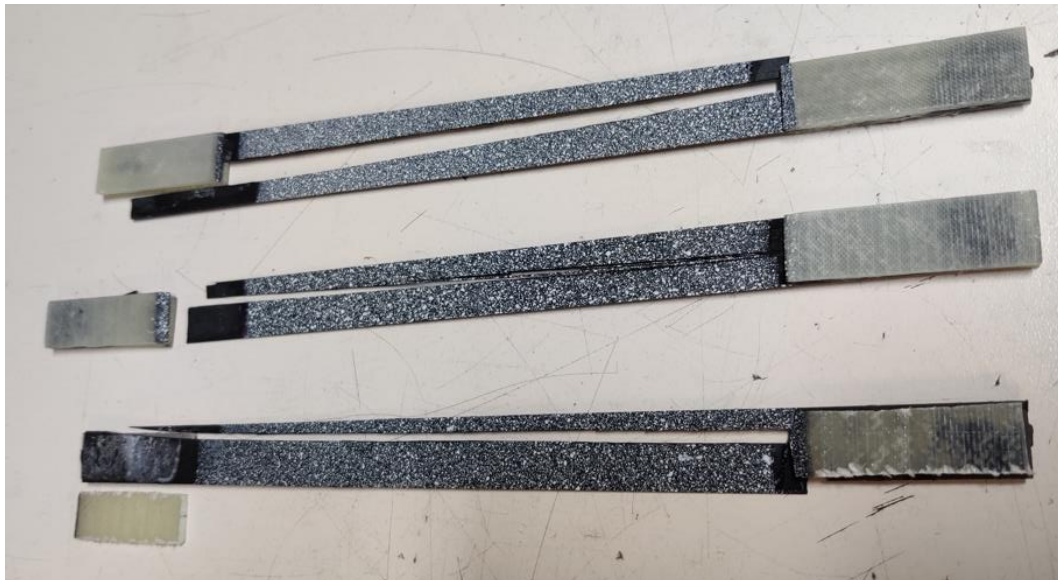
Figure 50: Aspect of the 0° coupons after dynamic tensile tests at 50s⁻¹.

Dynamic tensile tests were carried out on 0° coupons at 50s⁻¹ strain rate. The aspect of the coupons after the test is presented in Figure 50. Given the nature of this material, the main objective of this test is to determine how much stiffer the material becomes when subjected to dynamic loads, that is to say, the sensitivity of the Young modulus of the material at high strain rates.

Regarding this tests, two major remarks can be made. Firstly, the failure mode of the coupons, although longitudinal as in the QS tests, seems much less controllable. Failure tends to appear at the end of the coupons or even within the clamped length (not at the tabs' end as could be easily interpreted as potentially improvable from a technical point of view). Secondly, once the first elements of failure appear, it propagates suddenly in an abrupt

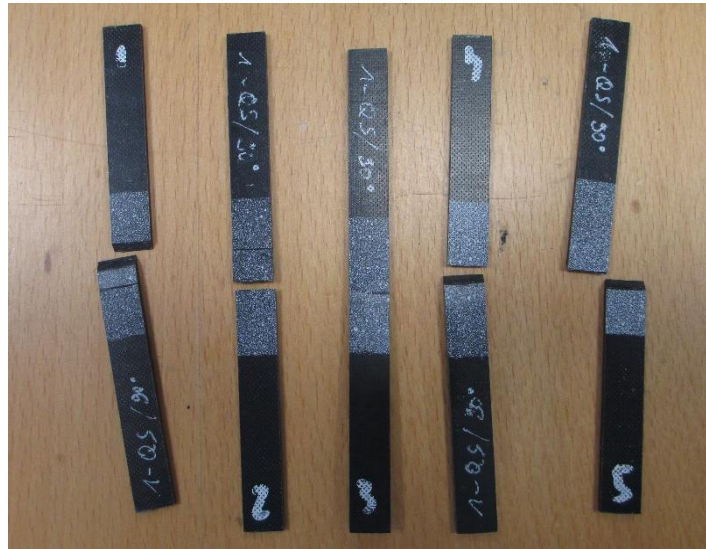
Figure 57: Compression coupons oriented at 90° after testing

The aspect of the compression coupons after testing is presented in Figure 57. The results are graphed in a similar fashion to the previous ones in Figure 58.

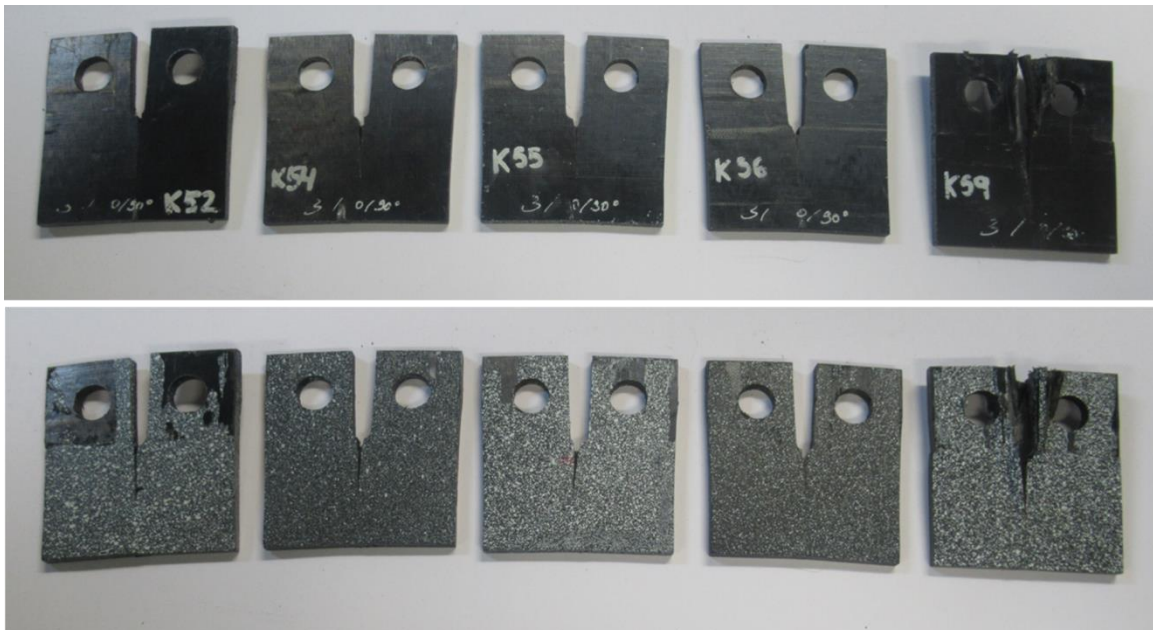
Figure 61: Aspect of CT coupons after testing.

The aspect of the CT coupons after the test is shown in Figure 61. The Force-displacement curves are presented in Figure 62.

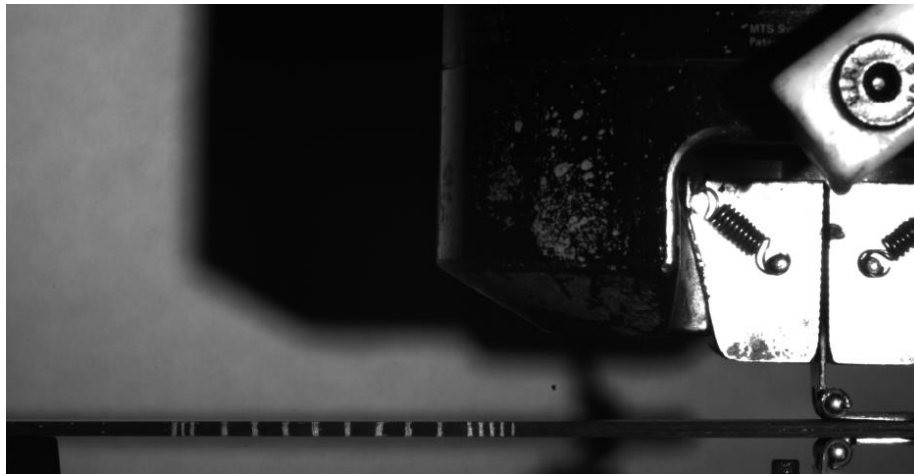
Figure 69: Test setup of interlaminar failure tests in Mode I with detail of the hinges employed.

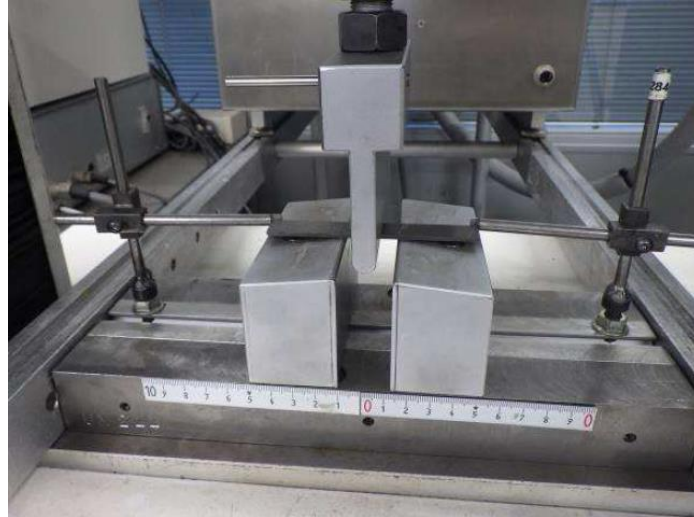
Figure 75: Test setup for the bending trials.

About the test setup, the test speed employed was 2 mm/min, with a span between supports of 27 mm. The radius of the supports and the loading edge were 2 mm and 5 mm, respectively. The test setup can be seen in Figure 75.

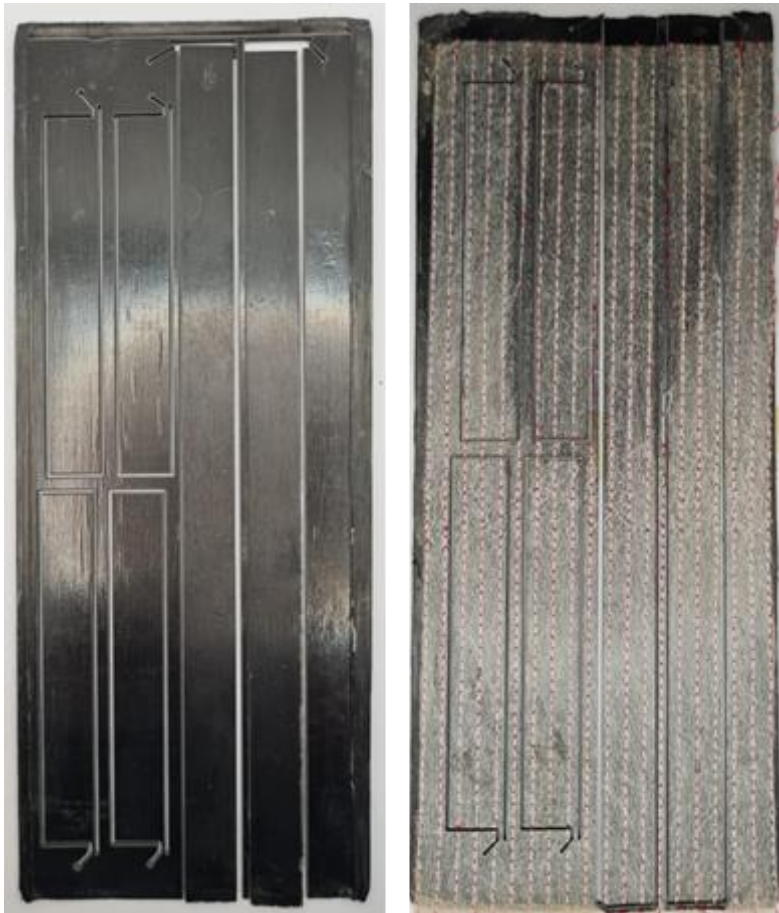
Figure 80: Cutted samples using waterjet technology placed in the origin plate

For the mechanical tests, samples were cutted by using the waterjet technology. For a wide range of mechanical testing bending samples with a length of 100 mm and width of 15 mm as well as tensile specimens with the dimensions (l x w) 250 mm x 15 mm were cutted. Examples of the coupons cutted from both manufacturing methods can be seen in Figure 80.

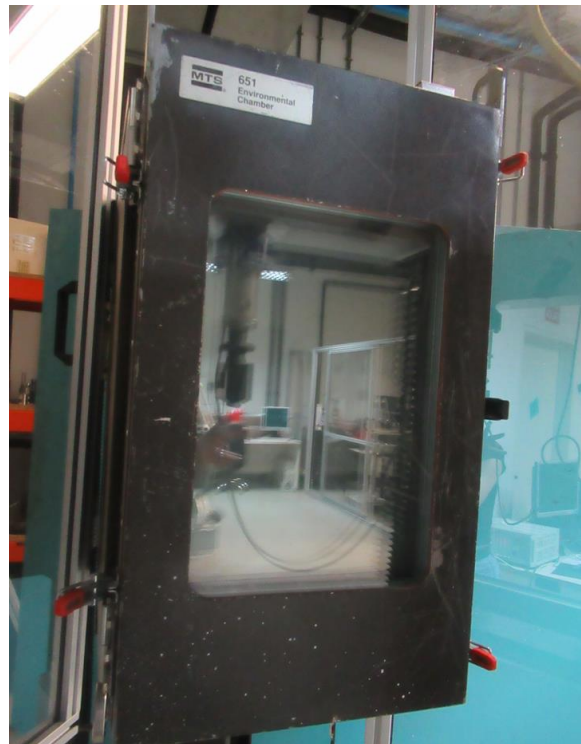
Figure 83: Climatic chamber used at Cidaut in SMA/CFRP tests.

For the tests at temperatures other than RT, a climatic chamber (Figure 83) was employed.

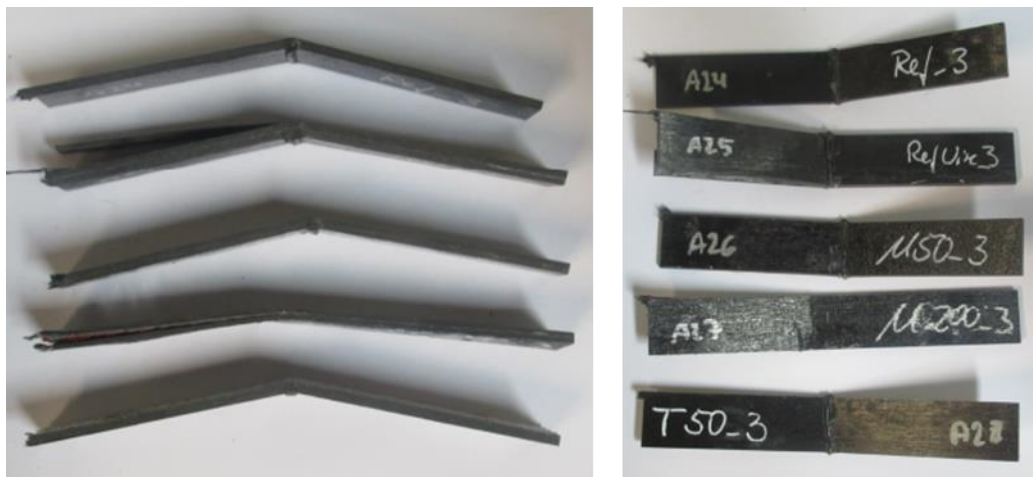
Figure 91: Aspect of SMA/CFRP coupons after three-point bending tests @ 100°C.

The aspect of the tested coupons after failure is shown in Figure 91. The associated force-displacement and stress-strain curves are depicted for all configurations in Figure 92 and Figure 93, respectively.

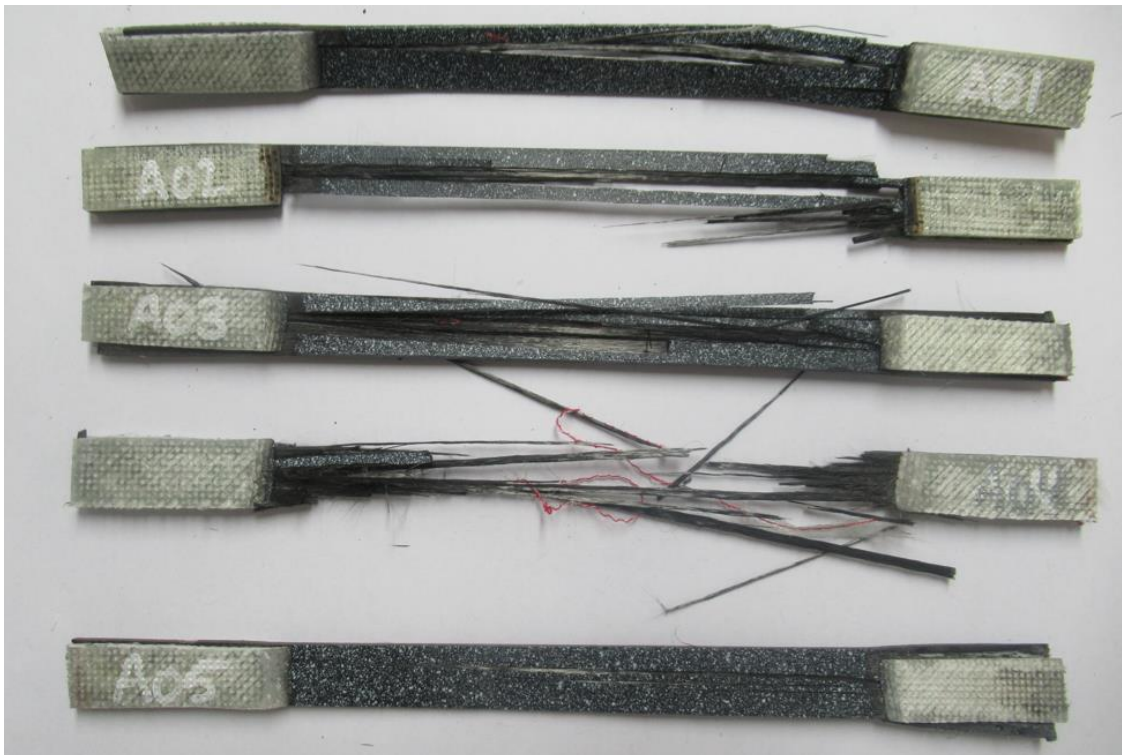
Figure 100: Aspect of SMA/CFRP coupons after QS tensile test.

The aspect of the tested coupons after failure is shown in Figure 100. The associated force-displacement and stress-strain curves are depicted for all configurations in Figure 101 and Figure 102, respectively.

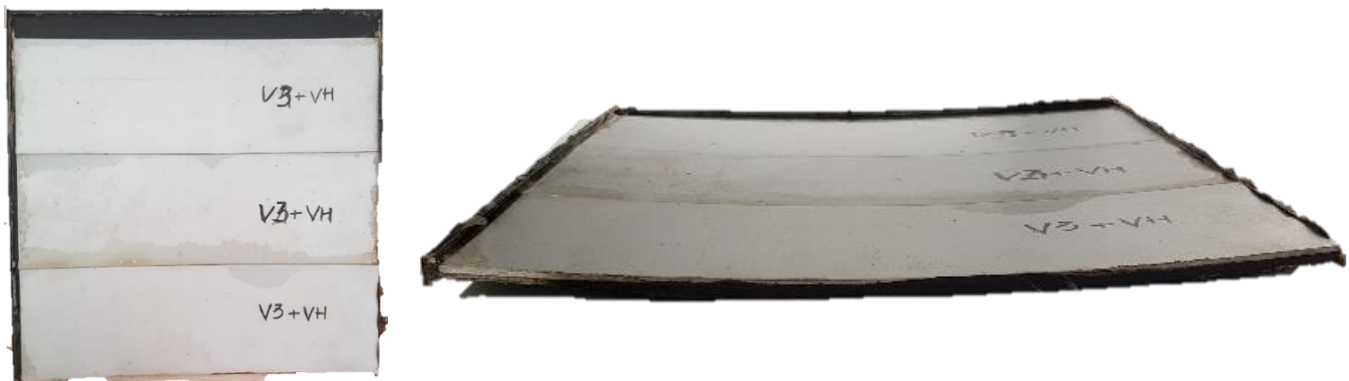
Figure 103: Hybrid laminates: result with the Vestmelt Hylink[®] Primer

As described in Deliverable D3.1, a good bond to the composite (CFRP-PA6) was established with the primer Vestmelt Hylink[®] applied to the aluminum (see Figure 103).

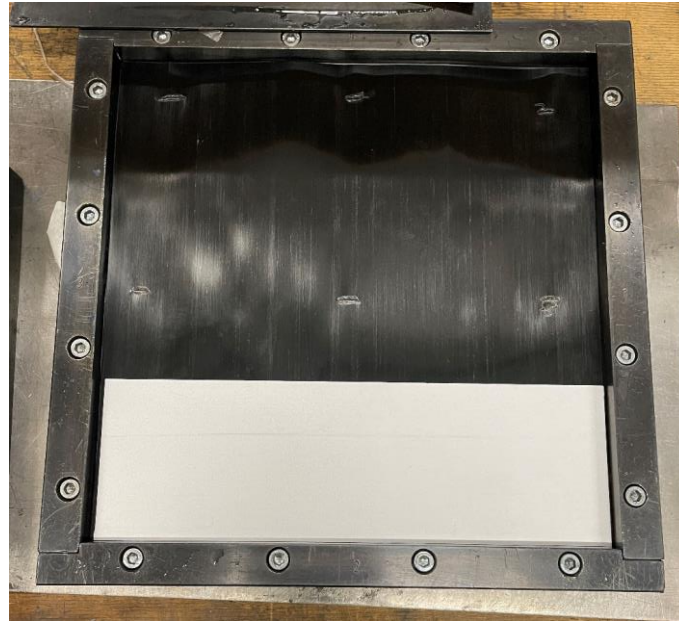
Figure 106: Placement of aluminum strips according to the last layer direction

Aluminum strips supplied by ASAS had a width of 80 mm. Therefore, 3 of these plates had to be placed side by side in the press tool. Since there is a significant difference in the coefficient of thermal expansion between aluminum and the composite, the three aluminum plates were inserted with the shorter edge is aligned in the direction of the fiber direction of the last fiber composite layer (see Figure 106). This configuration would result in less temperature induced strain at the bond interface.

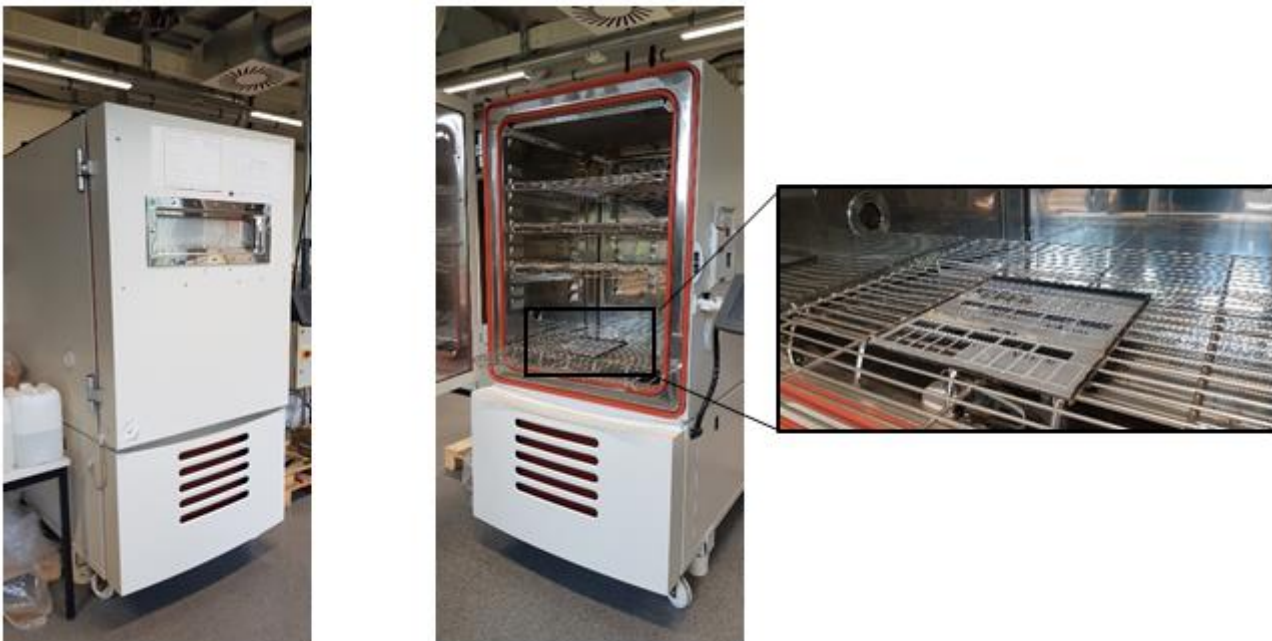
Figure 113. Climate chamber for carrying out climate change test as per PV1200

The climate change test of the hybrid specimens lasted 25 days (50 cycles, see Annex A). The test serves as a short-term test with a time-lapse effect. The equipment employed for these test and the test setup are depicted in Figure 113.

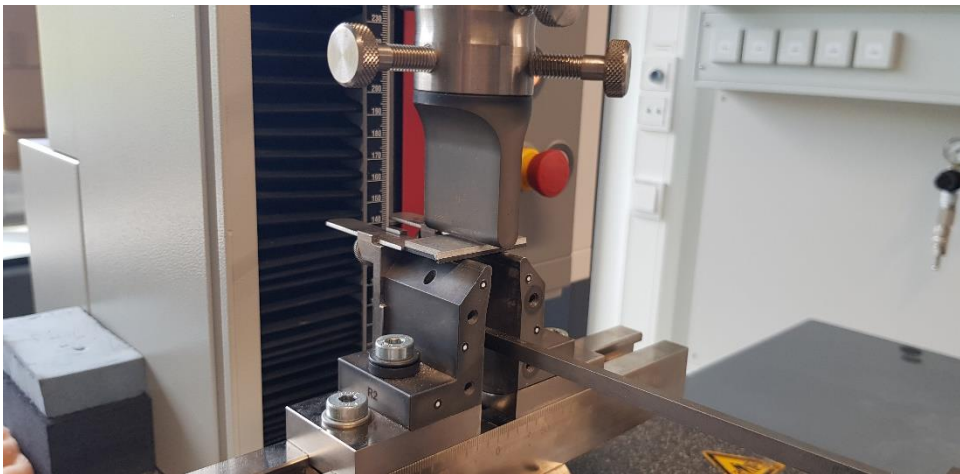
Figure 115: Test setup with mounted specimen

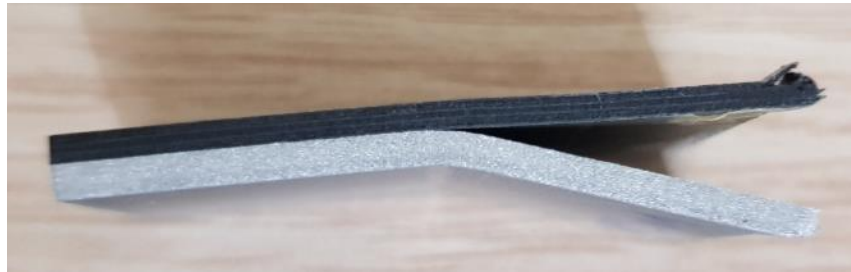
Figure 117: Tested specimen showing shear induced failure

From visual inspection of the specimens (Figure 117) shows that one half of the specimen is completely debonded along its length. This failure mode is characterized as a shear induced failure in DIN EN ISO 14130.
