# SQUAM ROCK LAND TRUST TRAIL PLAN

Prepared for the

**Squam Rock Land Trust**

**Mass Audubon's Ecological Extension Service**

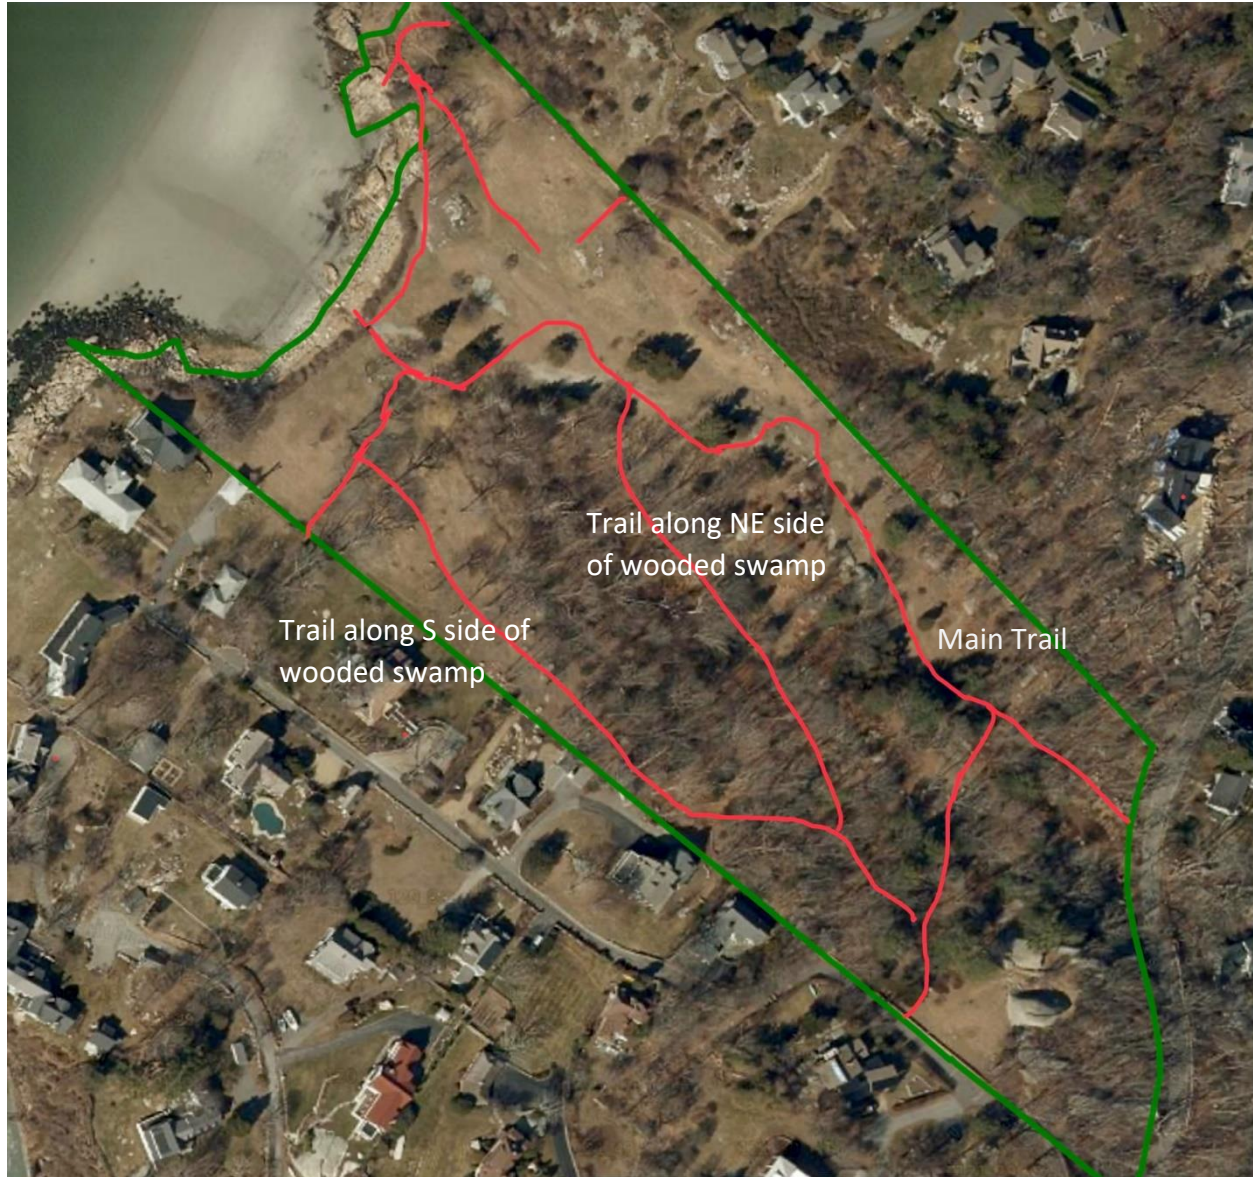
The aerial photo shows the current trails at Squam Rock Pasture.

All waypoints are from cell phone and are approximate locations. Rise and fall elevations determined from Gloucester GIS topography (1').
