**KENNEDY SPACE
CENTER**

CASE STUDY

Rocker Panel Base, Launch Pad 39A

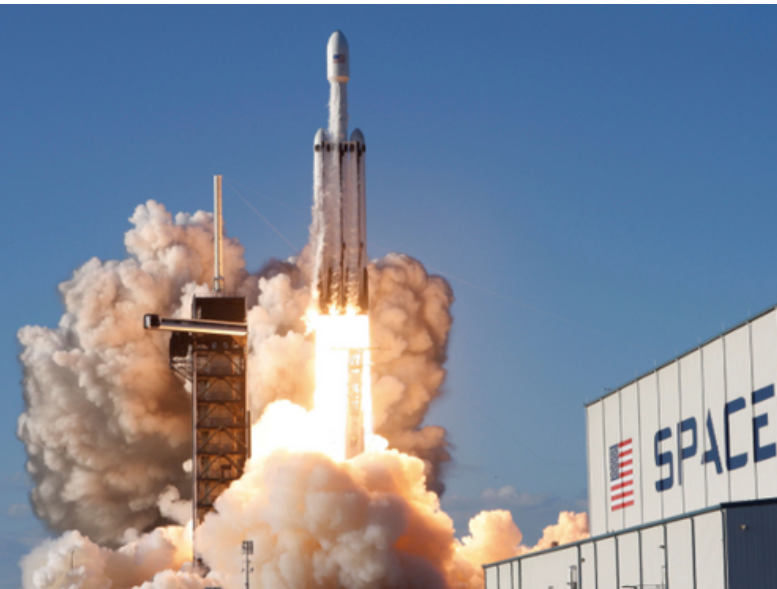
The Rocker panel base of Launch Pad 39A was experiencing severe concrete deterioration from exposure to a combination of corrosive atmospheric chlorides and fuel emission potassium percolate producing hydrochloric acid effluent from the shuttles rocket combustion system. Surface deterioration combined with wearing and cracking was allowing water to leak through the panel base to a tunnel below. Also, advanced corrosion of the imbedded steel in the structure and chloride contamination was contributing to the demise of the structure.

ABOVE: Corrosive chemical runoff from the rocket launches caused major damage to concrete

To arrest further deterioration and corrosion, Surtreat formulations were applied to improve the chemical and physical properties of the concrete. The formulations that were chosen for this project inhibit deterioration; improve durability and longevity of the structure by:

Demolition and removal of spalled and delaminated concrete took place before the application. Once the area was cleaned, application of Surtreat TPS II and TPS IV commenced. A special formulation was also used in designated repair areas to convert the ferrous oxide (rust) into a hard inert shell. Once the first application was completed, repairs to the spalled areas were made and a final application of formulations was made to the newly placed repairs.

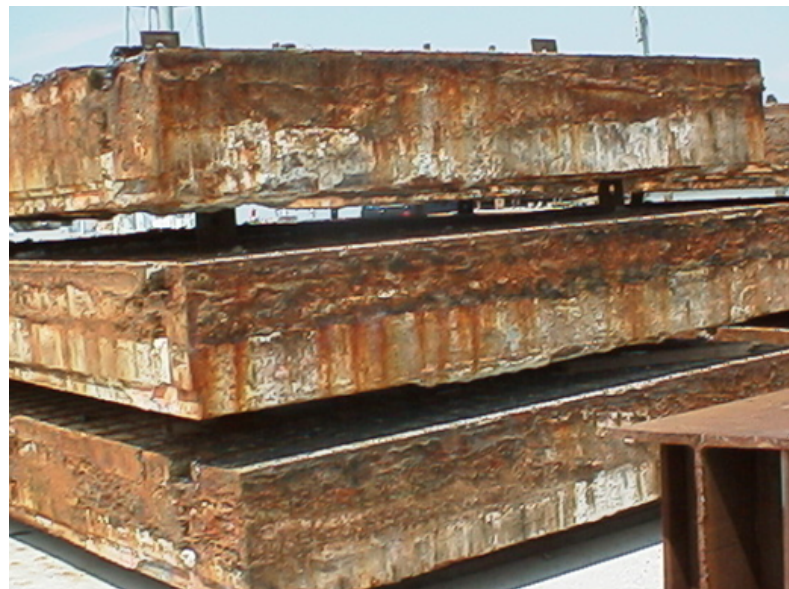
BELOW: An example of the corrosion that appears on metal elements at the launch pad.

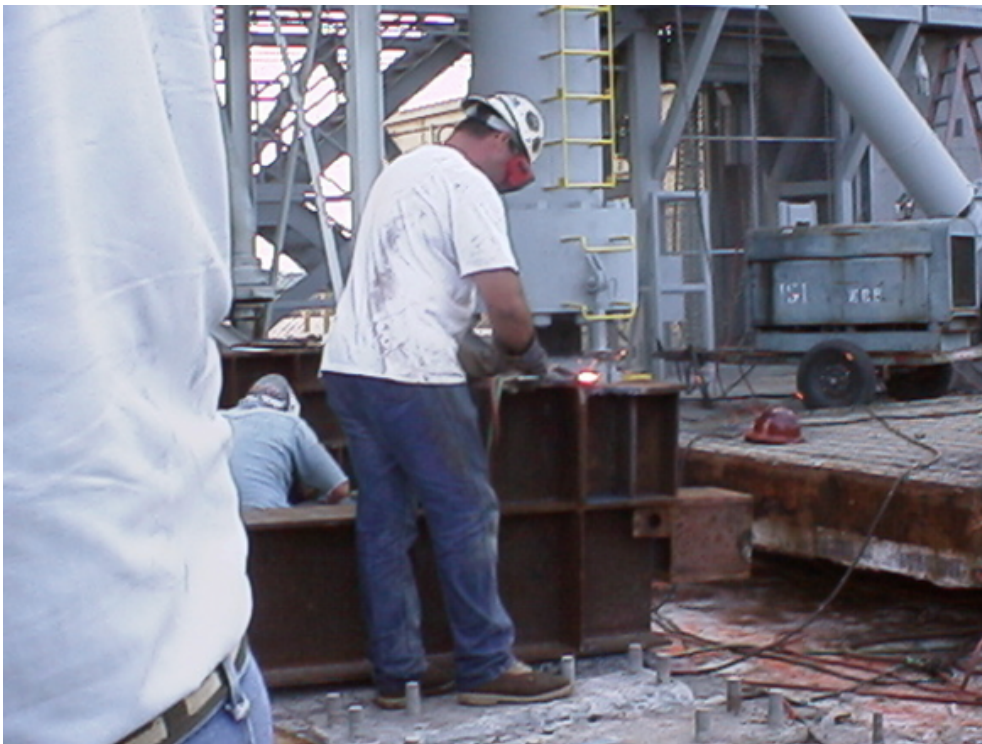
LEFT: Corroded metal elements on the launch pad being repaired and treated to prevent further corrosion to the structure.

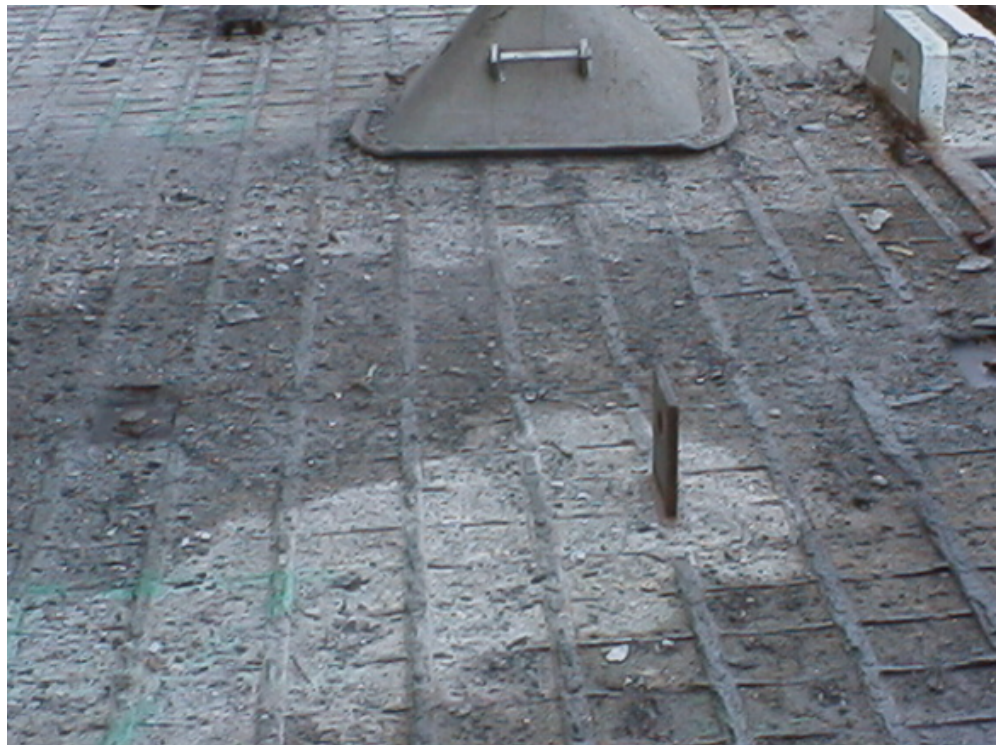
LEFT: Section of concrete that had the Surtreat TPS applied to the surface.

After application of Surtreat products, testing was conducted to ensure the expected results were obtained. The specified results of the project were met and the project was completed on time. Below are the results of the testing, which includes the measurements and the percentage change for each test conducted.

- Half Cell Positive Change of **43%**
 - 350mV to -200mV
- Corrosion Current Change of **133%**
 - 90 micro amps to +30 micro amps
- Polarization Resistance change of **55%**
 - 4281 ohm-cm² to 6612 ohm-cm²
