**SURTREAT®**

**WINDJAMMER  
CONDOMINIUMS**

# CASE STUDY

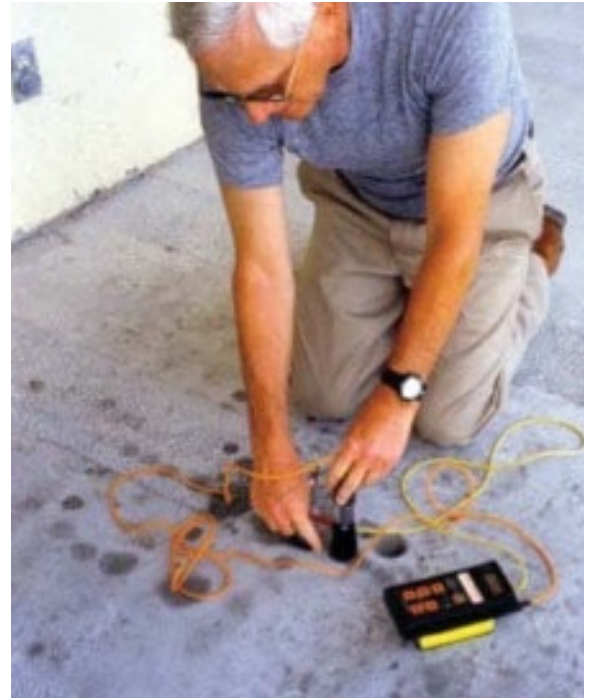
The half-cell was calibrated using a standard electrode and the test areas were dampened with distilled water. The resistance is kilo ohms (kW) and the half-cell potential in milli-volts (mV) were measured and are recorded in **Figure I**. Chloride analysis of drilling dust at 0 to 2 inches is 600 ppm. pH of dust is 7. This is a condition conducive to high level of corrosion. Half-cell measurements show that no corrosion is taking place.

There was a significant decrease in the half-cell potential measurements from 1995. They averaged about +65mV in comparison to an original measurement of -350mV. The resistance measurements in Sections I and III were very low, indicating good conductivity and high chloride and moisture content in the concrete. The **significant drop in half-cell readings and the fact that it went into the positive range shows that a high level of corrosion inhibition was obtained** on the rebar surface due to the penetration and reaction of **TPS II**.

**SURTREAT® TPS II** was applied to balconies at the Windjammer Condominium in 1995. Half-cell tests were run on an area of exposed, corroded rebar. The results gave an average measurement of  $-350\text{mV}$ . Several days after applying **SURTREAT® TPS II** to this area a half-cell reading of  $-250\text{mV}$  was obtained indicating an immediate reduction in corrosion potential. On February 20, 2000, half-cell tests were repeated on this same balcony. Three one-foot square areas on the balcony were exposed by removing a urethane coating. They were identified as areas I, II, III, and are shown in Figure 1 in relationship to the balcony dimensions. A ground attachment was made to a rebar section in the middle of the balcony and five (5) measurements were made at the corners and middle of each exposed area. Area I is the same spot where the half-cell measurements were made in 1995.
