WIMAR PERFORMANCE COATINGS, LLC TEST REPORT

ANSI/FM 4473 IMPACT RESISTANCE TESTING OF CHEMICAL SHINGLE COVERING/ROOF TILES

P6284.01-109-44

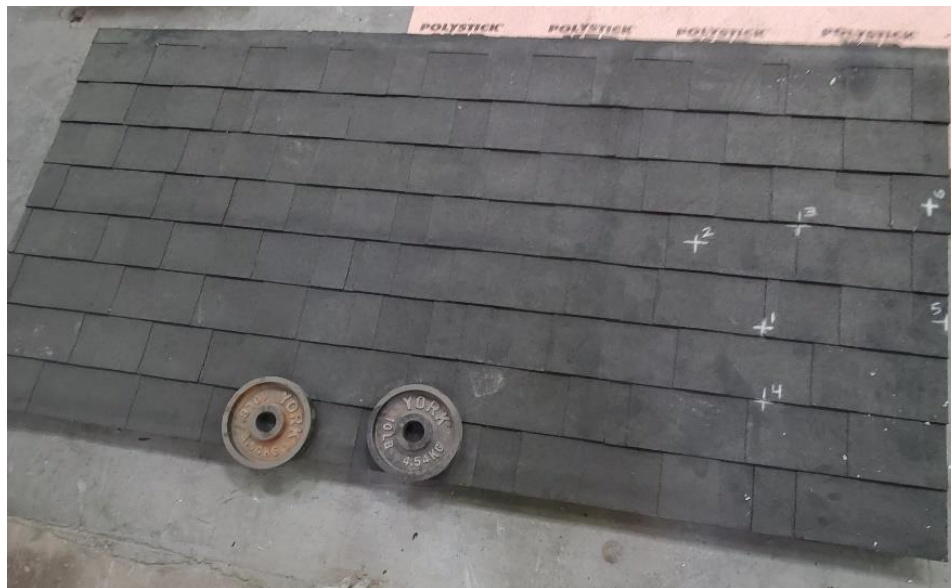
Photo No. 1
Test Deck Prior to testing

The test deck was constructed of an 8' x 4' piece of 3/4" plywood attached to 2 x 4 Spruce-Pine-Fir lumber around the perimeter to represent a supported roof structure. Tri-Flex XT underlayment was attached to the plywood using 1/2" cap staples approximately 5 - 6 inches on center around the perimeter and along the laps. 5" style E galvanized drip edge was utilized around the perimeter. Eight courses of IKO Cambridge Architectural Shingles were used along the test deck and fastened every 6" using 7/8" galvanized coil nails. The test deck was conditioned for 4 hours to set the adhesive strip on shingles. The WIMAR roof coating was applied at a 2 - 4 mil dry coating thickness across the test deck and then conditioned again for 4 hours to allow coating to cure.

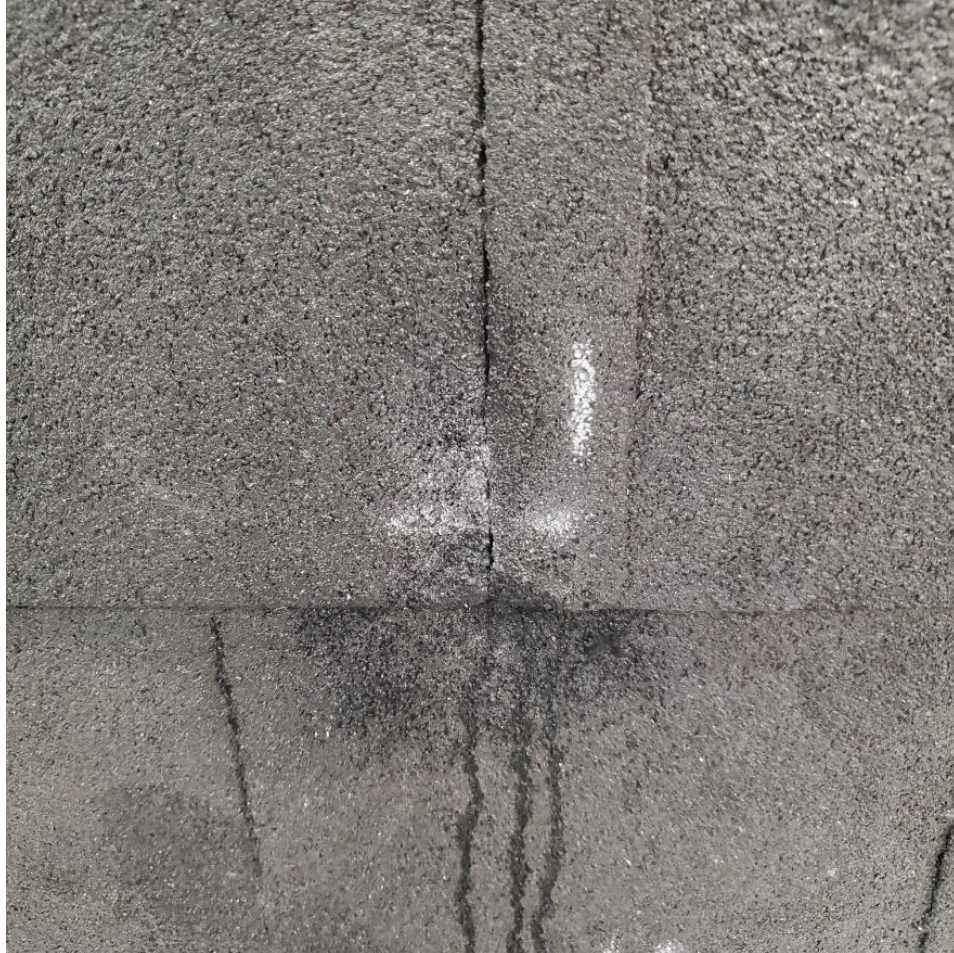
Photo No. 2
Location #1 after Impacts

IMPACT	VELOCITY m/s (fps)	ORIENTATION	MISSILE			IMPACT AREA	OBSERVATIONS	RESULTS
			WEIGHT g (lbs)	DIAMETER mm (in.)	ENERGY ft-lb			
1-1	32.5 (106.5)	15° of vertical	63.5 (0.140)	50.8 (2.0)	24.68	Vertical joint	No visible damage observed	Pass
1-2	32.0 (104.9)	15° of vertical	64.7 (0.143)	50.8 (2.0)	24.40	Vertical joint	Small indentation, no visible breakage or cracking	Pass
2-1	31.8 (104.4)	15° of vertical	63.9 (0.141)	50.8 (2.0)	23.86	Center of shingle	Indentation, no visible breakage or cracking	Pass
2-2	31.9 (104.6)	15° of vertical	67.2 (0.148)	50.8 (2.0)	25.19	Center of shingle	Indentation, no visible breakage or cracking	Pass
3-1	32.1 (105.3)	15° of vertical	68.3 (0.151)	50.8 (2.0)	25.95	Horizontal and vertical joint	No visible damage observed	Pass
3-2	32.3 (105.9)	15° of vertical	64.9 (0.143)	50.8 (2.0)	24.94	Horizontal and vertical joint	Small indentation, no visible breakage or cracking	Pass

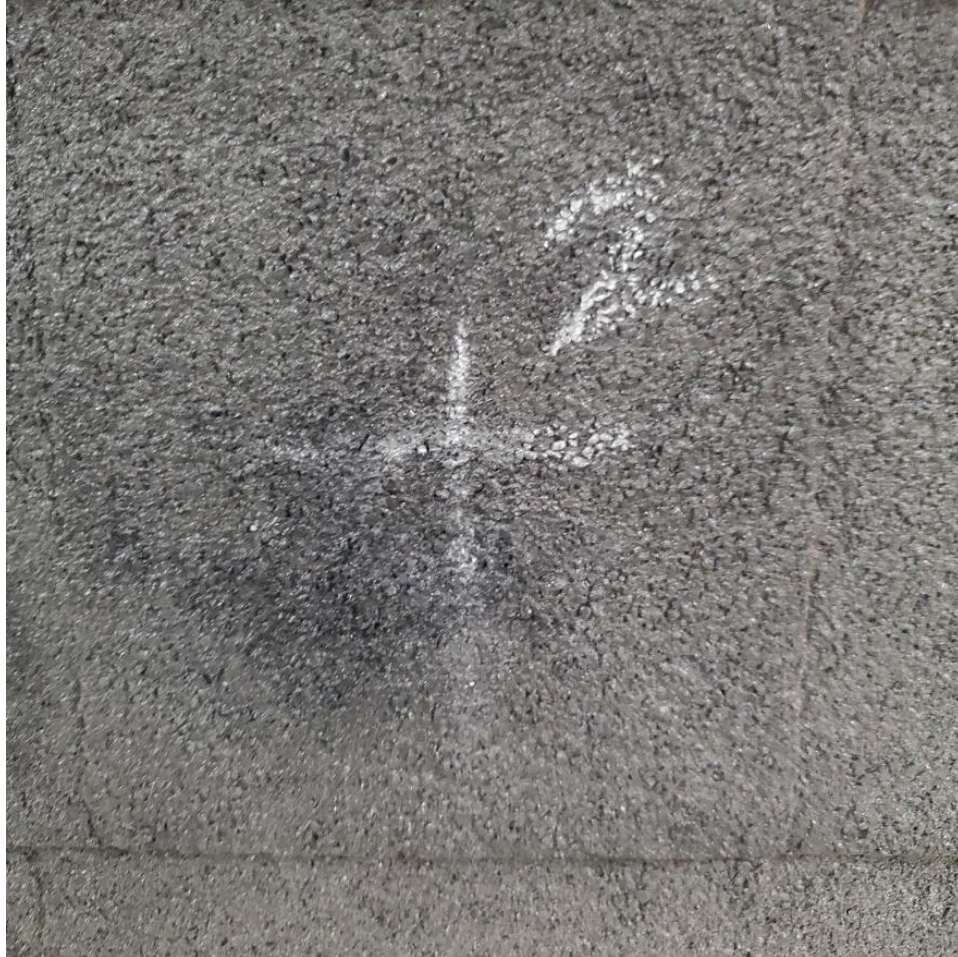
Photo No. 3
Location #2 after Impacts

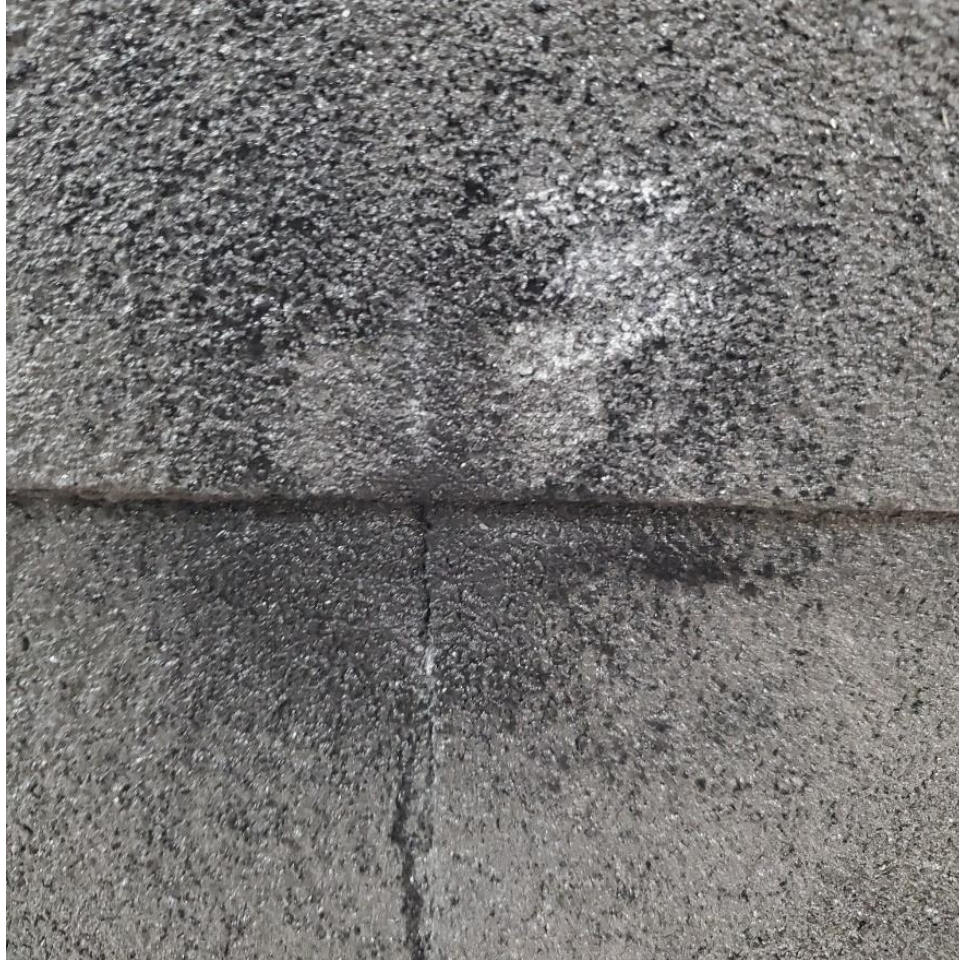
Photo No. 4
Location #3 after Impacts

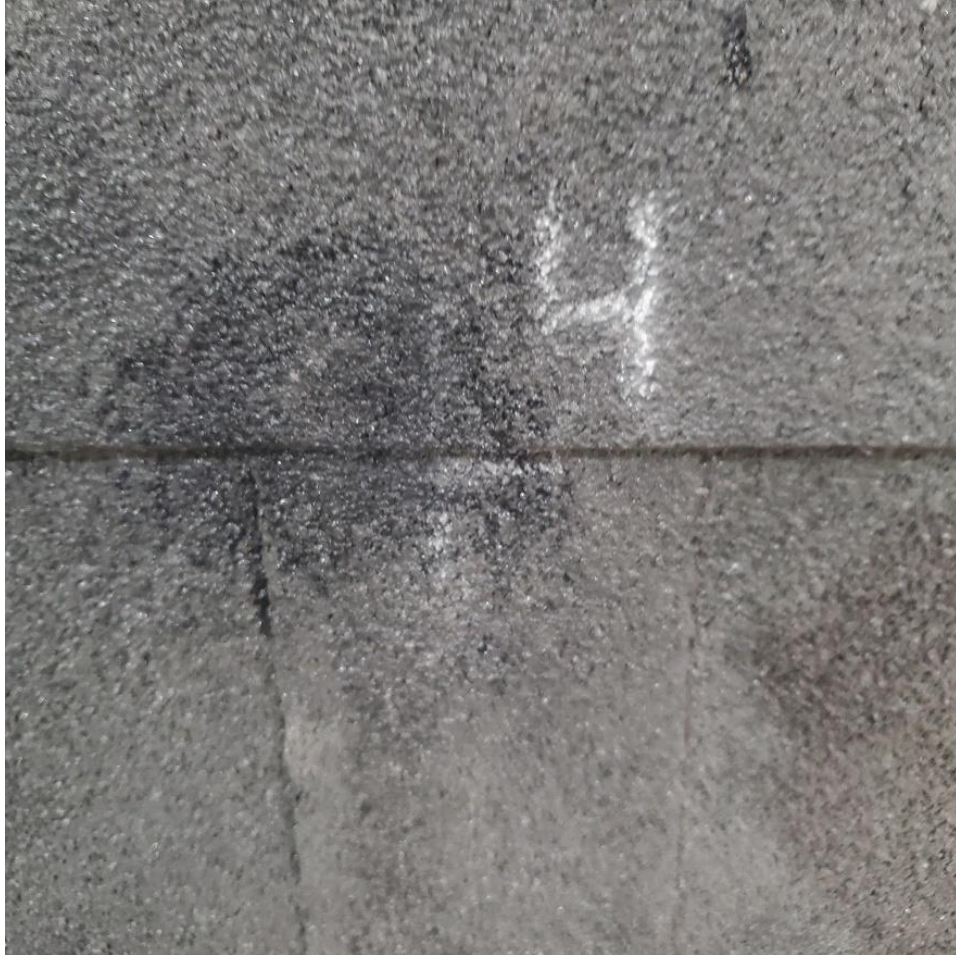
Photo No. 5
Location #4 after Impacts

4-1	32.2 (105.8)	15° of vertical	67.3 (0.148)	50.8 (2.0)	25.81	Horizontal joint	Small indentation, no visible breakage or cracking	Pass

IMPACT	MISSILE					IMPACT AREA	OBSERVATIONS	RESULTS
	VELOCITY m/s (fps)	ORIENTATION	WEIGHT g (lbs)	DIAMETER mm (in.)	ENERGY ft-lb			
4-2	32.0 (104.9)	15° of vertical	65.4 (0.144)	50.8 (2.0)	24.66	Horizontal joint	No further damages observed	Pass
5-1	31.9 (104.7)	15° of vertical	66.8 (0.147)	50.8 (2.0)	25.09	Right edge of the shingle	Small indentation, no visible breakage or cracking	Pass
5-2	32.1 (105.4)	15° of vertical	64.9 (0.143)	50.8 (2.0)	24.70	Right edge of the shingle	Slight cracking on edge, small indentation, no puncture or fracture	Pass
6-1	32.0 (104.9)	15° of vertical	68.1 (0.150)	50.8 (2.0)	25.68	Center of shingle	Small indentation, no visible breakage or cracking	Pass
6-2	32.6 (107.1)	15° of vertical	63.2 (0.139)	50.8 (2.0)	24.84	Center of shingle	Indentation, no visible breakage or cracking	Pass

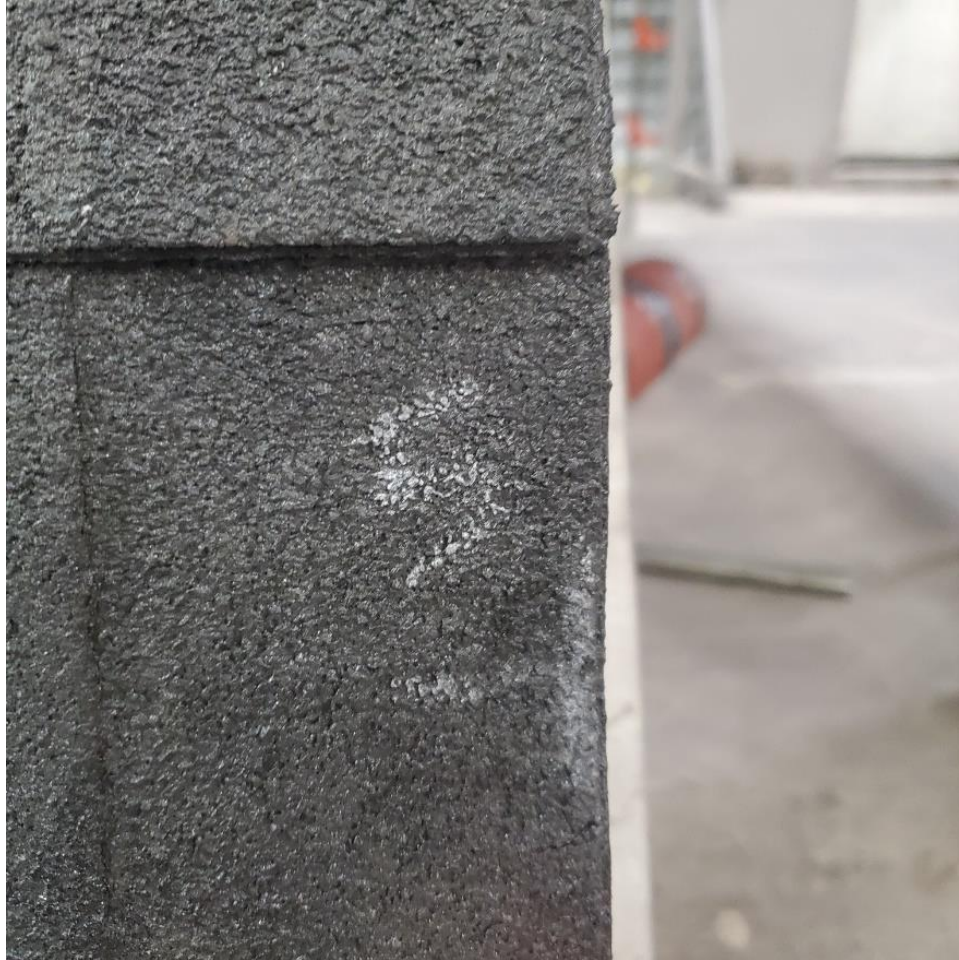
Photo No. 6
Location #5 after Impacts

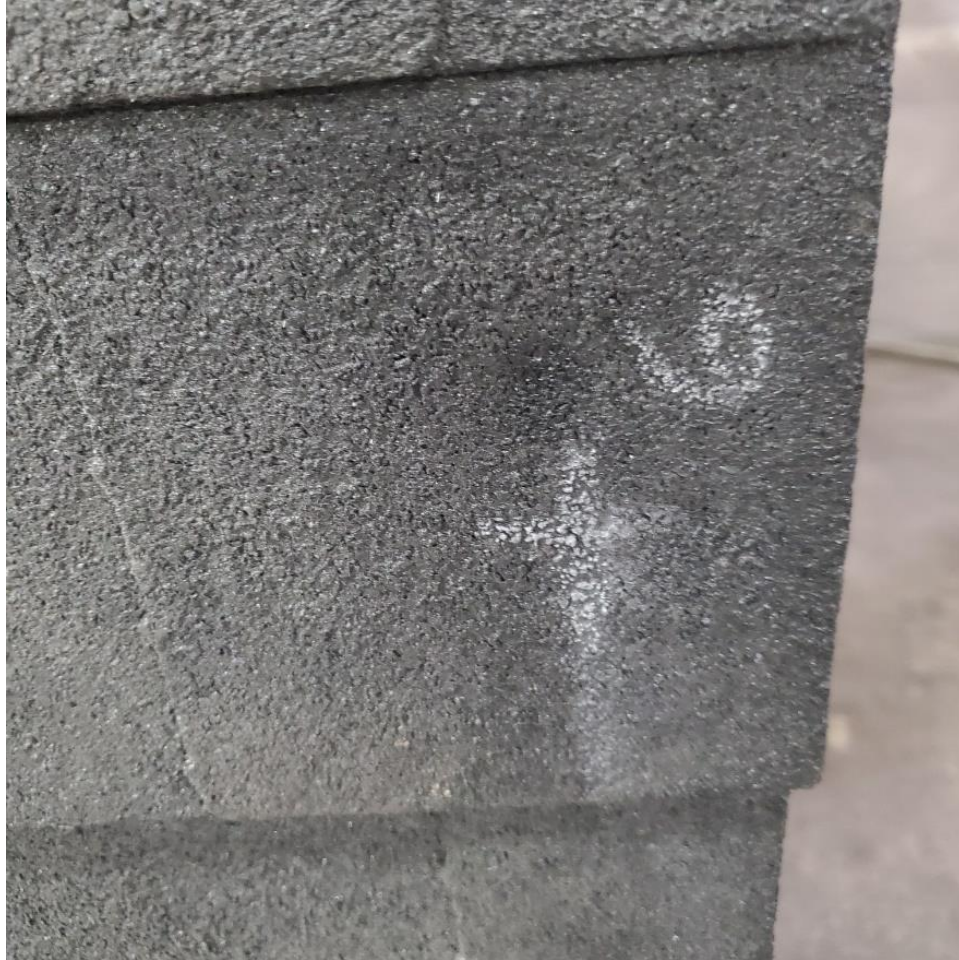
Photo No. 7
Location #6 after Impacts
