Agricultural Waterway Buffer Study
Whatcom County, Washington
2012

Summary

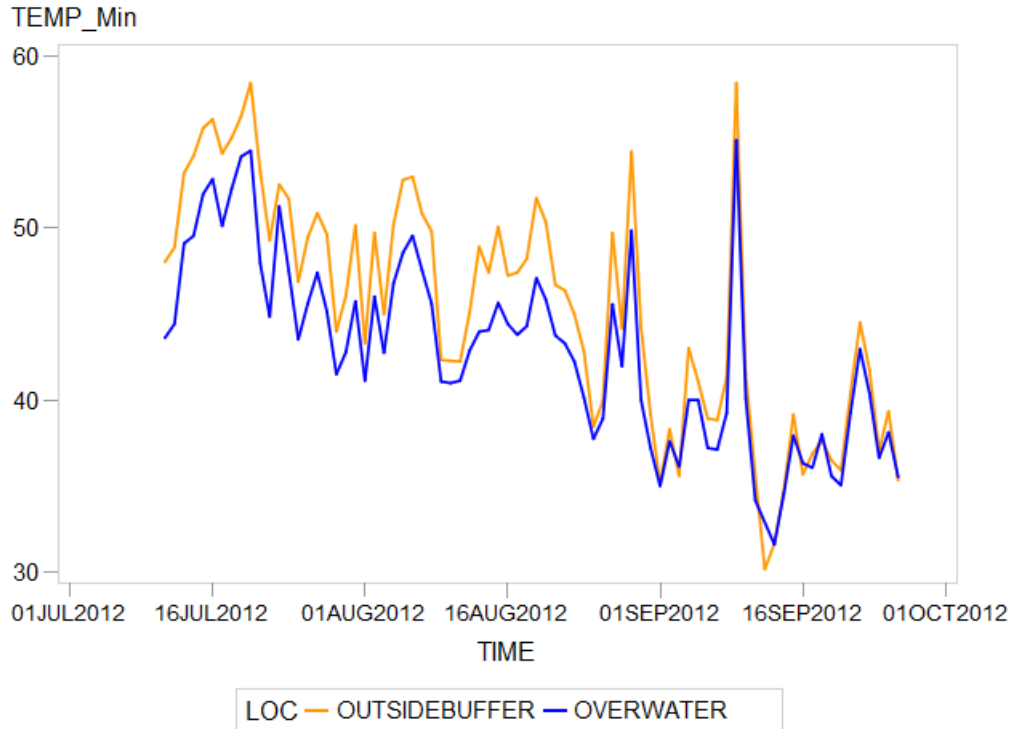
Appendix 7. Average Daily Minimum Temperature in 0' Buffer (Fourmile Creek) by Sensor Location, 2012.

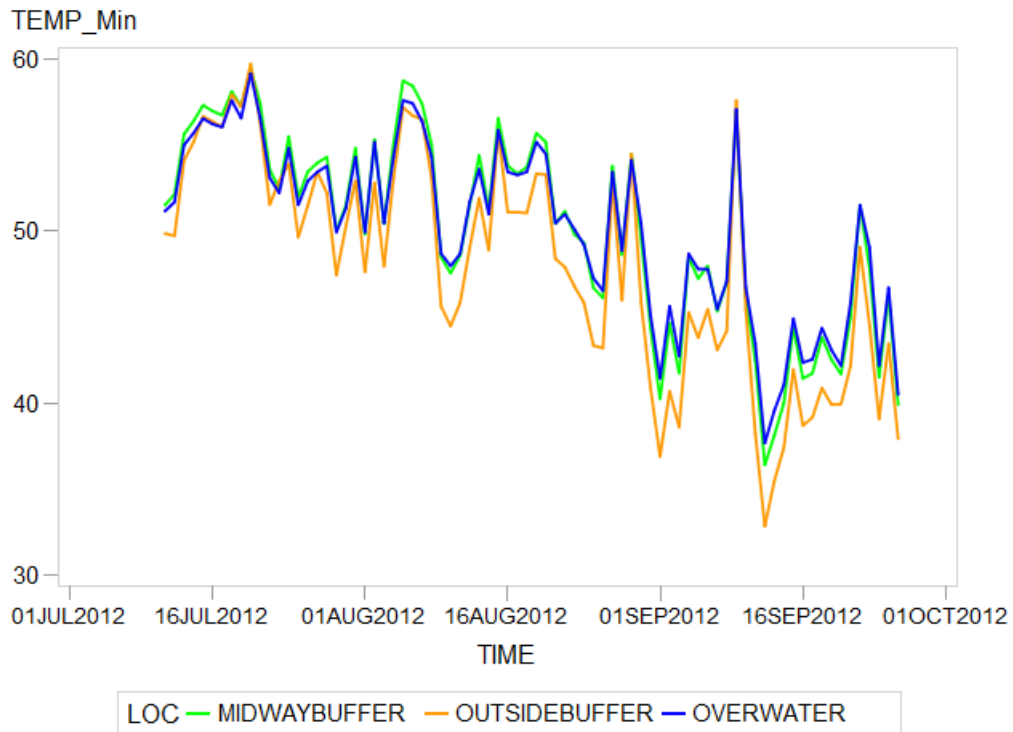
Appendix 13. Average Daily Minimum Temperature in 15' Buffer (Scott Ditch) by Sensor Location, 2012.

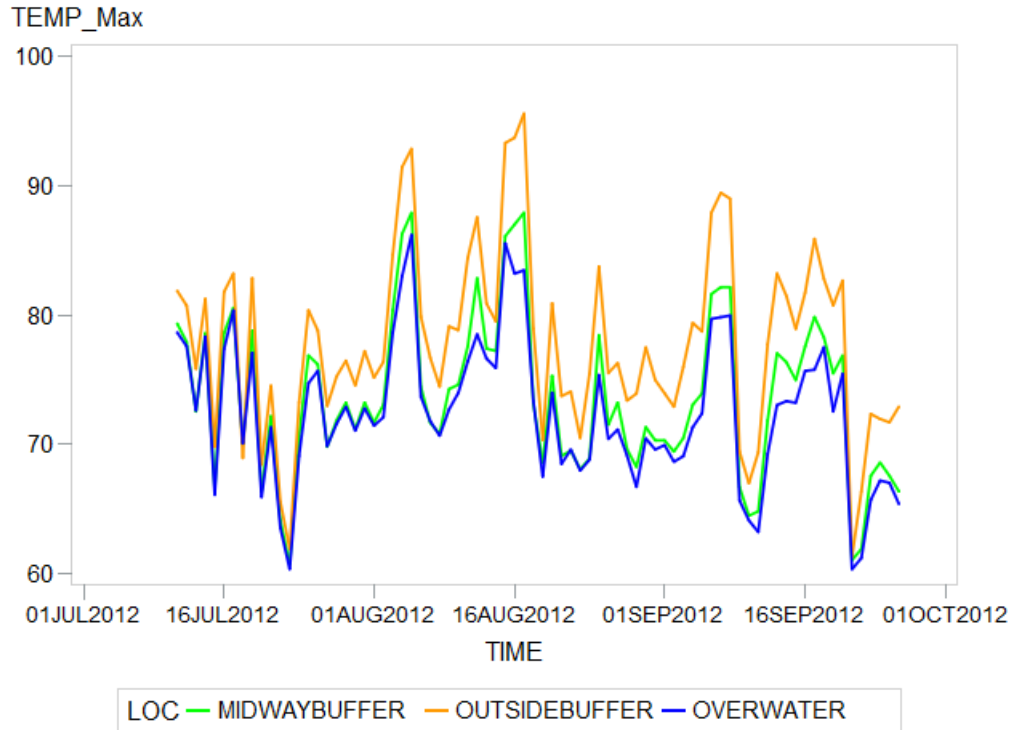
Appendix 18. Average Daily Maximum Temperature in 180' Buffer (Scott Ditch) by Sensor Location, 2012.

In the 180' buffer, average and minimum temperatures showed no significant difference when sensor location was compared, but maximum temperatures were significantly higher outside of the buffer as compared to inside.

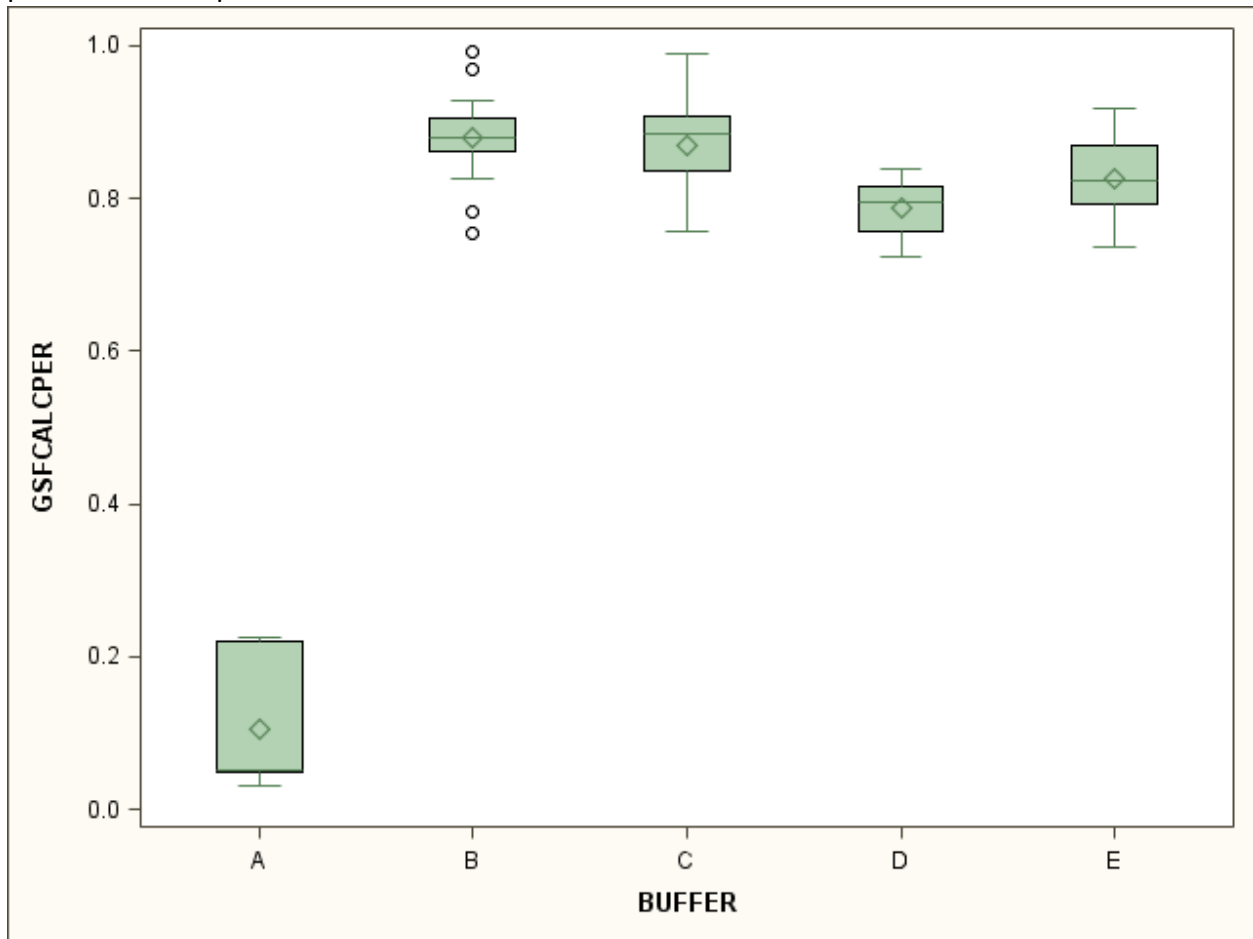
Appendix 21. Calculated effective shade (%) of different agricultural waterway buffers¹ from photos taken September 2012.

¹A = No planted buffer, B = 5' planted buffer, C = 15' planted buffer, D = 35' planted buffer, E = 180' planted buffer.

Effective shade was calculated by analyzing hemispherical photographs using HemiView[®] software. Photographs were taken on two dates in September and results are included in [Table 8](#). Values were combined across dates. The no (0') buffer had the lowest effective shade percentages ranging from 3-22%. The remaining buffers all had effective shade percentages above 72% and ranked in numerical order (mean percentage): 76% (35' buffer), 80% (180 buffer), 87% (5' buffer), and 88% (15' buffer). Box and whiskers plots (mean, quartiles, and min/max) are included in the appendix ([Appendix 21](#)). Examples of hemispherical photos can be found in [Appendix 22-26](#).

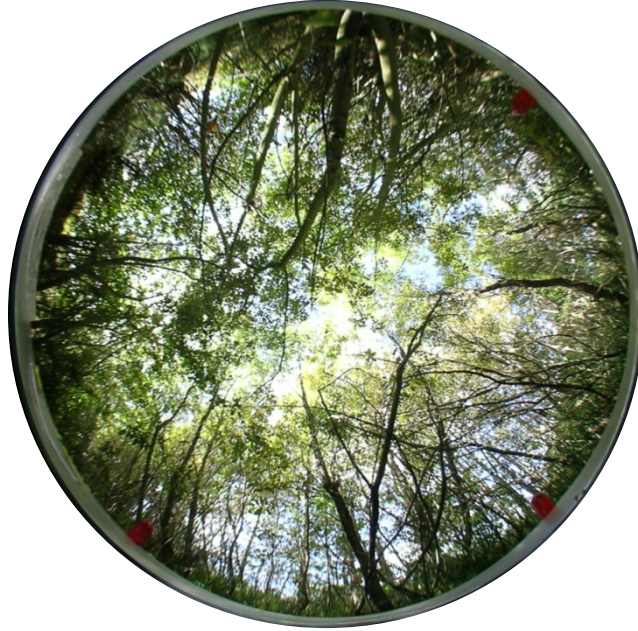
Appendix 22. Sample hemispherical Photo from 35' buffer, calculated effective shade of 76%.

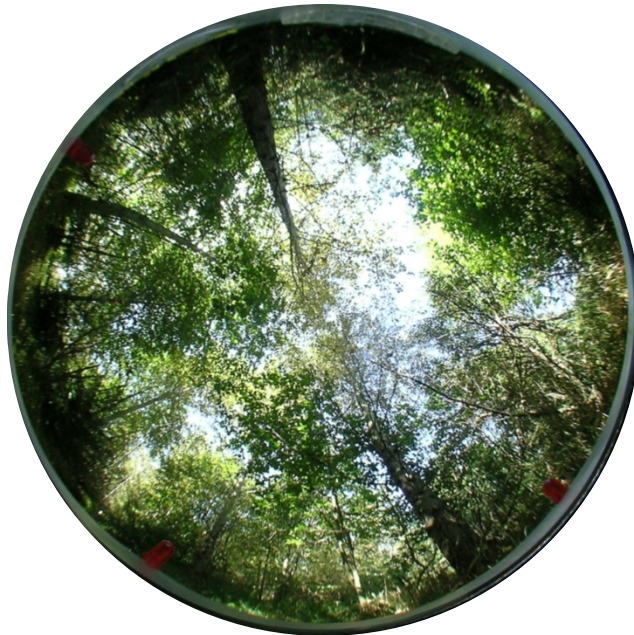
Appendix 23. Sample hemispherical Photo from 180' buffer, calculated effective shade of 79%.

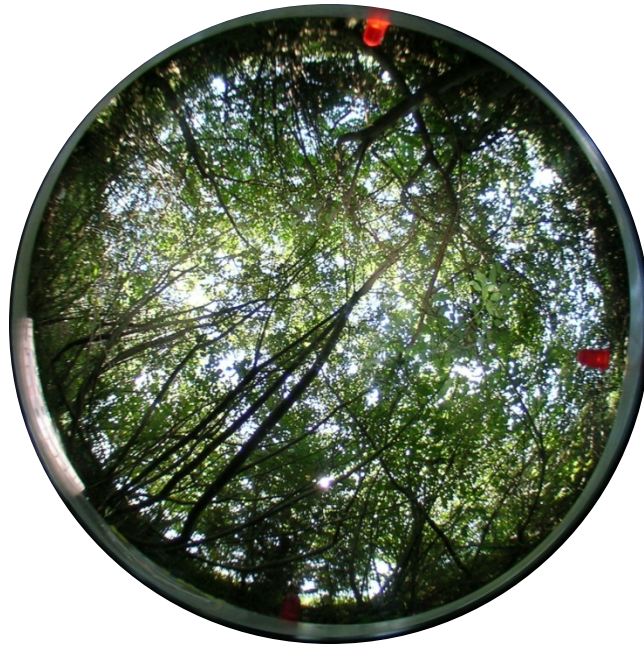
Appendix 24. Sample hemispherical Photo from 15' buffer, calculated effective shade of 89%.

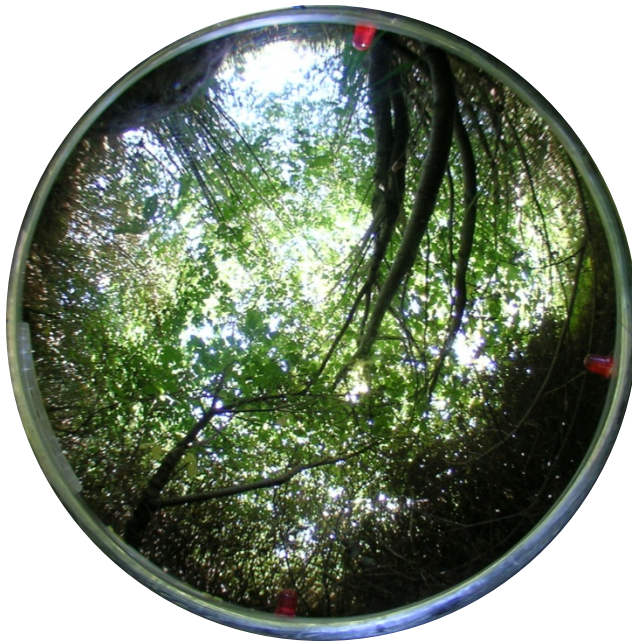
Appendix 25. Sample hemispherical Photo from 5' buffer, calculated effective shade of 90%.

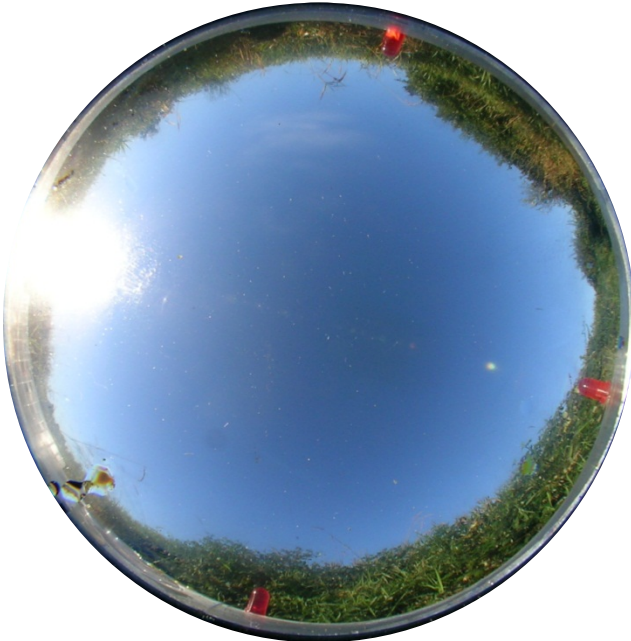
Appendix 26. Sample hemispherical Photo from 0' buffer, calculated effective shade of 3%.

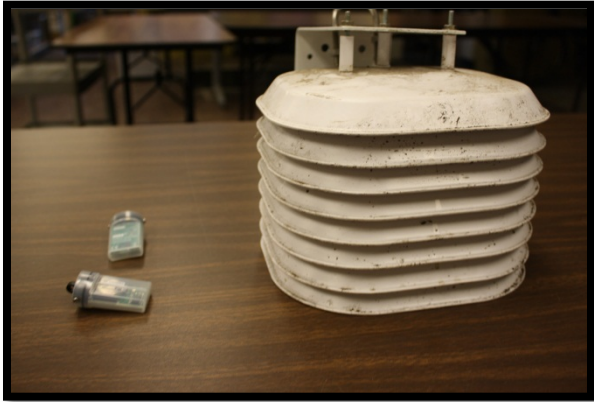
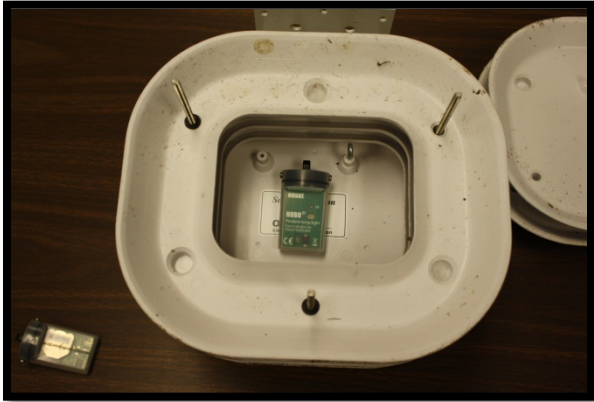
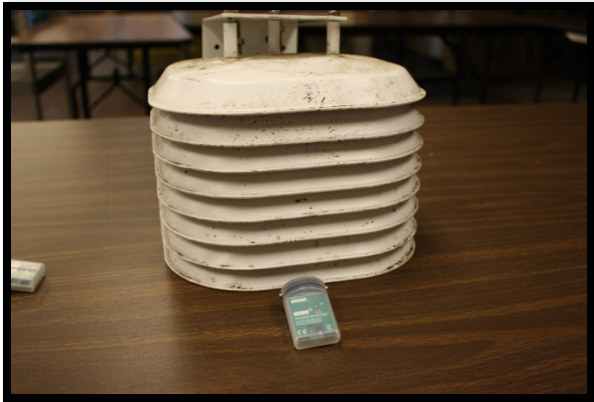
Appendix 27. Photographs of sensor and sensor housing.

In this study only air temperature was recorded, water temperature was not included because of available resources. Temperature logging stations were set up by 10 July 2012 and ended on 27 September 2012 for all sites. Temperature data was collected along three transects at each buffer site consisting of three logging stations. Each logging station consisted of one Hobo

Pendant ([Onset® Computer Corporation, Pocasset, MA](#)) temperature logger suspended within a solar radiation shield ([Appendix 27](#)). The stations were staked into the ground on posts three feet above the ground. For each transect; one logging station was placed outside the buffer in an un-shaded area, a second was placed mid-way between the furthest edge of the buffer and the center of the channel, and a third was suspended over the water channel. Data was recorded in 5-minute intervals, uploaded from the data loggers at 30-day intervals, and checked for battery longevity once a month. To evaluate the impact of buffer width on air temperature, data from sensors was compared between (sensor) location within a given buffer width across the replications (5' buffer: outside vs. mid-way vs. overwater). Daily maximum, minimum, and average temperature was calculated and then compared using PROC GLM (SAS, 2002) within each buffer but across sensor location. Before applying the model exploratory data analysis tools were used to describe data variability (e.g. portray data to identify outliers, extreme values, mode, correlation, and test for normal distribution and equal variance).
