Effects of Canarygrass on Dissolved Oxygen and Fish in Chimacum Creek

March 15, 2024

**Prepared by
Glenn Gately**

**Jefferson County Conservation District
205 W. Patison St.
Port Hadlock, WA 98339**

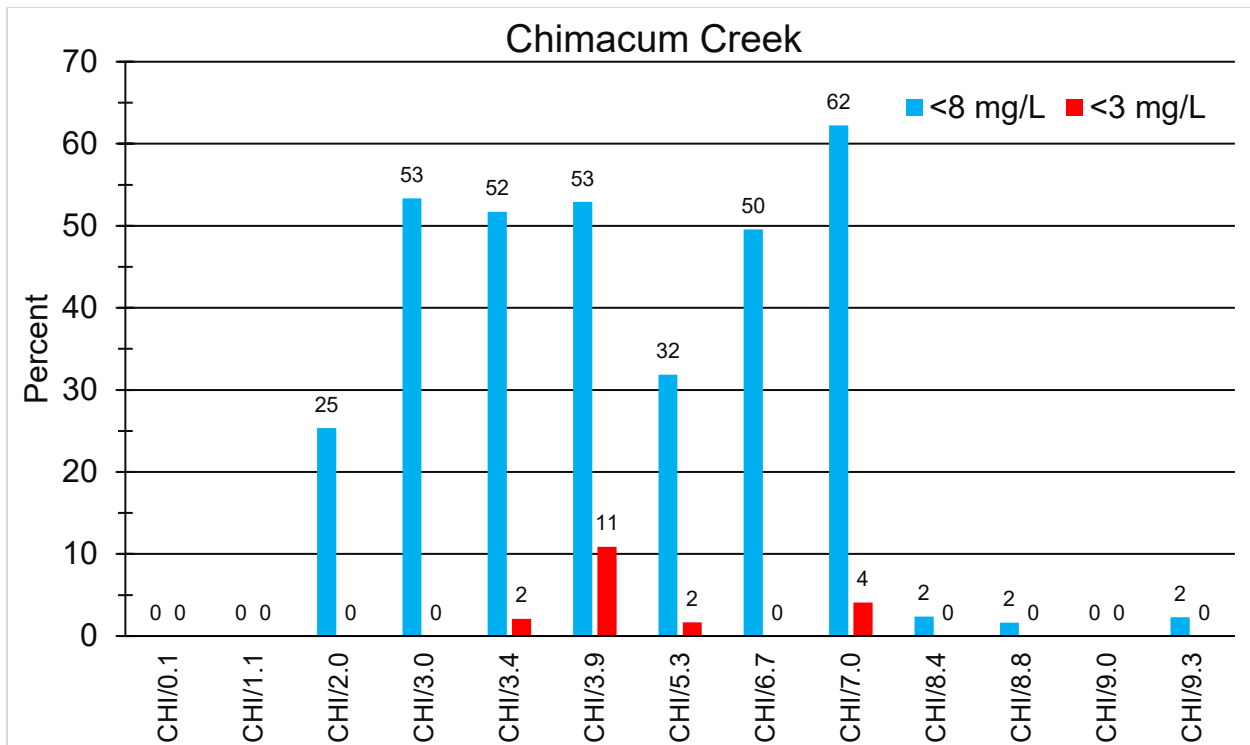
Figure 1. Percentage of dissolved oxygen measurements below 8 mg/L and 3 mg/L from 1995 to November 2023 in Chimacum Creek (top) and East Chimacum Creek (bottom). Salmonid production is impaired at dissolved oxygen levels below 8 mg/L and mortality can occur below 3 md/L.

Chimacum Creek, home to coho salmon, chum salmon, steelhead, and cutthroat trout, has been monitored for dissolved oxygen by Jefferson County Conservation District since 1995. Based on EPA's impairment levels, impairment has occurred in a substantial part of Chimacum Creek. Figure 1 shows the percentage of dissolved oxygen measurements that were below the 8 mg/L impairment level for the stations monitored from 1995 to 2023. Most of the impairment occurred between RM 2.0 and RM 7.0 (Figure 2). Dissolved oxygen levels were sometimes below the 3 mg/L acute mortality level within this reach.

Dissolved oxygen measurements on East Chimacum Creek showed some impairment occurring over almost the entire creek, but mostly between RM 0.4 and RM 2.8 (Figures 1 and 2). Dissolved oxygen levels were sometimes below the 3 mg/L acute mortality level within this reach.

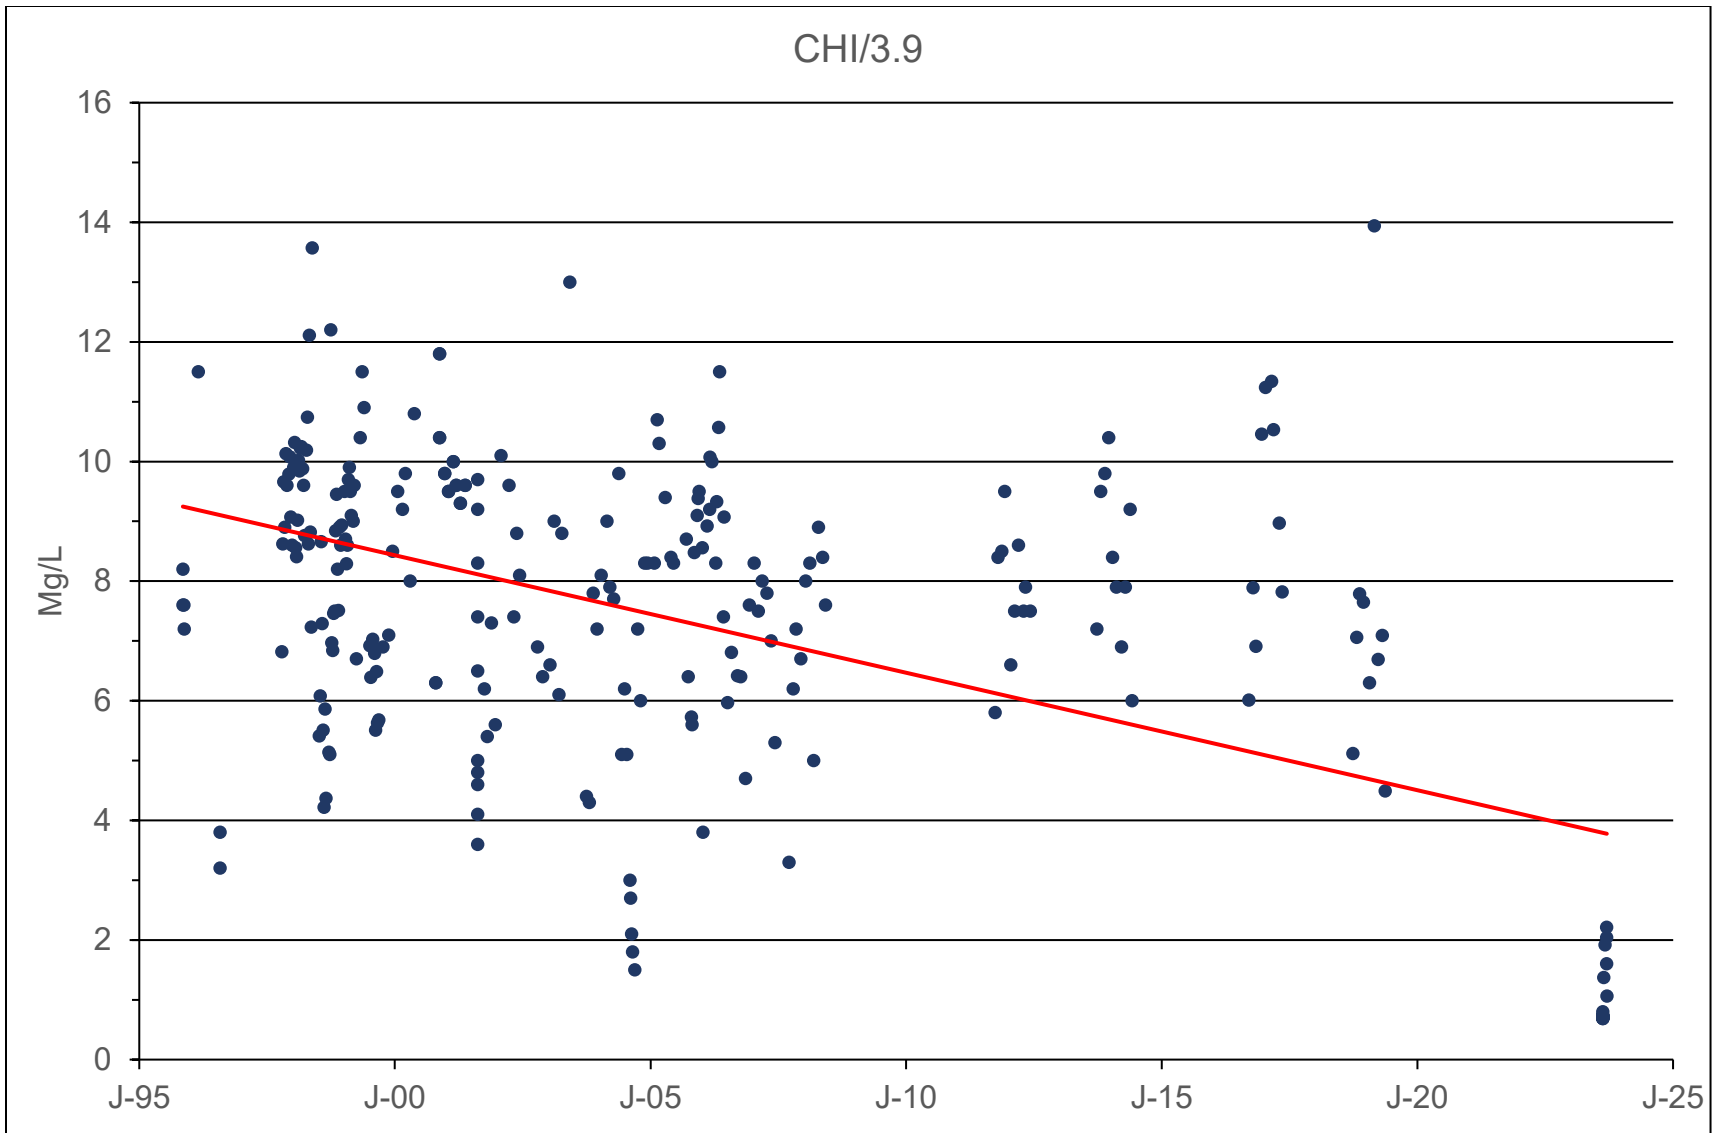
Figure 3. Dissolved oxygen concentrations with trend line at station CHI/3.9 on Chimacum Creek from 1995 to 2023.

Trend analysis was conducted on dissolved oxygen levels at three stations (CHI/3.9, CHI/5.3, and ECH/1.0) within the low dissolved oxygen reaches. All exhibited downward trends (Figures 3, 4, and 5).

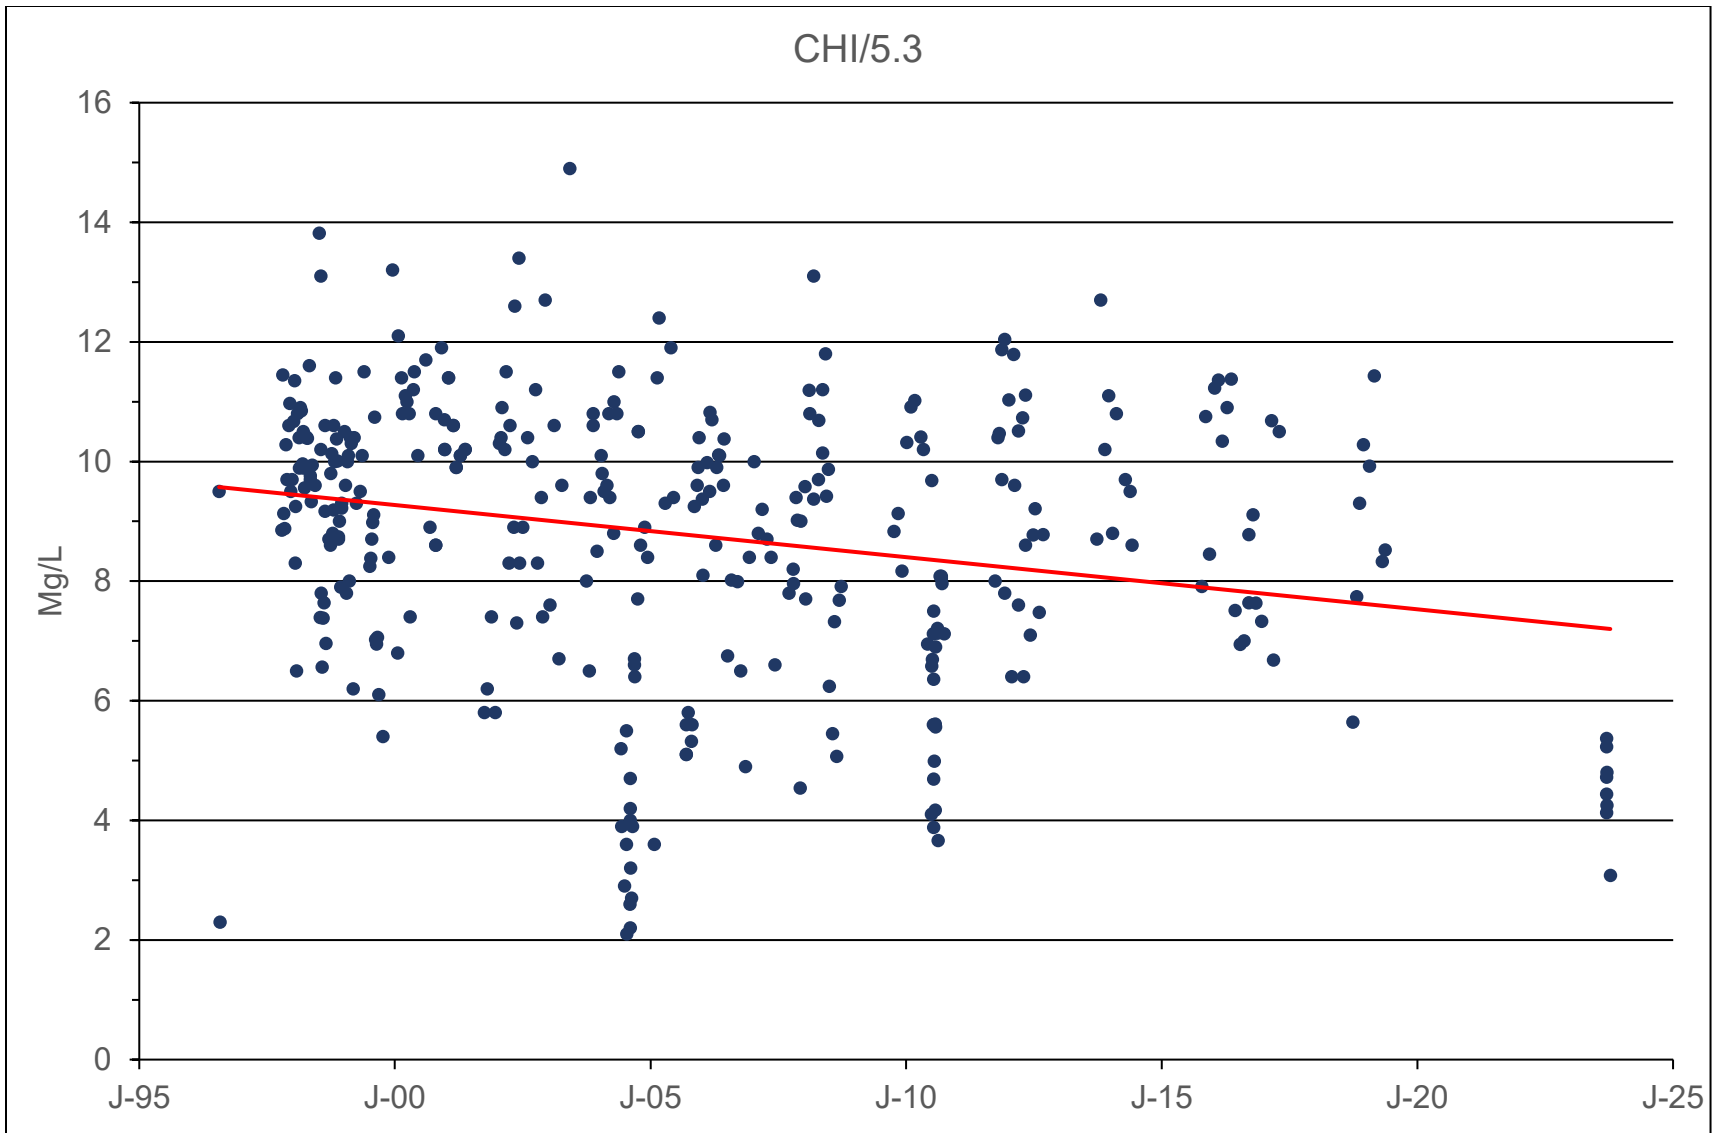
Figure 4. Dissolved oxygen concentrations with trend line at station CHI/5.3 on Chimacum Creek from 1996 to 2023.

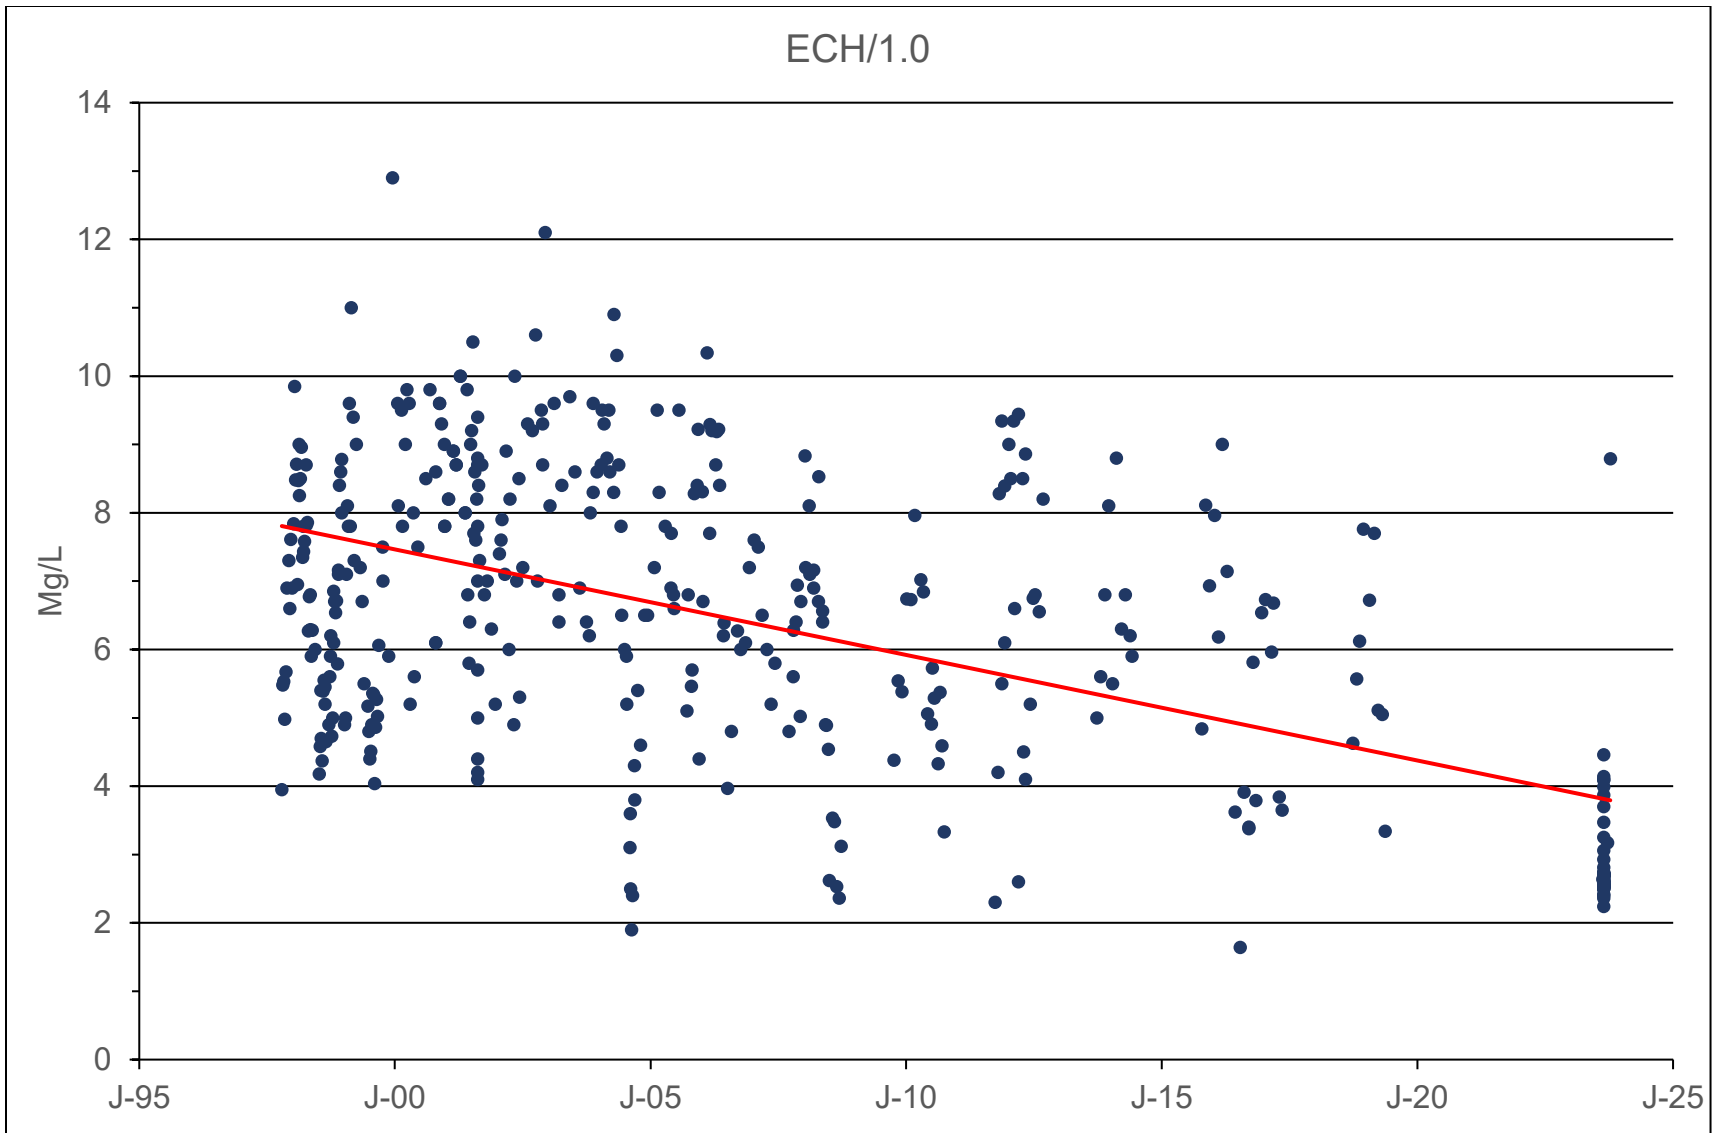
Figure 5. Dissolved oxygen concentrations with trend line at station ECH/1.0 on East Chimacum Creek from 1997 to 2023.

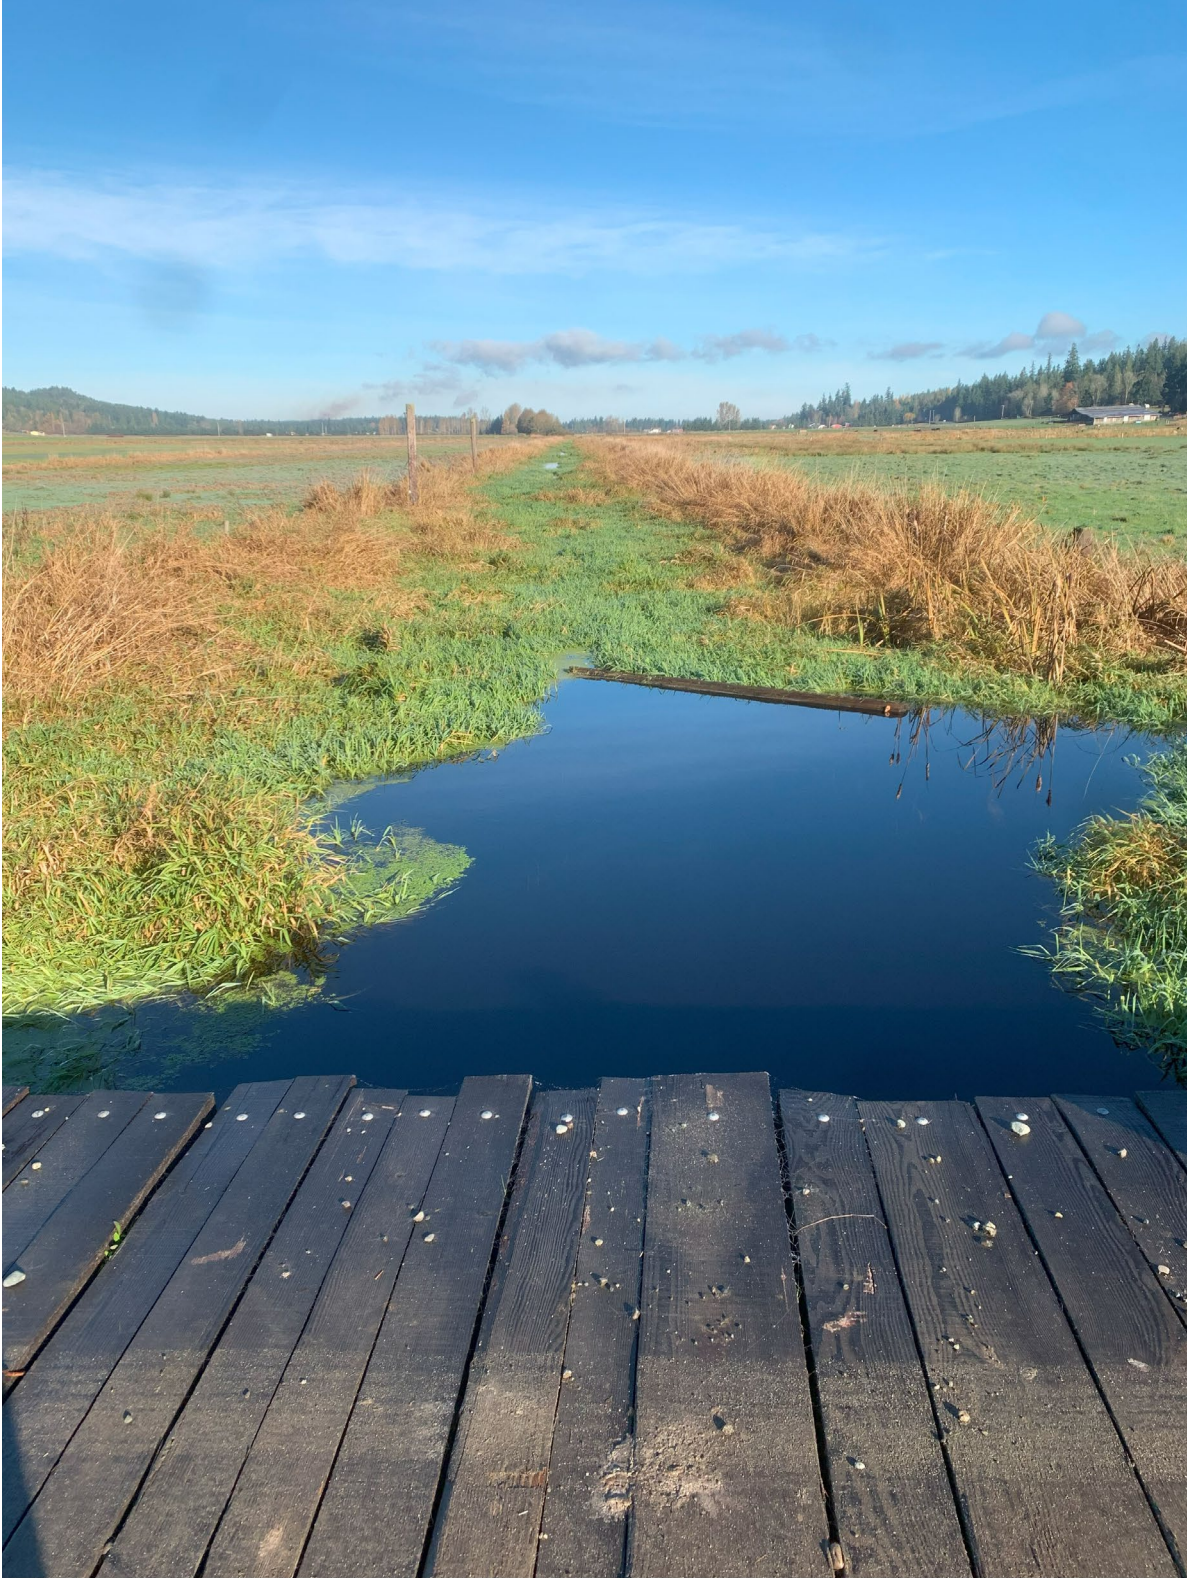
Figure 6. Photo taken from station CHI/5.3 on November 14, 2023, looking downstream. Station CHI/3.9 is 1.4 miles downstream and much of the channel between the two stations is choked with canary grass.

In August 2023, canarygrass was growing bank-to-bank in much of Chimacum Creek (Figures 6 and 7). Dissolved oxygen levels at station CHI/3.9 remained at a constant 0.7 mg/L from morning to mid-afternoon (Figure 9). At station ECH/1.0 on East Chimacum Creek, dissolved oxygen remained between 2.3 mg/L and 2.7 mg/L throughout the day. In contrast, in 2001, levels increased at both stations from about 4 mg/L to over 9 mg/L (Figure 9). Salmonids may survive low dissolved oxygen levels for brief periods but are not expected to survive at levels below 3 mg/L for extended periods.

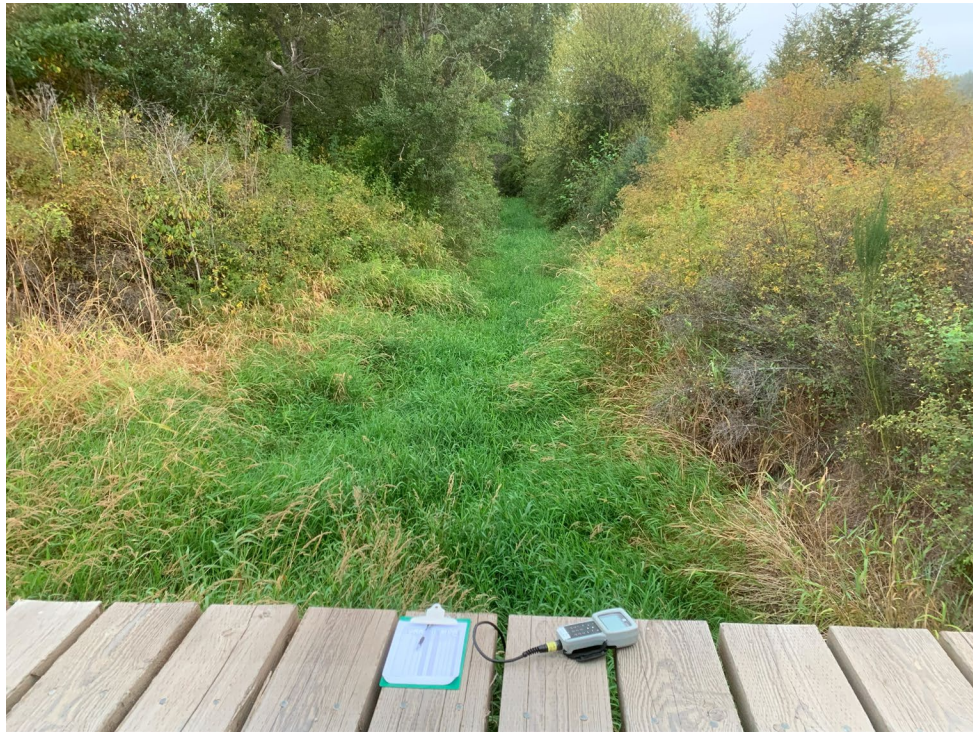
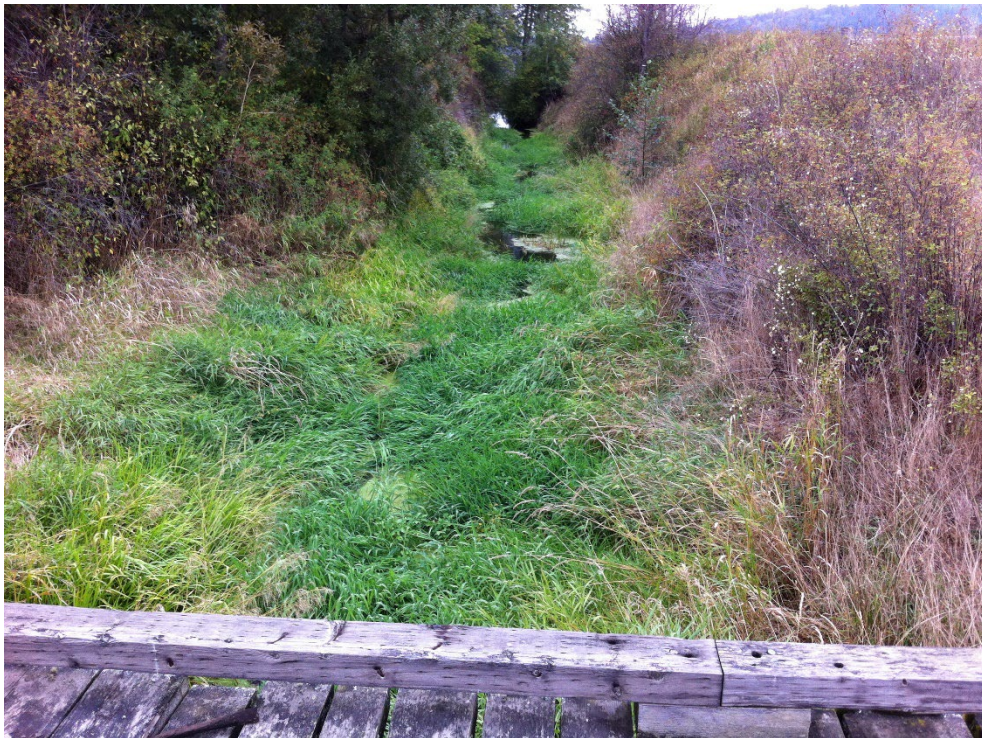
Figure 7. Photos looking downstream from station CHI/3.9 on November 14, 2023 (top) and September 18, 2014 (bottom).

Canarygrass removed in 2020 was back in 2023 and looking the same as it did in 2014. This cycle of removal and return has been reoccurring for decades.

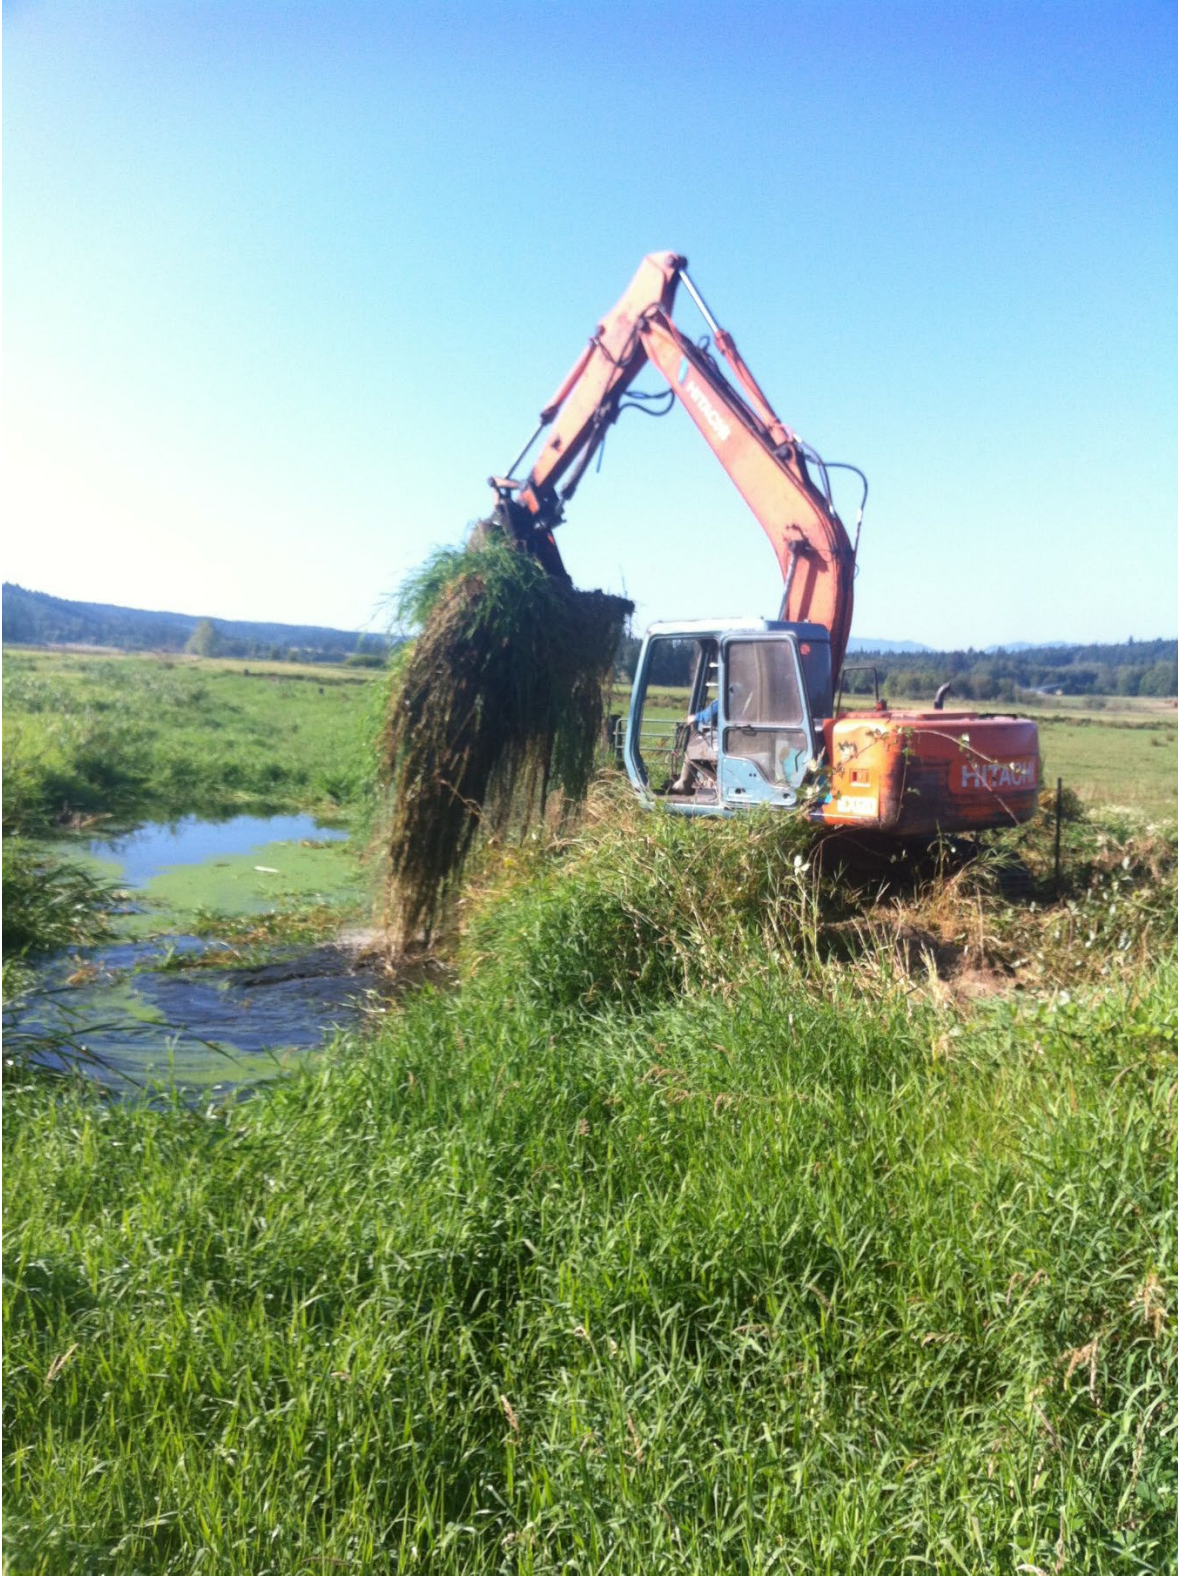
Figure 8. Photo of an excavator with a rake attachment removing canary grass from Chimacum Creek on August 14, 2020.

When plants die, they are decomposed by bacteria, fungi, and macroinvertebrates (e.g. mayflies and caddisflies). In the decomposition process, oxygen is removed from the water. The greater the biomass of decomposition material, the greater is the amount of oxygen removed. Undoubtedly, canarygrass is at the top of the list in terms of plant biomass in Chimacum and East Chimacum creeks. Its bank-to-bank growth pattern, its abundant stems, leaves, and rhizomes make for a lot of biomass (see Figure 8).

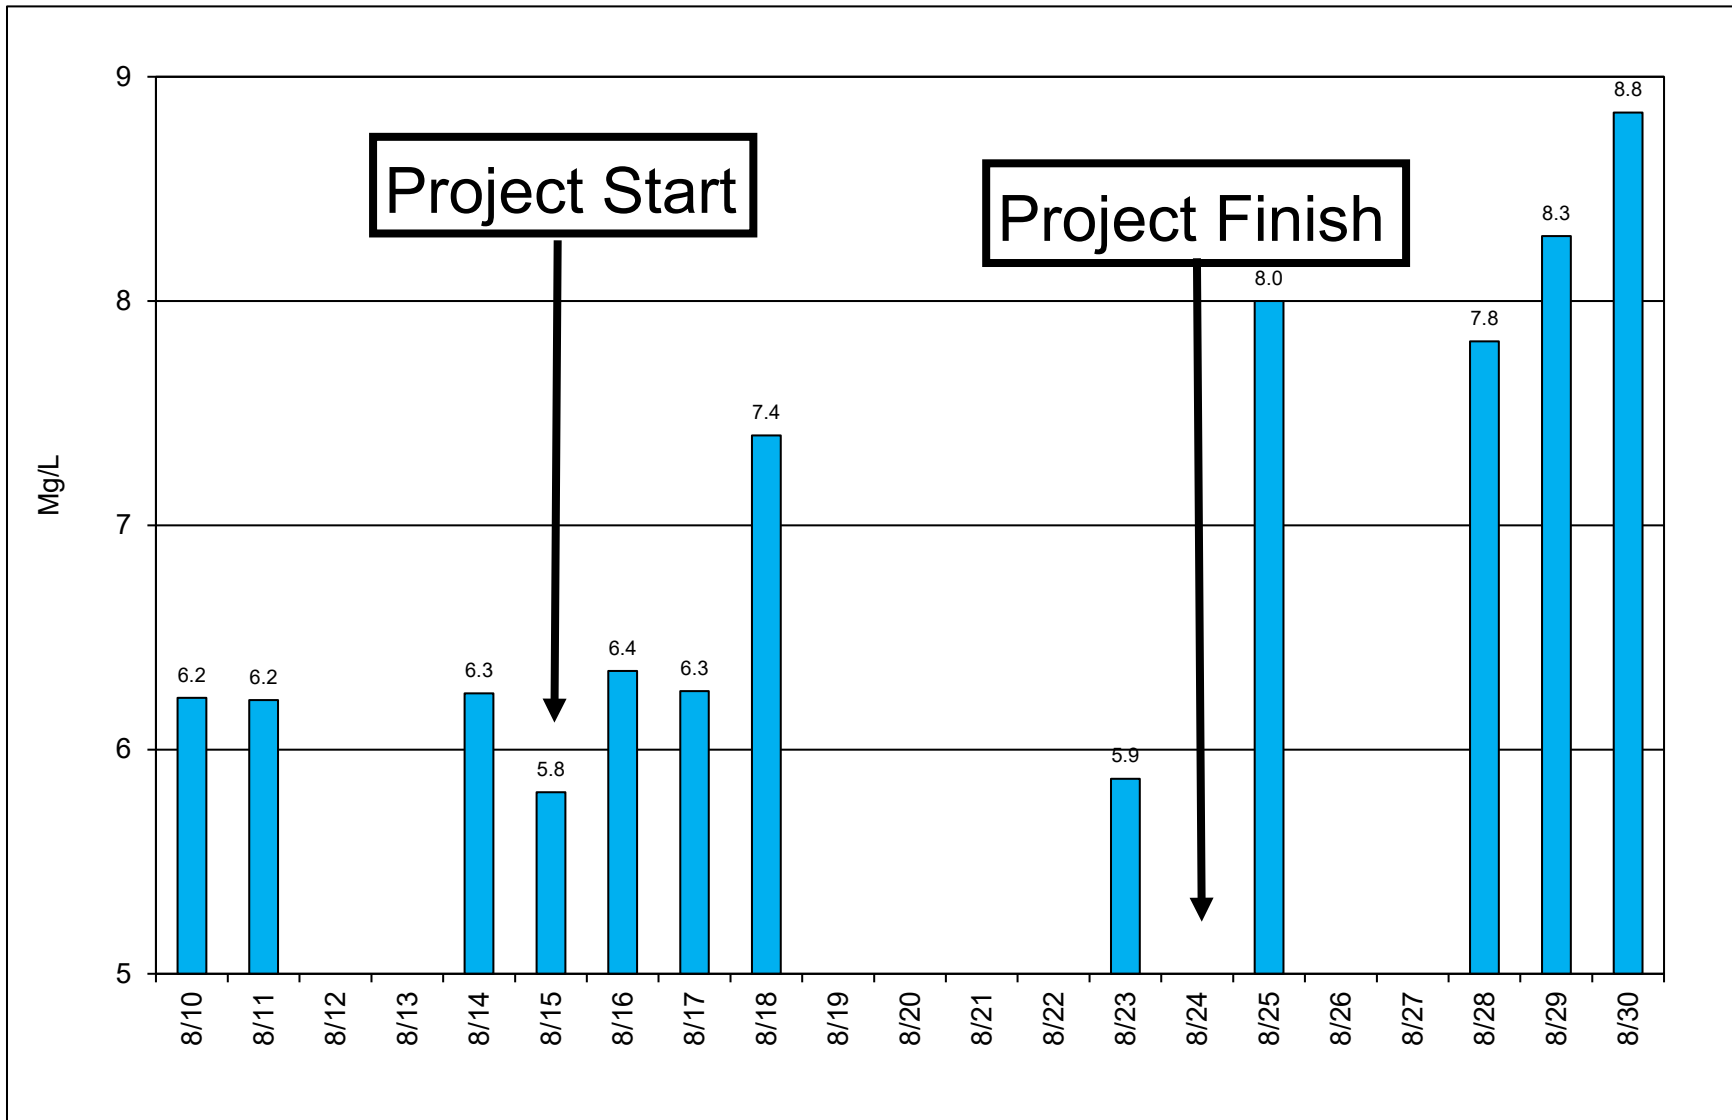
Figure 10. Dissolved oxygen levels monitored from August 10 to August 30, 2006 between 10:40 AM and 11:48 AM at station CHI/7.5 on Chimacum Creek. Canary grass and European bittersweet were removed from a half-mile section of channel (RM 7.5 – RM 8.0) from August 15 to August 24.

The removal of canarygrass can cause an immediate increase in dissolved oxygen. This was demonstrated in August 2006 when a one-half mile reach of Chimacum Creek (RM 7.5 – RM 8.0) was cleared of canarygrass and European bittersweet (Figure 10). European bittersweet is a vine that grows along the stream bank and extends over the stream when it has something to cling to. Like canarygrass, it decomposes in the

stream. Dissolved oxygen was measured at station CHI/7.5 at the downstream end of the reach on a regular basis at about 11:00 AM from August 10 to August 30. Canarygrass and European bittersweet were removed by an excavator fitted with a rake attachment from August 15 to August 24. Prior to the start of the project, dissolved oxygen ranged from 6.2 mg/L to 6.3 mg/L. After the plants were removed, dissolved oxygen increased to a range of 7.8 mg/L to 8.8 mg/L.
