A Secret Castle in the Usk Valley

David Morgan

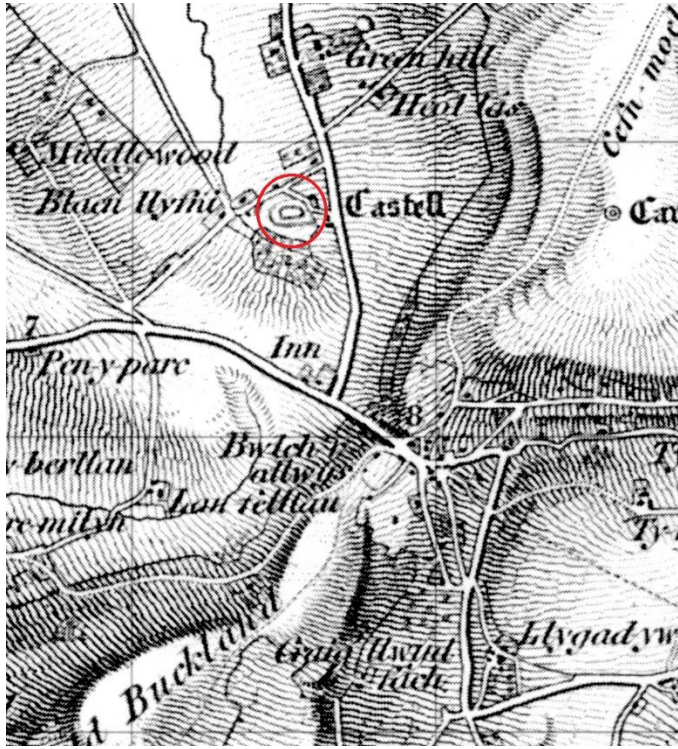
The Ordnance Survey 1st Edition map 1830 -33 showing the castle, ringed in red

The castle is to the north of the main road through Bwlch, now the A40(T), and just west of the road from Bwlch to Llangorse . It sits on a roughly rectangular artificial

earthwork about 120metres across at its widest extent, made up of material thrown up from the surrounding ditch.
