Lake Monroe Watershed Management Plan

Maggie Sullivan
February 23, 2022

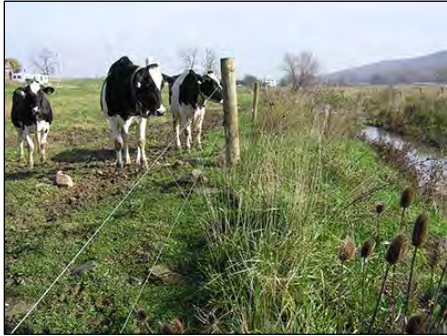
Livestock are one potential source of nutrients and bacteria. This source can be addressed by increasing the use of conservation practices like fencing livestock out of streams (as shown in photo to the left), installing heavy use area protection, and improving manure management. Streams can be further protected by planting pollinator habitat or trees along streams to create a riparian buffer that filters runoff before it reaches the stream and helps stabilize the stream banks.

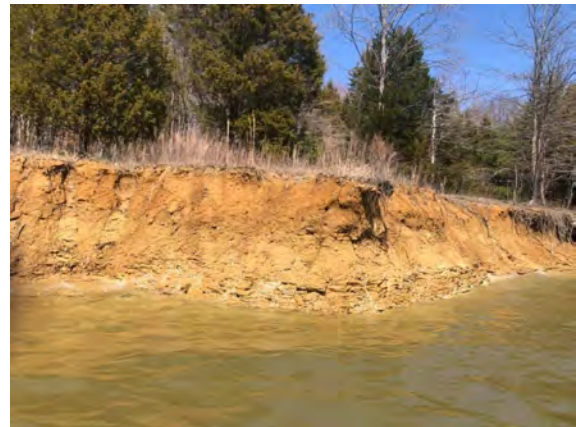
Figure 2-6 Lakeshore Erosion Along Lake Monroe (photo courtesy of Cathy Meyer)

Many community members also expressed concerns about lakeshore erosion as a sediment source and an eyesore. Significant erosion is visible along several stretches of Lake Monroe's shoreline, particularly when water levels are low. Though it is difficult to quantify, shoreline erosion may be a significant source of sediment in the lake. Shoreline erosion is exacerbated by fluctuations in water level due to management of the reservoir for flood control. When water levels are elevated for an extended period of time, the soil becomes saturated and can slough off in large chunks.

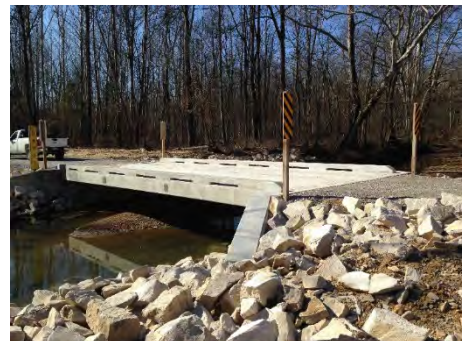
*Figure 2-8 Windshield Site 905
County Road 1200N at Negro
Creek in Hoosier National Forest*

Along South Fork Salt Creek, several roads north and west of Kurtz were identified as flooding regularly, including portions of Pike Road and Cornett Road. Several smaller stream crossings in Hoosier National Forest have been updated to improve both hydrologic flow and stream biology. These crossings were designed so aquatic wildlife could move easily upstream and downstream while also permitting larger stream flows without road flooding.

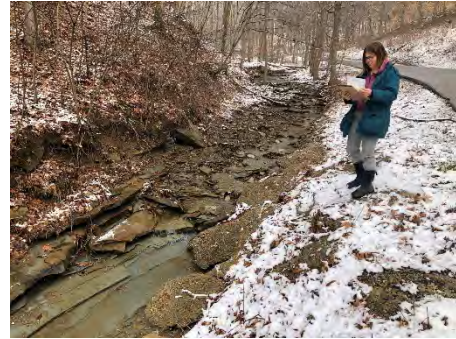
Figure 3-5 Recording observations at a stream site.
