# EVALUATION OF DIFFERENT METHODOLOGIES TO MANAGE SOIL EROSION.

Research Topic 1: **Site Selection Layout and Drainage**

Research Topic 5: **Management Erosion and Sedimentation**

Trial number: SA01WB-02 and SA05WB-02

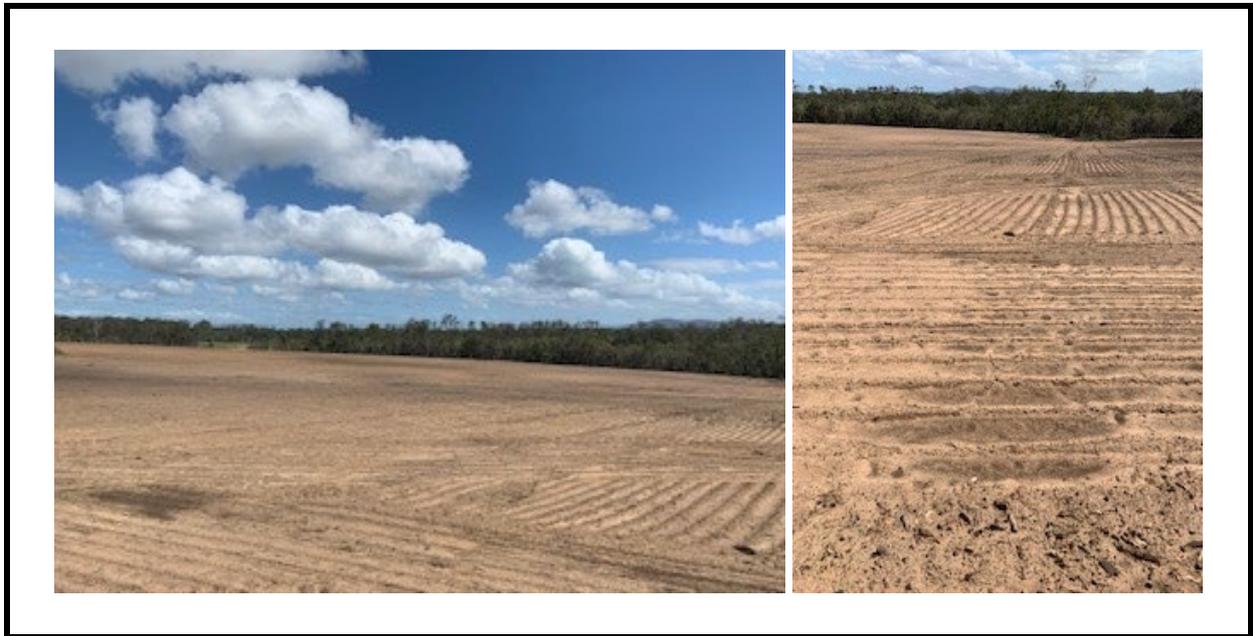
The total demonstration site is 3.5 ha consisting three different block layouts draining directly into three outfield drains. The total site was planted with smooth cayenne on a sandy loam soil type to a depth of 0.3 to 0.4 m with a heavy clay subsoil. The site is a westerly facing aspect with a varying 0.5 to 1.5% slope.

*Figure 1: trial site - prior to treatments*

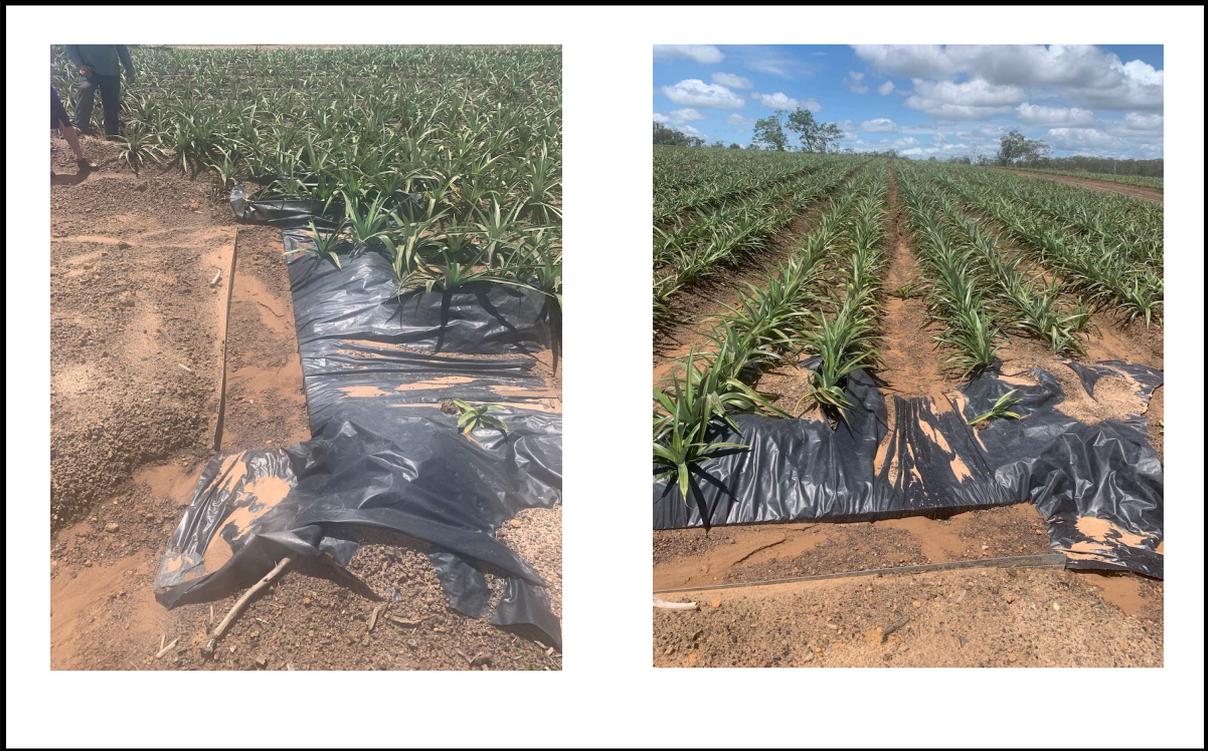
Soil erosion levels were measured using metal troughs buried at the edge of the pineapple fields in each treatment. Two metres of plastic sheeting were laid on the surface of the ground and seed beds leading into the troughs. The plastic sheeting allowed unobstructed flow of water and sediment directly into the troughs. The troughs captured water at each rainfall event and once the water had evaporated the sediment remained in the trough.

Figure 5: Treatment 1A - high amounts of sediment collected in catchment troughs..

Treatment	Soil Loss
1A - Standard	111
1B - Contour planting	44
1C - Contour Bank	71

- Significantly high amounts of soil erosion in the standard practices, lowest soil erosion in pineapples planted along the 1% contour and moderate soil erosion in pineapples planted down slope with contour drains / banks across the block.
- The block planted down slope with contour drains / banks sediment has captured the majority of soil erosion within the contour banks / drains.
- Clear, visible signs of waterlogging were observed in the treatment with pineapples planted along the 1% contour with potential for phytophthora root rot. However, this may assist those pineapples in the dry conditions.

The industry standard layout performed the least of the three block layouts. Beds planted up and over slopes is most commonly used across the industry and primarily focuses on row direction aligned to a north-south orientation for uniform crop growth. It is a low cost layout but has limited ability to manage soil erosion. Using this type of block layout additional soil management practices are required such as planting or placing plants in the inter-row, use of soil stabilisers etc. These practices add substantial cost and have their limitations.

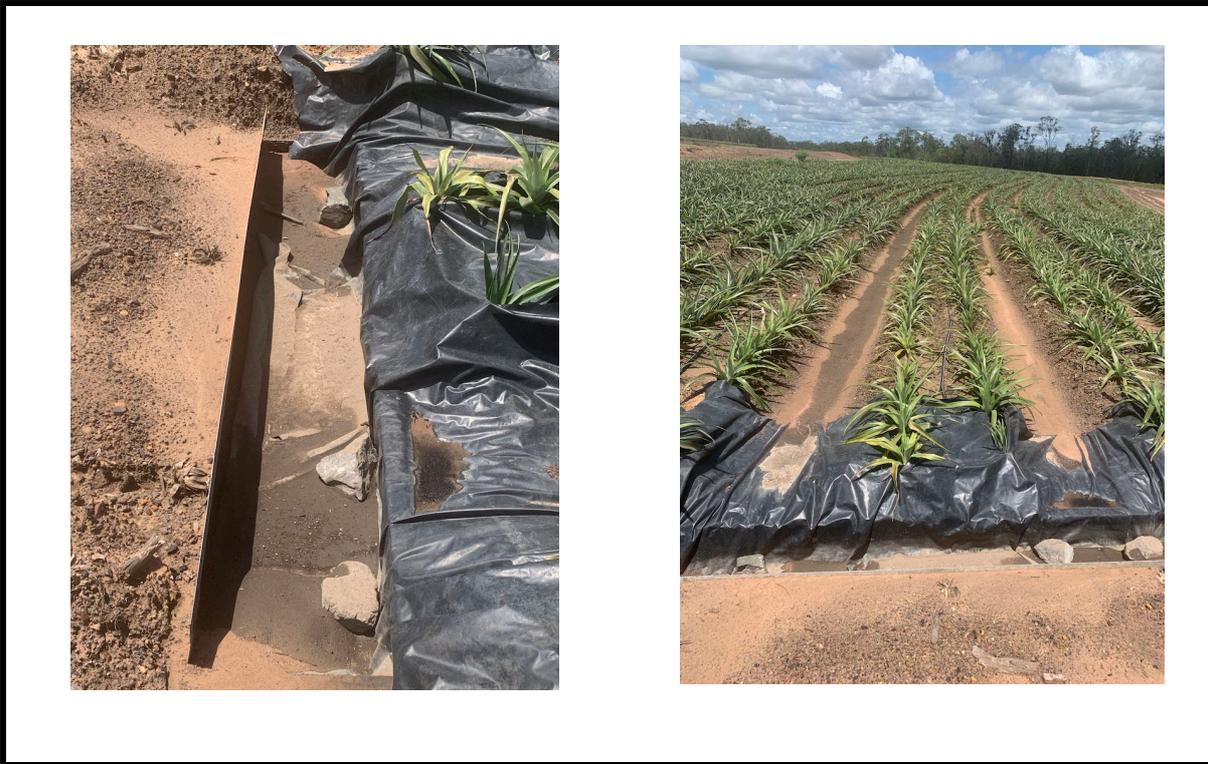
Figure 6: Treatment 1B - low amounts of sediment and evidence of water logging in field.

Beds planted along contours on a 1-2% slope are the most difficult to establish due to the complexity of forming beds across a slope to ensure the correct angles are achieved. This cannot be done with Global positioning systems (GPS). It is difficult to maintain bed uniformity with beds sloping or angled downhill due to the angle of machinery at bed forming. The potential for waterlogging is risk and will exacerbate phytophthora root rot and 'wet feet' if the slope is below 1-2%.

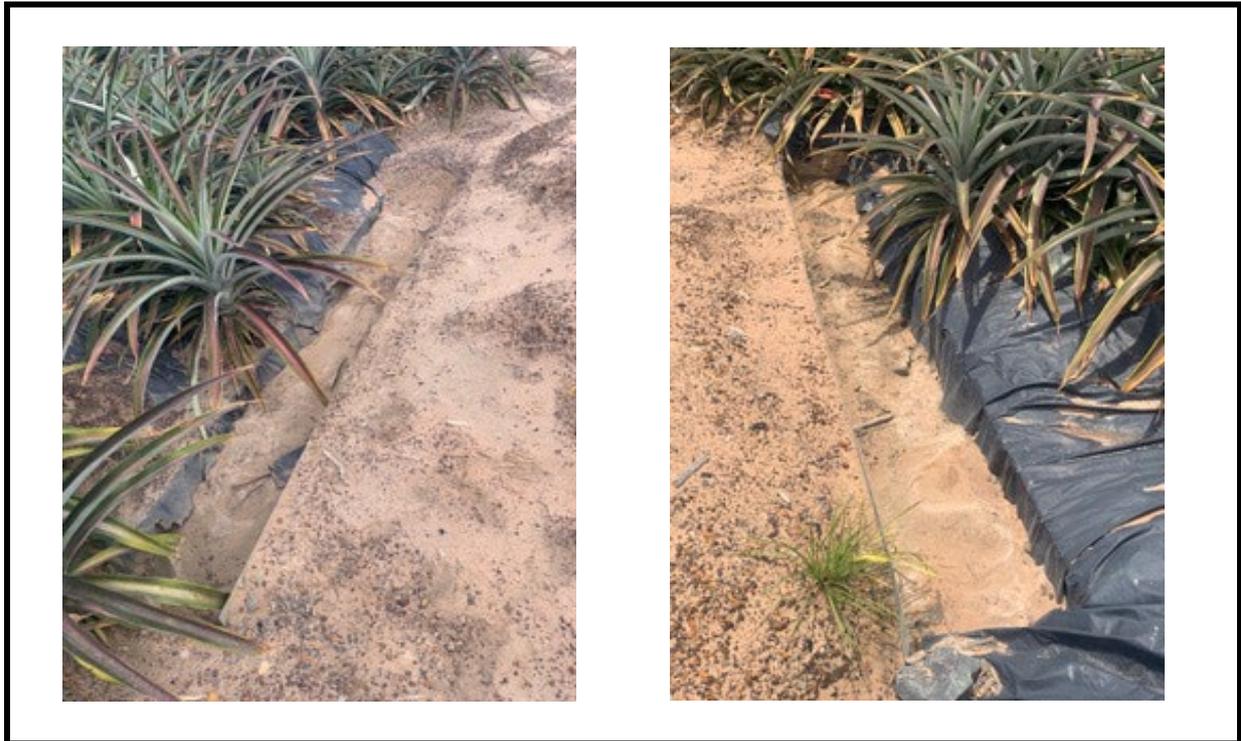
Figure 7: Treatment 1C – moderate amounts of sediment in catchment troughs.

Beds planted down slope with contour drains / banks across the block on a 1-2% slope will capture the majority of soil eroded within the contour banks / drains. This type of layout allows growers to align beds to a north-south orientation for uniform crop growth. This layout is simple to construct and cost-effective. The contour banks and drains are formed using grading equipment most commonly found on farm. The contour banks and drains are the width of this equipment and can be used to cost effectively clean and remove silt at any point throughout the cross cycle. This is often a limiting factor in smaller drains that require high manual labour and cost. The shape of the contour drains are wide and flat which disperses run-off water and minimises erosion. The contour banks stop run-off water moving from higher sections of the block into lower sections inhibiting accumulated water flow and build-up of sedimentation in the lower parts of the blocks.

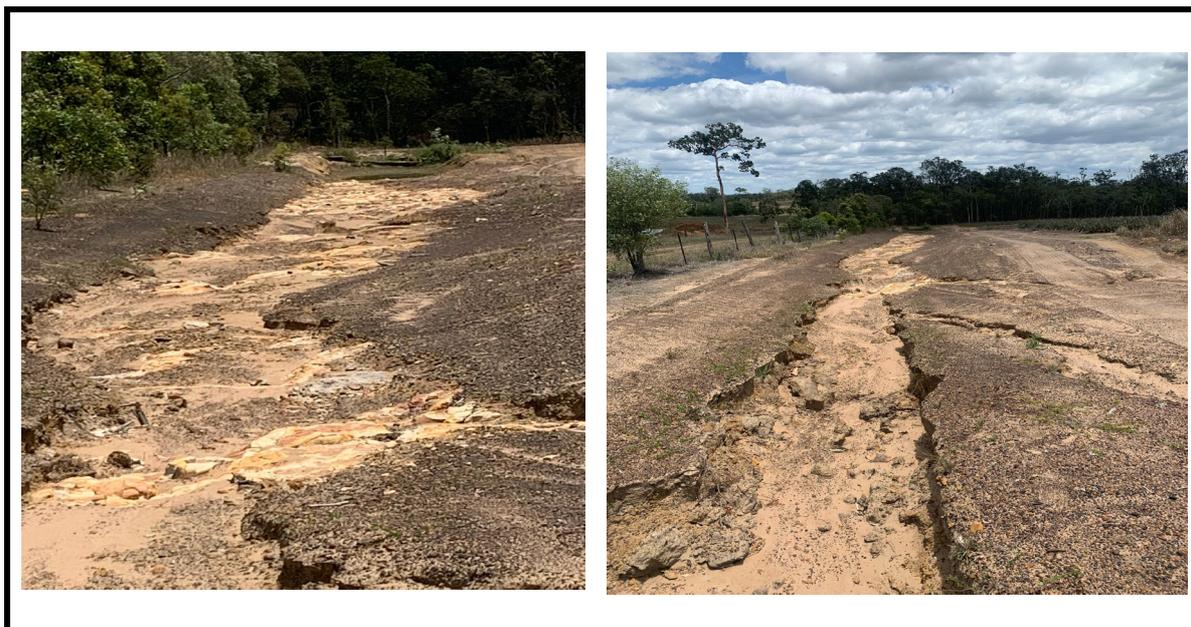
Treatment 2A consisted industry standard practices with no coverage or stabilisation of the drain. Observations over the 12 month period indicated severe scouring has occurred 40 - 60cm down to the hard rock and clay layers within the soil profile. The drain has limited capacity to retain any sediment and will continue to scour further over future rainfall events. A reinforced silt trap at the bottom of the drain was constructed to capture sediment but has not had the capacity to retain all of the erosion coming off the catchment area. High levels of sediment have overflowed the silt trap and left the farm.

Figure 8: Treatment 2A - scouring within drain at 12 months (left). Drain one month after installation (right).

The industry standard drain performed the least of the three drain designs. Maintenance requirements were substantially high due to the constant erosion and resultant scouring. These types of drains will further erode wider and deeper with continued rainfall events. In some areas where water consolidated, sediment would fill the drain reducing the overall functionality. The simplicity and low cost of construction was an advantage however the lack of surface stabilisation provided no protection against erosive damage from runoff water. The potential for major farm disruptions and crop damage during substantial rainfall events created a high risk (Griffin, 2019).

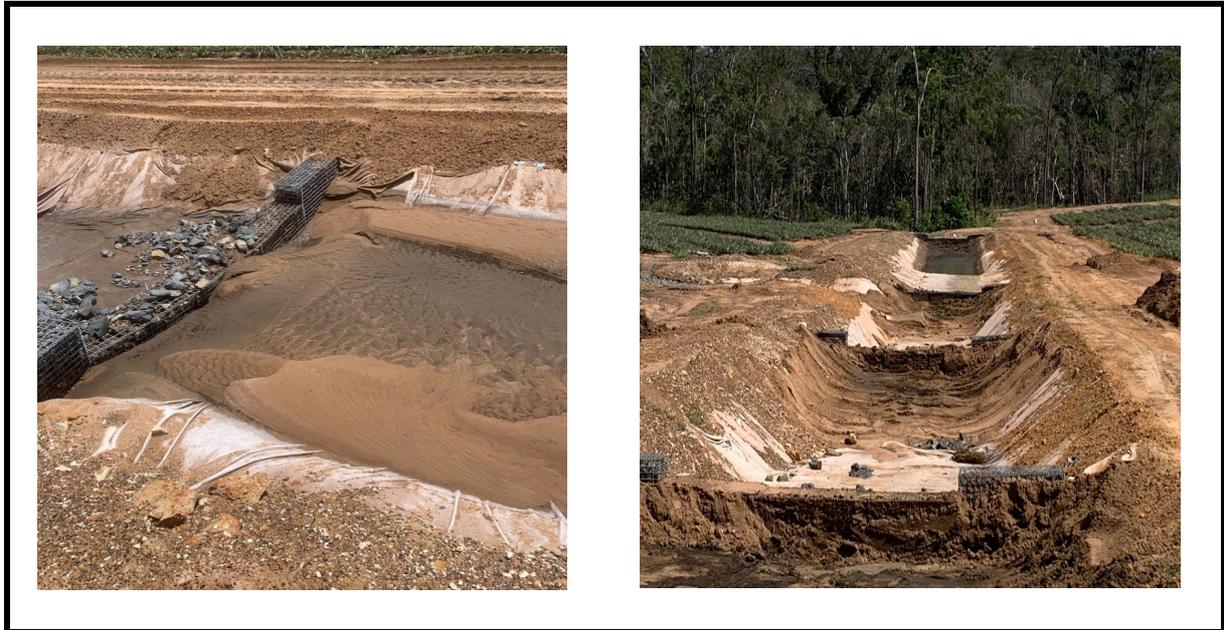
Treatment 2B consisted an open drain stabilised by Geofabric, segregated by three gabian basket levy banks with a silt trap located at the bottom. The catchment area emptying into this drain is from beds planted up and over slopes with no contour banks (standard practice). Within this treatment a high level of erosion from the catchment area has been contained by the gabian basket levy banks. The containment of the sediment has primarily occurred above each of the gabian basket levy banks which require continual maintenance.

*Figure 9: Treatment 2B - Sediment captured behind levy bank (left). Sediment removed from primary drain (right).*

Drains constructed with gabian basket levy banks and geofabric for soil stabilisation gave the best reductions in sediment losses off farm. The success of this type of drain was the gabian basket levy banks which acted as a barrier to slow water as it moved down gradient but not significantly limit water from exiting the block. It is critical the strategic placement of levy banks is needed to maximise the drain effectiveness. These drains were most effective at capturing large volumes of sediment in high rainfall events however consisted high cost, elaborate construction and were labour intensive. Extra care was needed when cleaning out sediment traps due to geofabric lining, making the process more time consuming. The concept can be modified and simplified to reduce costs and labour (e.g. gabion basket weirs replaced with rock strips) (Griffin, 2019).

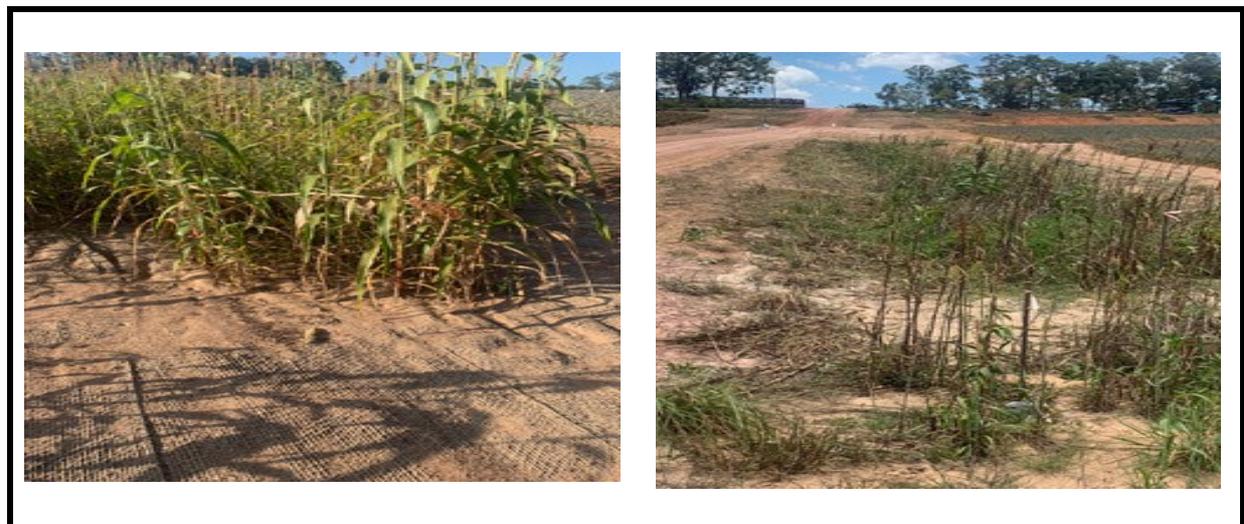
Treatment 2C consisted an open drain stabilised by Jute Mesh as a ground cover then planted with a vegetative crop of sorghum. The drain then emptied into a sediment pond at the bottom. The catchment area emptying into this drain consisted beds planted down the hill with contour drains across the slope. Within this treatment moderate levels of sediment were captured in the drain, however a good volume of sediment over-flowed into the sediment pond moving around the planted vegetation.

*Figure 10: Treatment 2C - eroded soil captured on jute mesh (left). Vegetated drain at 12 months (right).*

Drains constructed with jute mesh and vegetative planting for soil stabilisation is a simple, low cost construction process. Reductions in sediment loss off farm using vegetative coverage is very successful. However, earthmoving equipment is required to sculpt drain and labour to lay the jute mesh lining. The jute mesh has a limited lifespan of approximately 12 months. Soil stabilisation with vegetation takes time to grow before it can be effective for erosion control. It is important to understand soil and seed loss can occur before vegetation can establishment. Vegetative drains can harbour weeds, be a vector for pests and disease and may require management to avoid potential flow concentrations. Jute mesh lining alone would also be effective for short term erosion control. Other materials (e.g. carpet) can be used in place to assist soil stabilisation and vegetation establishment (Griffin, 2019).
