# FIBREGLASS PUMP STATIONS: 10 YEARS EXPERIENCE IN NEW ZEALAND

Presented at the Water New Zealand Conference, Rotorua, November 2011

*Holyoake, K.M.; ARMATEC Environmental Ltd, and Guthrie, B.C; ITT Water & Wastewater NZ Ltd*

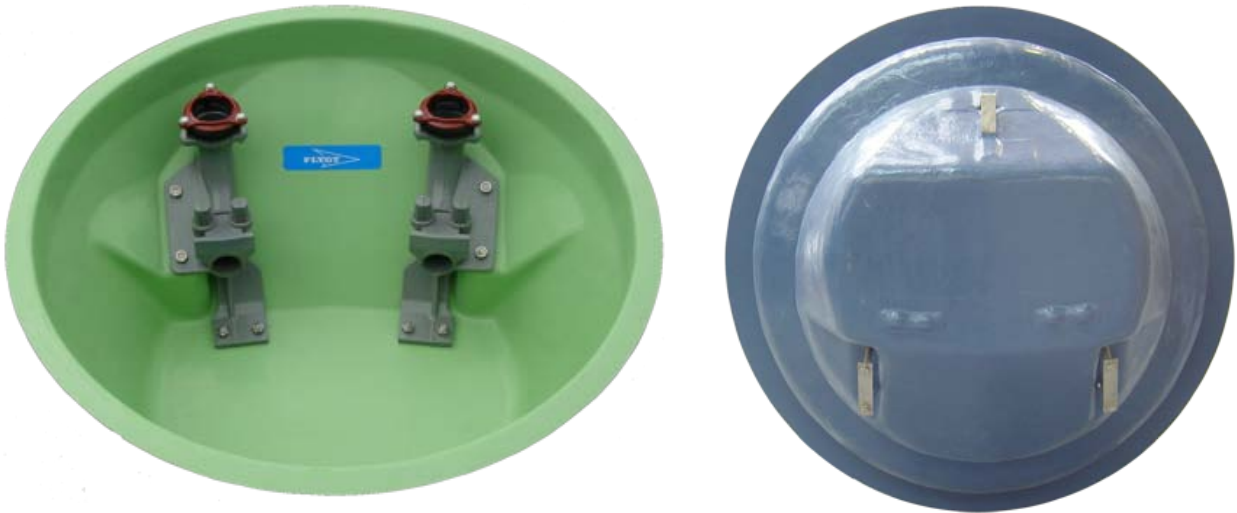
Pump anchorage in fibreglass pump stations can be either on the floor, or on the sloping side just above the base (Photographs 3,4). The discharge foot bolts through the base and can be embedded in concrete to provide secure anchoring. The mass of the concrete can then absorb any out of balance energy. This optional extra poured concrete has proven very effective in New Zealand conditions, and is preferred by many installation contractors and Councils.

*Photographs 3, 4: Contoured base with discharge bends mounted.*

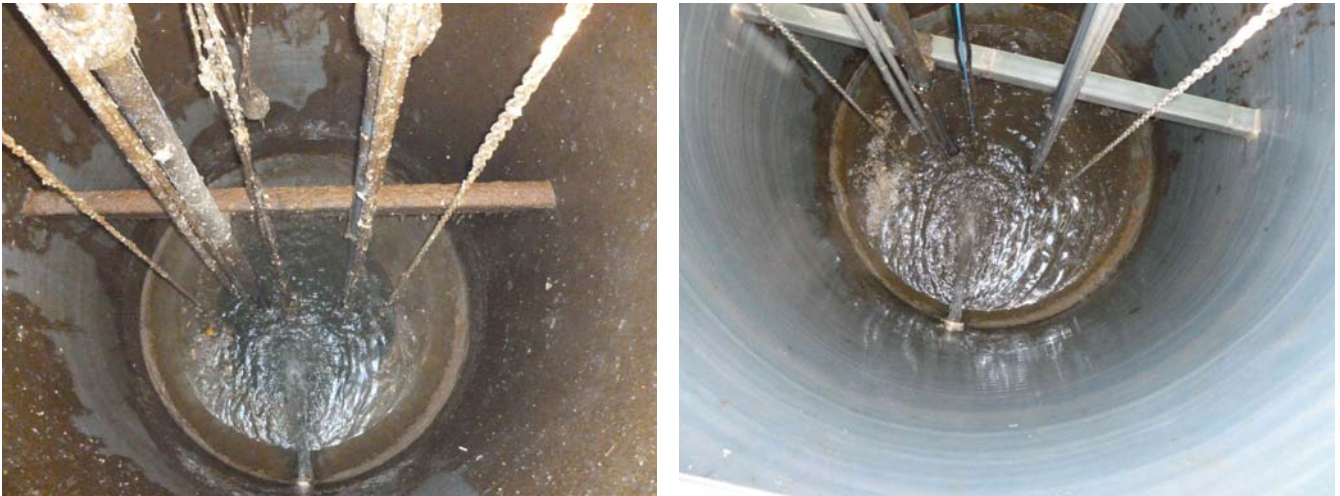
Fibreglass manufacturing techniques result in smooth sidewall finishes on the inside of the vessel. Wastewater solids can still stick to the walls, but are easily and quickly cleaned down with a standard hose or well washing regime.

*Photographs 5 & 6. Fibreglass pump station before and after 5 minutes cleaning with hose.*

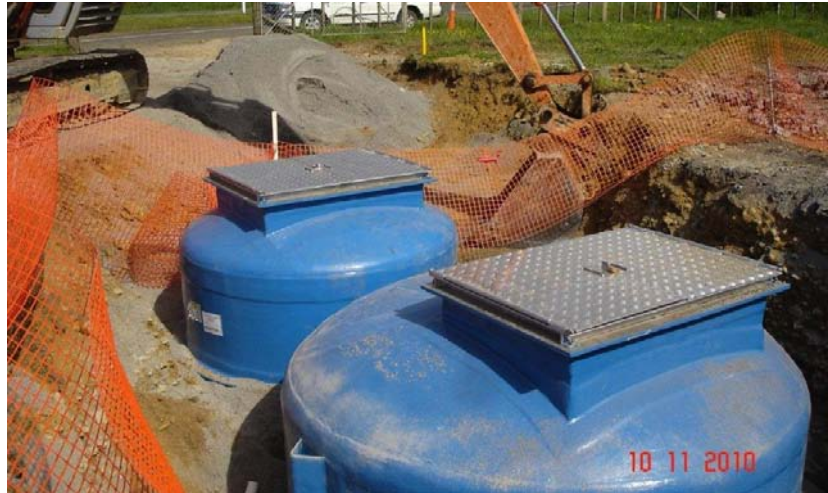
Photograph 18: Eketahuna Fibreglass Pump Station and Fibreglass Valve Chamber

The Eketahuna pump station was installed in 2010 to handle wastewater from the lower parts of the rural town of Eketahuna. The installation included a fibreglass valve chamber. The supervising engineer from the Tararua District Council stated (Bonny, 2011) that the installed cost was about the same, or a little lower, than building it in traditional all concrete. He stated that there were huge savings in reduced health and safety costs, as no one needed to enter the pump station during construction. These savings in time, resources, supervision, and labour are often difficult to quantify. Total project cost analysis showed that the costs of the fibreglass vessels were only 30 percent of the total pump station and valve chamber project cost.
