INSPECTION REPORT

For the Property at:
SAMPLE ADDRESS
GRAYSLAKE, IL

Prepared for: SAMPLE REPORT
Inspection Date: Saturday, August 1, 2015
Prepared by: Lucas Weigle

Report No. 1029

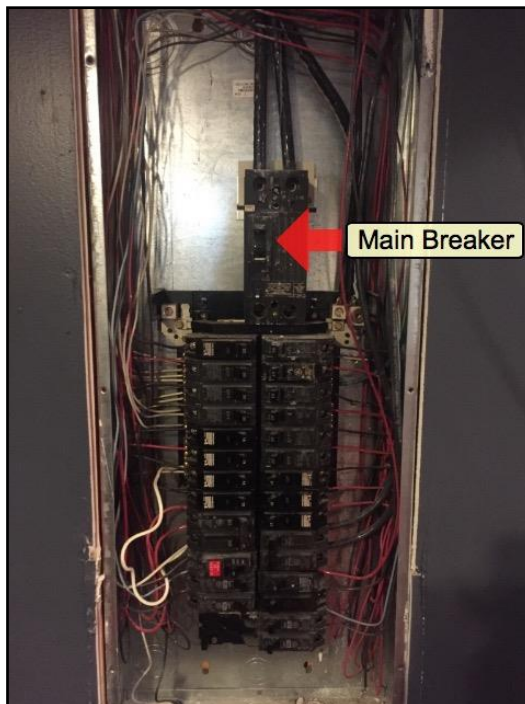
Main disconnect/service box type and location:

• Breakers - basement

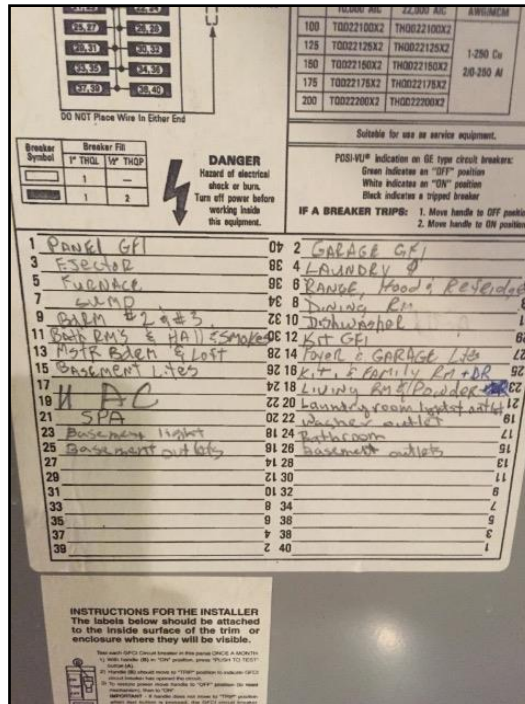
SERVICE BOX, GROUNDING AND PANEL \ Distribution panel

10. Condition: • Loose panel

Panel cover missing 3 screws. Obtain proper screws for installation via local hardware store or contact a licensed electrician if needed.

Implication(s): Electric shock | Fire hazard

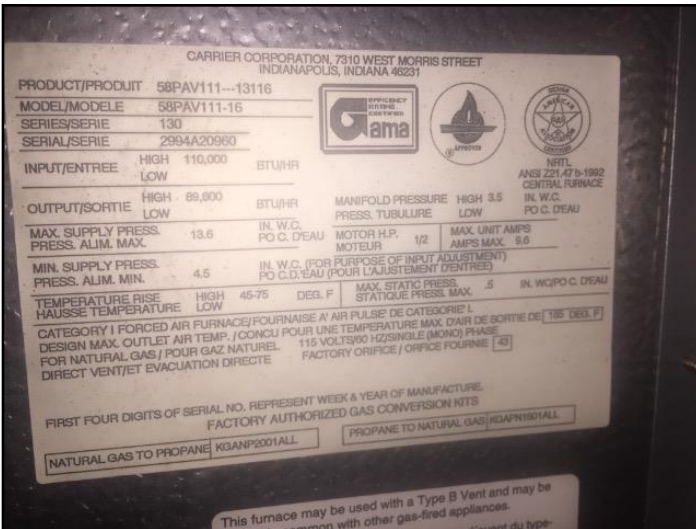
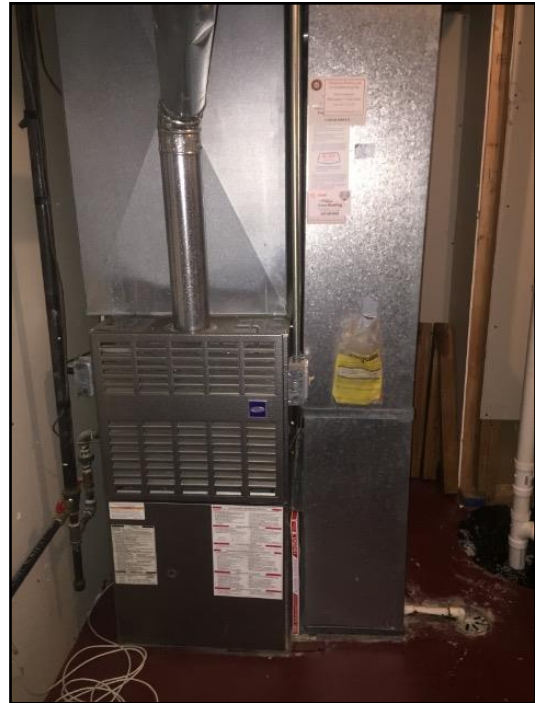
Manufactured: July 1994

Model number: 58PAV11116 Serial number: 2994A20960

18. **Condition:** • Near end of life expectancy

Start budgeting for its replacement. Contact a licensed HVAC professional.

Implication(s): Equipment failure | No heat for building

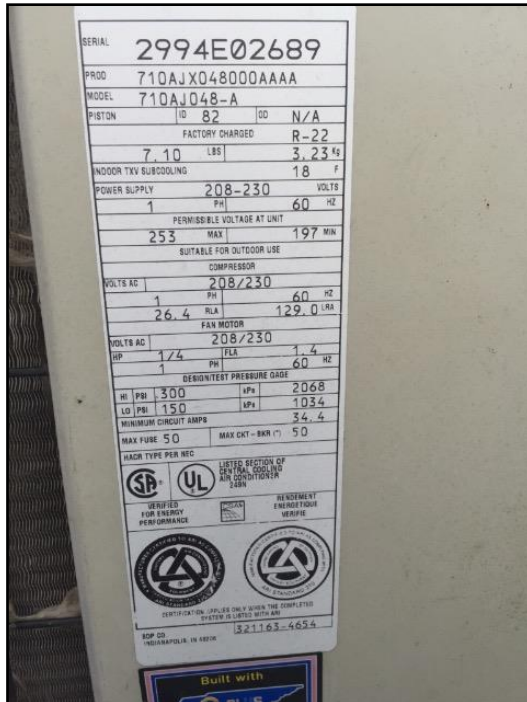
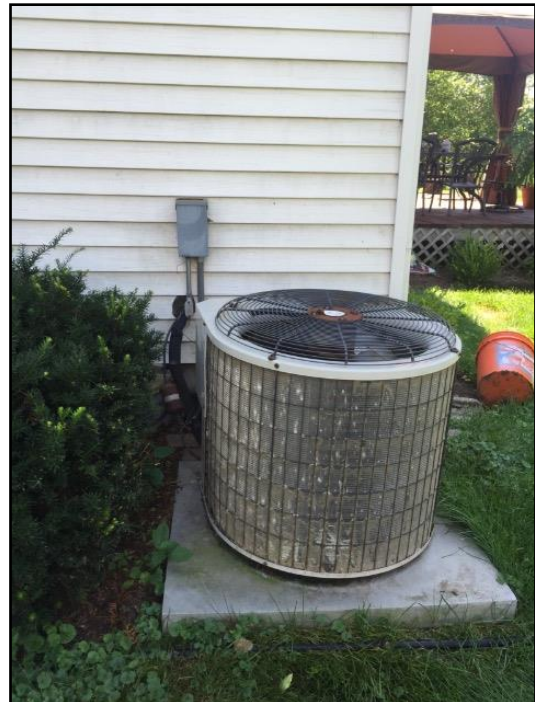
Manufactured: July 1994

Model number: 710AJ048A Serial number: 2994E02689

22. **Condition:** • Near end of life expectancy

Implication(s): Equipment failure | Reduced comfort

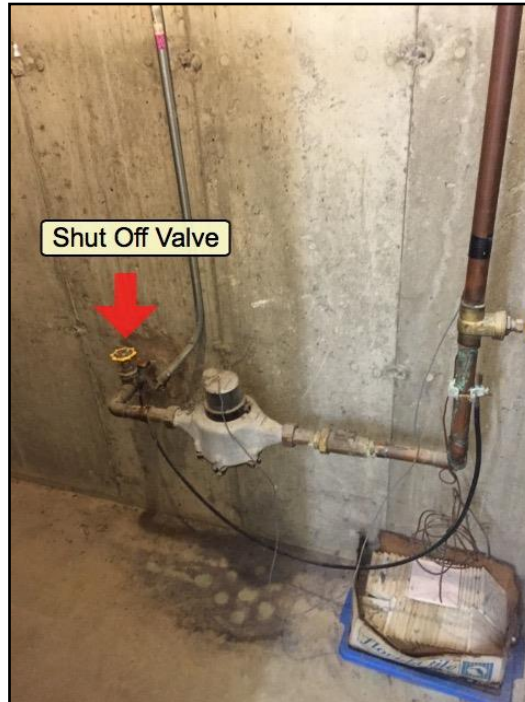
Meter is located in the basement on the northeast wall

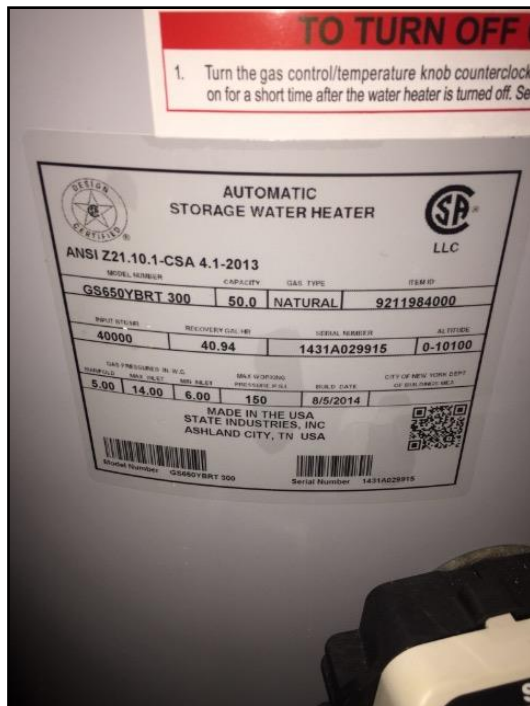
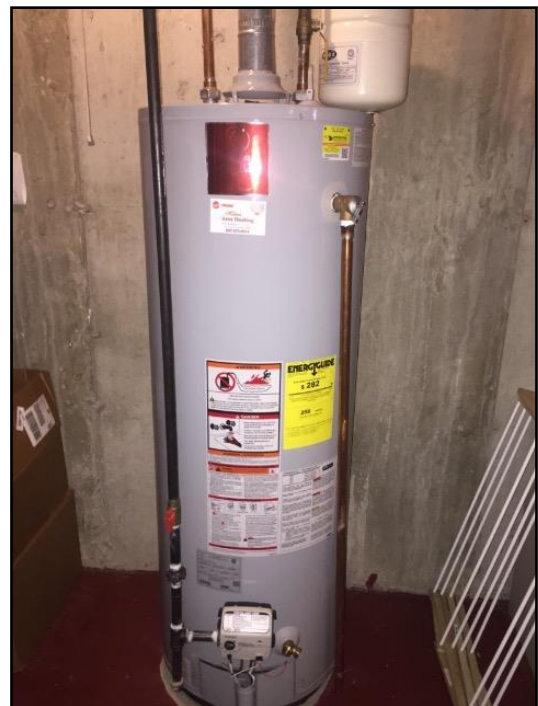
Manufactured: August 2014

Model number: GS650YBRT 300 Serial number: 1431A029915

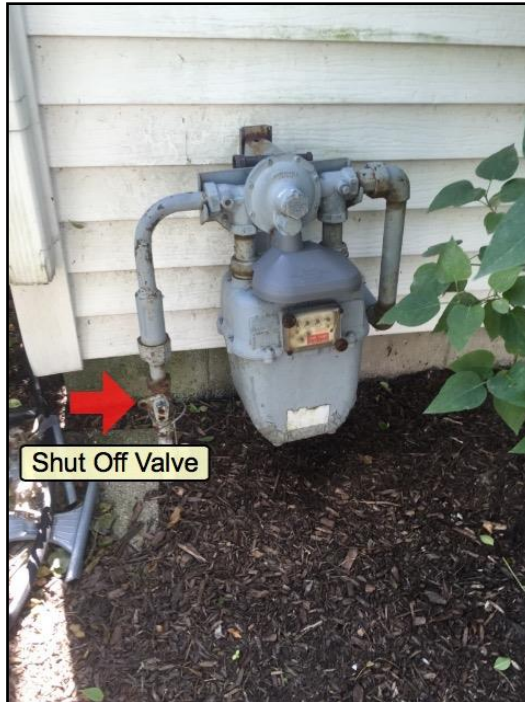
Located on the north exterior wall
