BOHOL HERITAGE CHURCHES

Summary of Findings & Recommendations - STRUCTURAL

The JV Digiscript and EM2A Partners & Co was commissioned by the National Museum to undertake a detailed investigation of the causative mechanisms, environmental factors (Geology and Geotechnical considerations) to come up with General Conclusions and recommendations on the directions for Repair, remediation and reconstruction for each of the specific 9 Heritage Structures assigned to the JV.

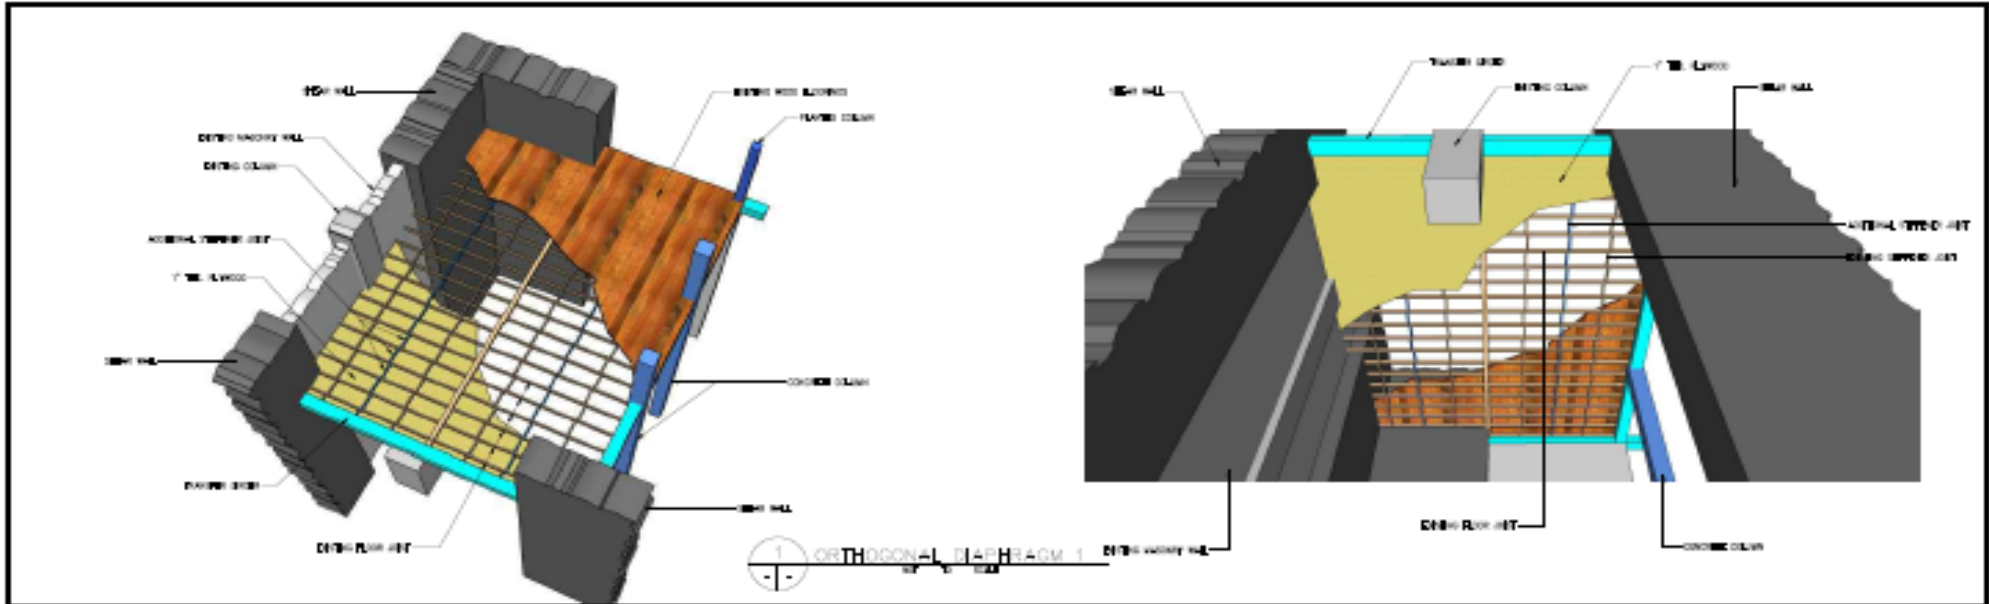
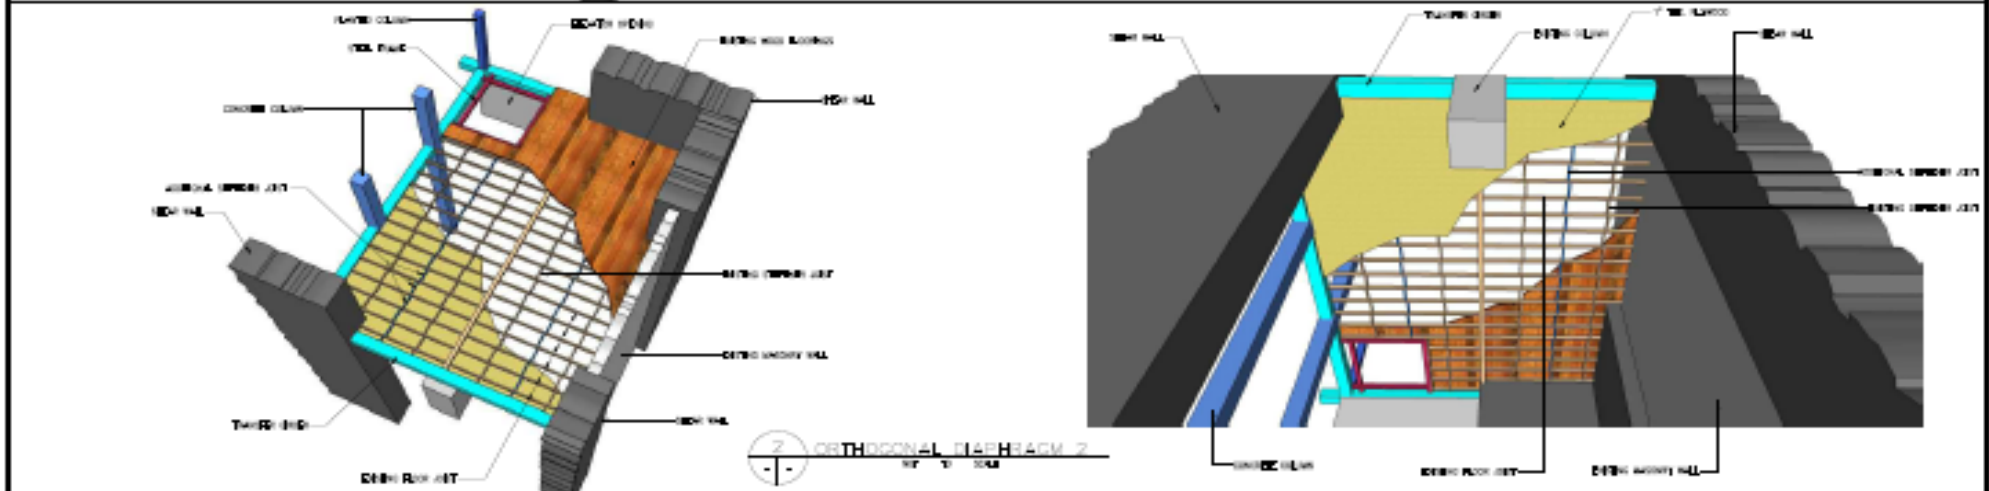
OF HORIZONTAL TIMBER FLOOR DIAPHRAGMS STIFFENED BY PLYWOOD IN BOTH ORTHOGONAL DIRECTIONS

Due to the addition of an RC concrete deck at the 2nd Floor Level, lateral loads have aggravated the already Damaged Structure.

Additional beams/girders attached to these walls serves as horizontal Transverse Girders..

To the Left are the lateral deflections of the existing masonry walls when retrofitting is applied using Horizontal Diaphragms and Shear Walls. The highlighted lines are the additional structural framing used to carry the new loads. These structural framing are also supported by the shear walls (highlighted plates). It is observed that theoretical lateral deflections have been greatly reduced from 589 mm to 8 mm on the middle top of the façade wall. This proves that horizontal diaphragms play a big contribution in distributing the lateral stresses on the walls..

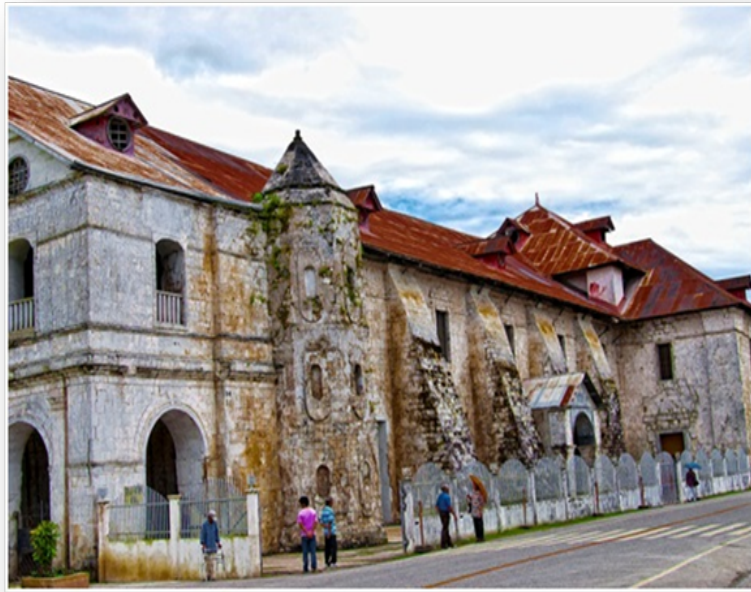
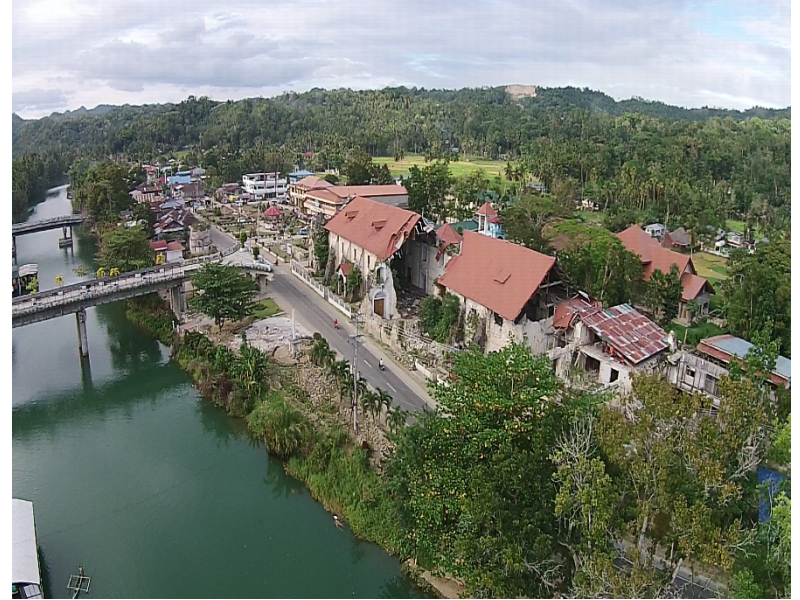
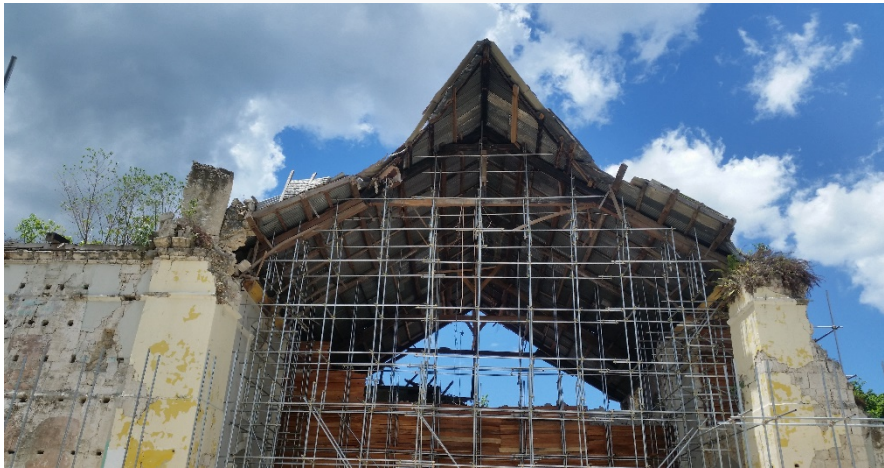
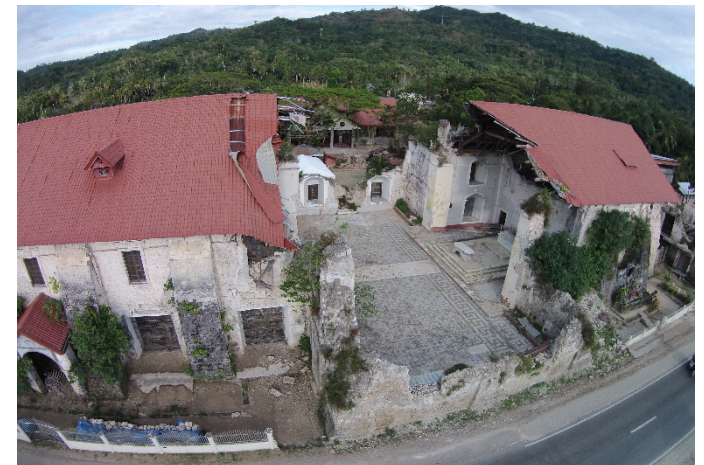
LOBOC CHURCH

The major damage sustained were on **the unbuttressed transepts** as well as the front and rear facades of the church which were also not buttressed.

The buttressed walls are only lightly damaged. This is clearly due to the presence of the buttresses serving as stiffener along the walls of the church nave but not on the transept sections.

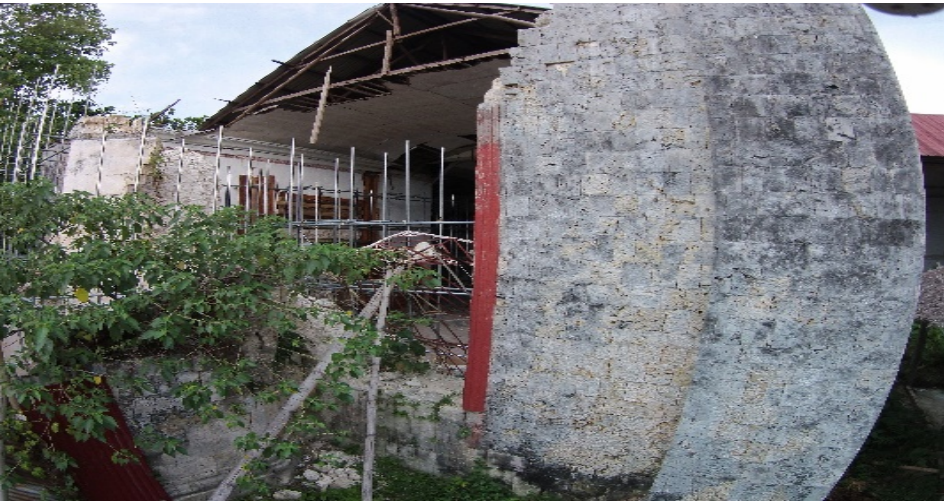
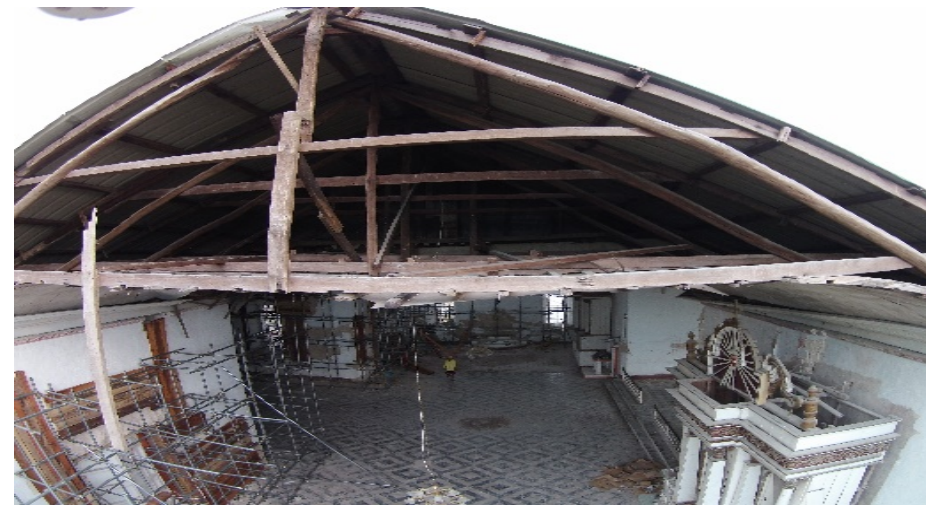
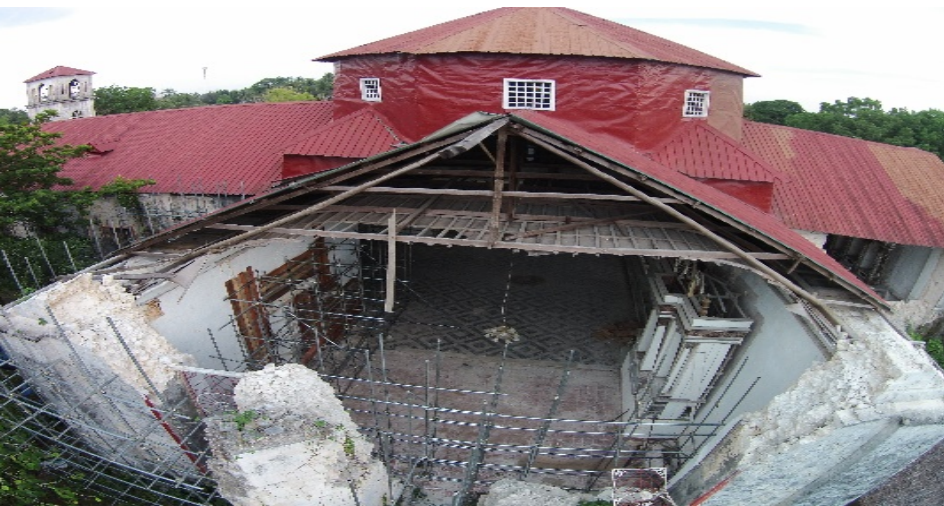
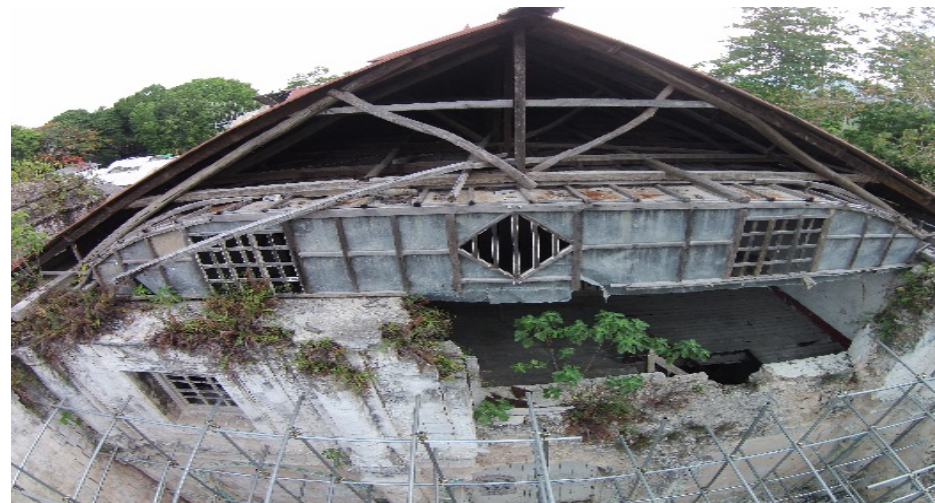
CORTES CHURCH

The damage to walls are in general relatively minor **with the exception of the extensive damage suffered by the transept walls initiated at the reentrant corners.**

The wall damage consisted mostly of cracks and delamination of plaster. These are generally amenable to repair and remediation to prevent further crack propagation.

Effective coupling of the existing walls to the retrofitted buttresses would require the use of dampers or dissipative devices to absorb the energy during seismic excitation to prevent major separation of the wall/buttress interface.

The transept walls can be reconstructed using a Lime mortar wall with independent foundation footings when provided with a veneer wall at the interior and exterior that is bonded to the existing wall by lime mortar with wire mesh anchored to the concrete.

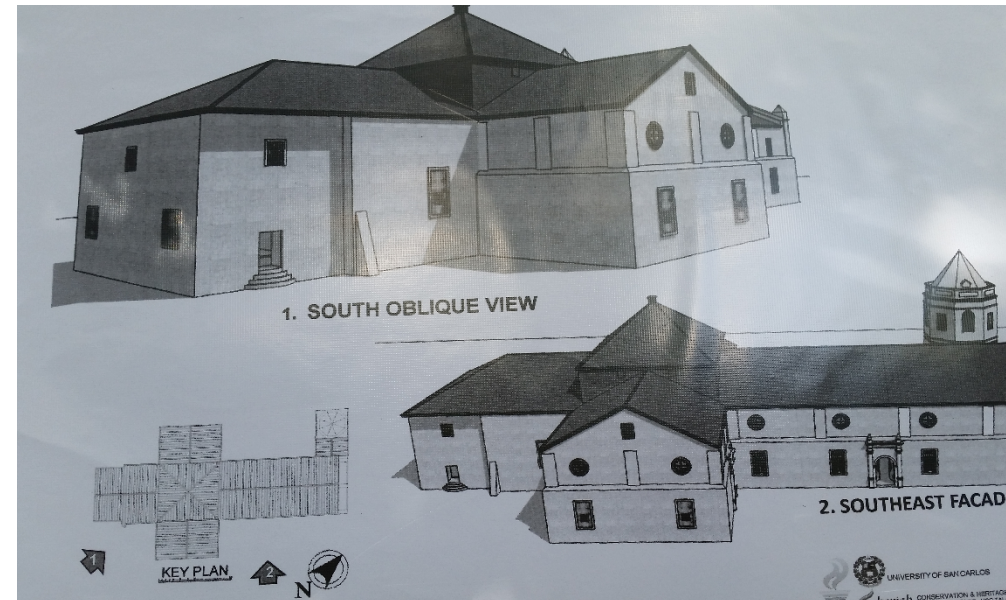
Maribojoc Church PARTIAL CAVITIES MAP

However, there is still the concern of the occurrence of interconnected cavities within the church footprint and elsewhere. These would have to be verified and addressed before reconstruction plans are even contemplated.

Faithful reconstruction, tracing the original footprint of the church, would be a realistic direction to take to do away with any geotechnical concerns such as settlement or bearing capacity failure due to past preloading history.
