FINAL REPORT

HIGH LEVEL BRIDGE PEDESTRIAN AND CYCLING SAFETY REVIEW

AUGUST 2016

PREPARED FOR
CITY OF EDMONTON

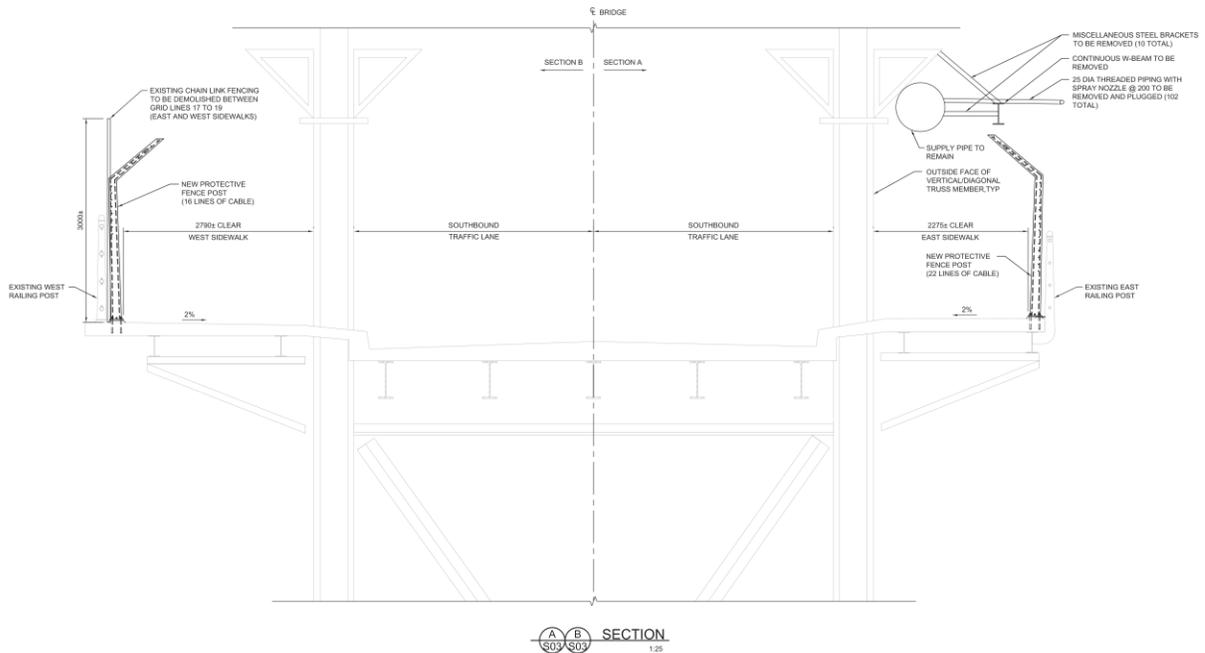
Figure 3: High Level Bridge Typical Cross-Section
Source: City of Edmonton High Level Bridge Tender Drawings

Following the installation of the protective fences, the typical pathway widths are 2.3 metres on the east side pathway, and 2.8 metres on the west side pathway, as shown in **Figure 3**.

On-site observations indicated that these widths resulted in some conflicts (near collisions) between users of the pathways on both sides of the bridge. In particular, the most significant conflicts were observed along the east pathway due to limited width and the pathway being used as a two-way facility shared between pedestrians and bicycle users. There were minimal separations between road users, especially between cyclists, travelling in opposite directions on the east pathway due to the narrow width. Issues were observed when cyclists engaged in a passing maneuver and crossed to the opposite of the pathway, which created conflicts with pedestrians who may not be aware of the passing, as well as oncoming bicycle users. Similar issues were observed on the west side pathway. Although the west side pathway is wider, similar issues were experienced due to the higher pedestrian and cycling volumes on this side of the bridge.

The Guide further states that a 0.6 metre horizontal clearance be maintained from lateral obstructions. However, this lateral clearance is seldomly constructed for bridges due to the high additional cost. The existing widths provided on the east and west pathways are clearly substandard to the dimension (minimum 3.0 metres) recommended by the Guide for two-way operation with both people walking and cycling. It should be noted that, prior to the installation of the protective fences, the east side pathway did not satisfy the minimum width of 3.0 metres recommended by the Guide.

Given the existing conditions, to ensure the safe operation of the pathways, it is suggested that the pathway operations be modified, and it would be desirable that the resulting operations and widths would be in accordance with the Guide, i.e. meeting minimum design guidelines.

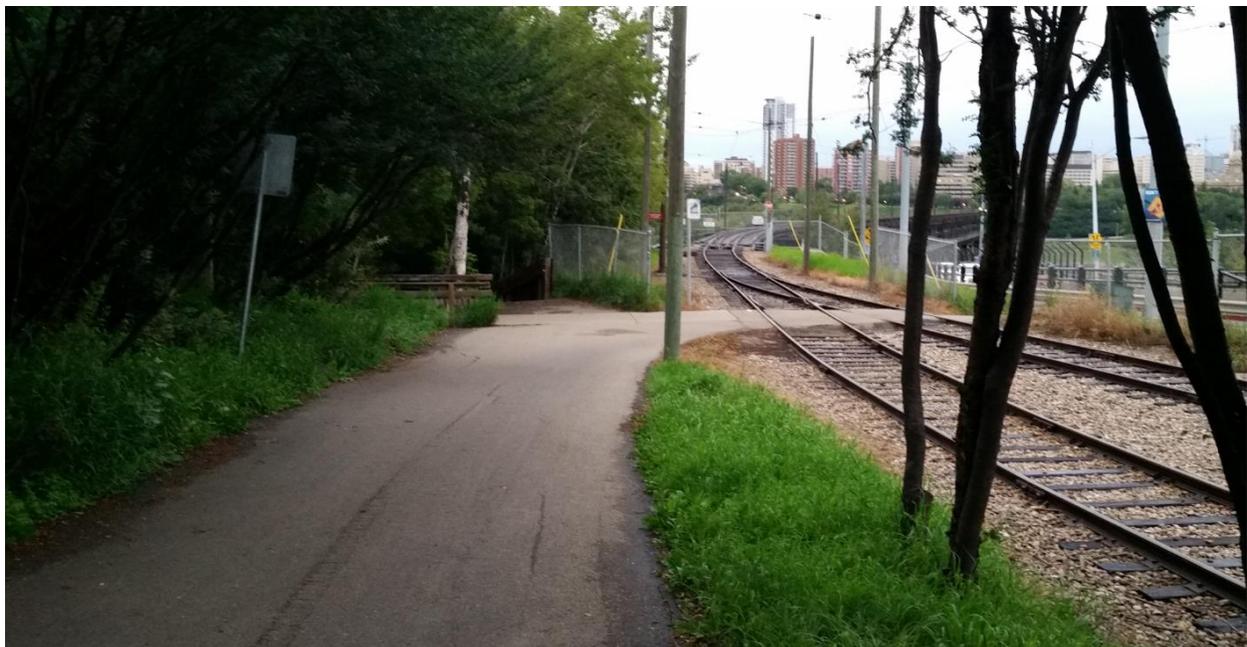
Figure 17: South End/West Side Parallel Multi-Use Pathway

The pathway south of the bridge on the west side is currently being used as a shared use pathway with two-way operations (**Figure 16** and **Figure 15**). The current width of this pathway does not meet TAC's minimum width guidelines. Further, the pathway is confined by a fence separating the pathway from the rail tracks. However on this side of the bridge approach, there is no fence separating people walking and cycling from motor vehicles. Some utilities are also located within the pathway, resulting in further constraints at some locations. This lack of separation could create a situation where if a person walking or cycling were to lose control and fall off of the pathway they could be struck by moving motor vehicles. There is a shared use pathway that runs parallel to the narrower sidewalk (**Figure 17**). The limited lighting, overgrown vegetation and lack of visibility from the street can make this route less appealing due to personal safety concerns, resulting in more people cycling on the narrower pathway.

- Consider widening the west side pathway, subject to structural, geotechnical and/or property constraints. This may require working with other stakeholders to acquire additional space from the rail right-of-way if required.
- Consider installing a guard rail to prevent pedestrians and cyclists that fall from being struck by moving motor vehicles (**Figure 18**)
- Consider providing more lighting and additional vegetation maintenance on the designated multi-use pathway that runs parallel to the roadway on the west side of the bridge.

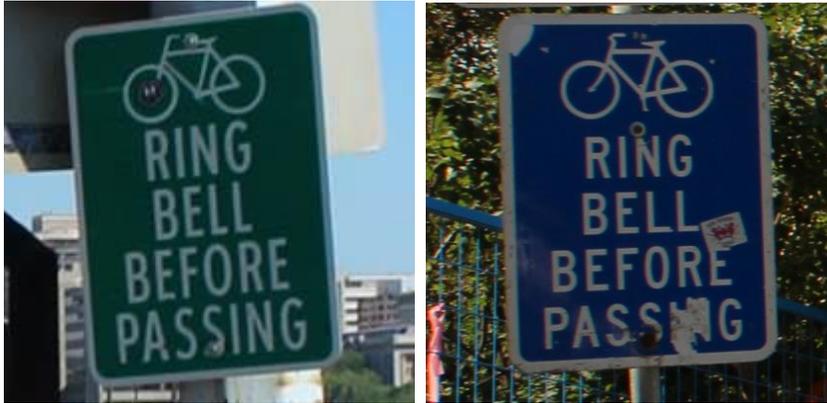
Figure 21: Examples of Existing Ring Bell before Passing Signage

- Ring bell before passing signage is already provided at the beginning and end of the pathway; however, this is not located on the bridge itself, and should be added at regular intervals in both directions along the pathway (suggested spacing of 100 metres) (**Figure 21**).

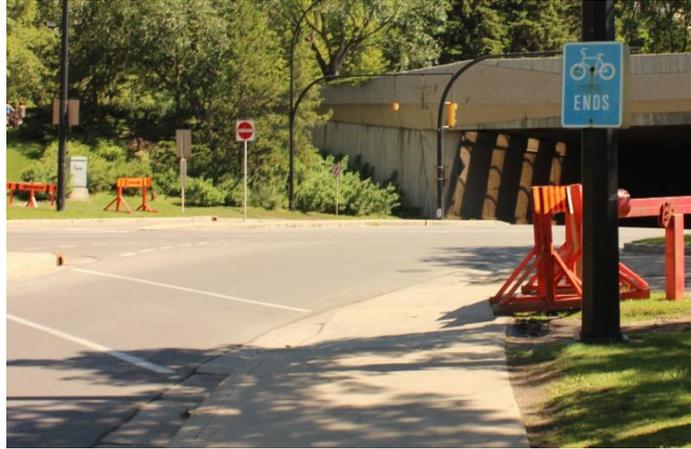
Figure 26: Bicycle Route Ends Signage

As seen in **Figure 27** below, there are a number of intersections that a person walking or cycling needs to cross to access the connections on either side of the bridge. People walking and cycling are sharing the sidewalk and crosswalk space, which can be uncomfortable and pose a safety risk to both user groups. It is also unclear if people cycling are permitted to share the sidewalks and crosswalks with people walking, as existing signage indicates that the shared use facility designation ends and there are no multi-use crossing (elephant's feet) markings or signage permitting cycling at crosswalks (**Figure 26**).

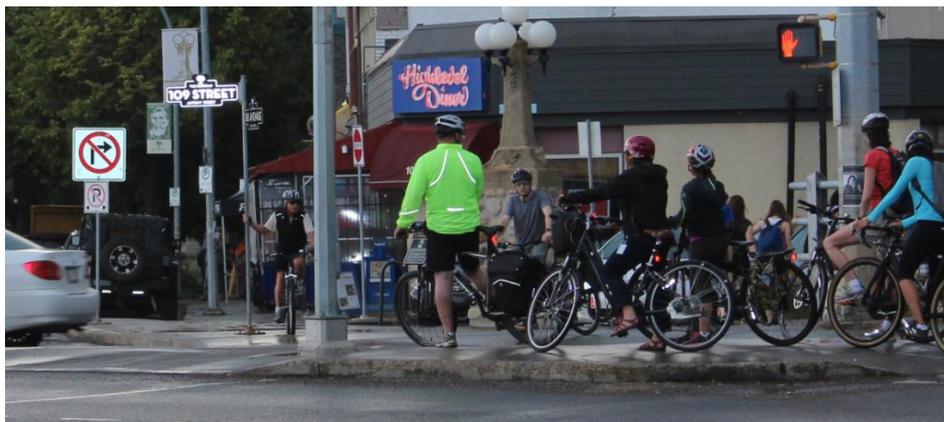
Figure 30: Refuge Island at 109 Street

Similarly to the north side, there are a number of different ways people walking and cycling can access the different sides of the bridge as seen in **Figure 29**. While not as complex as the intersections on the north side, the crosswalks and refuge islands still are functioning as a shared space for people walking and cycling and can create confusion as well as space constraints as both users are travelling through the intersection (**Figure 30**).

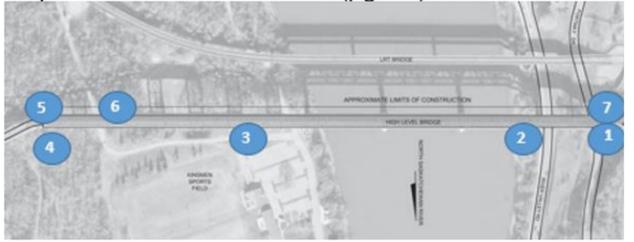
<p>Issue 2: Lack of Barrier Between Pathway Users and Motor Vehicles</p> <ul style="list-style-type: none"> The gaps between the truss members along the bridge deck on both pathways present a potential safety risk. Crossfall is greater in the areas of the truss members, and the deck slopes towards the roadway. 	<ul style="list-style-type: none"> The length of the bridge structure. 	<ul style="list-style-type: none"> Consider installing enhanced physical separation between the carriageway and the west side and east side pathways (example: additional cables).
<p>Issue 3: Obstructions and Pinch Points</p> <ul style="list-style-type: none"> There are several pinch points along the pathways which have constrained widths. At these pinch points the pathway narrows and creates an obstruction for pathway users, this is a potential safety hazard. 	<p>Map of Pinch Point Locations (pg. 18)</p>

<ul style="list-style-type: none"> Consider installing reflective hazard markings on all obstructions. Consider the installation of obstruction pavement markings. Consider installing additional warning signage at pinch points. Consider adding advance warning signs for pinch points. Consider removing where applicable the metal barrier located on the southeast approach.
